**Bundesstelle für Seeunfalluntersuchung**  
**Federal Bureau of Maritime Casualty Investigation**  
Federal Higher Authority subordinated to the Ministry of Transport  
and Digital Infrastructure

Investigation Report 86/13

**Very Serious Marine Casualty**

**Fatal accident  
of the entrance to the port of  
Figueira da Foz, Portugal  
on the training craft  
SY MERI TUULI  
on 10 April 2013**

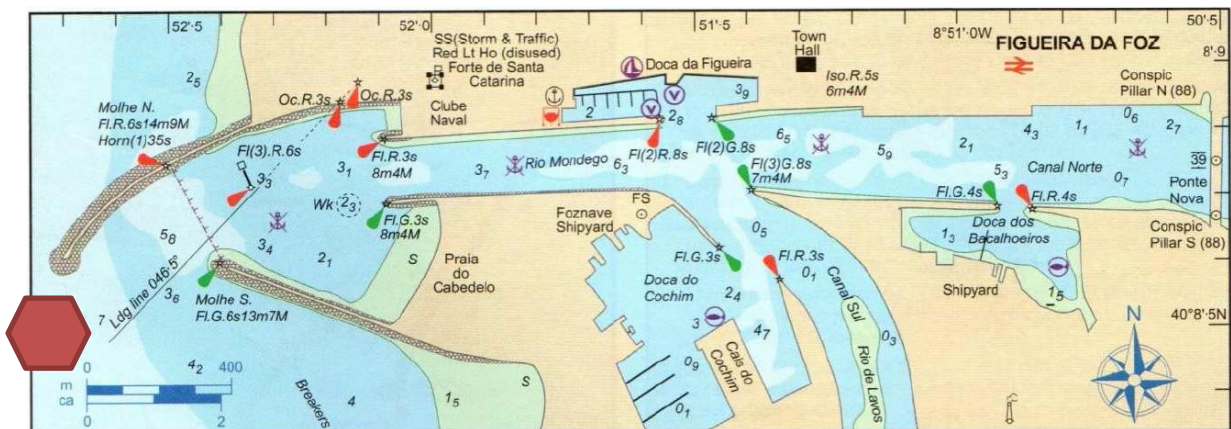
Fig. 2: Reeds Nautical Almanac 2013, scene of the accident

The northerly lighthouse on the jetty is incorrectly plotted in Reeds Nautical Almanac 2013 (see Fig. 2) and the charted depths correspond with the Imray chart (Edition 2005).

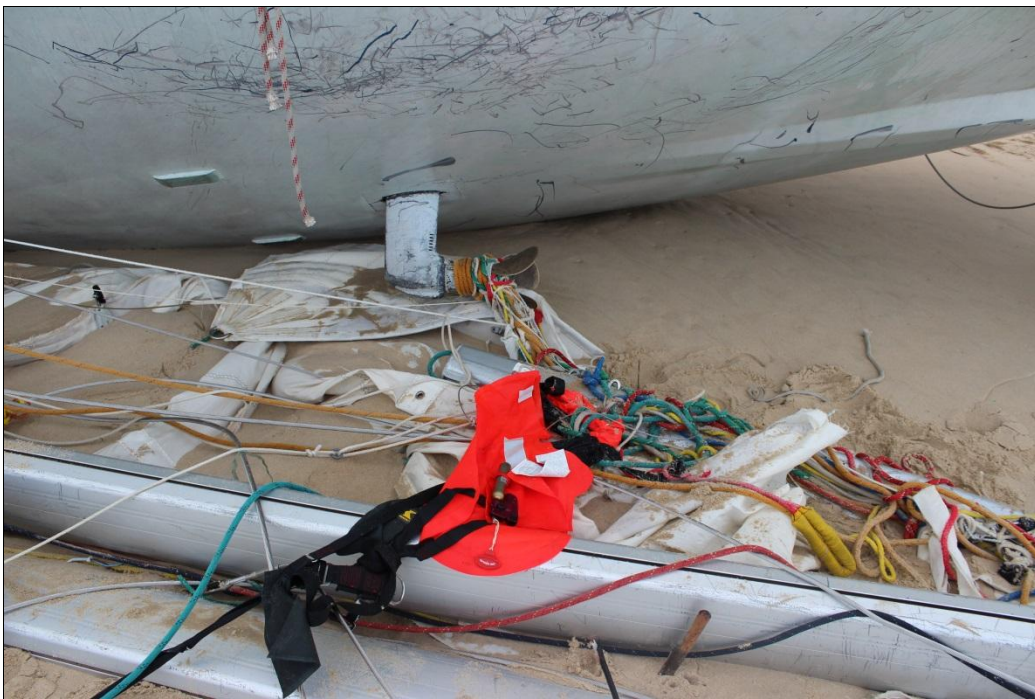
Fig. 4: Blocked screw

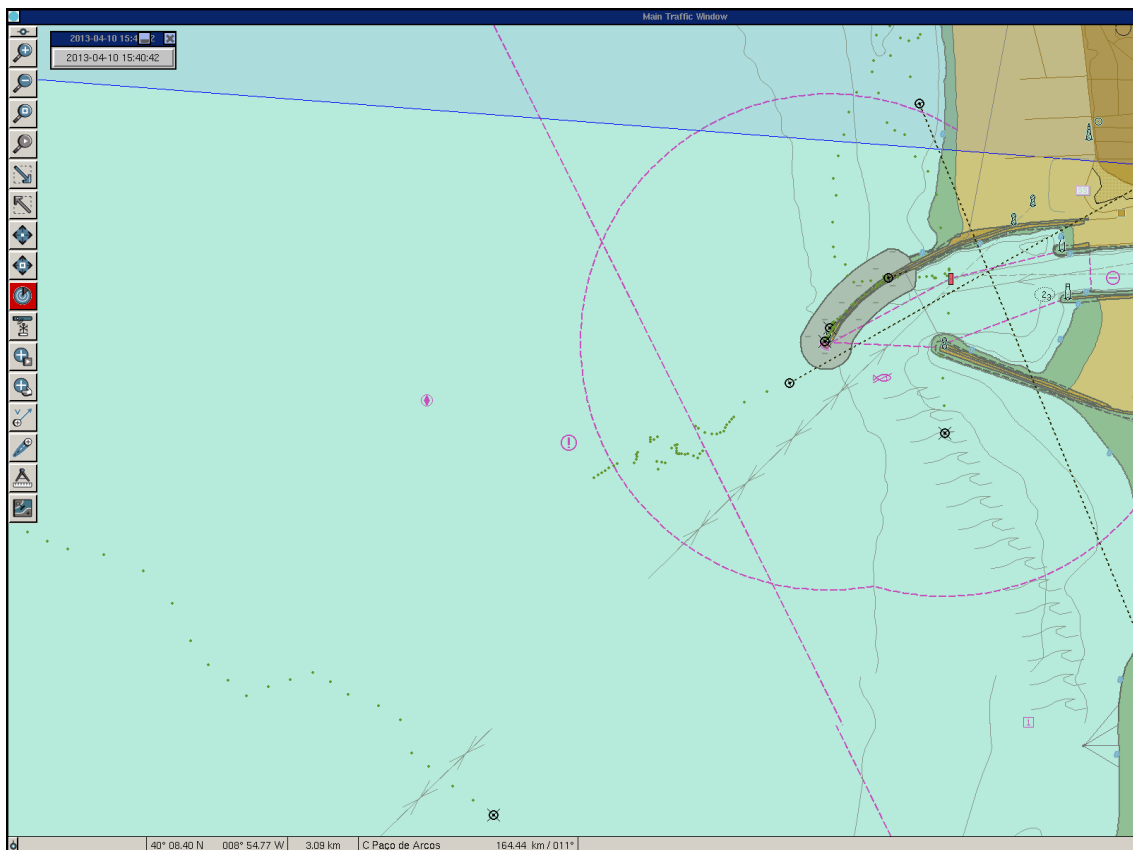
ECS with current Navionics charts and charted with extended northern jetty was used for navigation. According to the radar recordings, the accident happened at 1641 on 10 April 2013 just south-west of the northern jetty outside the calm zone.

Fig. 9: Radar recordings at the time of the accident (1641)

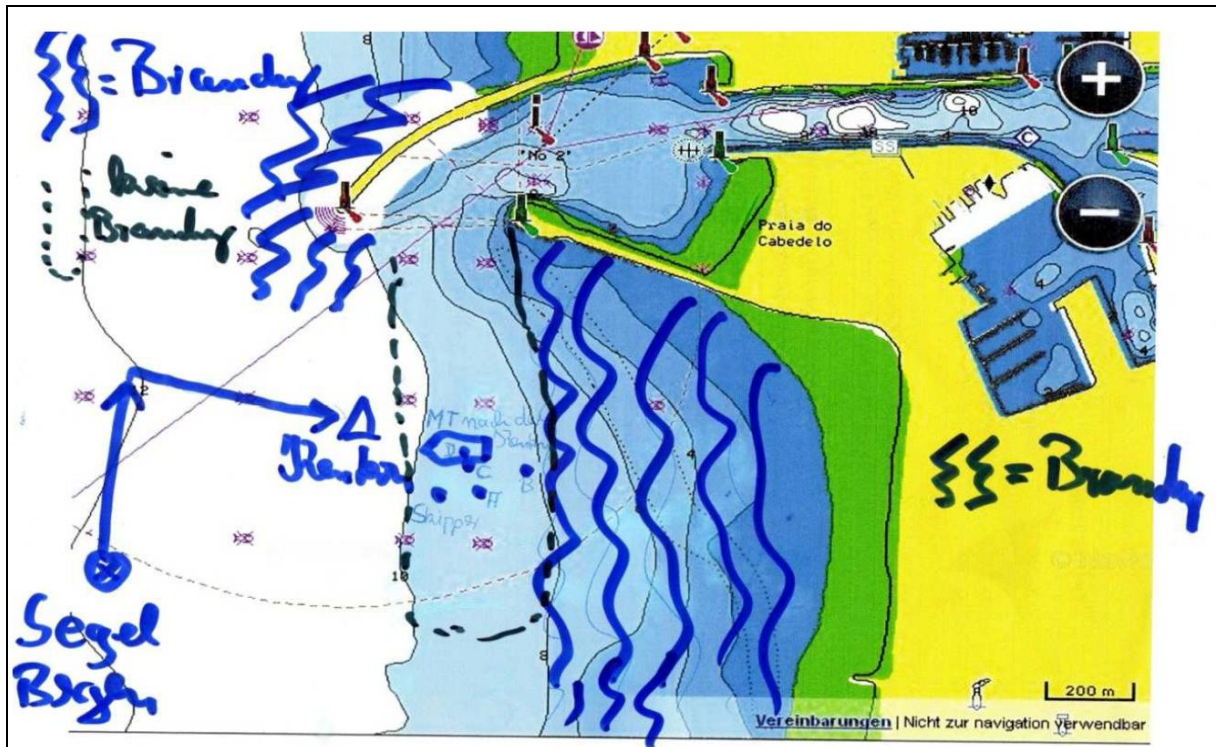
The sketch prepared by the sailing school, Nordtoern & Well Sailing, which overlays a Navionics nautical chart, shows the possible positions of where the sail was struck and the accident. This indicates that the MERI TUULI was located in the zone protected by the jetties. The scene of the accident was presumably closer to the northern jetty, in the unsheltered area (s. figure 9).

Fig. 10: Sketch by Well Sailing

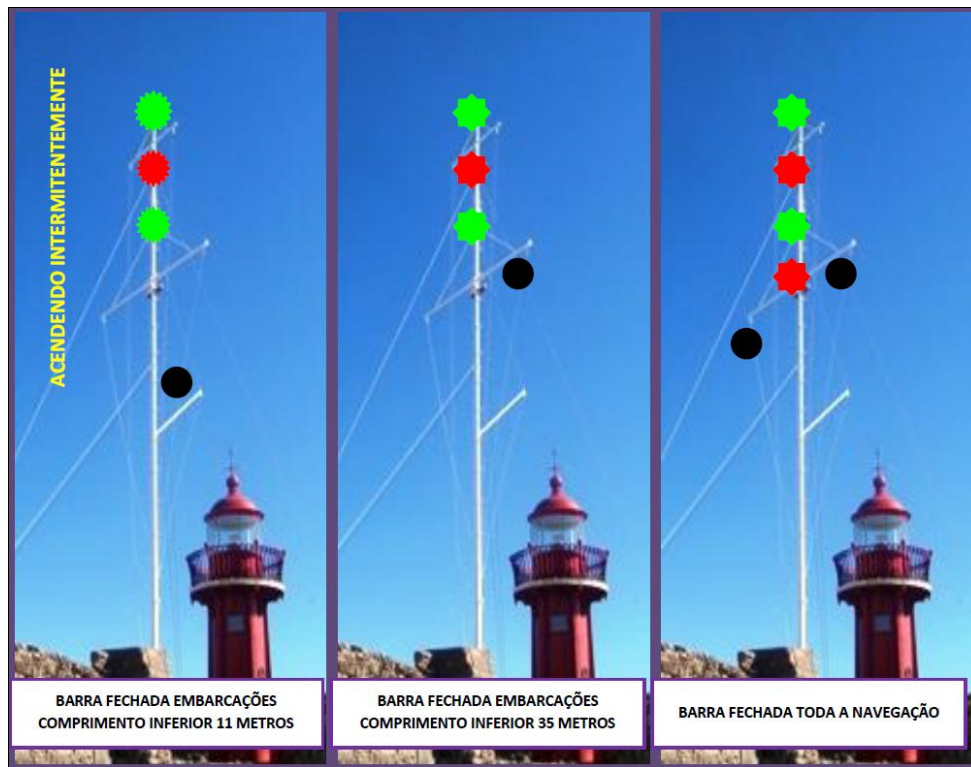
A small park with sandy beach is in front. The signal mast was not visible to the naked eye from the southern jetty. The signals are shown incorrectly in the sailing directions of Reeds and Imray. The following would be correct if the entire port was closed: Day signal: two parallel high black balls. Night signal: four fixed vertical lights in the colours green, red, green, red. Partial closure for vessels up to 35 m in length: Day signal: one high black ball. Night signal: three fixed vertical lights in the colours green, red, green. Partial closure for vessels up to 11 m in length: Day signal: one semi-high black ball. Night signal: three flashing vertical lights in the colours red, green, red. The ball's diameter is 50 cm.

Fig. 11: Santa Catarina signal mast

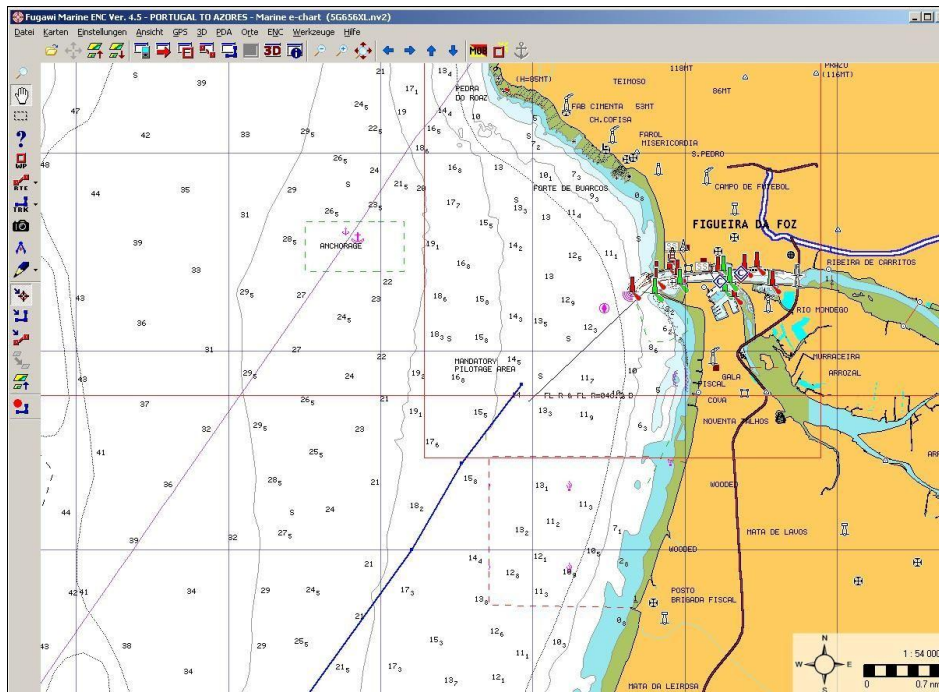
According to the MERI TUULI's carriage list, Navionics electronic charts operated with a nautical chart plotter and on-board computer with navigation software from Fugawi, as well as small craft charts from Imray for the west coast of the Iberian Peninsula were on board. The extended northern jetty at Figueira da Foz was already plotted on the electronic nautical chart. The track of the MERI TUULI is also shown at intervals of 1 nm. The plot finishes about 1 nm south-west of the plotted pilot transfer point. There was a fault after that. Presumably, the GPS antenna was damaged. Therefore, the plot is incomplete.

Fig. 18: Plot of Fugawi-Navionics nautical chart

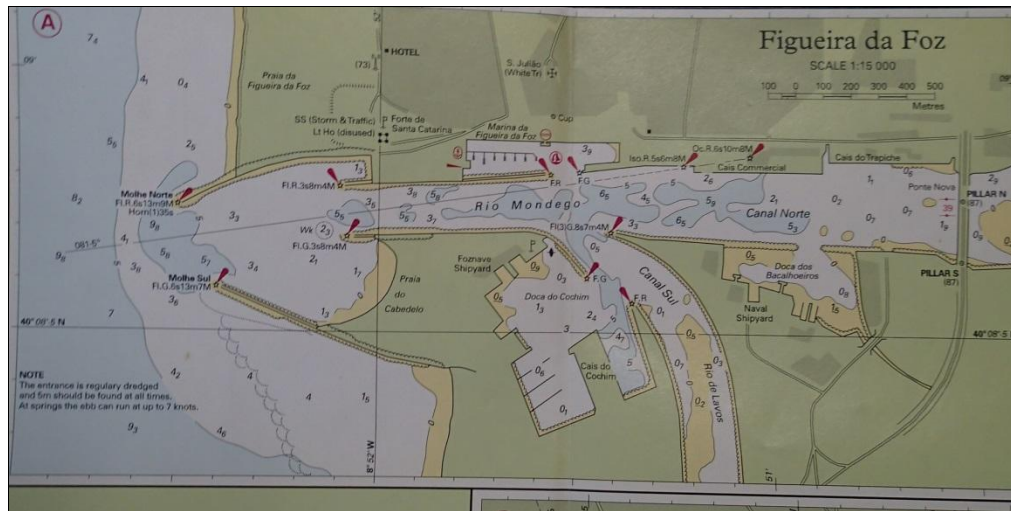
Fig. 19: Copyright: Imray Nautical Chart C49, 2005, Edition 2005

The extended jetty was not plotted on the Imray C49 chart, edition: 2005, reference system: WGS 84, scale: 1:350000 with the port map for Figueira da Foz, scale: 1:15000. The depth areas at the entrance differ from those in the official British Nautical Chart 3228. Here, only the 10 and 5 m contours are plotted in the area of the entrance without bar. The latest edition of C49 dates back to March 2012. The survey for the official Figueira da Foz nautical chart is from the year 2005 (reference system: ED 50). The GPS receiver would have to be set to ED 50 or the position adjusted to WGS 84 (0.07' south and 0.09' west in this case). The lighthouses at the entrance are faint on the aerial photo. The Santa Catarina signal mast is not visible.

The Imray Nautical Chart C49 seized by the port authority in Figueira da Foz was from 2005 and revised by continuation sheets. However, the chart was replaced by a new issue in March 2012. The now extended northern jetty is not plotted in the old issue and the charted depths are different to those in the official nautical charts. The extended northern jetty is already plotted in the Reeds Nautical Almanac 2013; however, the beacon is in the wrong position and the charted depths correspond with the Imray chart from 2005. The Santa Catarina signal mast is plotted in both publications. In Reeds, the VHF calls for Figueira da Foz are specified incorrectly or insufficiently. There are the stations with the calls 'Marina da Figueira da Foz' VHF 8, 16, 'Figueira da Foz Pilots (Praticos)' VHF 14, 16, 'Capimarfoz' VHF 8, 16, and 'Polimarfoz' VHF 11, 16. The last two stations refer to the harbour master and the police station, which are in the same building. There is evidence to show that the MERI TUULI called Capimarfoz three times on channel 16 without getting a response. The marina did not have a permanent listening watch. A last ditch attempt by the MERI TUULI would have been calling the pilots on channel 14 or 16. These frequencies are not specified in the Reeds that was used. However, Reeds states in the foreword on page three that the information in the book is not verified by a hydrographic service and liability for errors cannot be accepted. The natural conditions and port signals are only referenced briefly in the voyage information for the Portuguese coast. Other sailing directions, such as the officially available Spanish sailing directions *Derrotero de las Costas de Portugal y SW de Espana*, or the local Portuguese port requirements like *EDITAL N.º 01/2013 INSTRUÇÕES PARA A NAVEGAÇÃO E PERMANÊNCIA NO ESPAÇO DE JURISDIÇÃO MARÍTIMA DA CAPITANIA DO PORTO DA FIGUEIRA DA FOZ* were additional sources, which are available in the maritime library of the BSH, for example. The Navionics electronic nautical chart used was up to date.

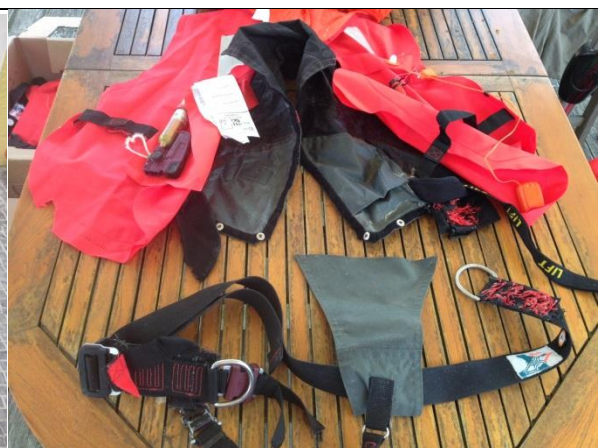
Fig. 24: Tattered lifejacket

A breaking load test by the manufacturer revealed that the damage at the torn seams occurred at a force of 3.21 kN (327 kg) if only one D-ring was connected with the lifeline. If two D-rings were connected, then the chest strap would not tear until 11kN (1,120 kg).

During the rescue, the inflated lifejackets impeded the survivors from the MERI TUULI. 257N jackets with spray hood were found, some of which had been removed and were tattered. It is possible that 150N jackets would have been easier to handle. It was not possible to climb the craft's stern ladder when they were inflated. Moreover, in the cockpit the skipper helped to release twisting and constriction at the neck of a sailor caused by the pressure of the lifejacket. The crotch strap also proved obstructive for one crew member. The designers of the lifejacket attempted to combine the function of a fall arrest belt with that of an inflatable lifejacket. The effect of this was the removal of the lifejacket by some crew members during the rescue and tragic death of a crew member. For unknown reasons, the inflatable lifejacket of the fatally injured police officer did not inflate. In the case of the liferaft having not inflated, which drifted off, a mistake occurred in that attention was not paid to the fact that the release cord was no longer fixed to the craft because of the destroyed railing.

The BSU recommends that the sailing school inspect and possibly improve the life-saving appliances on its recreational craft, in respect of their adequacy on international voyages on the Atlantic, in particular. Based on the area of operation (high seas, coastal waters or sheltered waters), it is important to ensure that the equipment is arranged so that the risk of falling overboard is reduced as far as possible and reboarding is facilitated. In this context, it is important to assess whether on sailing craft smaller lifejackets are more suitable than multi-purpose jackets with greater buoyancy. With regard to lifelines, based on the challenges of the area of operation an assessment must be made as to whether a fall arrest system with crotch strap and shock absorber, which is separate from the lifejacket, should be provided and anchoring points appropriate for reducing the risk of injury during high roll moments are available on the craft.

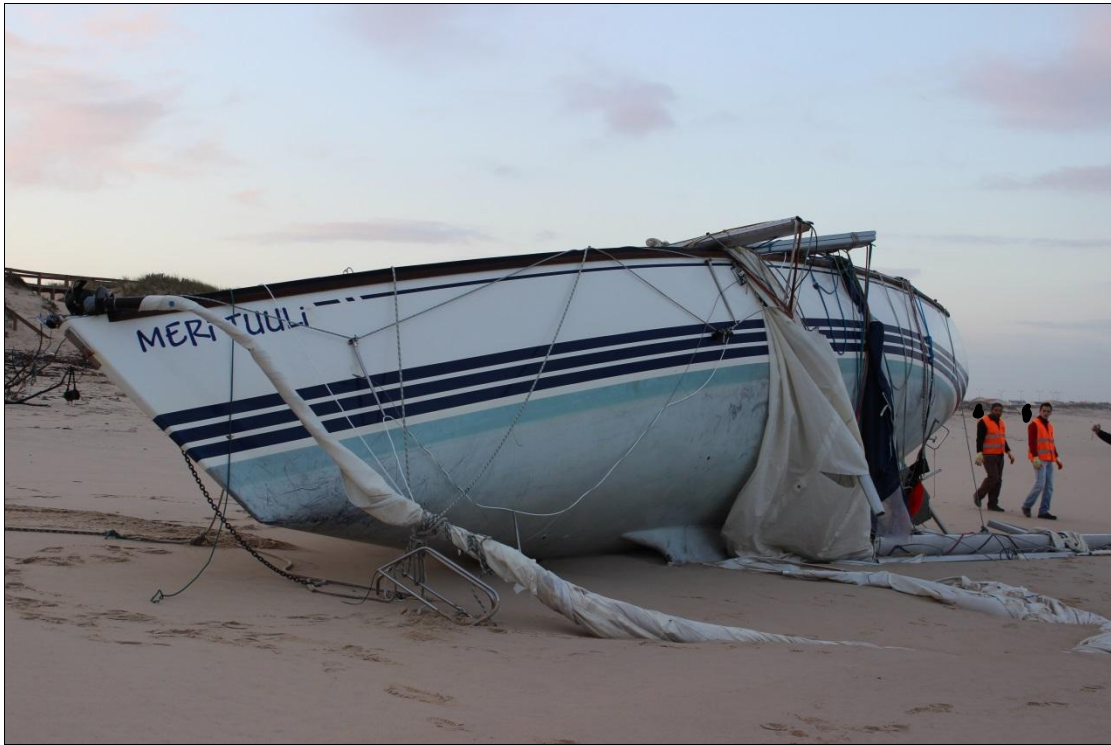
The BSU believes that the accident was caused by the MERI TUULI broaching to the starboard side with aft breaking steep sea, which washed over the craft. At the same time, the groundswell caused by the swell and the chaotic crossing sea resulted in a steep 5-6 m-high wave, which rendered the rudder ineffective and led to strong roll moments, probably to the port side. The mast probably struck the surface of the water and broke (knockdown). The hull's range of stability of 115° allowed the MERI TUULI to right herself unaided and she drifted towards the beach because the screw was blocked. The exact scene of the accident could not be determined because AIS signals are not officially recorded by Figueira da Foz. According to witness statements, it is likely that the scene was about 100-200 m away from the northern jetty. The final nautical mile was not recorded on the electronic nautical chart plotter because of damage to the GPS antenna. Since the rigging was completely replaced about a year ago and at 1-2% elongation, the cables could not have been fully stretched yet, the mast possibly broke due to loose shrouds or a construction of the manufacturer that might be too weak<sup>14</sup> On the other hand, the shroud loads are calculated and specified by the mast manufacturer based on the rules for construction. The heeling moments of the hull are taken into account in the process. Possible forces when the mast strikes the water surface are not considered.

Fig. 25: Broken mast and railing

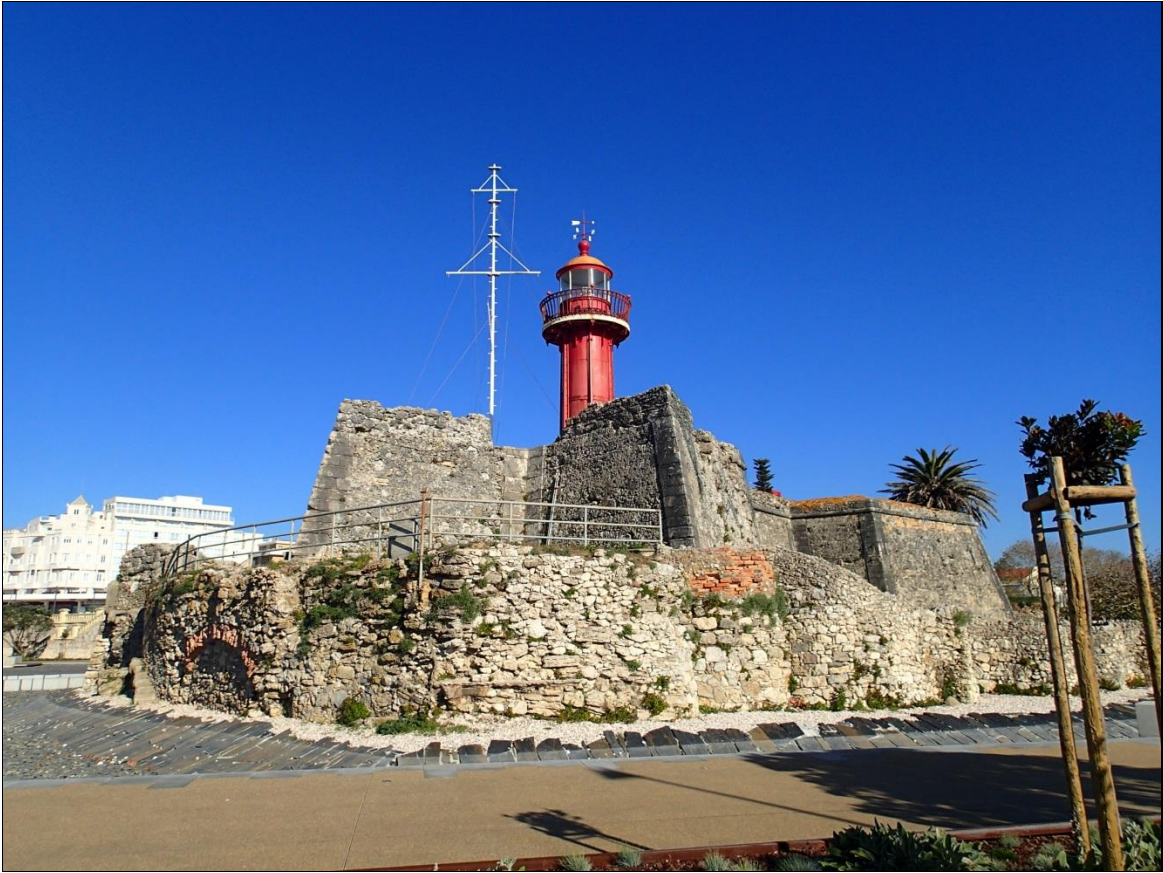
Fig. 28: Santa Catarina signal station

The signal mast with the day signals of 50 cm in diameter is invisible outside the outer, recently completed jetties, from the sea.
