Investigation Report 94/13

**Serious Marine Casualty**

**Grounding  
of the MV NORFOLK EXPRESS  
on 18 April 2013  
on the River Weser**

10 April 2014

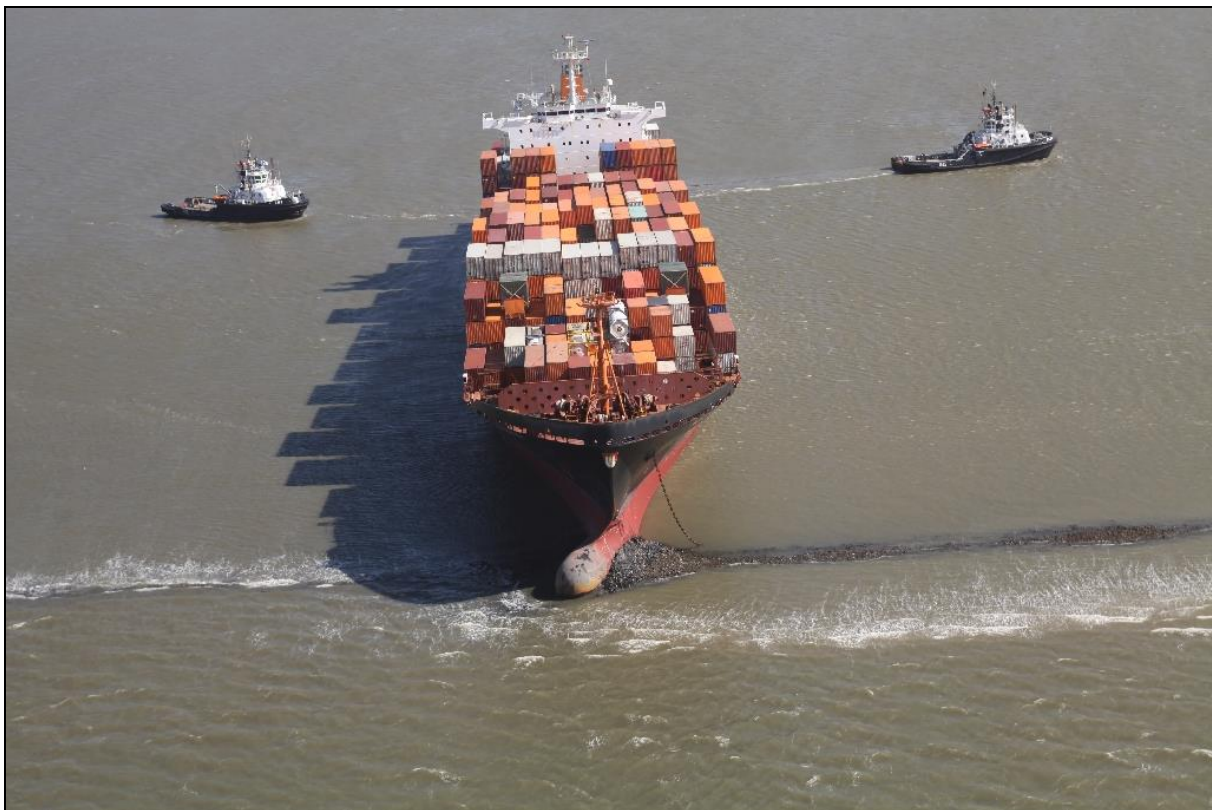
Figure 4: Photo taken from the helicopter to determine the damage

The crew of the NORFOLK EXPRESS and that of the helicopter both found damage on the bulbous bow. By closing the relevant bulkheads, it was possible to restrict the water entering there to the forepeak. The volume of water was so small that the NORFOLK EXPRESS remained buoyant.

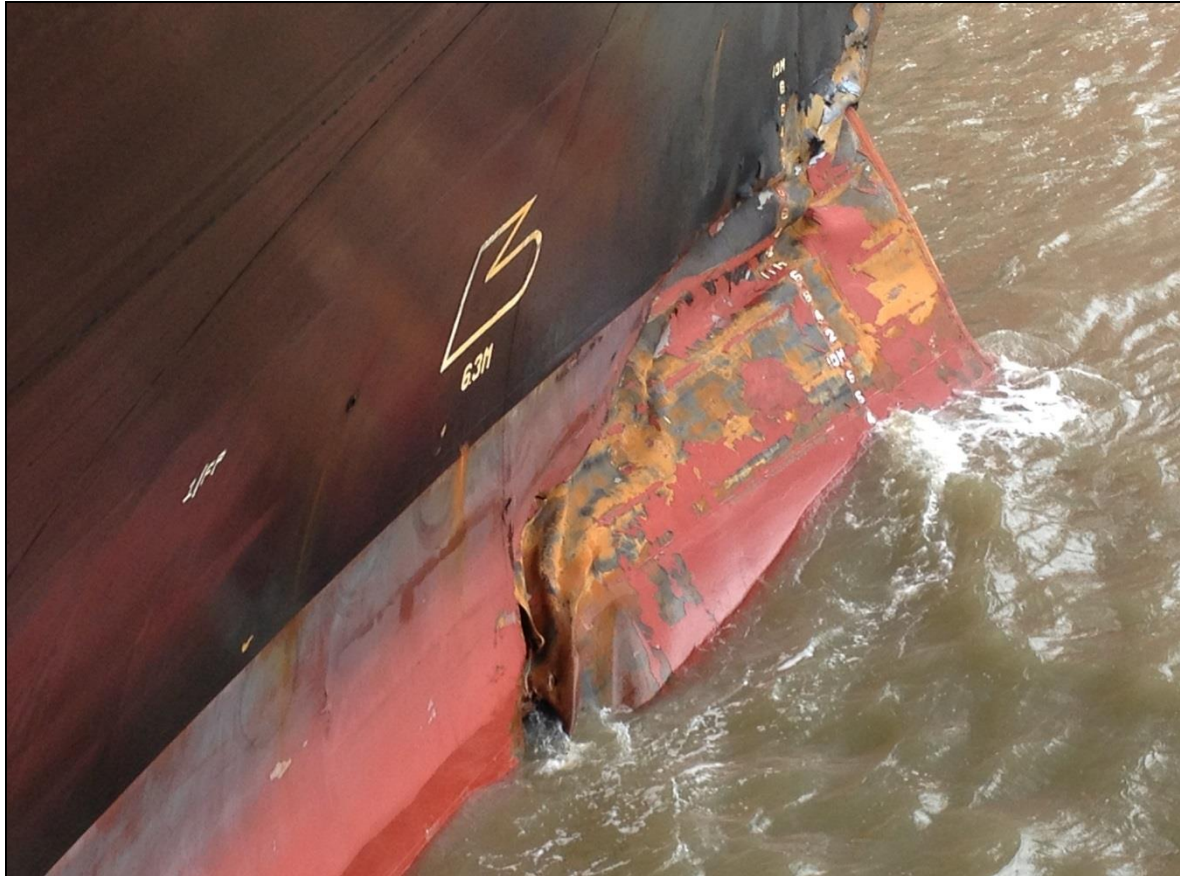
Figure 5: Damage to the bow

Starting at the collision bulkhead, the bulbous bow was severely bent to starboard. This was replaced in dry dock at Bremerhaven from 6 May 2013 onwards. As can be seen in Figure 6, the repair work was almost completed on 4 June 2013.

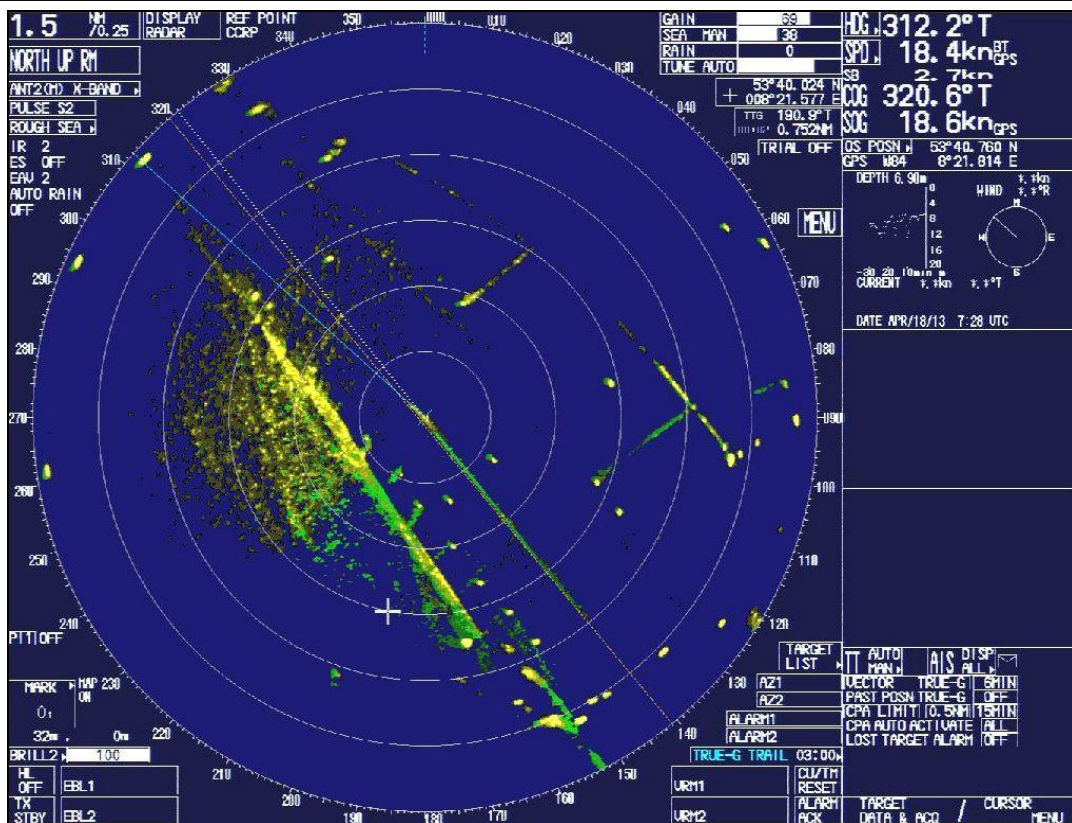
Figure 7: Radar image at 092900 – rudder blocks

Figure 7 shows the initial situation when the rudder blocks and the ship starts to turn away to port. Her speed stood at 18.6 kts.

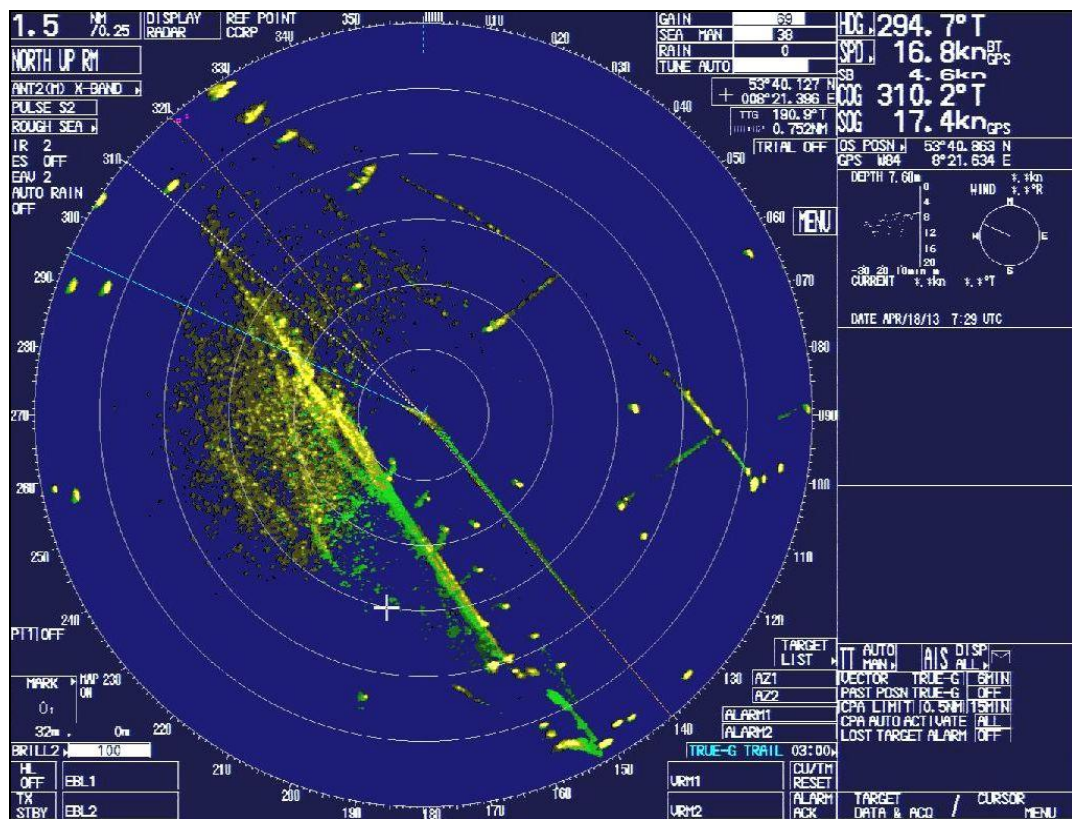
Figure 8: Radar image at 092929 – anchor is dropped

Figure 8 shows the time at which the anchor was dropped according to the VDR audio recording. Finally, Figure 9 shows how the NORFOLK EXPRESS is grounded from 0931.

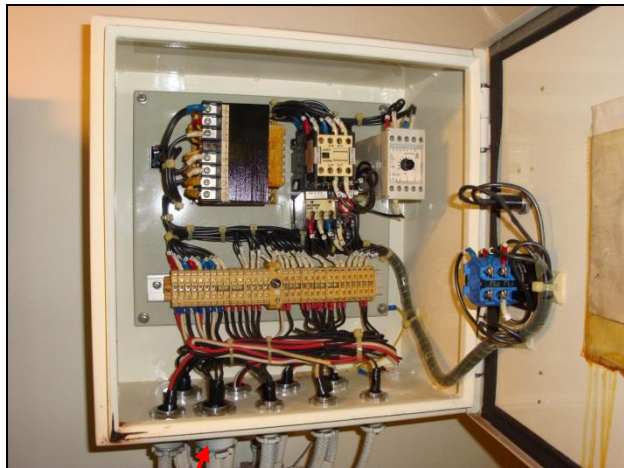
Figure 10: Open electronic switch box

A firm specialising in such hydraulic systems was commissioned by the vessel operator to find and correct the fault. The specialists needed four working days to determine that a rectifier was defective. However, this fault was intermittent, meaning it was hard to identify. These rectifiers transmit an electronic signal to a solenoid valve. This then enables hydraulic control of the steering gear: the hydraulic oil actuates the direction valves of the steering gear, which move the rudder via long lever arms. The fault was on the starboard control unit; a second control unit exists on the port side. The ship's command could have switched to this control unit; however, this did not happen.

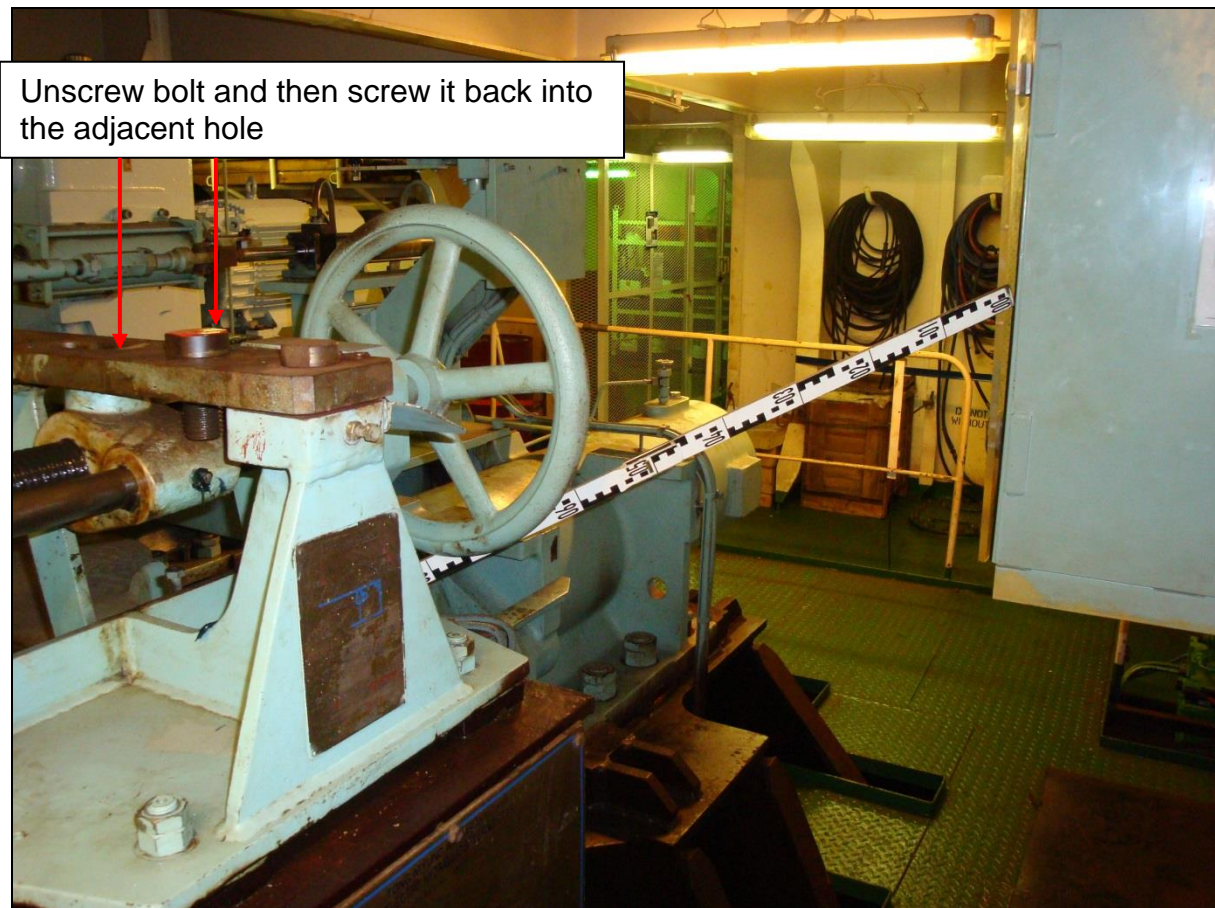
Figure 13: Switching to manual emergency operation

The option to bypass all the electronic and hydraulic systems and move the rudder blade by means of a hand wheel is provided for emergencies. To do this, the bolt that holds the steering rods together has to be released and engaged differently. This takes several minutes.

The Federal Bureau of Maritime Casualty Investigation and the Bermuda Maritime Administration recommend that jointly the vessel operator, Anglo-Eastern Ship Management, train its ship's commands in the use of the emergency systems regularly. In particular, a ship's command should be aware of how to change the steering gear's control system.

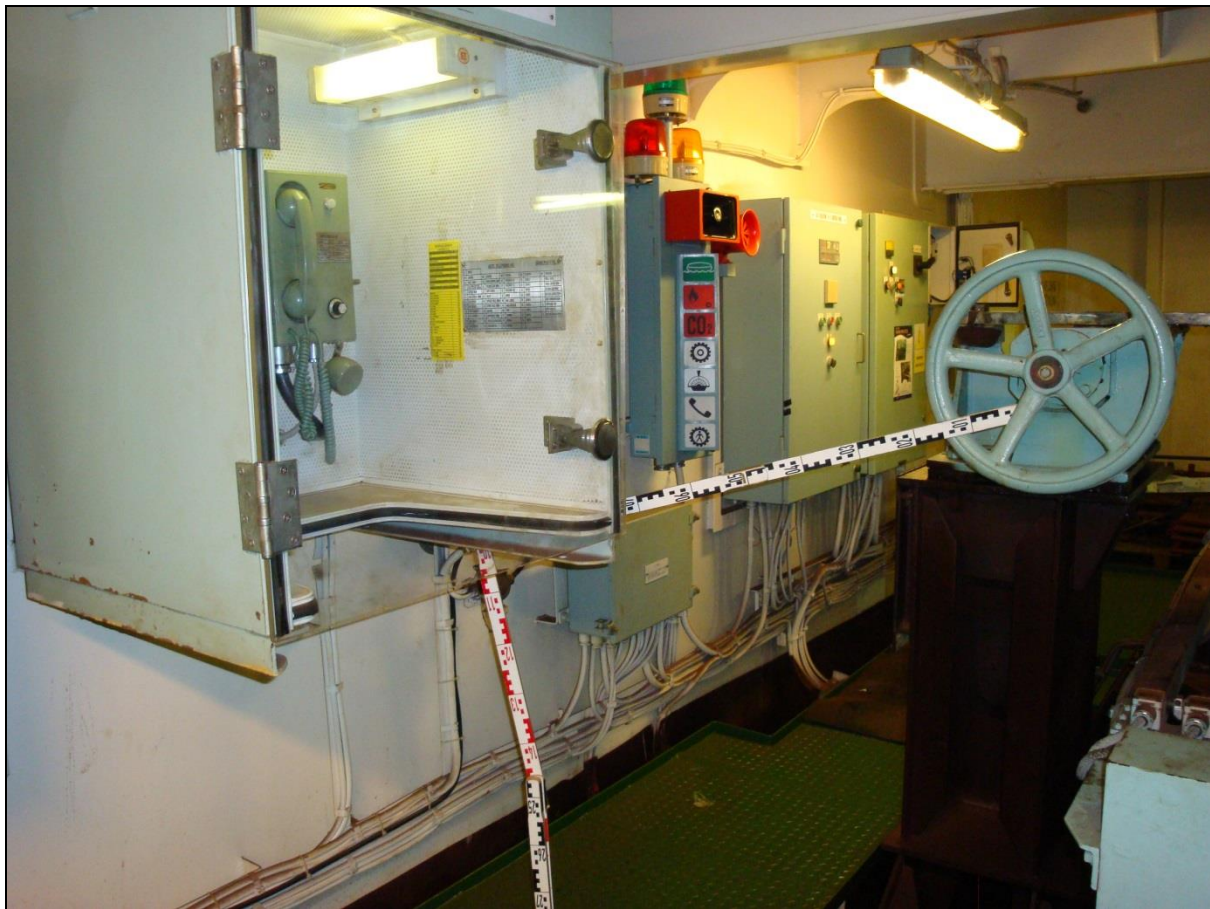
Figure 14: Distance from the phone to the hand wheel for operating the emergency rudder system

A half-open phone box is located in the immediate vicinity of the steering gear. The two existing phones were tested in the presence of the BSU personnel. The cable is long enough to reach the hand wheel for the emergency rudder system. This means that it is quite possible for a crew member to use a handset and implement helm commands from the bridge on the hand wheel. This phone was not used in connection with the accident. Instead, witness statements confirmed that a handheld VHF transceiver was used.

With regard to the phones located in the steering gear compartment, no room for improvement is discernible.
