**MINISTRY OF TRANSPORTATION OF THE REPUBLIC OF LITHUANIA  
MARINE SHIP ACCIDENT AND INCIDENT INVESTIGATION MANAGER**

**MARINE SHIP ACCIDENT INVESTIGATION  
FINAL REPORT  
2/7/2014 No. (E)-TA-2**

<b>Marine ship</b>	<b>VICTORIA SEAWAYS</b>
<b>Company</b>	<b>AB DFDS Seaways</b>
<b>Ship type</b>	<b>Passenger ferry/ro-ro ship</b>
<b>Registration No.</b>	<b>813</b>
<b>Incident location and date</b>	<b>Baltic Sea 55-02.4 N. 015-45.6 E. April 23, 2013</b>

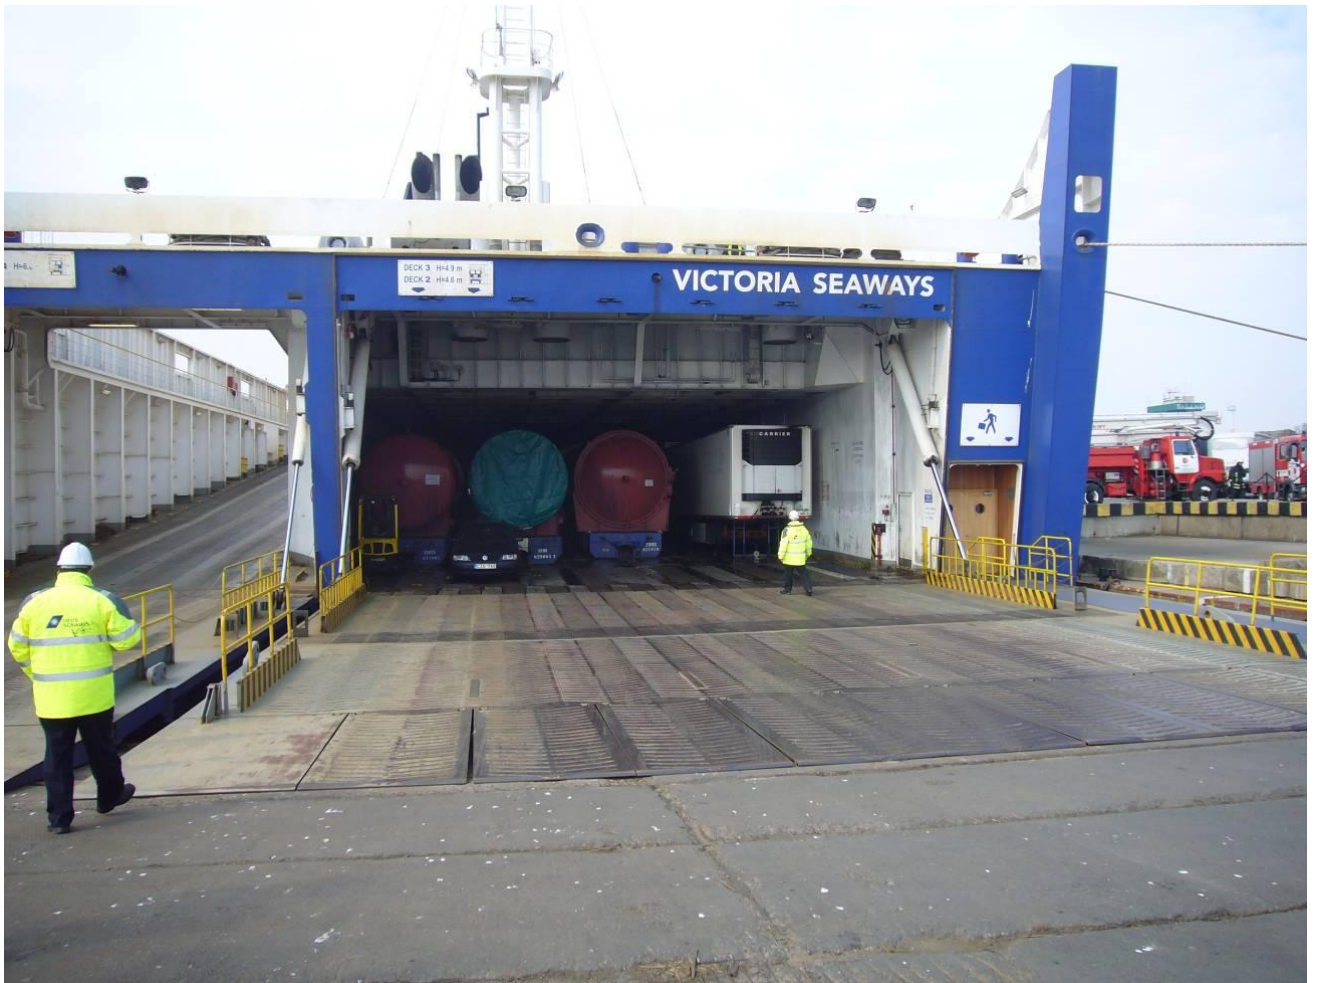
Figure 2: The ferry after returning to Klaipėda

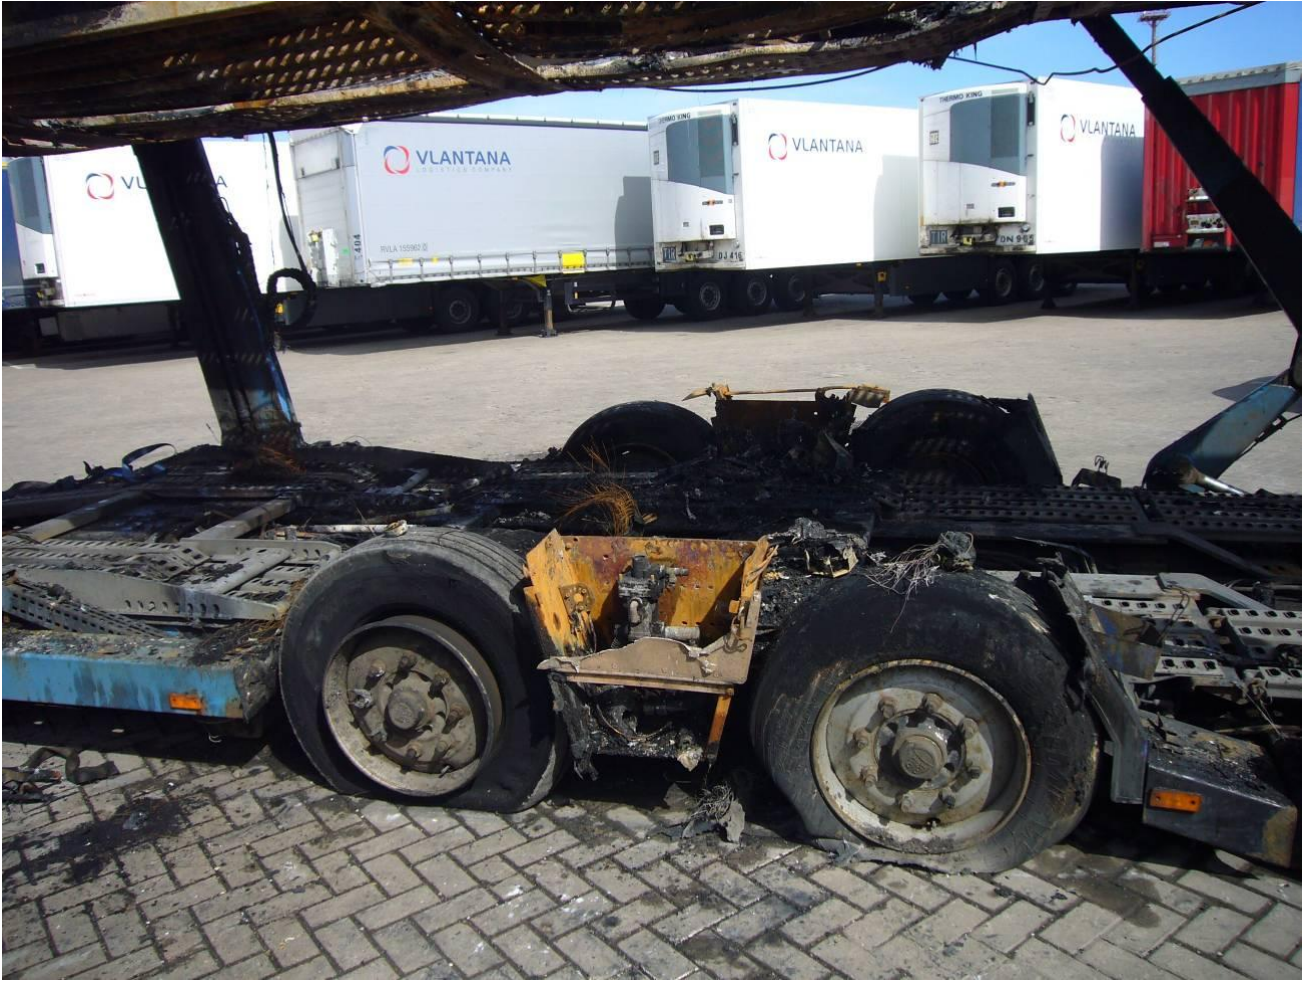
This marine accident (fire) is classified as SEVERE ACCIDENT. The fire has destroyed six cars and car trailer. There were no casualties or personal injuries. The superstructure of the ship has been covered in soot.

Figure 3: Burned down trailer

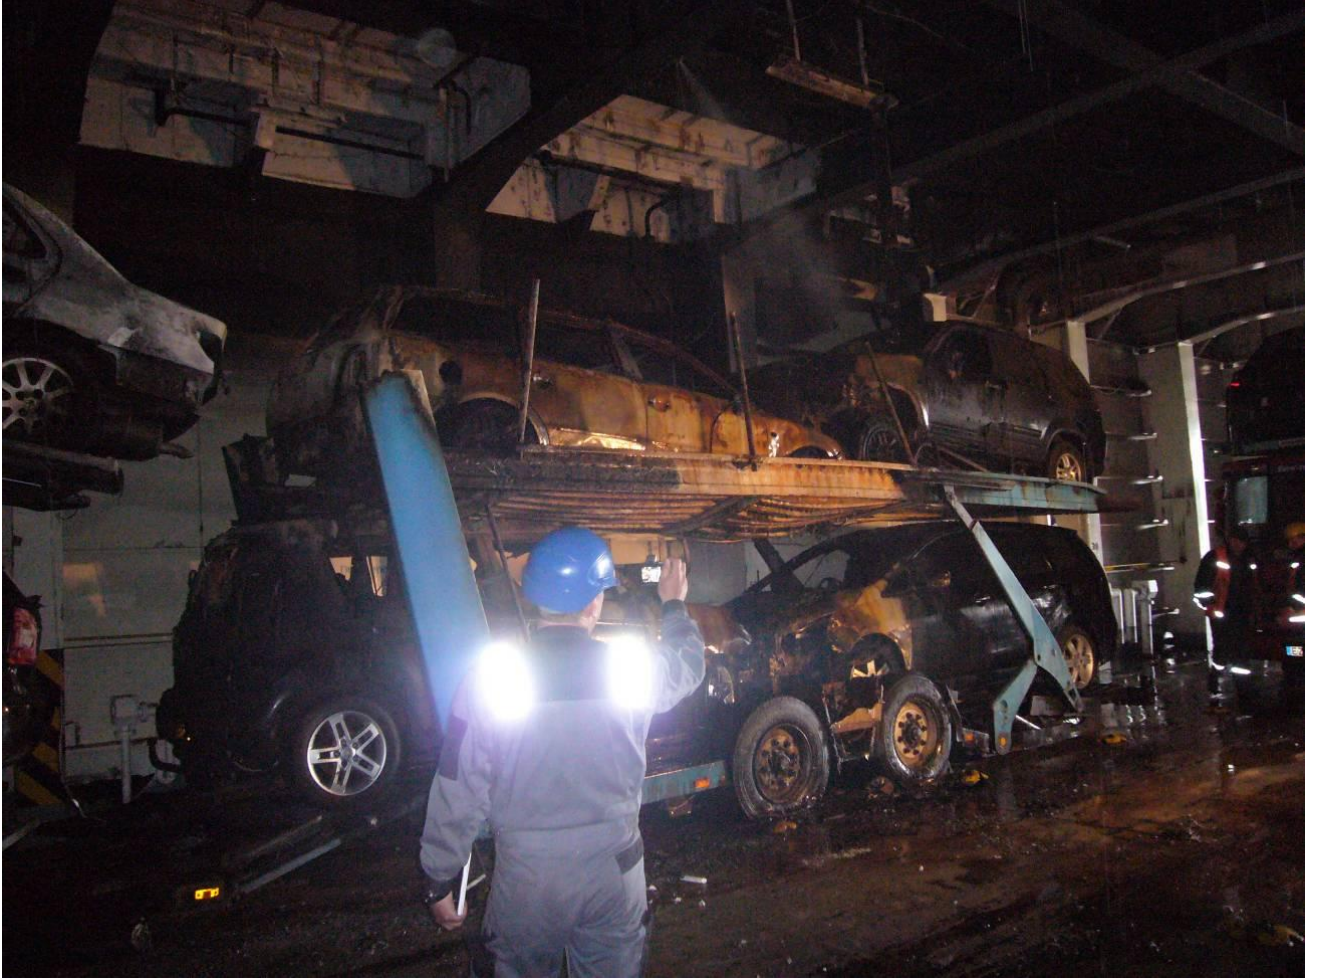
Figure 4: Burned down cars

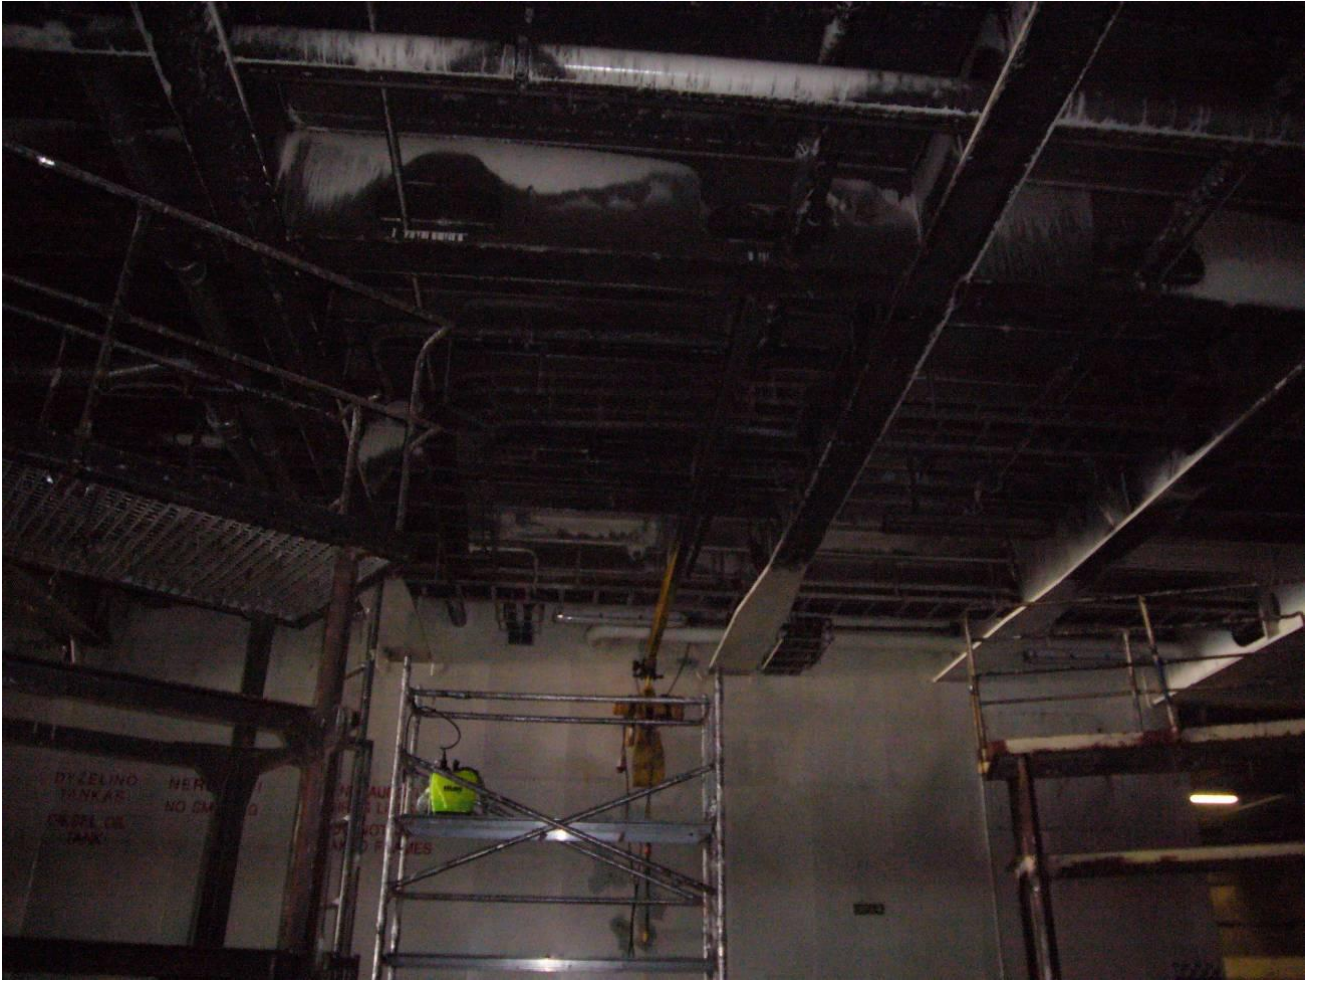
Figure 5: Sooty deck roof

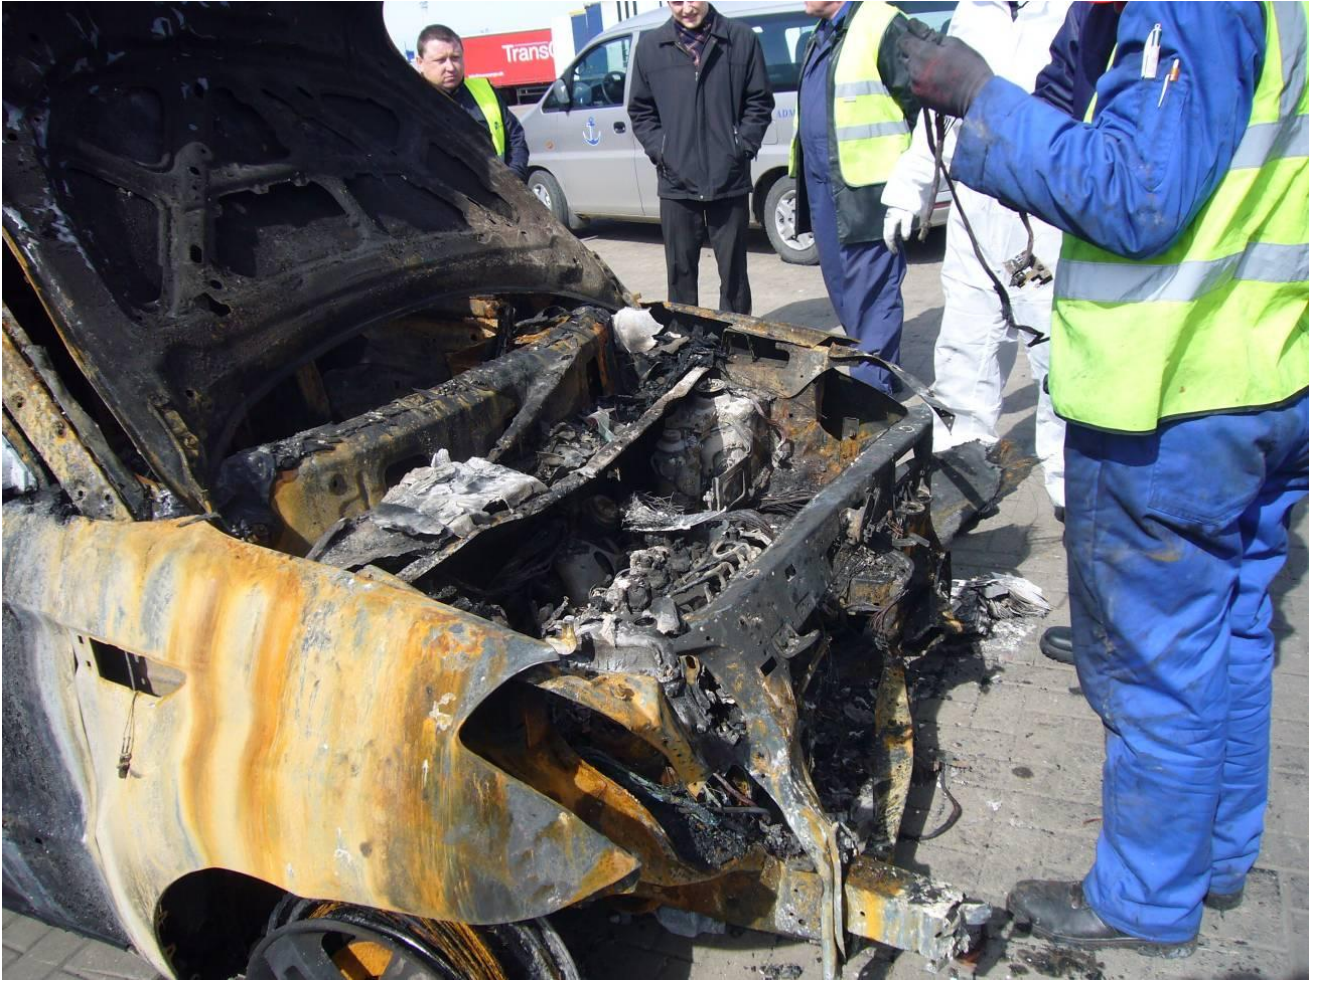
A poor technical condition of one of the second-hand cars in the cargo has been identified as the cause of fire. A short circuit in the electrical system of the car caused sparks that fell on a dirty surface of the engine and caused the fire.

The analysis states that this severe accident has occurred because potential poor condition of transported second-hand cars has not been considered. Presumably the insulation of power wires of one of such was damaged and a short circuit occurred due to the impact of water and wind. This caused sparks that presumably fell on a dirty surface of the engine and caused the fire.

Figure 6: The car thought to have caused the fire

The investigation of this severe accident has led to a conclusion that all second-hand cars should be transported with their batteries disconnected. This procedure should be supervised by appointed members of the crew.

1. We recommend to issue an order to ferry captains to appoint members of their crews responsible for checking if the batteries of all transported second-hand cars are disconnected before the ship leaves the port.

2. We recommend to install stationary carriage fire fighting guns (water or water-foam) on the company ships (ro-ro type) and connect them to the fire fighting system on cargo decks.
