Bundesstelle für Seeunfalluntersuchung
Federal Bureau of Maritime Casualty Investigation
Federal Higher Authority subordinated to the Ministry of Transport
and Digital Infrastructure

Investigation Report 07/14

Serious Marine Casualty

**Collision between the
installation vessel PACIFIC ORCA and the
fishing vessel JURIE VAN DEN BERG
north of TSS Terschelling-
German Bight on 17 January 2014**

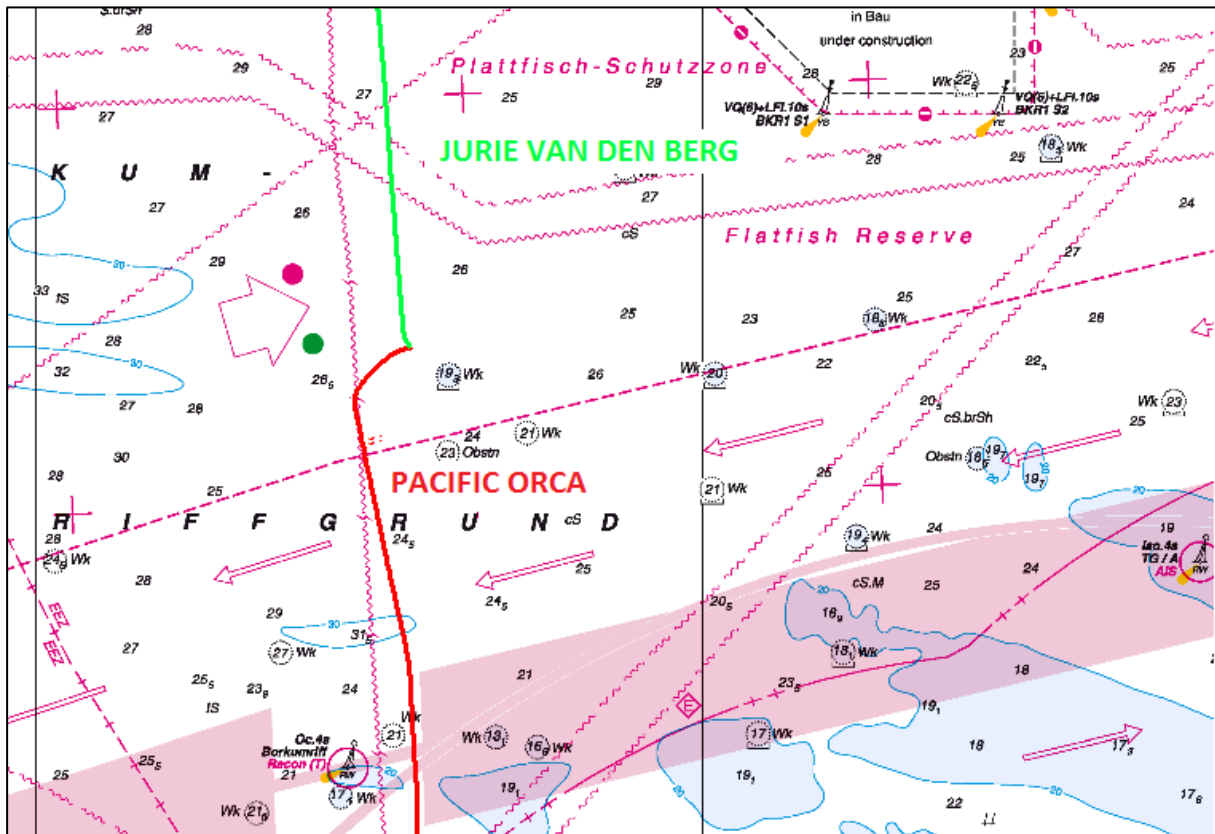
Figure 4: Track of each vessel

The fishing vessel proceeded on a course of 176° at about 10 kts. The skipper claimed that he initially identified the PACIFIC ORCA on the radar at a range of 10-11 nm and later visually at a range of 3 nm. Using the radar system and the electronic nautical chart, he found that the PACIFIC ORCA was sailing on a reciprocal course at approximately the same speed and that the closest point of approach stood at 0.8 nm if the vessels passed starboard to starboard. When the skipper recognised the PACIFIC ORCA's course alteration to starboard and the risk of collision, the distance to the PACIFIC ORCA was, according to his statement, 0.5 to 1 nm. A course alteration to port was initiated and an order issued to set the engine to astern. The collision was unavoidable, however. First, the fishing gear's starboard boom struck the PACIFIC ORCA. As events unfolded, the fishing vessel scraped along the entire port side of the PACIFIC ORCA. All the crew members woke up because of the collision and went to the bridge. The fishing vessel was then inspected for leakage. Water ingress was not found. The voyage to Eemshaven was continued after communicating with the PACIFIC ORCA on VHF.

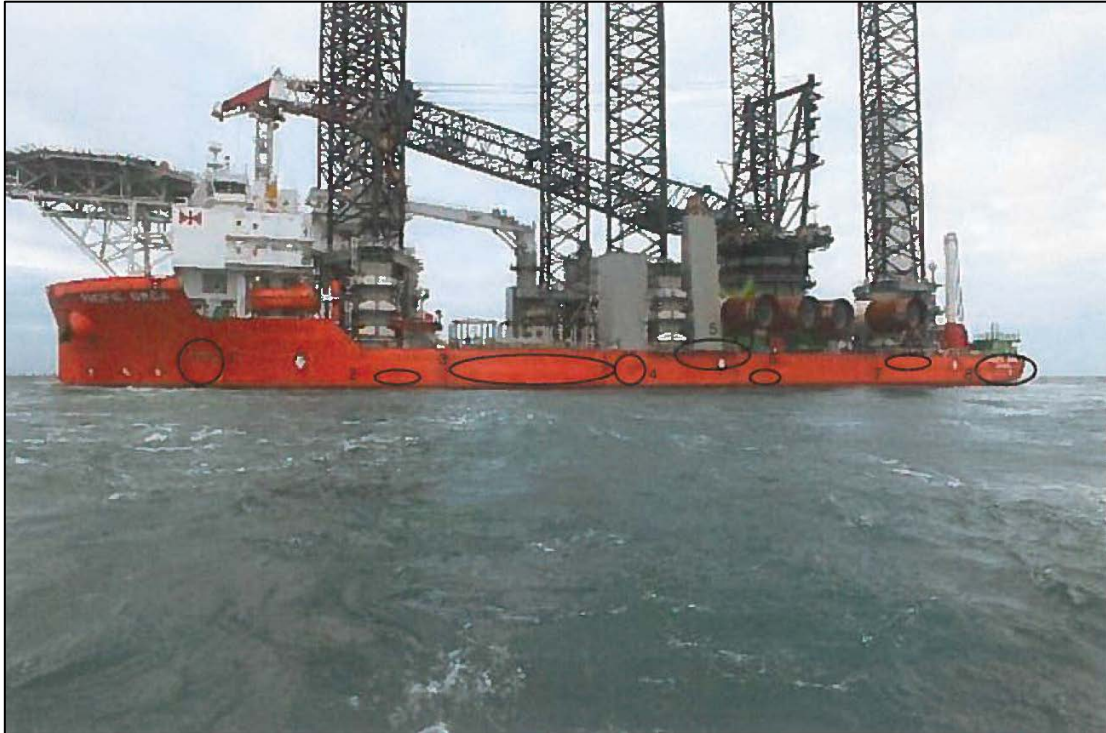
Collision damage on board the PACIFIC ORCA was only minor. Next to a puncture in the shell plating in the forward section of the ship, only minor damage (dents, paint abrasions and deformations on a carrier platform) was found.

Figure 5: Apparent collision damage

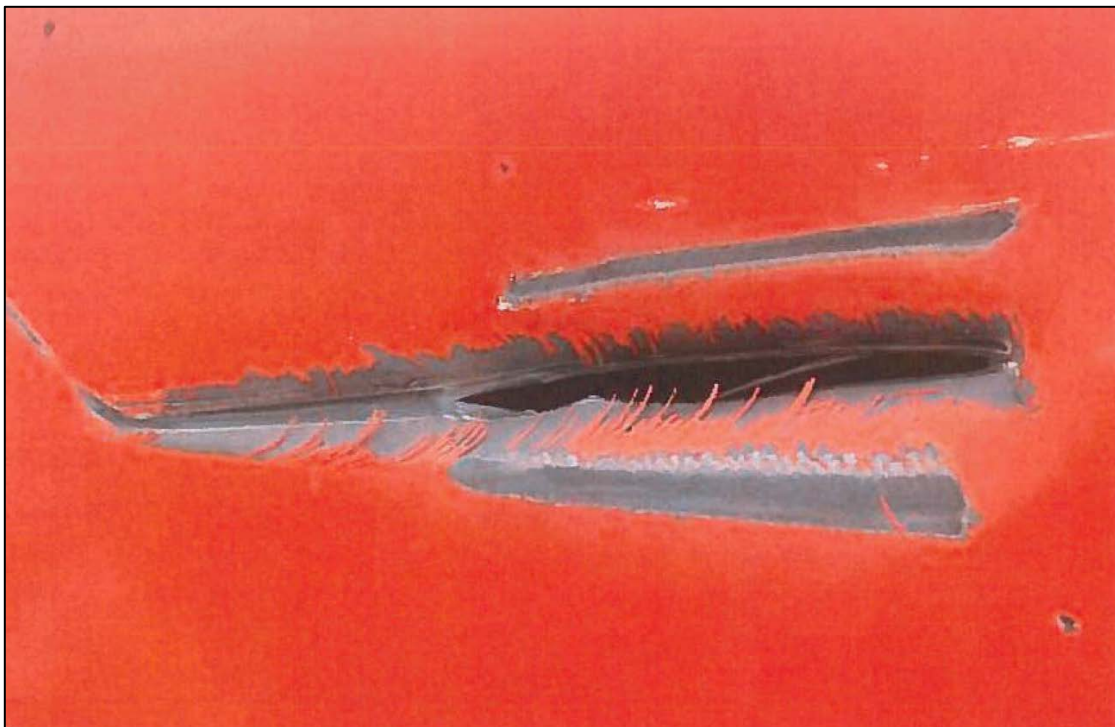
Figure 6: Punctured shell plating

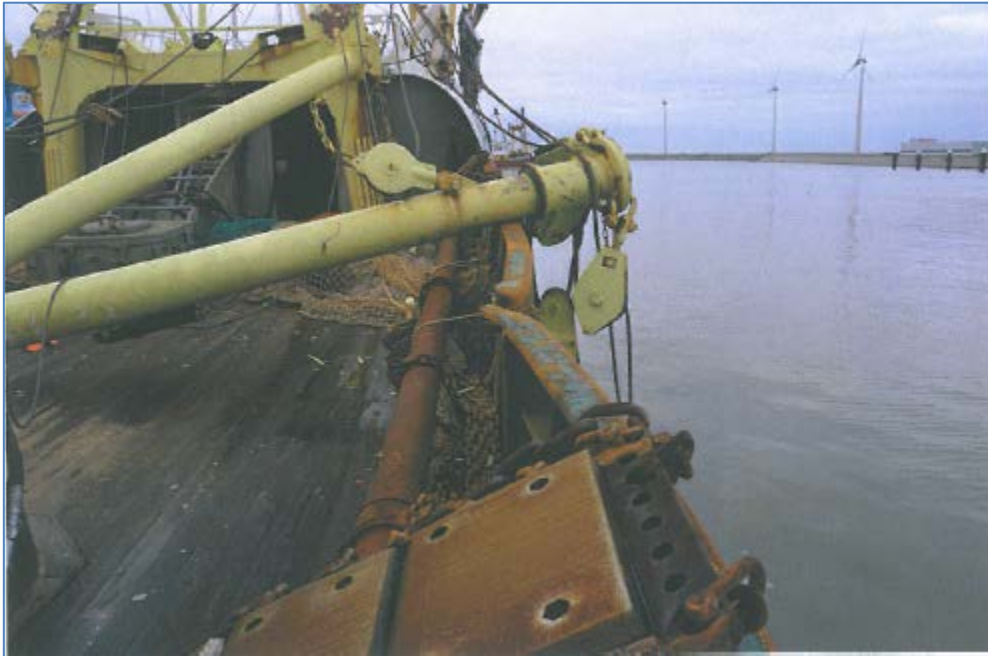
The damage to the JURIE VAN DEN BERG was much greater. There was extensive damage to the entire starboard side, the fishing gear, as well as the forward and aft mast. Part of the damage was caused by the PACIFIC ORCA's deck cargo, which towered over the hull wall.

Figure 7: Damage to the starboard side and fishing gear

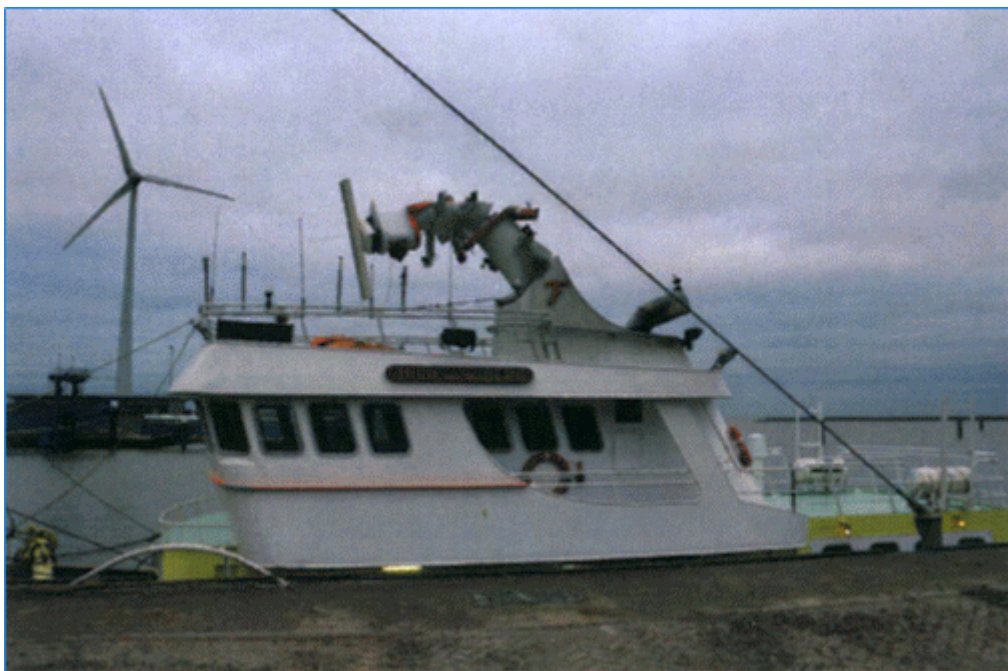
Figure 8: Buckled aft mast

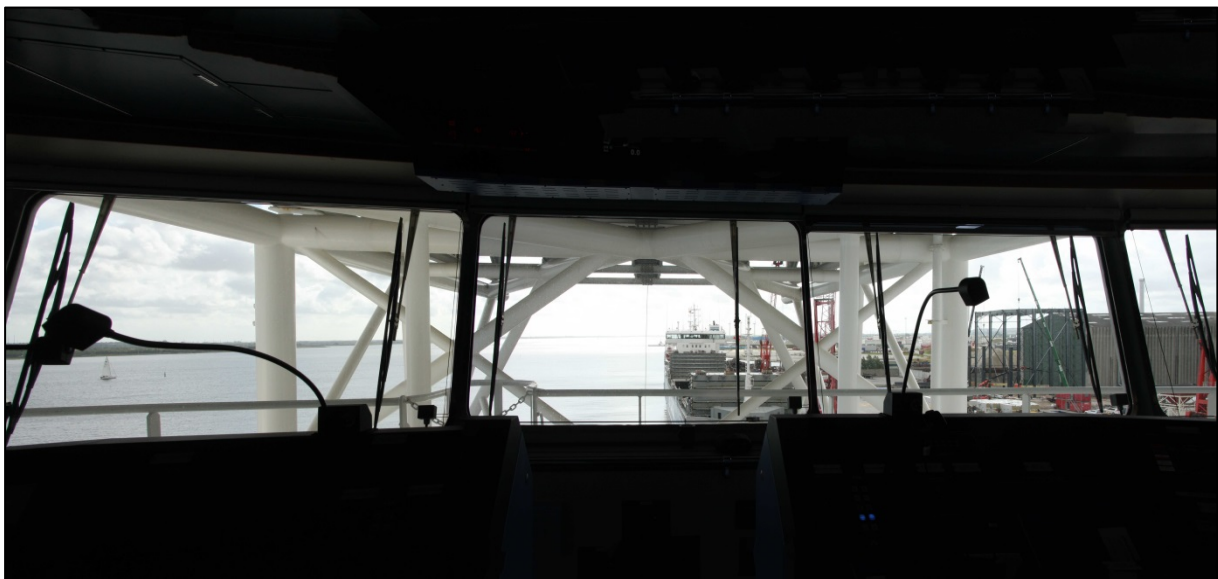
Figure 9: Obstructed visibility at the main steering position

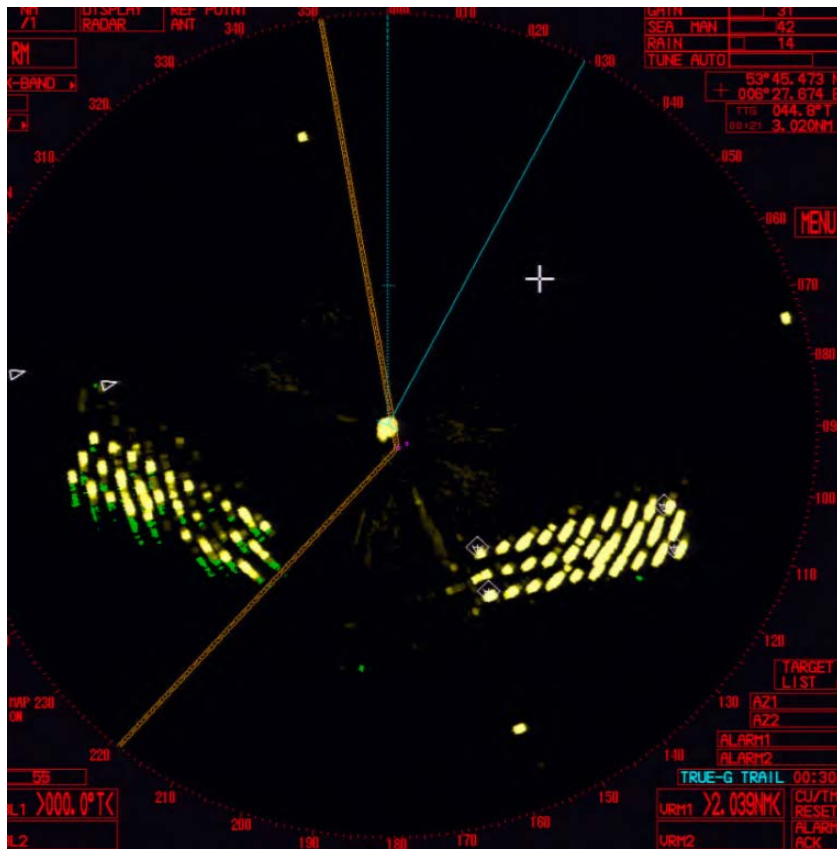
An exceptionally high number of false echoes and shadow sectors were noticed during the analysis of the radar images. These are caused by the PACIFIC ORCA's six legs. The performance standards⁶ for radar equipment states the following in respect of installation of the radar antenna:

Figure 15 is indicative of the false echoes of an entire wind farm due to reflections. At the same time, two vessels (AIS targets to the left of the image) are in a shadow sector, meaning a radar echo is not displayed for them.

Figure 15: Radar image with reflections

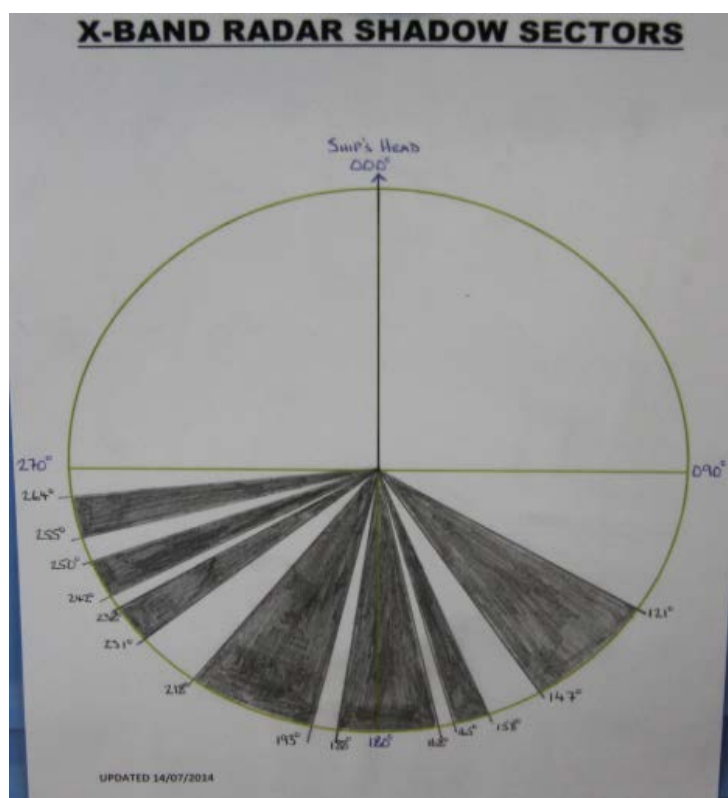
Figure 16 shows the photo of a drawing of the shadow sectors of the X-band radar system. The display is attached below the radar system (see Figure 10).

Figure 16: Shadow sectors

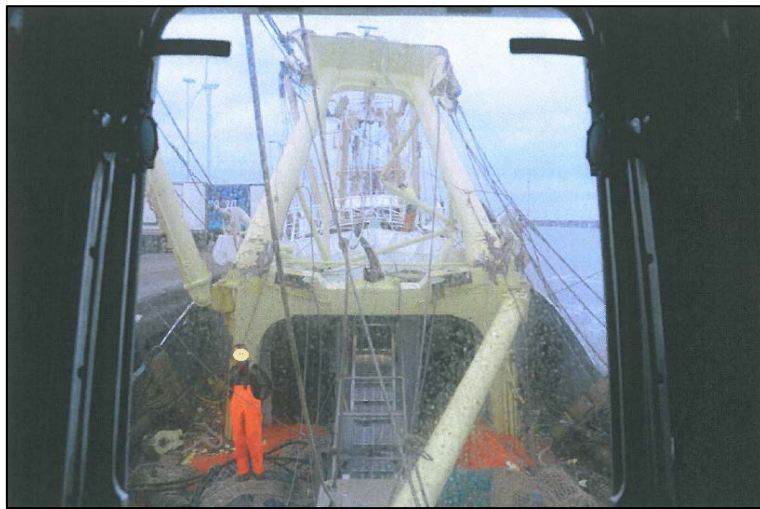
Obstructed visibility forward of the bridge caused by the fishing gear.

Figure 19: Obstructed visibility

The Federal Bureau of Maritime Casualty Investigation recommends that, having regard to the duration of the voyage, the owner of the JURIE VAN DEN BERG man the vessel with sufficient resources to ensure that prescribed hours of work and rest, as well as bridge manning can be maintained.

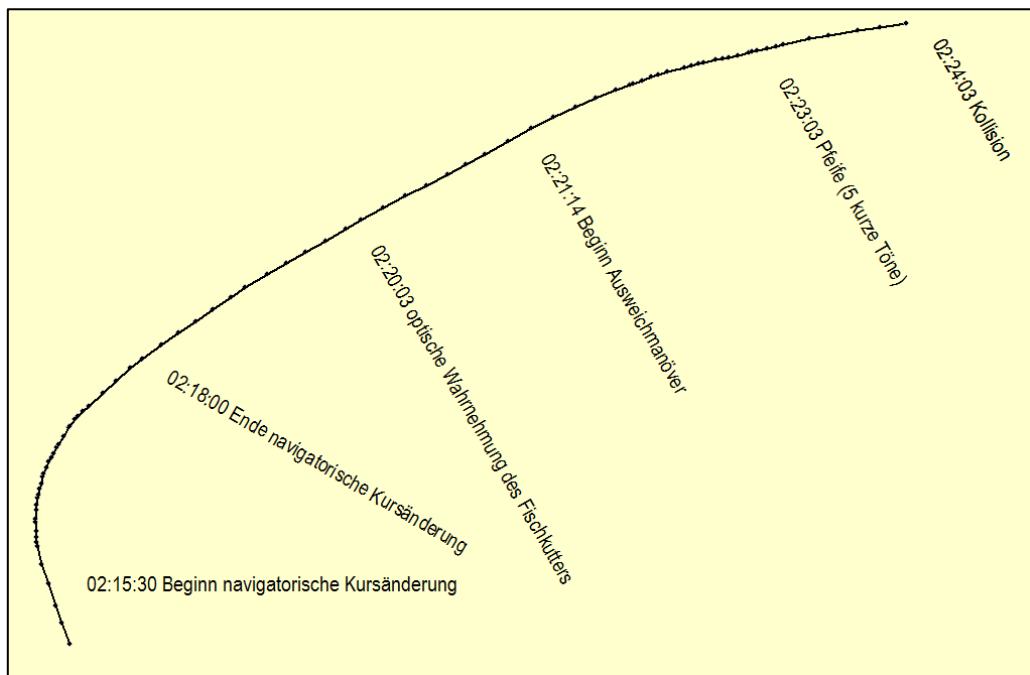
Figure 25: Track of PACIFIC ORCA

The range was 1.0 nm when the JURIE VAN DEN BERG was identified on the PACIFIC ORCA. After determining the steady bearing and the associated risk of collision, the distance between the vessels had dropped to 0.62 nm. The second officer estimated the distance to be 0.5 nm or less. An alteration of course to starboard from 054° to 084° (TH) was then carried out on the PACIFIC ORCA. The investigators believe that execution of the course alteration was too moderate for this short range. Firstly, the course was only altered by about 30°; secondly, the maximum rate of turn reached was only 28°/min. By contrast (see figure 25), the previous navigational course alteration was executed at a maximum rate of turn of 48°/min. Moreover, a maximum rate of turn of 86°/min. was reached during the 'hard to starboard' course alteration initiated immediately before the collision. This first evasion manoeuvre was completed about one minute before the collision. The risk of collision still existed, however. Apart from sounding five short blasts of the whistle, no further action was taken. Therefore, the course and speed of the PACIFIC ORCA was virtually unchanged in the final minute before the collision. The PACIFIC ORCA only began to turn to starboard again immediately before the collision. At this point, it was no longer possible to prevent the collision.

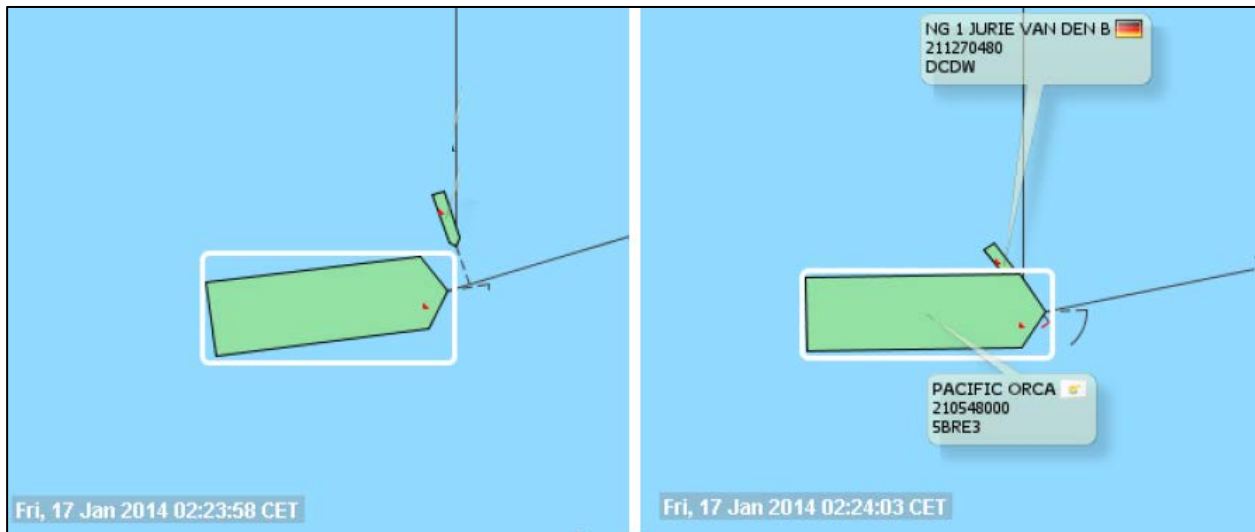
Figure 26: Collision (AIS display)

Figure 20, it is evident that a course alteration to port is initiated on the JURIE VAN DEN BERG between 022239 and 022255. Here, the distance to the track of the PACIFIC ORCA stood at 9-11 ship lengths. The investigators assume that a port manoeuvre was initiated on the JURIE VAN DEN BERG because they had not observed the course alteration of the PACIFIC ORCA, initially went for a starboard-to-starboard pass and thus wanted to give the PACIFIC ORCA more room. The whistle signals of the PACIFIC ORCA may have led to the error being noticed. After realising this error, a starboard course alteration was initiated. The distance was too low to avoid the collision, however. The vessel only turned significantly a few seconds before the collision. As a result, the two vessels collided almost at right angles (see Figure 26). A change in speed is not visible on the JURIE VAN DEN BERG.
