**Bundesstelle für Seeunfalluntersuchung**  
**Federal Bureau of Maritime Casualty Investigation**  
Federal Higher Authority subordinated to the Ministry of Transport  
and Digital Infrastructure

## Investigation Report 124/14

# **Exploding shrimp boiler on board the fishing vessel KLAUS GROTH on 19 May 2014 south-west of Amrum**

18 May 2015

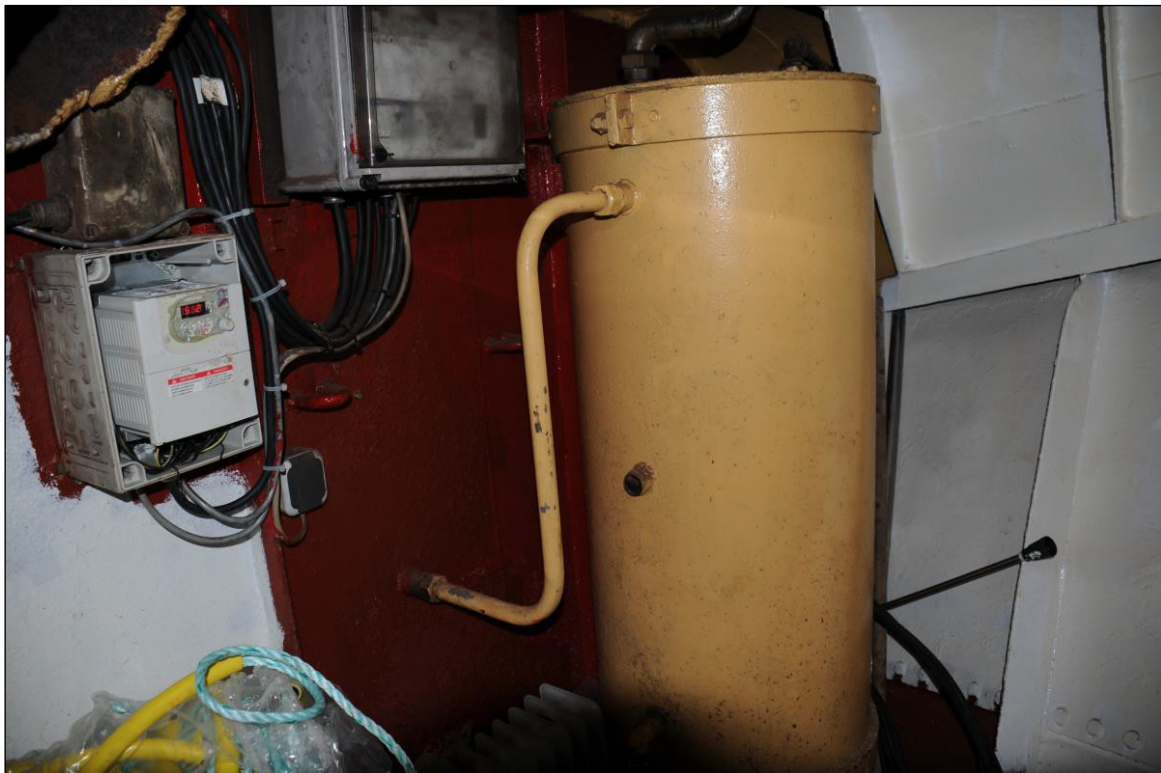
Figure 4: Diesel tank beneath the forecastle

The shrimp boiler is heated by means of a statically operated cup burner of the simplest design. The system is supplied via a tank in the immediate vicinity beneath the forecastle. The diesel fuel travels through a pipe joint to the cup burner by means of static pressure in the storage tank. The flow is regulated using only a needle valve, the setting of which was not changed according to the skipper.

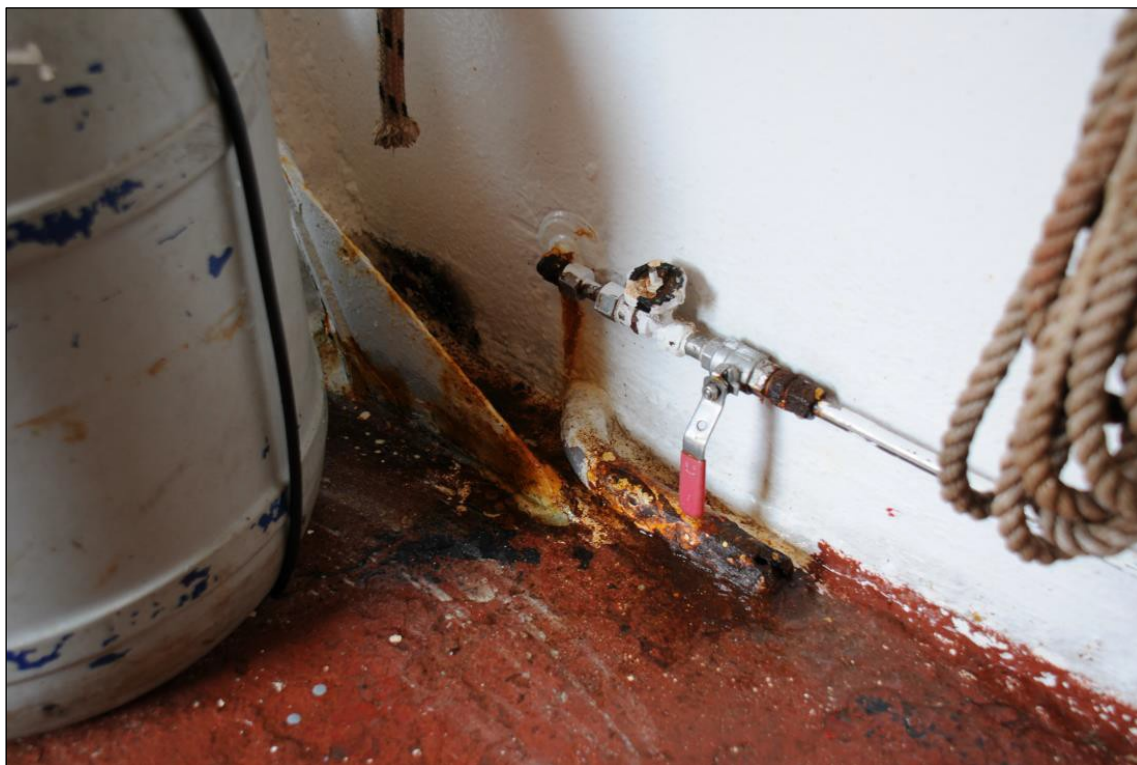
Figure 5: Main ball valve with upstream throttle needle valve

There is no regulation of fuel quantity. It appears that the throttle valve, which is fixed based on experience, is set so that a certain level of fuel remains in the cup burner. Consumed diesel is re-filled via the tank. If the flame extinguishes and this goes undetected, then the cup burner would inevitably overflow.

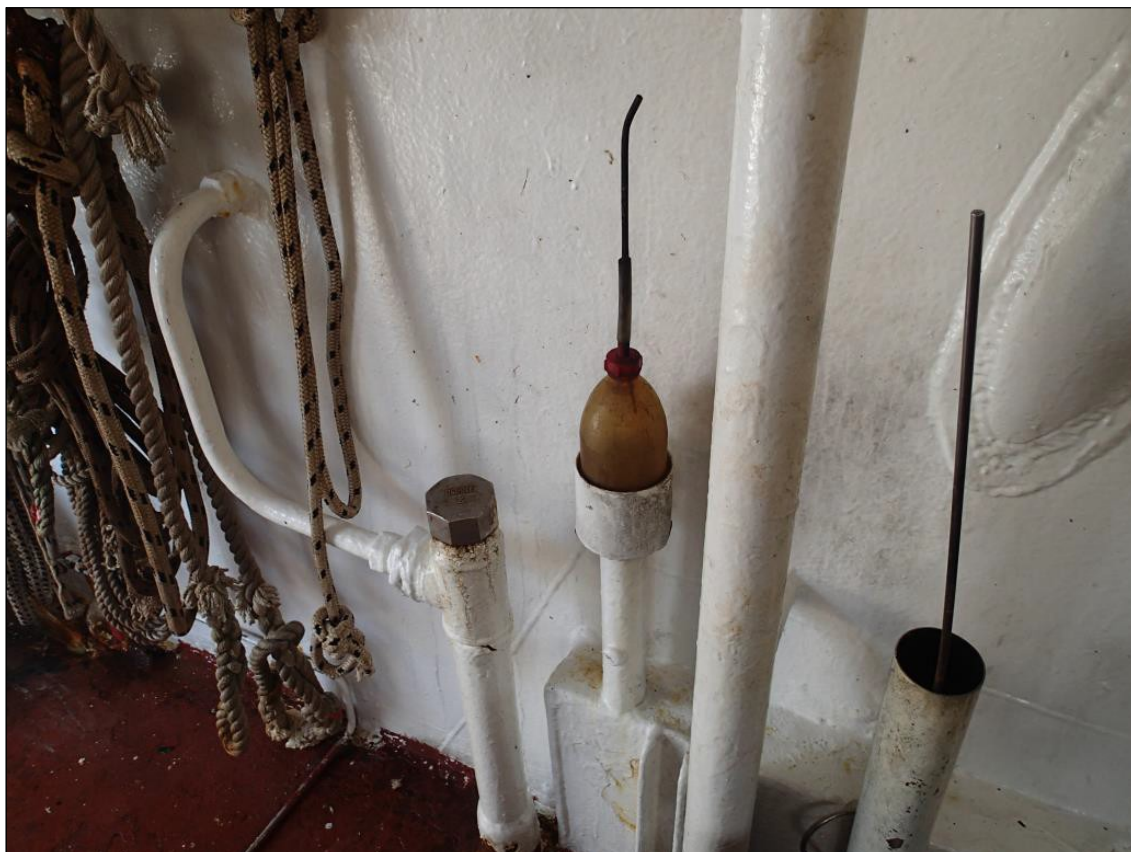
Figure 6: Petrol bottle and wick

It is also conceivable that petrol was added to the overheated combustion chamber for re-ignition, which would lead to the gas igniting and/or the development of darting flames due to the sudden evaporation on hot surfaces.

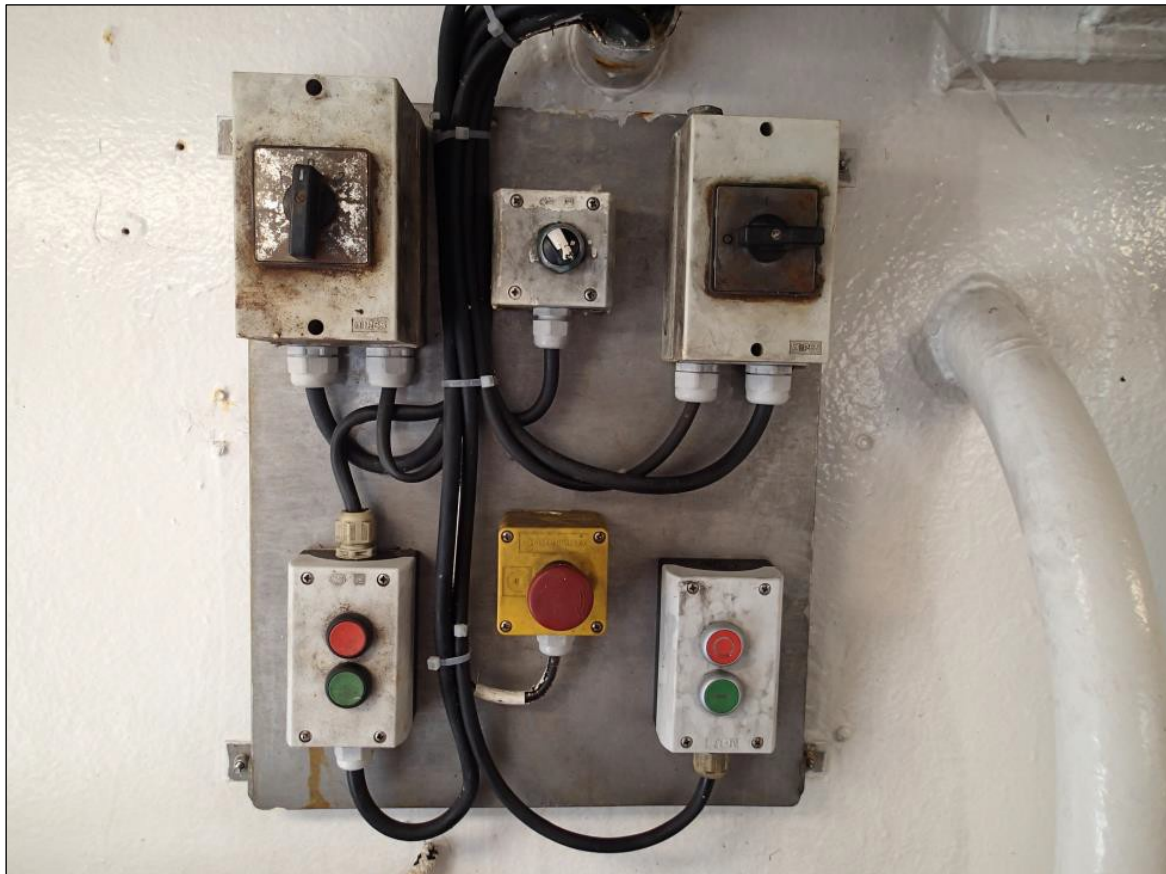
Figure 7: Switch and emergency stop for the shrimp boiler system

The shrimp boiler system is equipped with an emergency shutdown; however, this only affects the system's conveyor belts. Here, there is no regulation or monitoring and emergency shutdown of the burner's circuit.

The operation of cup burners without flame controllers and open fuel surfaces is not in line with current standards, on ships and boats, in particular. The absence of metering equipment, controlled injection technology, and emergency stop systems for shutting down the fuel supply, in particular, borders on gross negligence.

As an initial measure, the skipper and owner opted to have an automated quick closing valve installed in the fuel line.

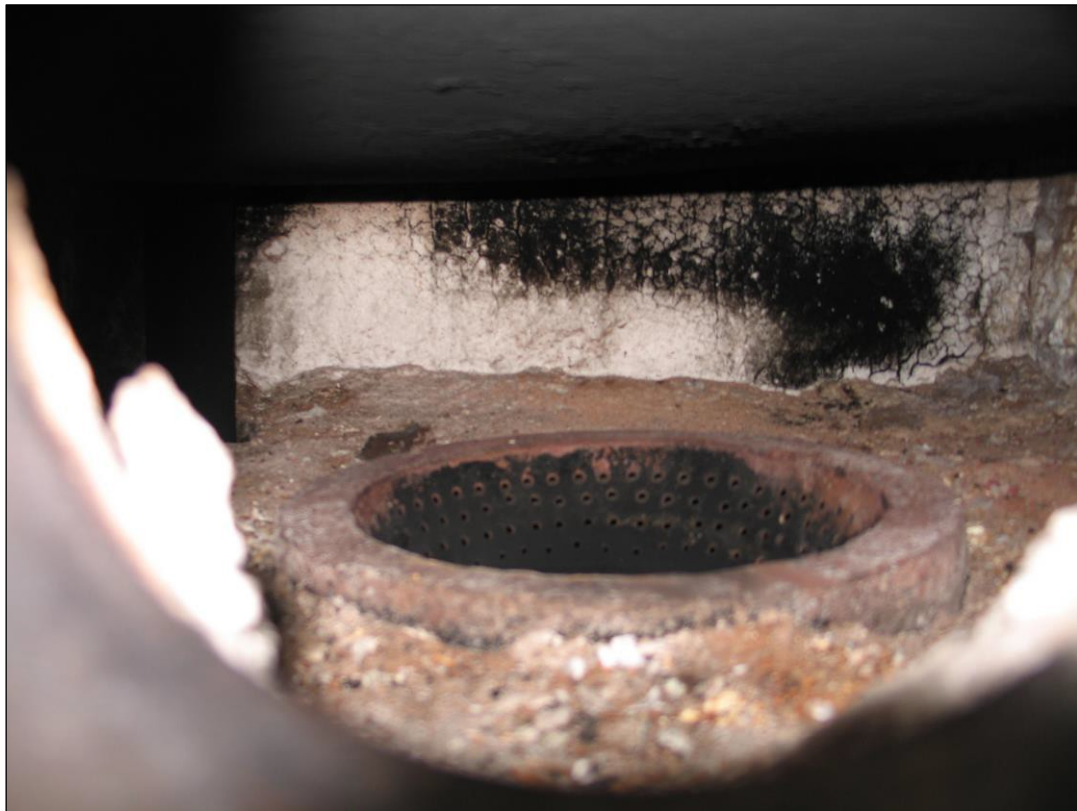
Figure 10: Cup burner below the tank

After the shrimp basket was tilted, it would be feasible that the deckhands noticed that the burner was no longer working. It is not possible to verify how long the flame was extinguished. Due to the permanent flow, it is possible that the diesel overflowed into the air apertures and then atomised. The result would be a highly flammable and possibly explosive atmosphere (6-12% by volume) in the combustion chamber.

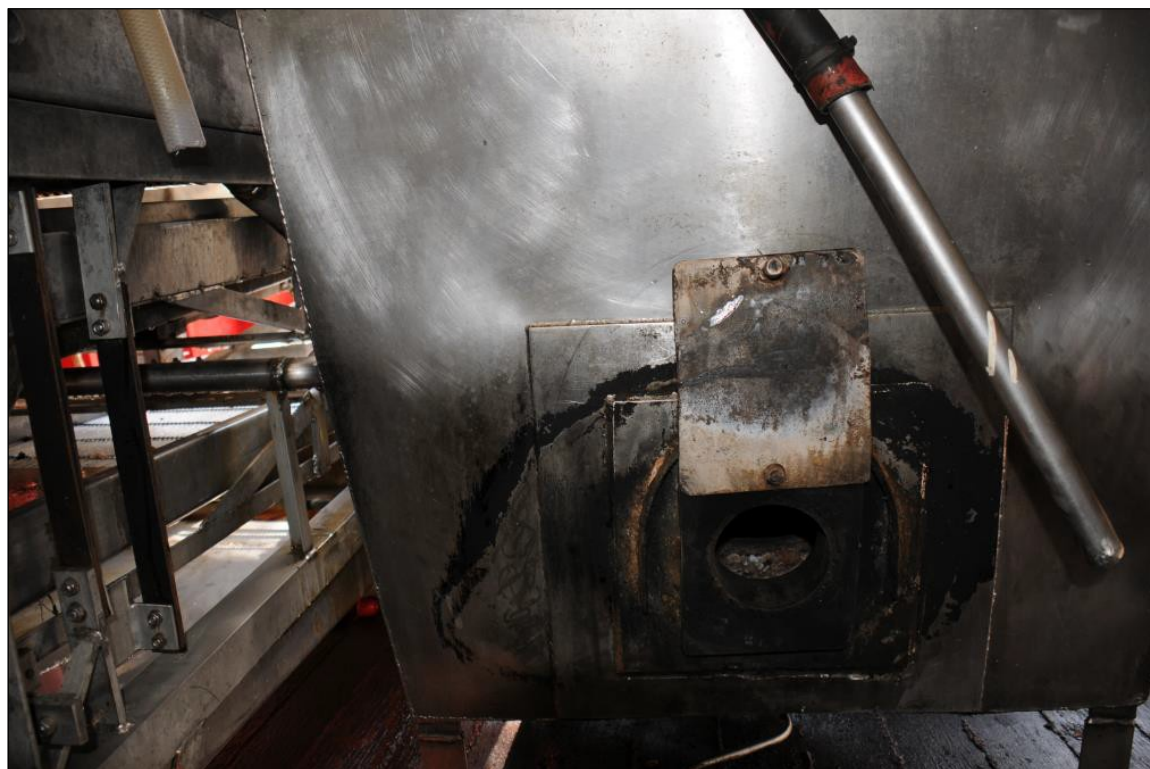
Figure 15: Fully open ignition aperture

Local testing by the expert revealed that the chimney effect is sufficient to evacuate the gases via the exhaust pipe when the blower is running and the fire damper is closed. When the fire damper is opened, the chimney effect drops and there is a marked discharge through this aperture.

It is highly probable that subsequent re-ignition or approaching with a burning wick or other source of ignition (e.g. burning cigarette) would cause the escaping gas cloud to ignite. The effect would be similar if the fuel (diesel) was not processed mechanically, but evaporated due to the build-up of heat in the insulated combustion chamber.

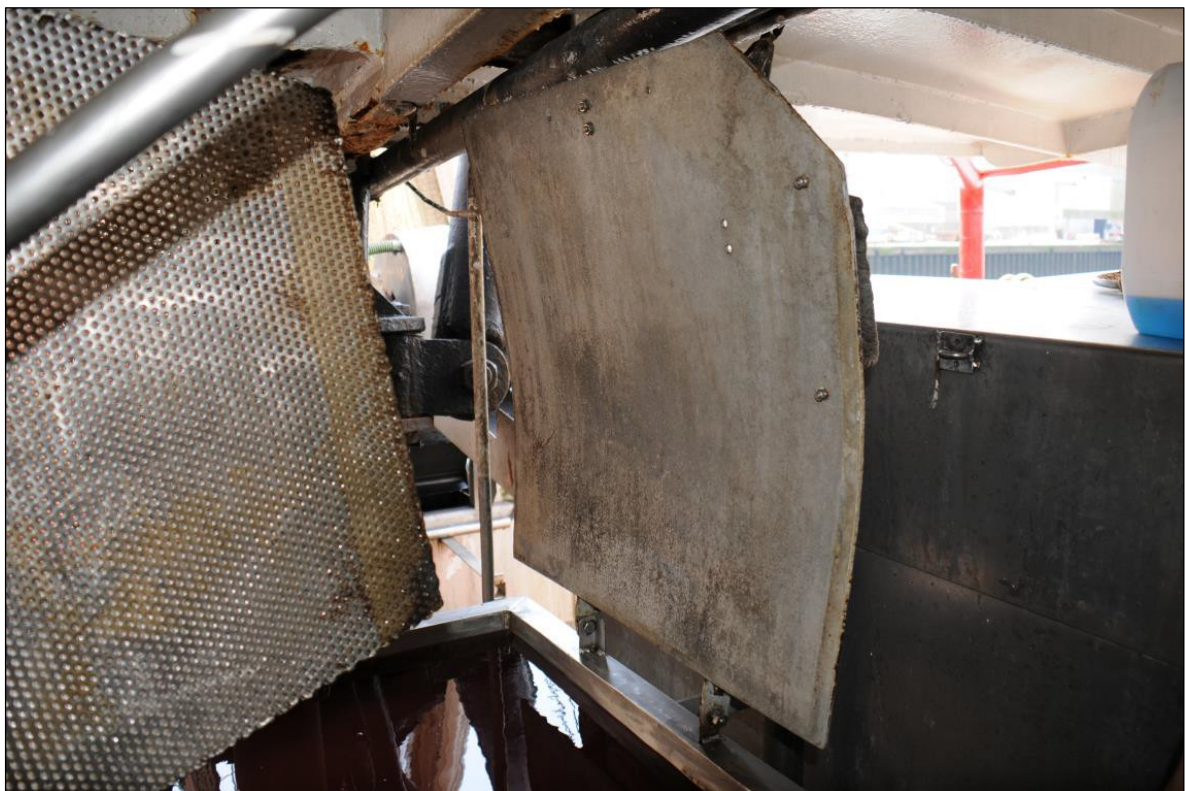
Figure 17: Deck structure struck by lid

A detonation in the combustion chamber with ensuing pressure build-up is conceivable as another sequence of events. That the water tank was raised briefly as a result of that would be theoretically possible. The pressure release through this narrow coaming area would be accompanied by a rapid emission of flames. This would explain the pattern of burns on standing operating personnel. Also indicative of this scenario would be the shrimp boiler's buckled lid. The opened lid striking the deck structure could explain this deformation.

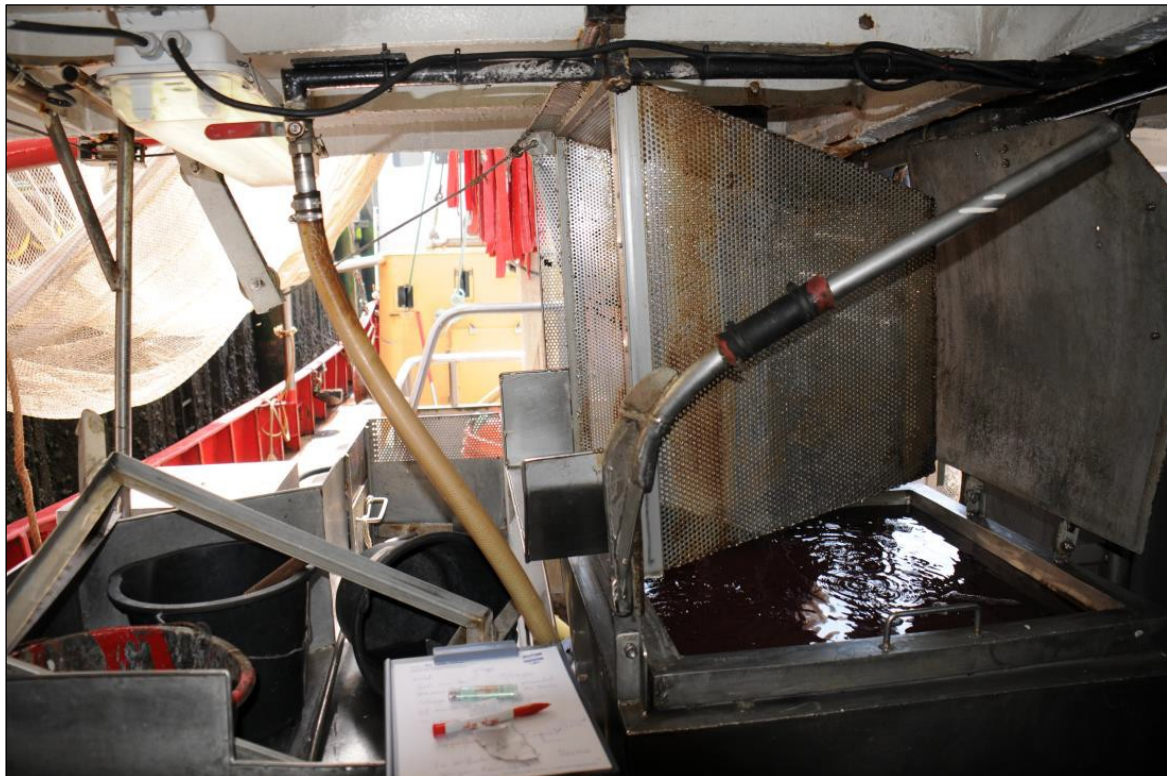
Figure 19: Tilted shrimp basket

A twisting of the shrimp basket in the tank, causing the tank to raise when tilting, is rather unlikely but cannot be discounted. It is also possible that this would have affected the mixture formation in the combustion chamber and caused a detonation with flame emission.
