**Bundesstelle für Seeunfalluntersuchung**  
**Federal Bureau of Maritime Casualty Investigation**  
Federal Higher Authority subordinated to the Ministry of Transport  
and Digital Infrastructure

Investigation Report 128/14

**Serious Marine Casualty**

**Allision between the MSC BENEDETTA and  
pier in Zeebrugge on 16 May 2014**

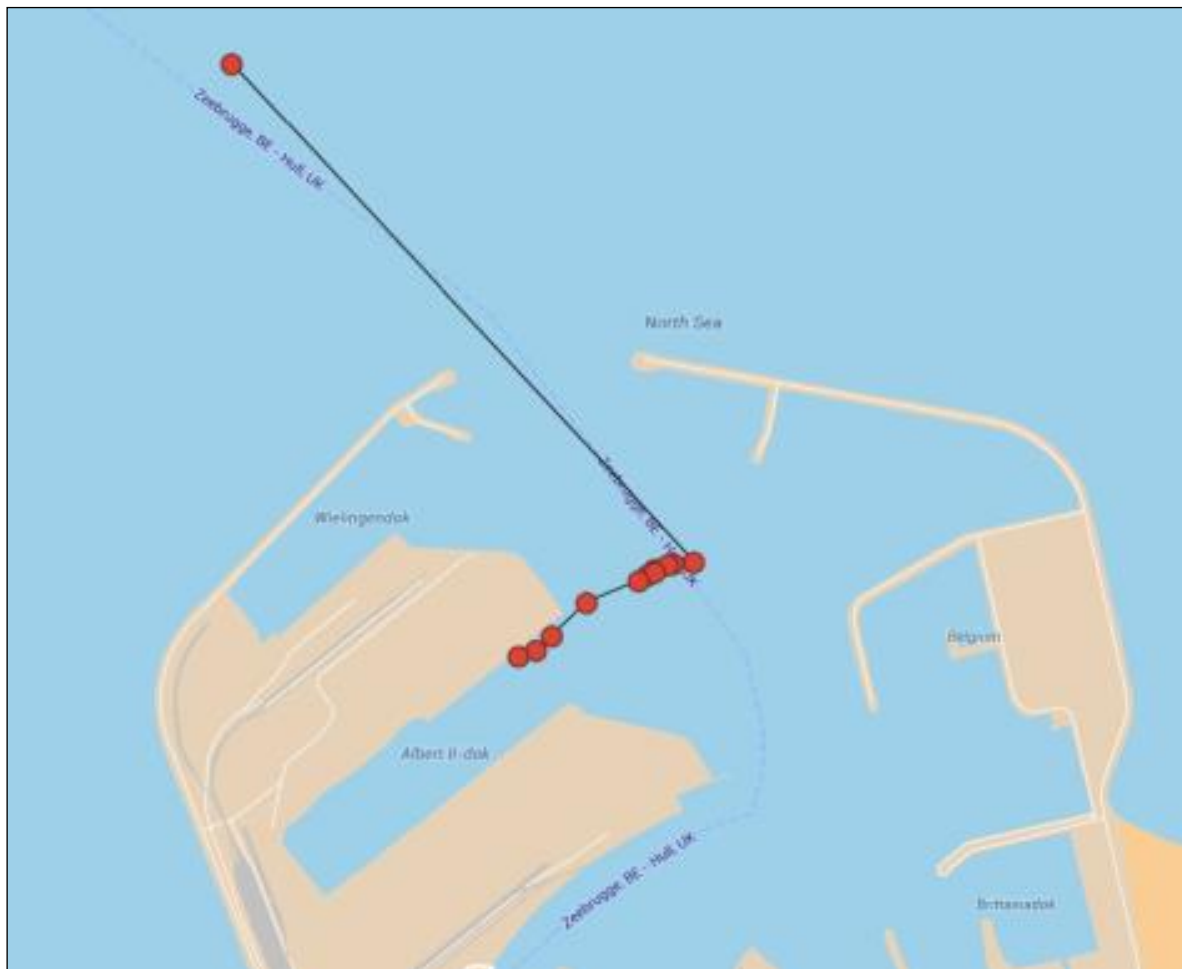
Figure 3: AIS track of the berthing manoeuvre

The ship was stopped at 0448; the heading was about 150°, in order to start the turn to starboard as the bow thruster was ordered fully to starboard, the bow tug to starboard and the stern tug to port. According to hydrodynamic effects this did not lead to a starboard turn. It was then decided to set the rudder to dead slow astern in order to shift the pivot point to the stern of the ship. This rendered the bow thruster and the bow tug more efficiency.

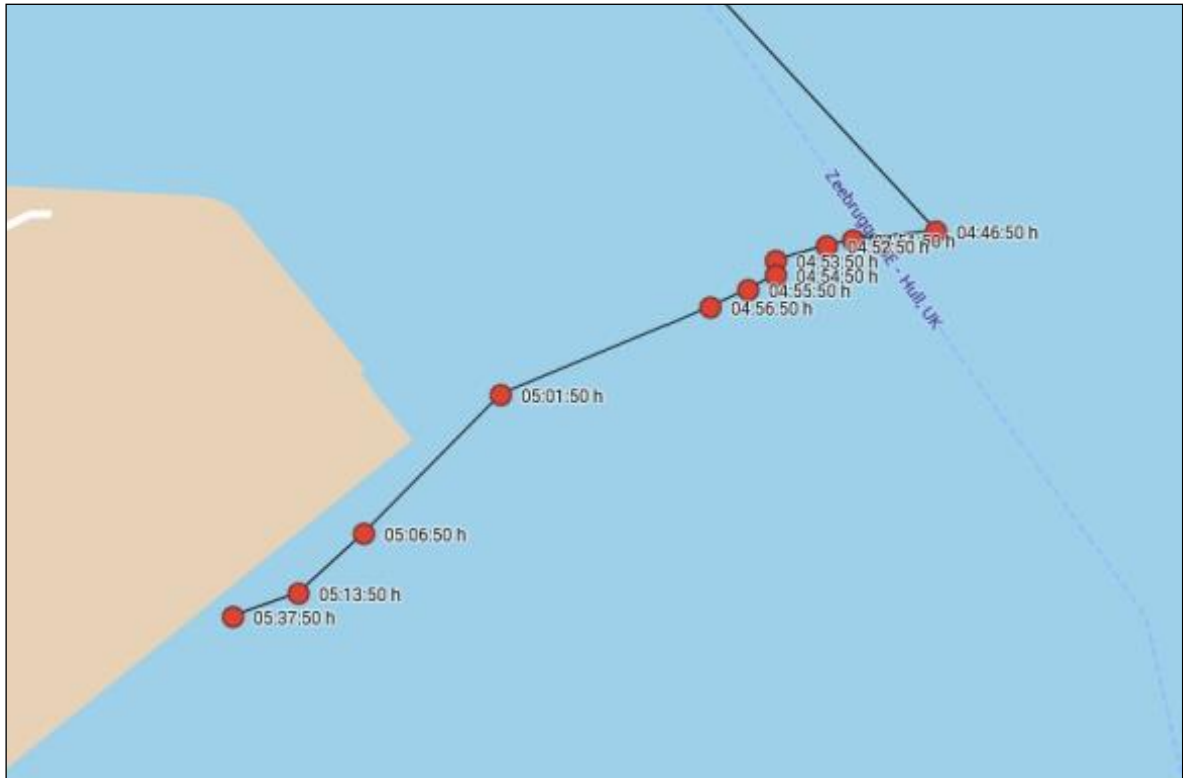
At 0502, the pilot recommended half astern. At 0503, the VDR indicated a speed of about 1.5 kts ahead and lateral movement of the entire ship to starboard of about 0.5-1.0 kts.

The starboard side of the MSC BENEDETTA collided with the pier at 0504. This is clearly audible on the audio recordings by the VDR. The main engine was immediately stopped and the bow thruster set to 50% to starboard. Shortly afterwards, the MSC BENEDETTA was moored at the pier and the damage assessed.

Figure 4: AIS track of the berthing manoeuvre (in detail)

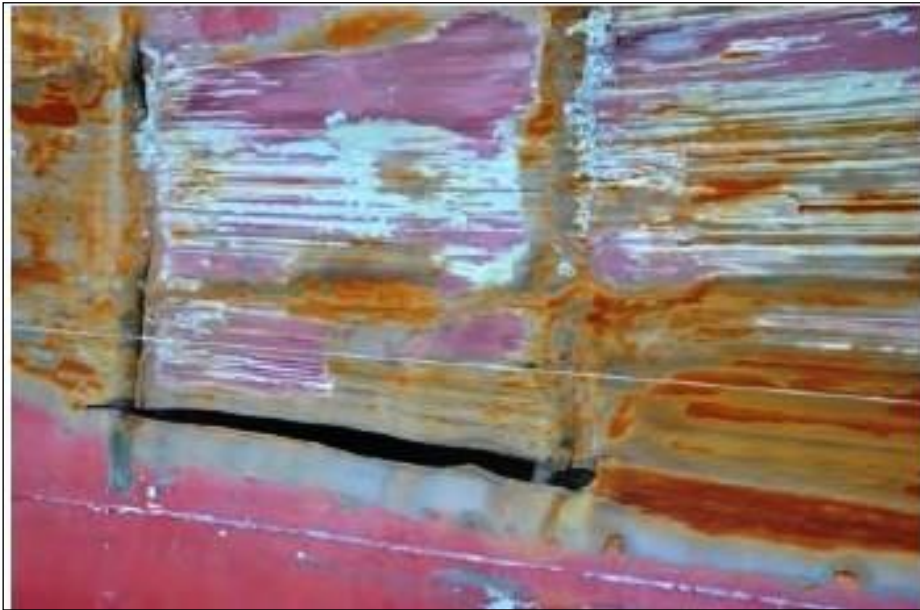
A tear formed in the shell plating level with the water line, through which two ballast tanks filled with water. However, there was no environmental pollution.

Contact with the pier resulted in severe damage to the outside of the fourth and fifth ballast water tanks. Since the tear formed level with the waterline, these tanks took on a substantial amount of water rapidly.

Figure 6: Photo of the tear

Extensive repairs were necessary.

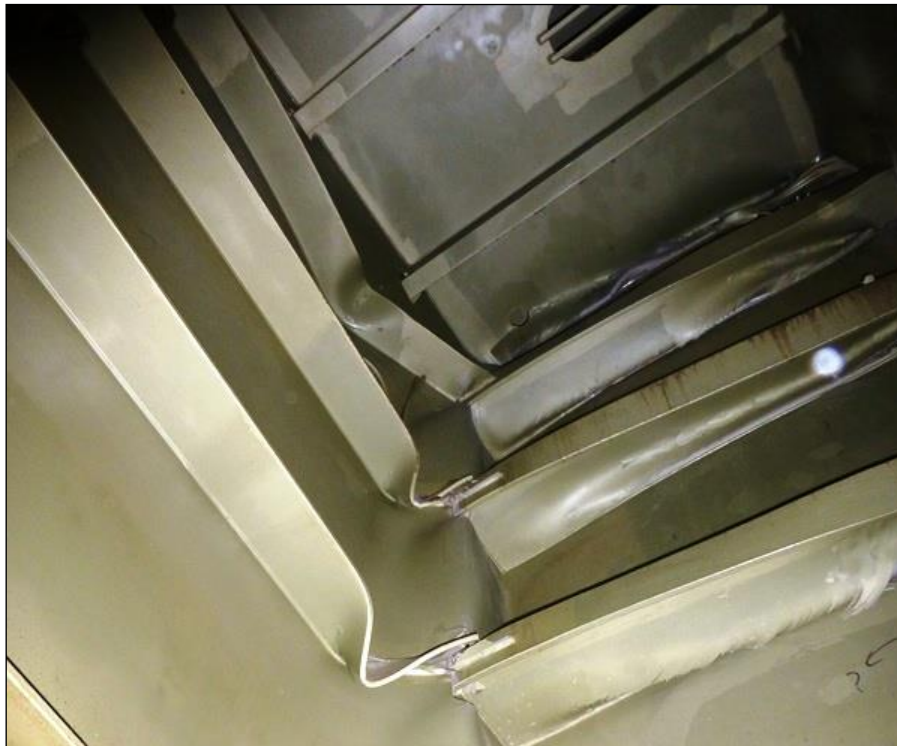
Figure 7: Buckled frames

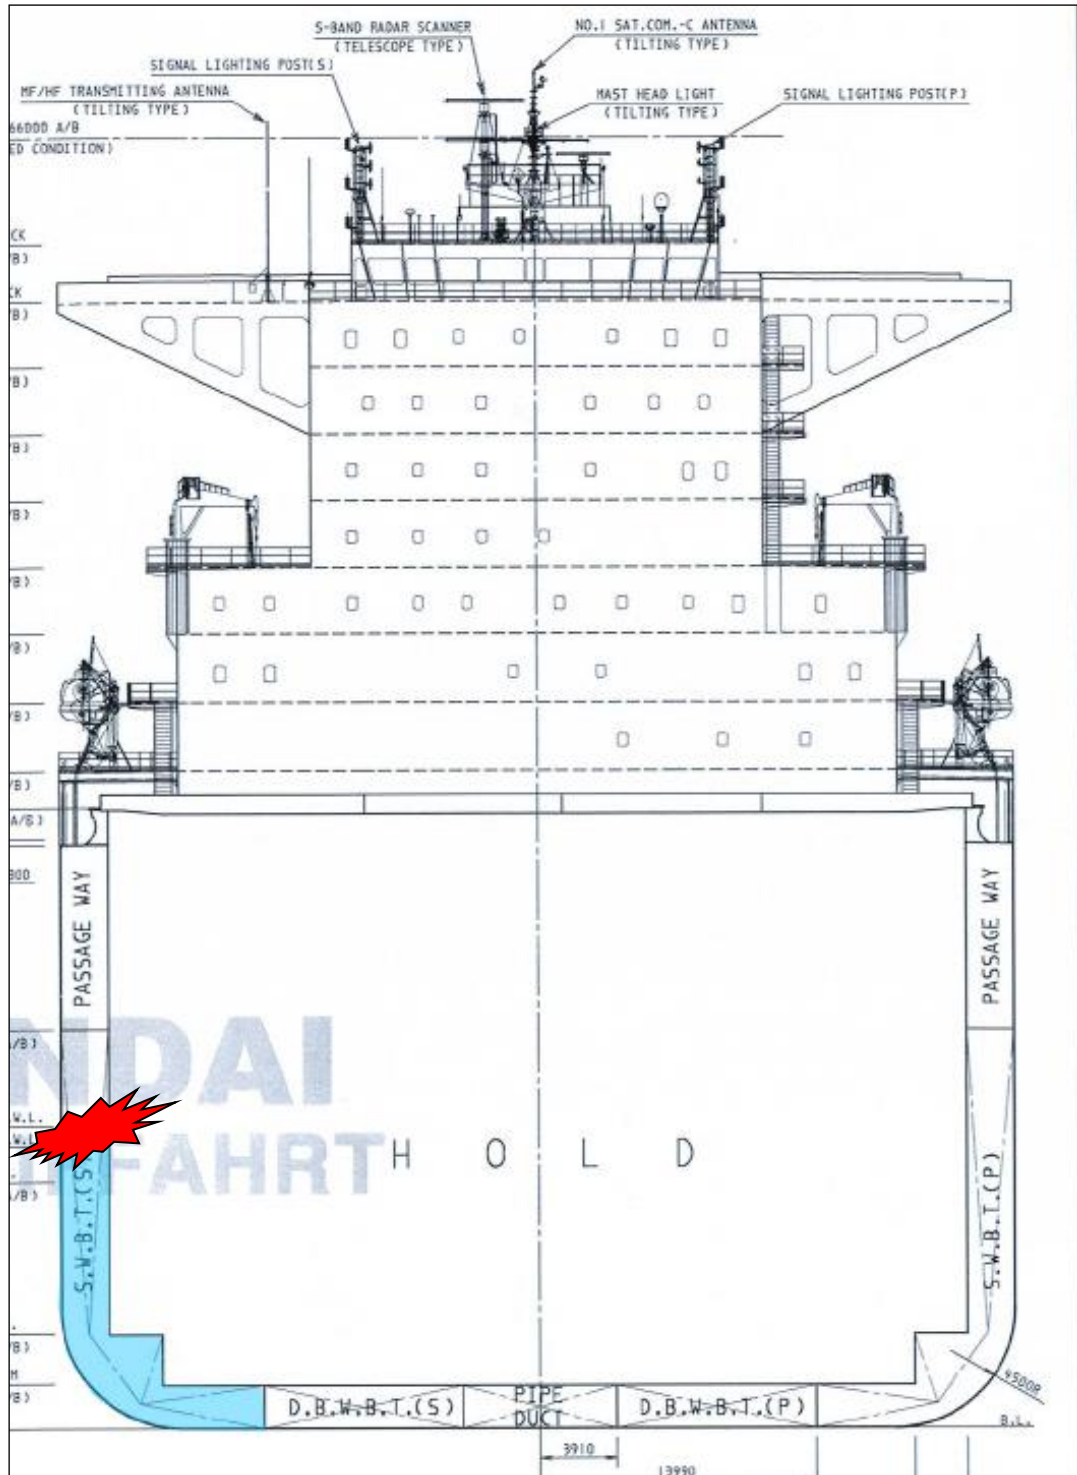
Figure 8: Approximate position of the leak

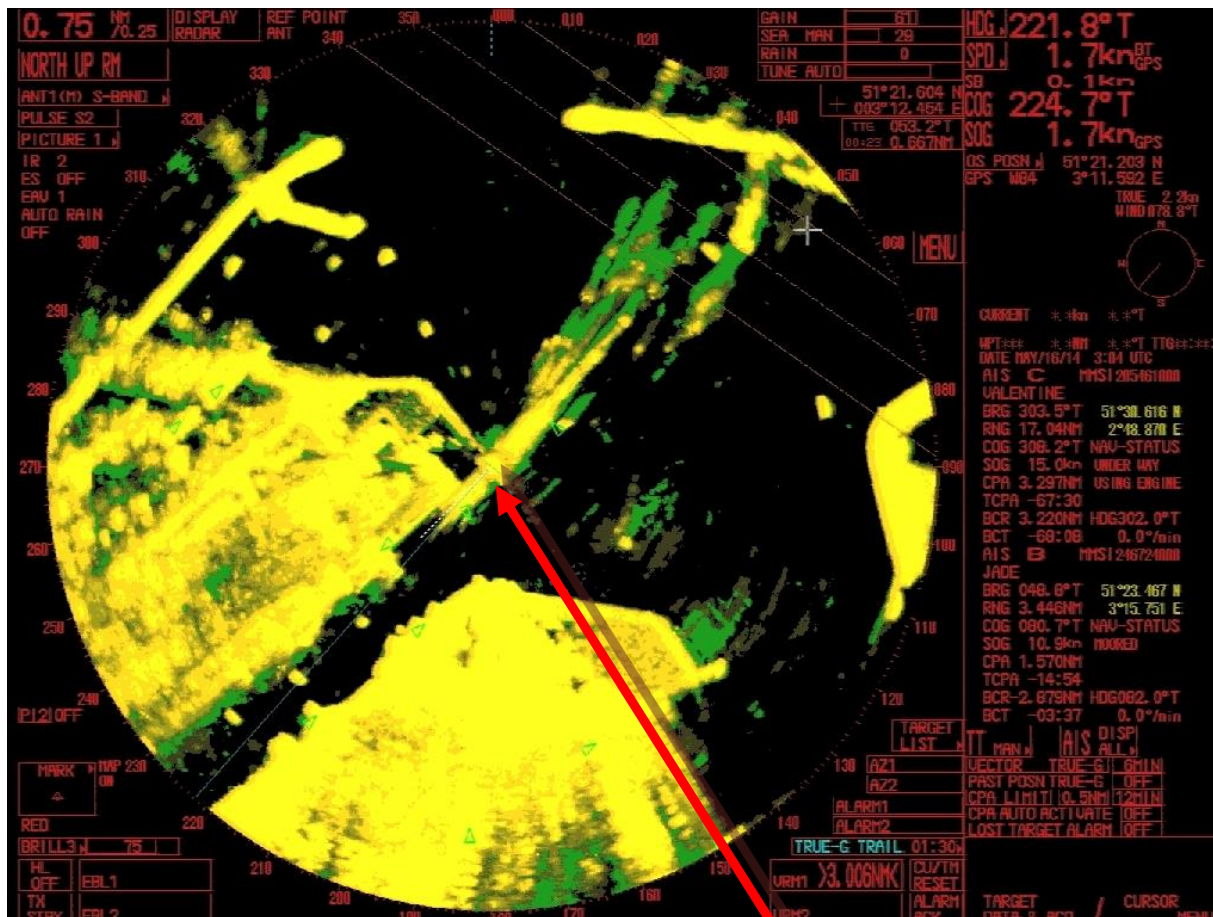
Inter alia, audio recordings are available in addition to the radar image. The allision is clearly audible at 0504.

Figure 9: Radar image at the time of the accident (0504)

Figure 8 shows the radar image of the MSC BENEDETTA (centre of the frame) at the moment that her starboard side struck the pier.
