Bundesstelle für Seeunfalluntersuchung
Federal Bureau of Maritime Casualty Investigation
Federal Higher Authority subordinated to the Ministry of Transport
and Digital Infrastructure

Investigation Report 140/14

Very Serious Marine Casualty

**Fatal accident in the
port of Goole, England,
on board the MV SUNTIS
on 26 May 2014**

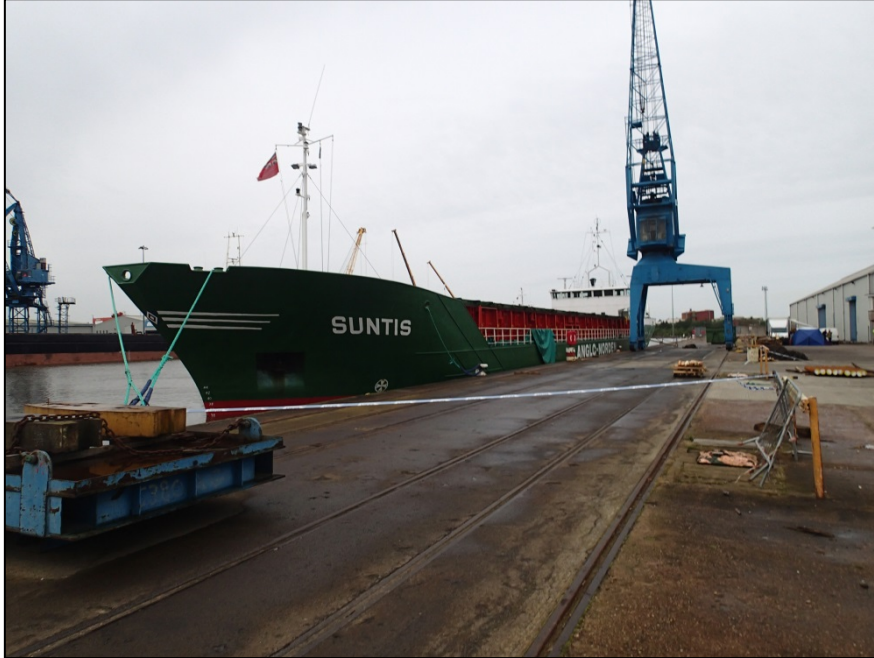
Figure 3: MV SUNTIS at 1000 on 27 May 2014

The deck cargo was already completely discharged. The protective tarpaulins were still on the hatch and on the main deck in places; one green tarpaulin hung overboard.

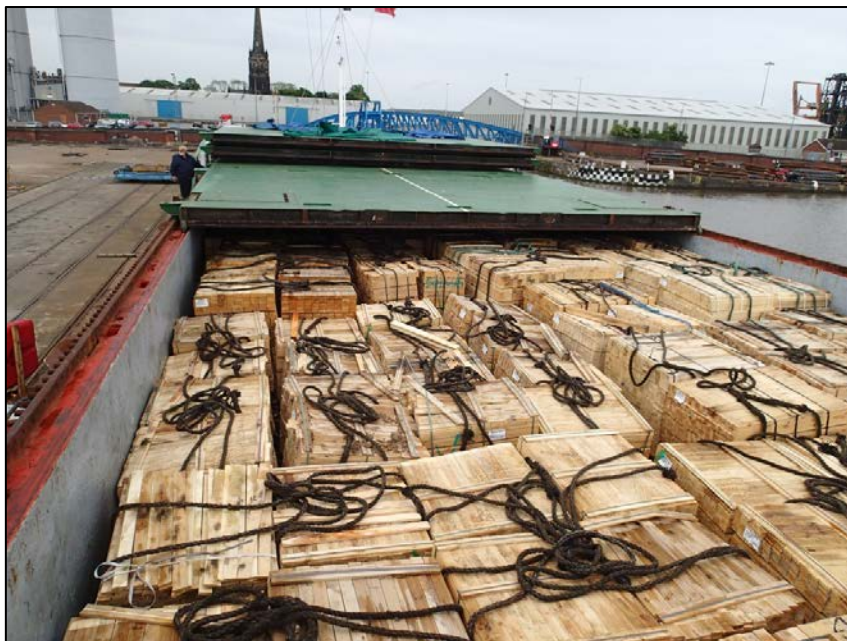
Figure 4: Open hatch and timber cargo

When the hatch was opened, a strong odour of freshly cut timber disseminated, which made breathing normally difficult even before entering the hatch. The remainder of the survey on the forecastle revealed a cut yellow rain jacket, a cut T-shirt, and a galley knife next to the access to the tween deck. The galley knife was being used to cut the clothing on the collapsed seamen. A subsequent interview revealed that the clothes of the collapsed seamen were cut up with a kitchen knife for resuscitation.

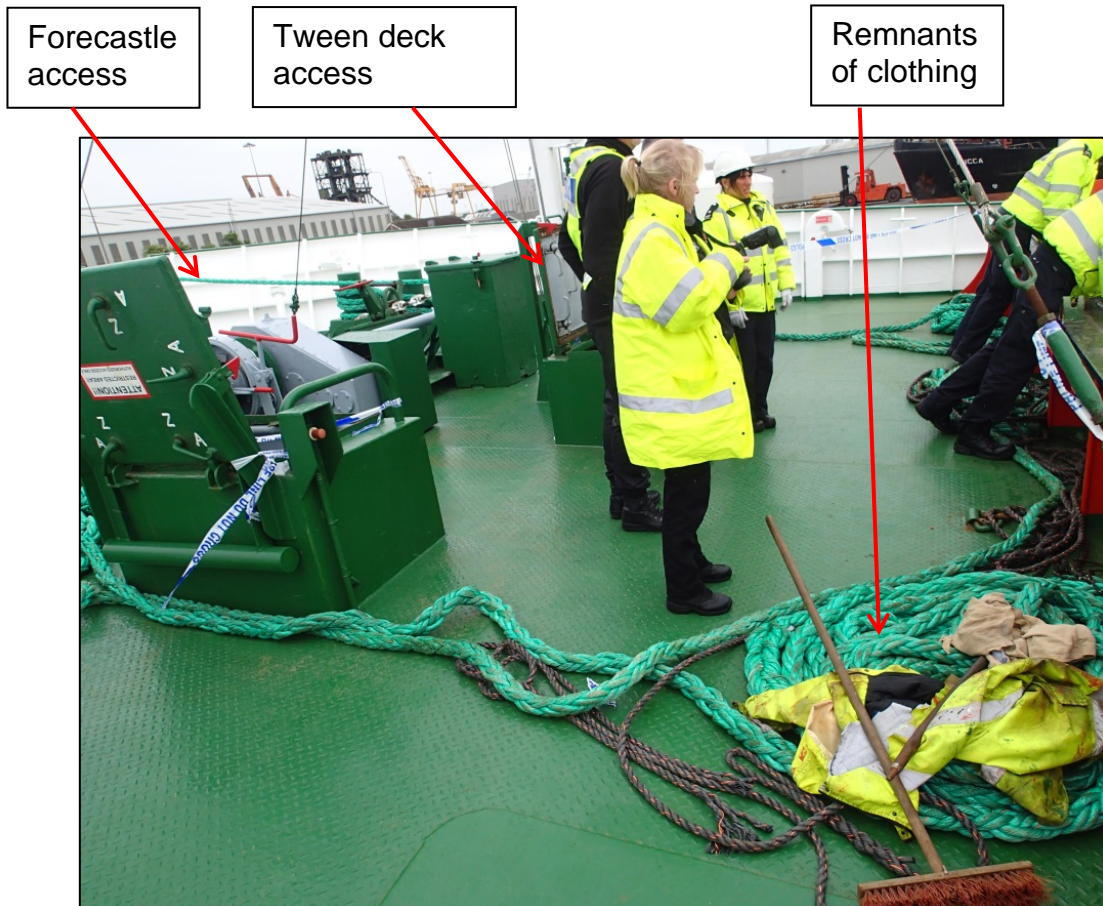
Figure 5: Forecastle with access points

The forecastle's access hatch, which is used as a cable-tier/paint store/bosun's store, can be locked with a padlock. However, the tween deck's (forecastle store deck) hatch was secured against unauthorised access only by a bolt and eye nut. The tween deck's hatch was marked clearly with warning signs:

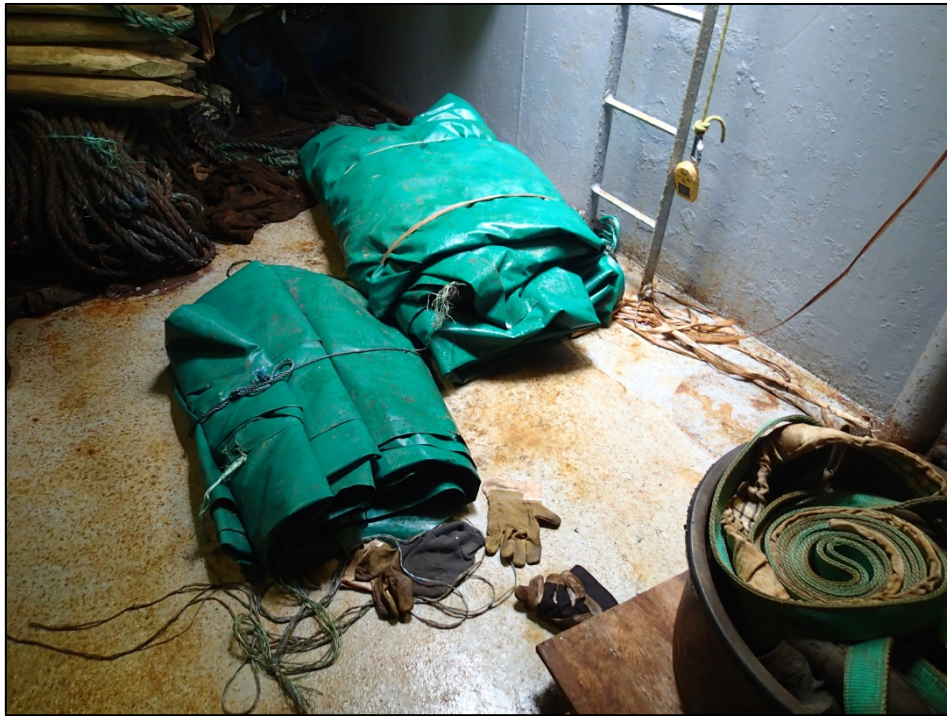
Figure 8: Tween deck

Two green tarpaulins were found below on the tween deck directly next to the ladder. Immediately next to them were two pairs of gloves and a winter hat. A safety helmet was next to the ladder on the bulkhead behind the tarpaulin. A partly smoked cigarette was later found behind the ladder (see figure 15).

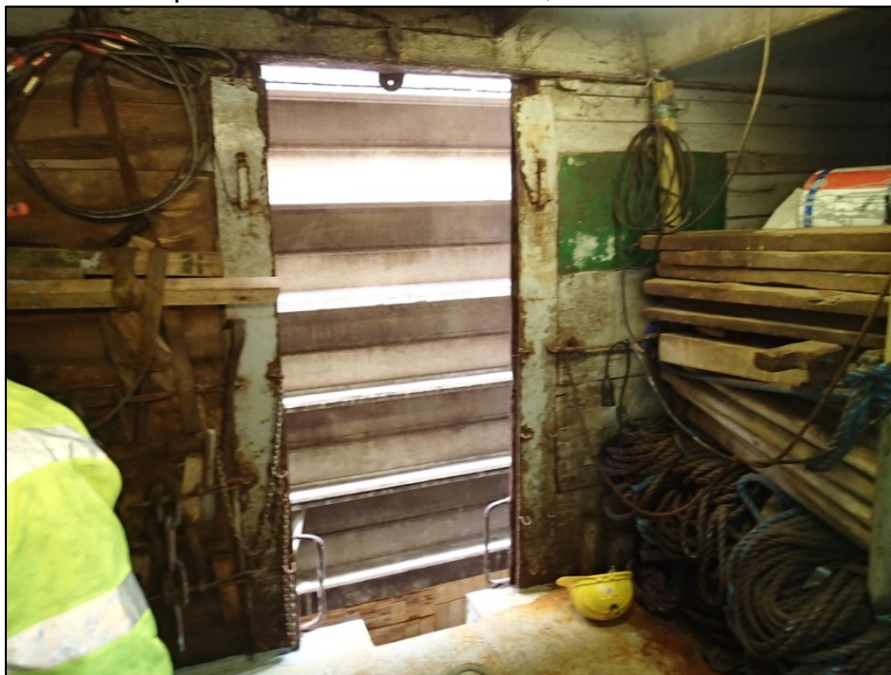
Figure 9: Cargo hold access with second helmet

Another helmet was found on the port side next to the cargo hold's access. The access can be secured with chains to prevent people from falling and closed completely with timber planks. This was not done, however.

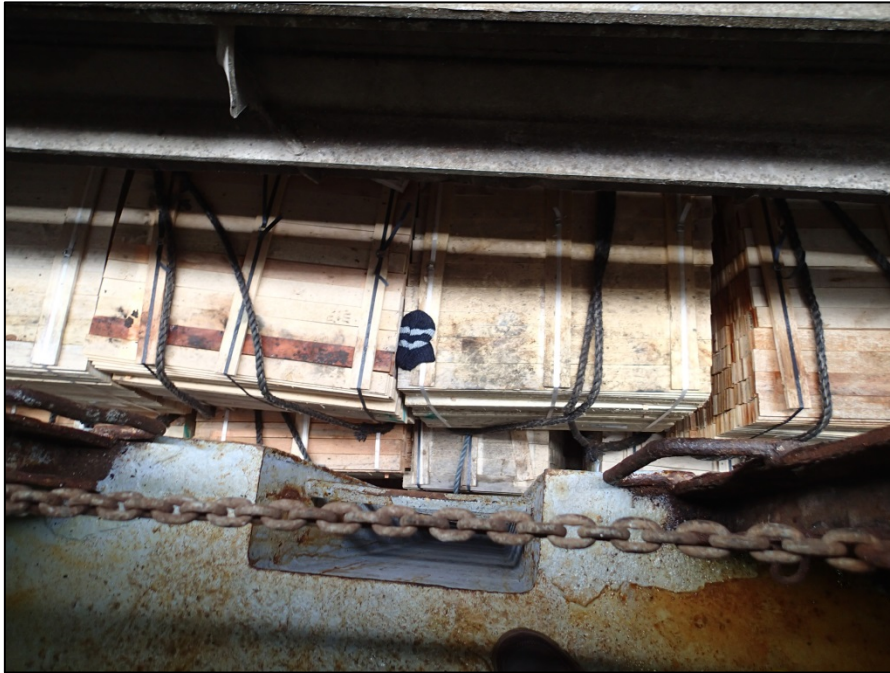
Figure 10: Winter hat on the timber cargo

A second winter hat was found directly below the access on the timber stack in the cargo hold.

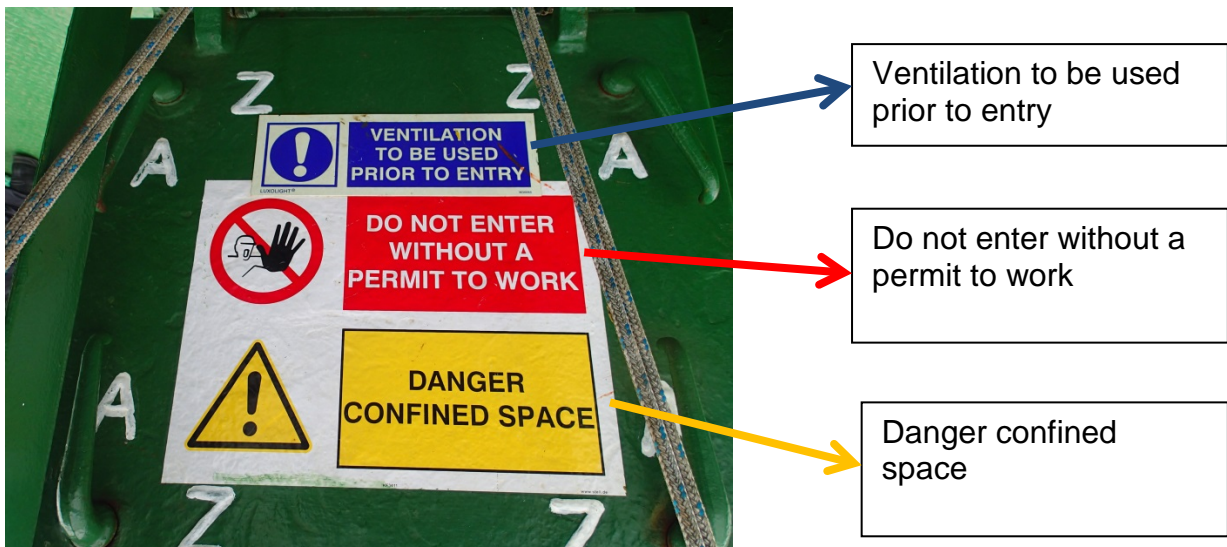
Figure 12: Labels on the hatchway cover

Access on the forecastle to the tween deck is made via a hatchway cover and with a ladder. This hatchway cover is secured against unauthorised access merely by means of eye nut and bolts. The hatchway cover was provided with the following labels:

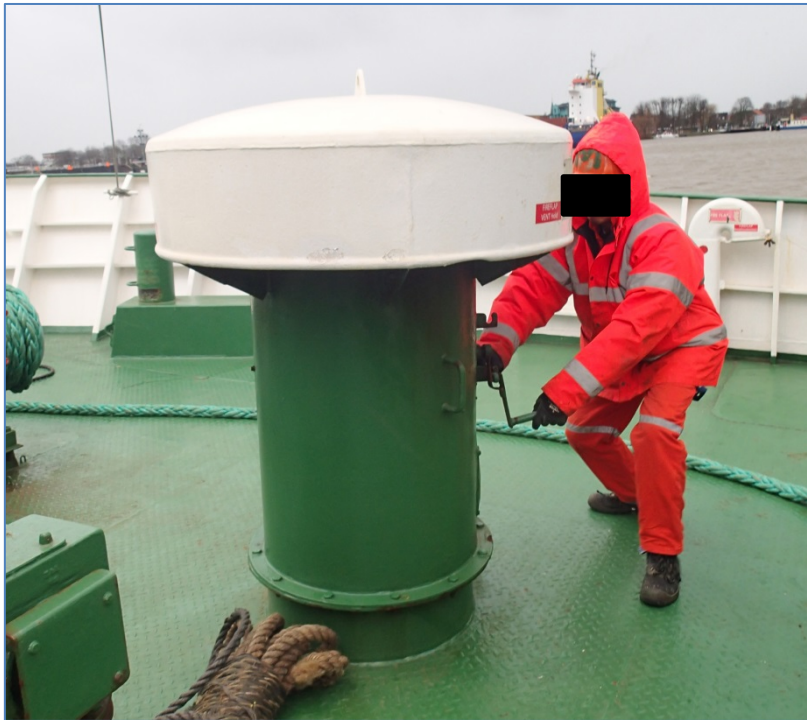
Figure 13: Forward cargo fan

A large electric fan ventilates the cargo hold and compartment on the tween deck. On the forepeak, it can only extract from the tween deck. The fan is switched on at a switch cabinet on the port side forward in the cable-tier. Additional ventilation is provided via the aft access door to the cargo hold or via a ventilation flap, which is installed next to the aft door to the cargo hold. In the main, ventilation is provided by opening the cargo hatchway.

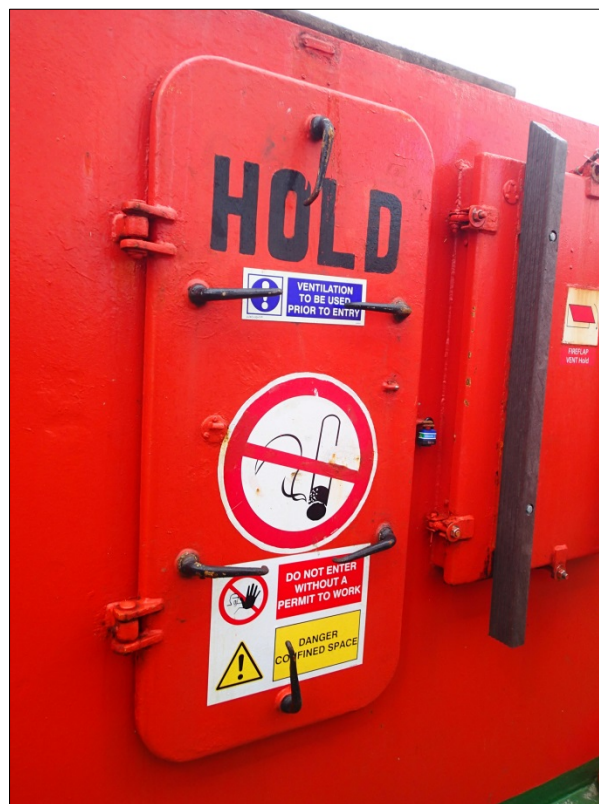
Figure 14: Cargo hold access and ventilation flap

The cargo hold door bears the same warnings and labels as the forward access hatch to the tween deck.

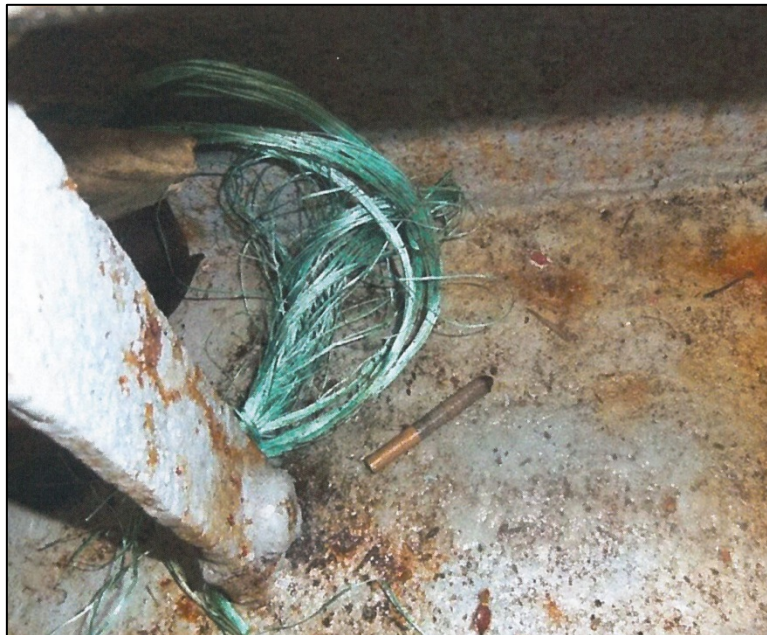
Figure 15: Cigarette on the tween deck

The two OSs were neither instructed nor ordered to climb down into the cargo hold. It was initially assumed that the reason the two crew members were found on the tween deck was that one of the OSs, who was known as a chain smoker, climbed down into the cargo hold to smoke there. This is supported by the fact that a partly (1/3) smoked cigarette of the brand he smoked on board was found behind the ladder. The second OS would have then climbed down to rescue his colleague when he saw that something was not right.

This assumption is opposed by the fact that the superstructure and main deck behind the superstructure are the areas designated for smoking on board. There is a clear instruction not to smoke on the deck, especially during loading and discharging operations. There is also a strict instruction not to smoke in the cargo hold and tween deck and this instruction is applied restrictively.

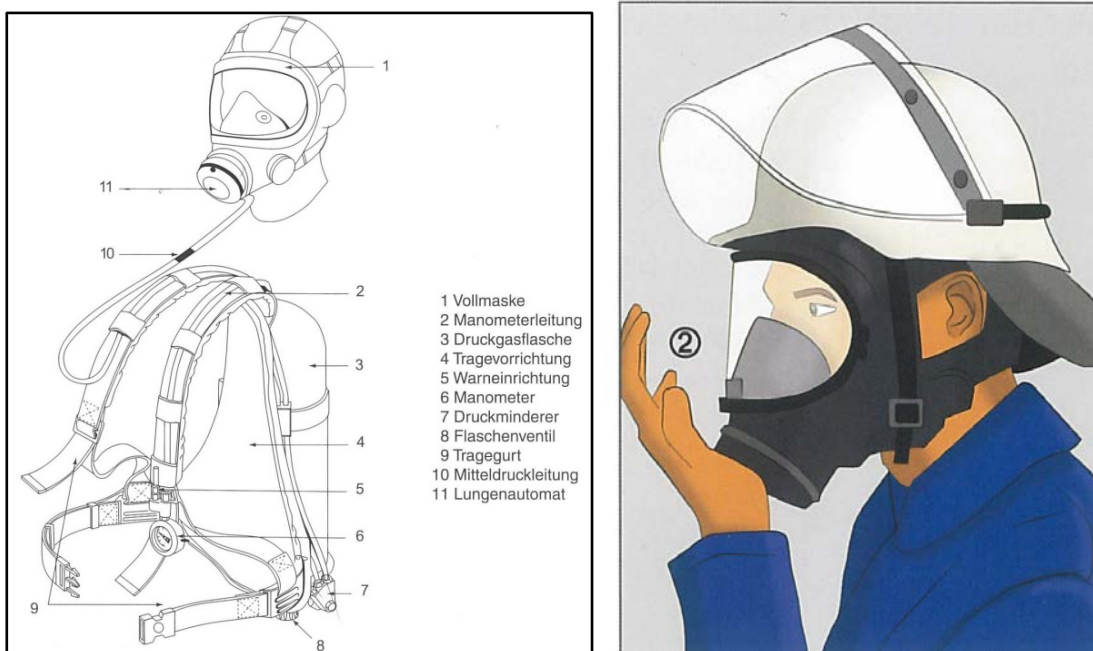
Figure 16: BA and full-face mask leak test

BAs are provided for firefighting and rescue operations. All the crew members are usually trained on operating these devices and receive regular refresher training. The full-face masks that belong to the self-contained breathing appliances are stored separately in a box for protection. The lung governed demand valve is connected only after the mask is donned and leak tested using the ball of the thumb. This procedure is described in the ship safety services manual of the Ship Safety Division (BG Verkehr). If a mask is (as in this case) forgotten or not used, it is still technically possible to breathe using the lung governed demand valve. However, harmful gases are inevitably inhaled through the corners of the mouth and nose.

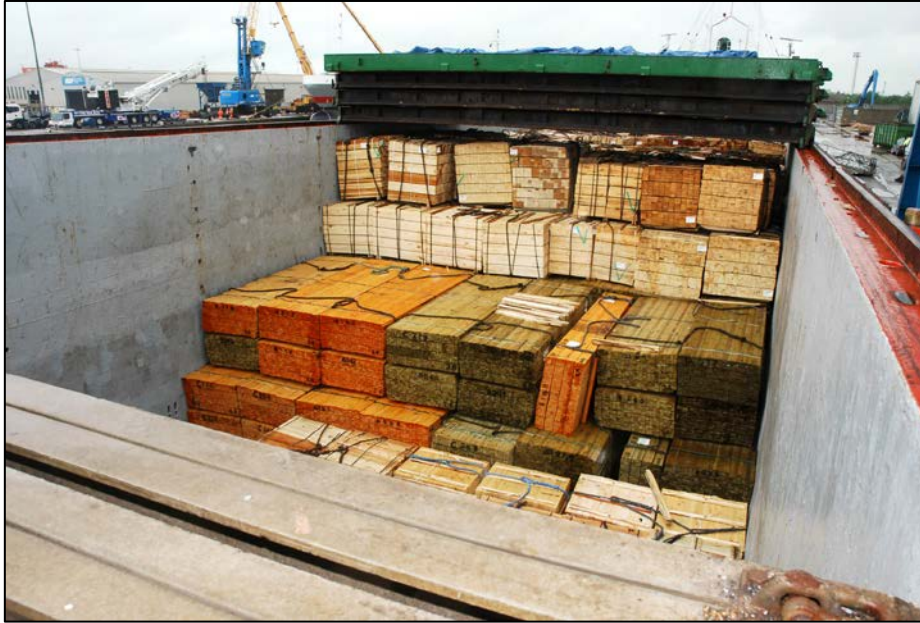
Figure 18: Various colours of the timber

Based on the various colours of the timber and according to the information of the timber merchant on the Internet, it is reasonable to assume that the following fungicidal wood preservatives were used:

During the investigation in the port of Goole, it was noted that the wood was extremely moist. It is quite possible that the wood preservatives caused this moisture. It was not possible to determine the amount of wood preservative in the timber or atmosphere during the investigation.

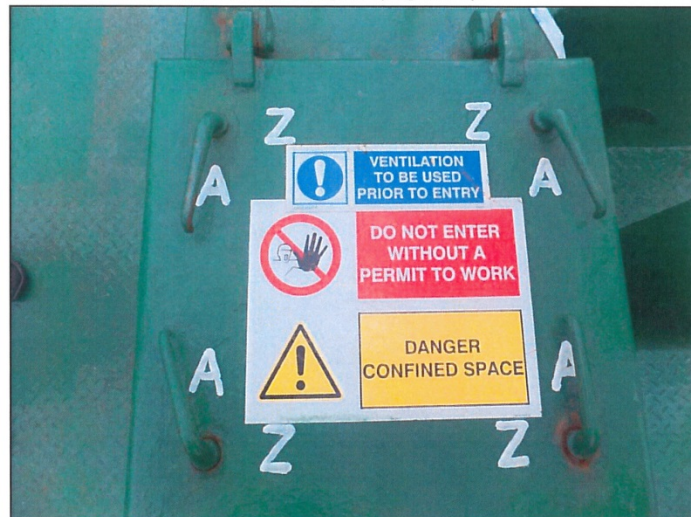
Figure 1

With a timber cargo loaded in the hold and the hatch covers closed, access to the compartment was subject to a permit-to-work and confined space entry procedures. The lid of the hatch into the compartment had signs indicating the potential dangers (**Figure 1**).

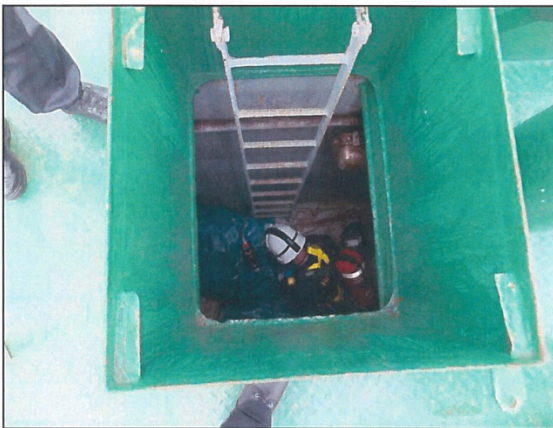
Figure 2

The Fire and Rescue Service analysis of the atmosphere after the accident showed normal readings (20.9%) of oxygen content at the access hatch; the readings reduced to 10% just below main deck level inside the hatch opening and to between 5% and 6% at the bottom of the ladder into the compartment (**Figure 2**). Such low levels of oxygen cannot support life. Anyone exposed to such levels will faint almost immediately, followed by convulsions, coma and respiratory seizure within a few minutes. It is likely that the timber cargo caused the deprivation of oxygen in the cargo hold and access compartments.
