Bundesstelle für Seeunfalluntersuchung
Federal Bureau of Maritime Casualty Investigation
Federal Higher Authority subordinated to the Ministry of Transport
and Digital Infrastructure

Investigation Report 155/14

Serious Marine Casualty

**Collision between the ferry
ADLER EXPRESS
and the pier
in the port of Wittdün, Amrum
on 4 June 2014**

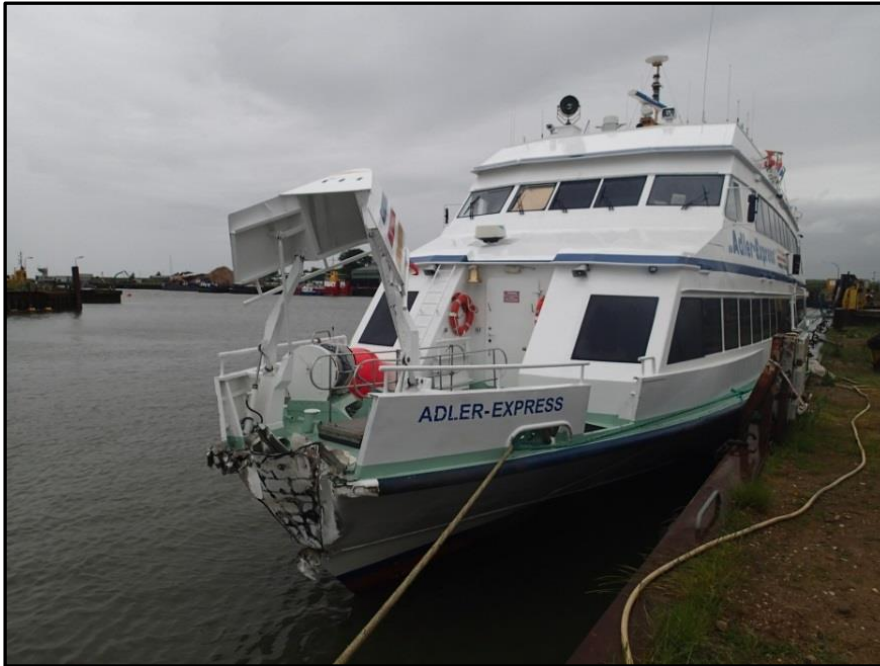
Figure 3: Damage to the fore section

The fore section of ADLER EXPRESS was heavily damaged. During the collision, the bow was pushed in about 50 cm and the deck torn open. The damage zone extended from the main deck to about 1.40 m below. The damage was above the water and no water ingress was reported. Moreover, the collision bulkhead remained intact during the accident. The bow visor with hydraulic cylinders and bearing brackets was deformed and it was impossible to move the visor. The harbour master did not report damage to the pier in Wittdün.

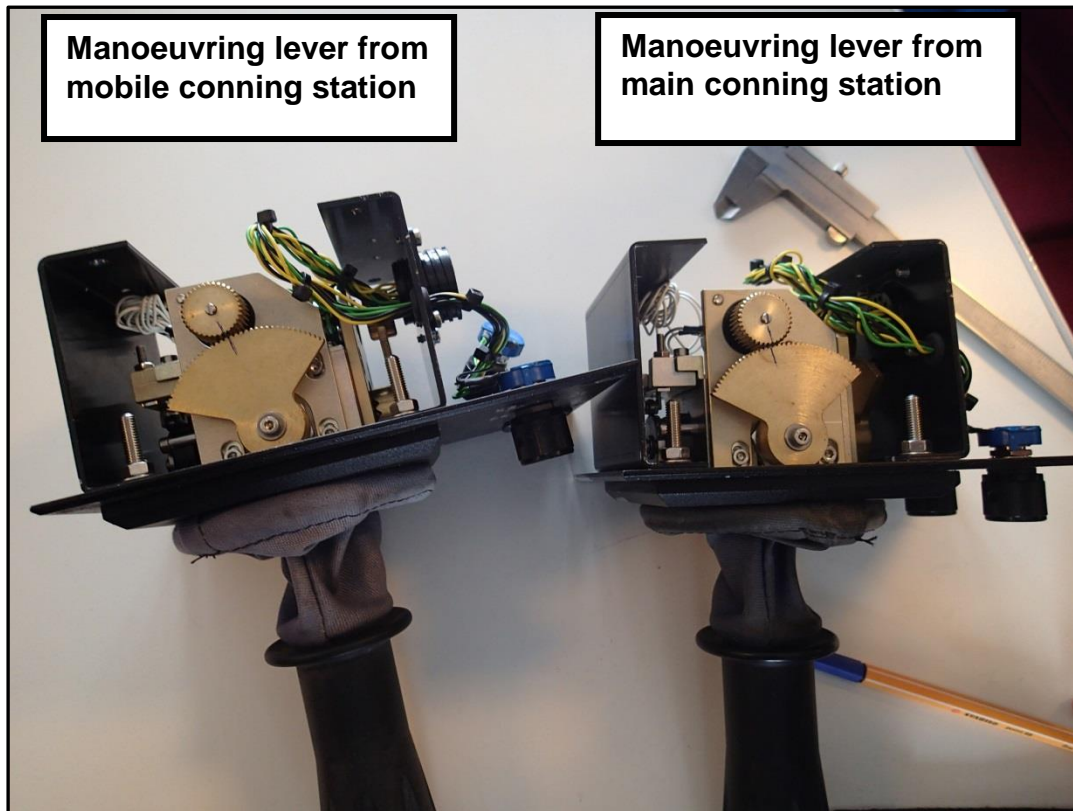
Figure 9: Manoeuvring levers

It was found that when the manoeuvring lever (joystick) was set to full astern quickly (lever as far as it would go) at the main conning station, the engine rpm dropped to its lowest idling speed and the water-jet propulsion system's control flaps remained in the preceding position. In addition, a steering error alert was displayed on the monitoring system. It was also possible to read the above error message from the error history stored on the day of the accident, meaning this malfunction must have also occurred on the day of the accident.

Using the lever, the engine speed control is transmitted through a brass segment to a cogwheel located on the shaft of a signal potentiometer. The resistance measurement on the potentiometer revealed an infinite value for the speed control in the full astern position. As a result of this incorrect value, the rated speed dropped to idling speed and thrust as per the manoeuvring lever was therefore absent. Further investigation revealed that a locking screw on the potentiometer shaft's cogwheel had loosened and because of that, the steering signal transmitted did not match the sailing mode.

The manoeuvring lever is replaced after 2,000 hours of operation or at least once a year. The manufacturer has used thread locking compound to additionally secure the locking screw on the potentiometer's cogwheel against unintentional loosening due to vibration.

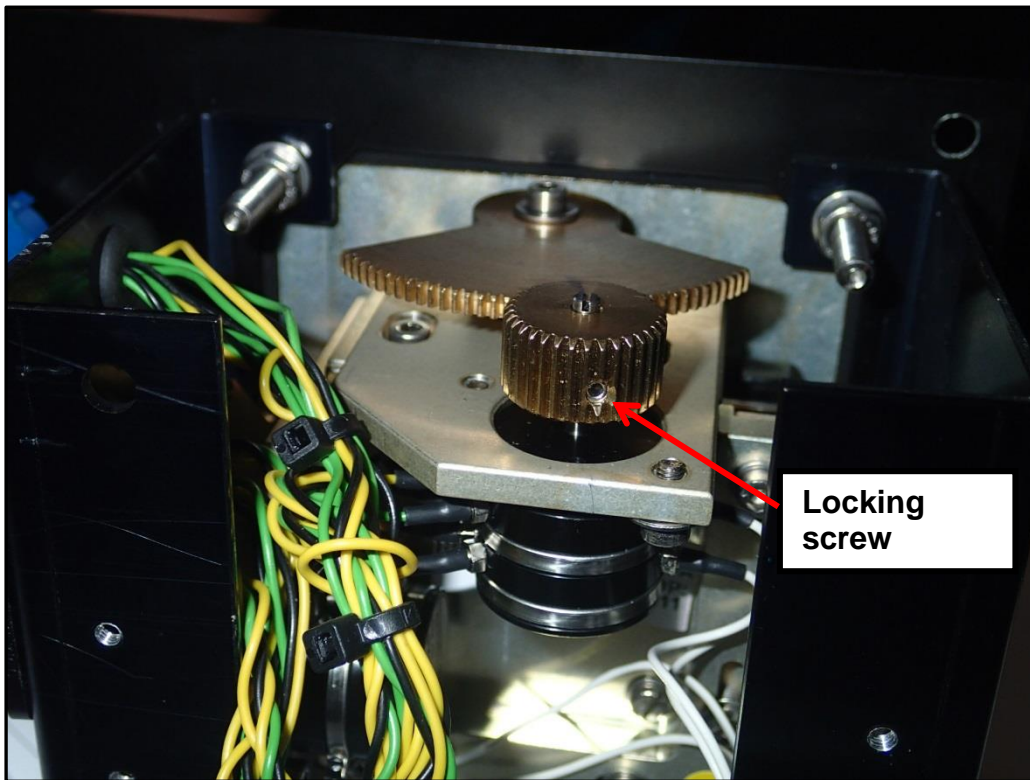
Figure 10: Potentiometer and cogwheel

The accident was caused by an unpredictable technical defect on the manoeuvring lever at the ADLER EXPRESS's main steering position.

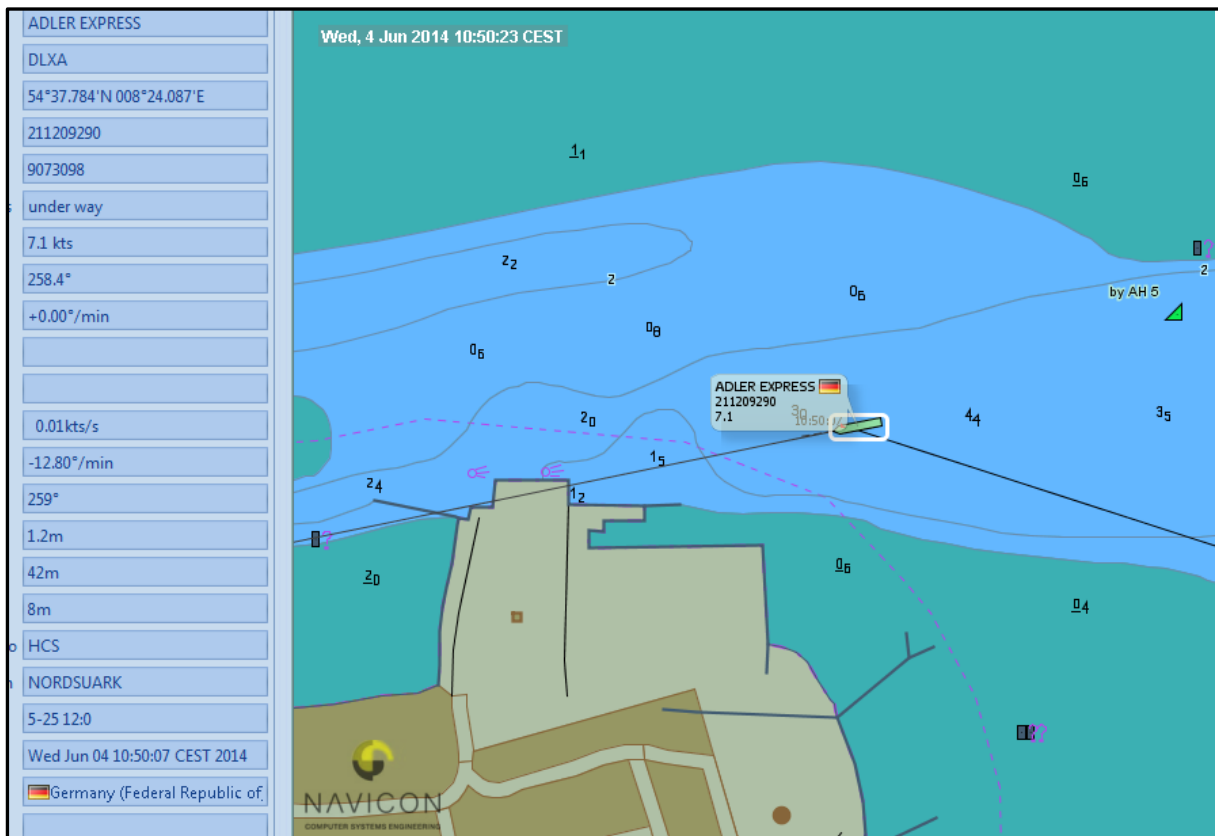
Figure 11: AIS recording at 105023

The above image shows the normal course alteration to port at 7.1 kts.

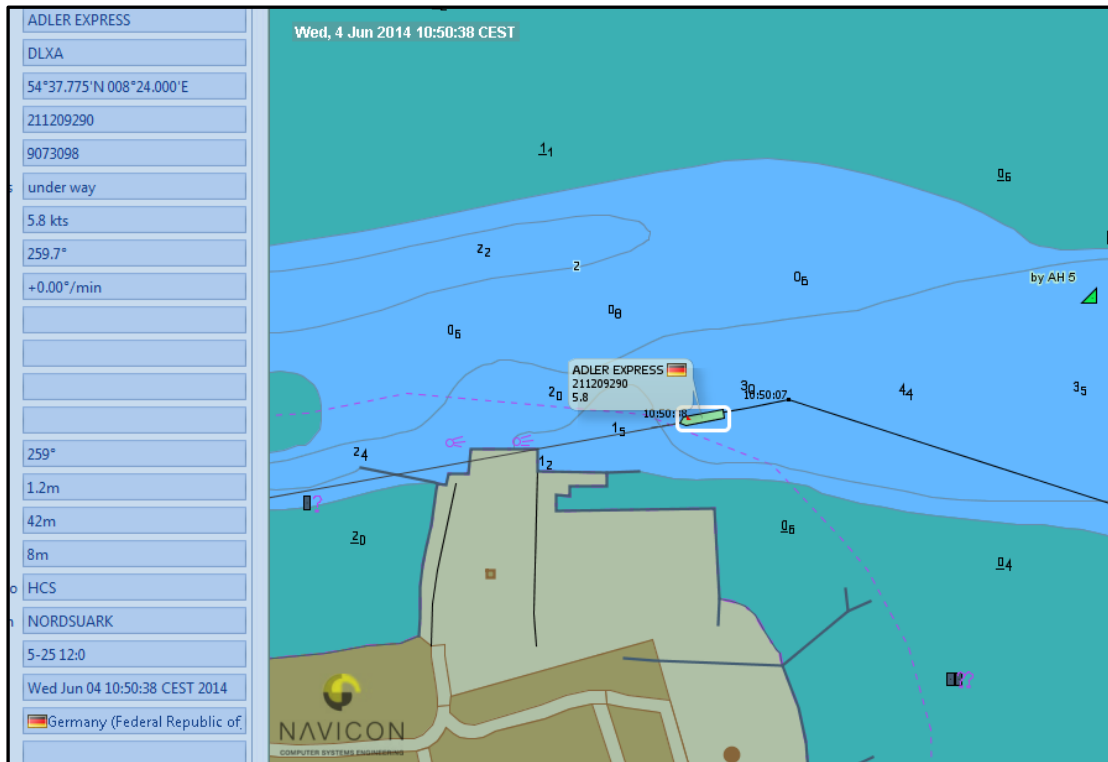
Figure 12: AIS recording at 105038

The course is unchanged and the speed reduced to 5.8 kts.

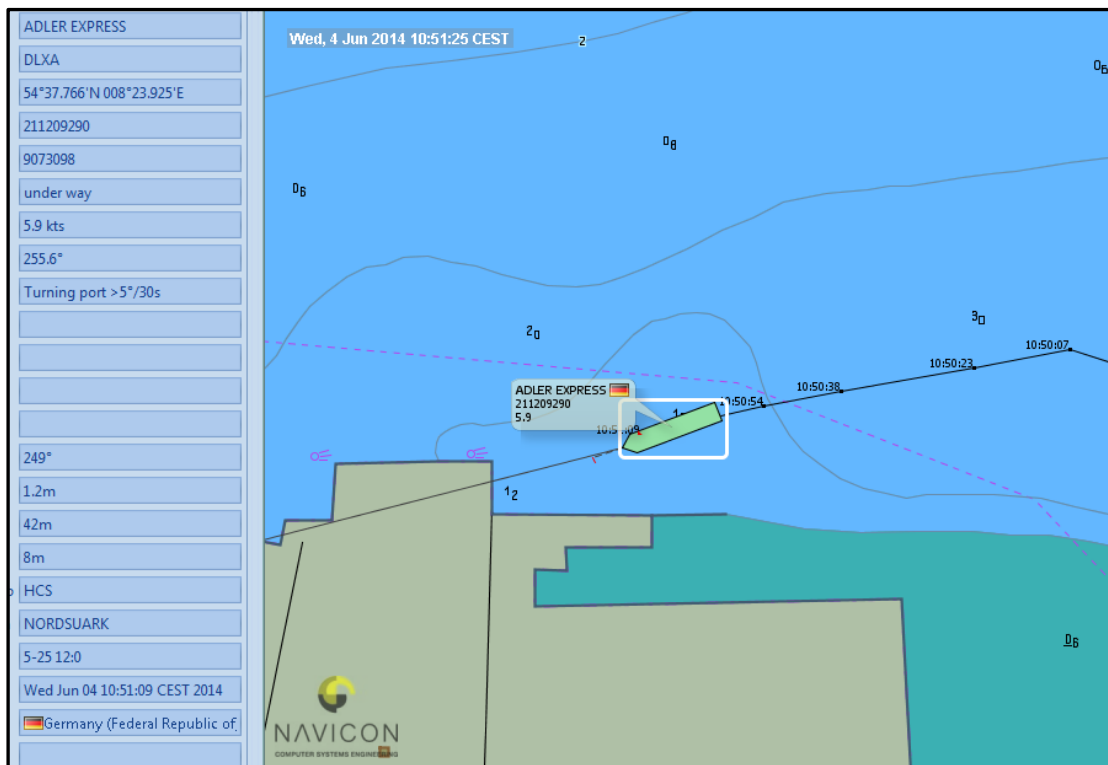
Figure 13: AIS recording at 105125

There is a course alteration to port and an increase in speed at 105110.

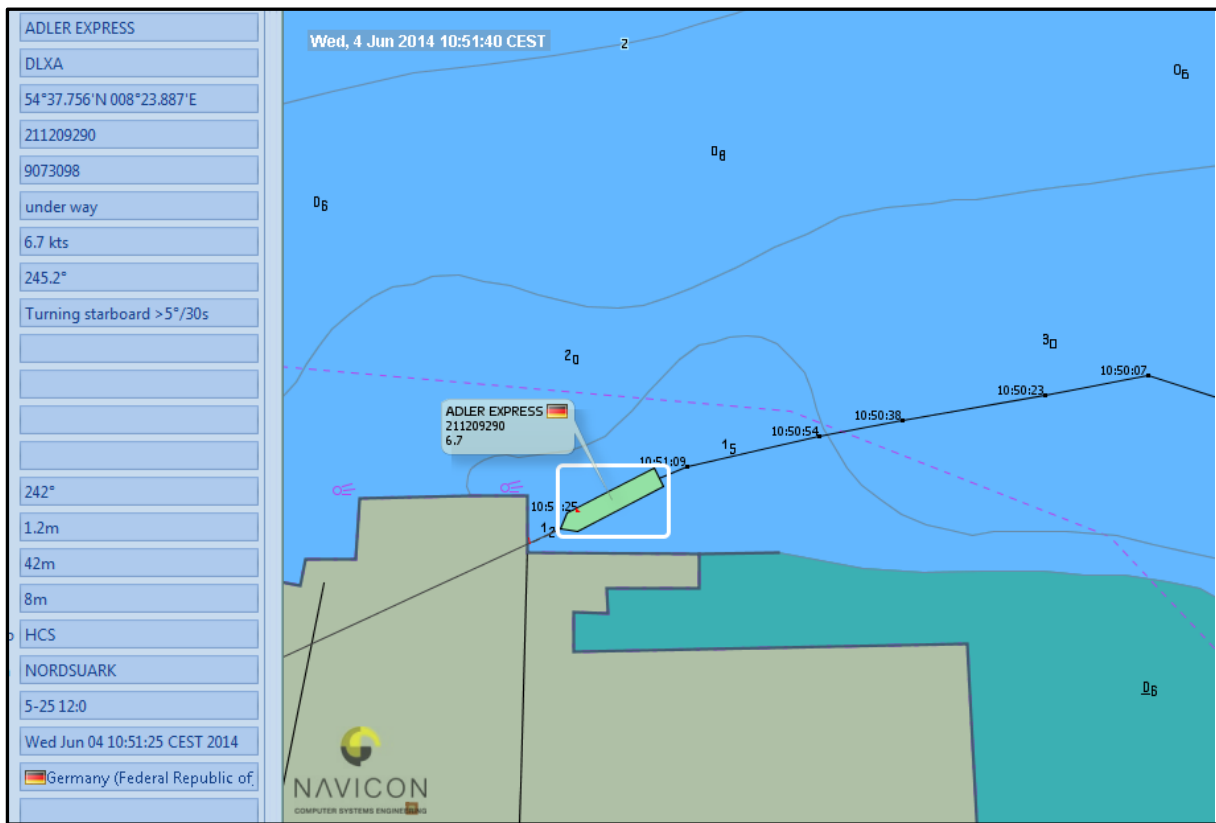
Figure 14: AIS recording at 6.7 kts

Another increase in speed is evident at 105140 and the ADLER EXPRESS collides with the pier at about 105141. 31 seconds passed between the last unexpected course alteration with increase in speed at 105110 and the collision. A reduction in speed is seen on this track on all the other days considered before or after that of the accident.
