Bundesstelle für Seeunfalluntersuchung
Federal Bureau of Maritime Casualty Investigation
Federal Higher Authority subordinated to the Ministry of Transport
and Digital Infrastructure

Investigation Report 265/13

Very Serious Marine Casualty

**Foundering of the Sailing Yacht
FALADO VON RHODOS
on 9 August 2013
off Iceland**

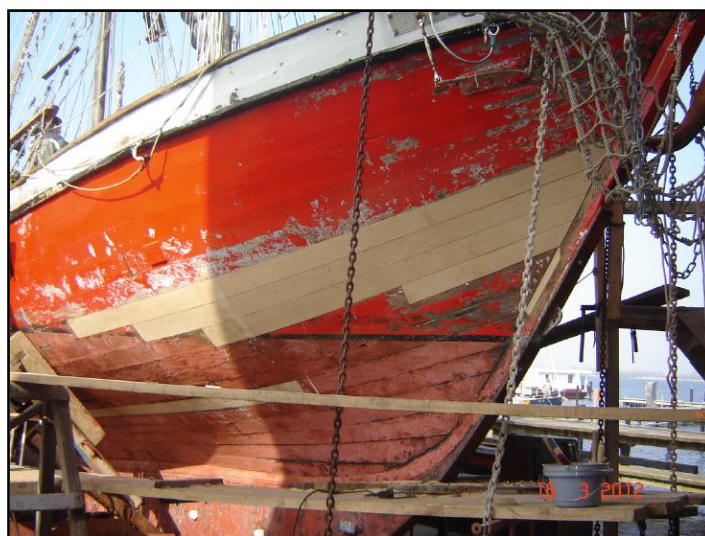
Figure 3: Renewed planking on the starboard side

In March 2012, 17.3 running metres of planking were renewed forward on the starboard side in five strakes and 4.8 m on the port side in two strakes at the Modersitzki shipyard in Maasholm. This shipyard had already renewed 11 running metres of planking in two strakes and installed additional frames on the plank joints in 2008.

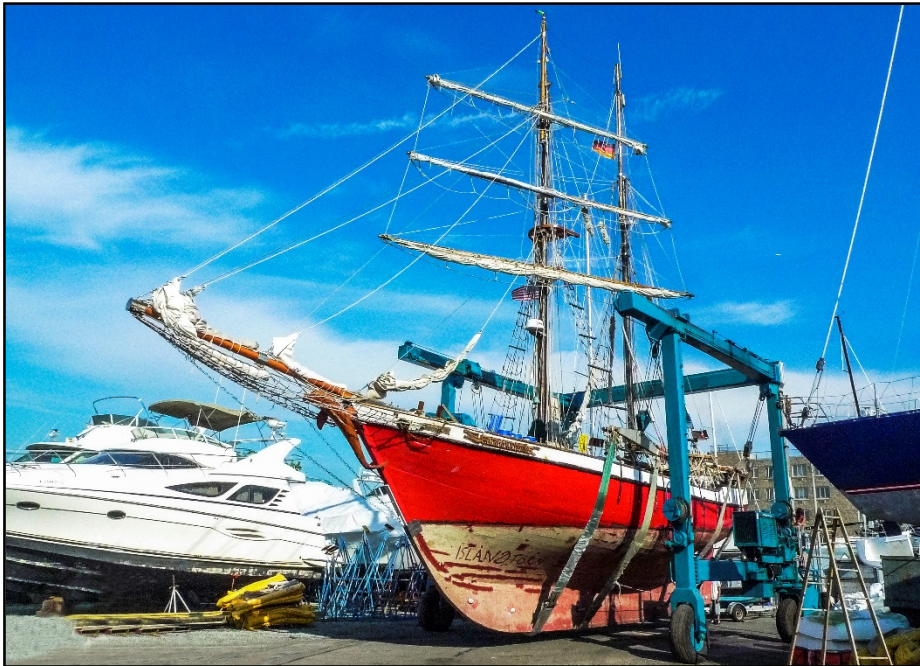
Figure 5: On the travel lift in the United States in May 2013

Dry-dock works were carried out on the hull in the Consolidated Yachts shipyard at City Island, New York, from 27-31 May 2013. Inter alia, several joints were re-caulked without outside assistance and the starboard shroud fittings relocated. On the stem, where the bobstay (the two chains in the following figure) is attached to the stem fitting, lead sheet was pinned/bonded beneath the stem fitting to prevent any leakage there. After she was launched, a leak was discovered on the port side in the lower berth, meaning the vessel had to be hauled out of the water again. This leak was sealed from the outside and also pinned with the application of lead; no further problems occurred after that.

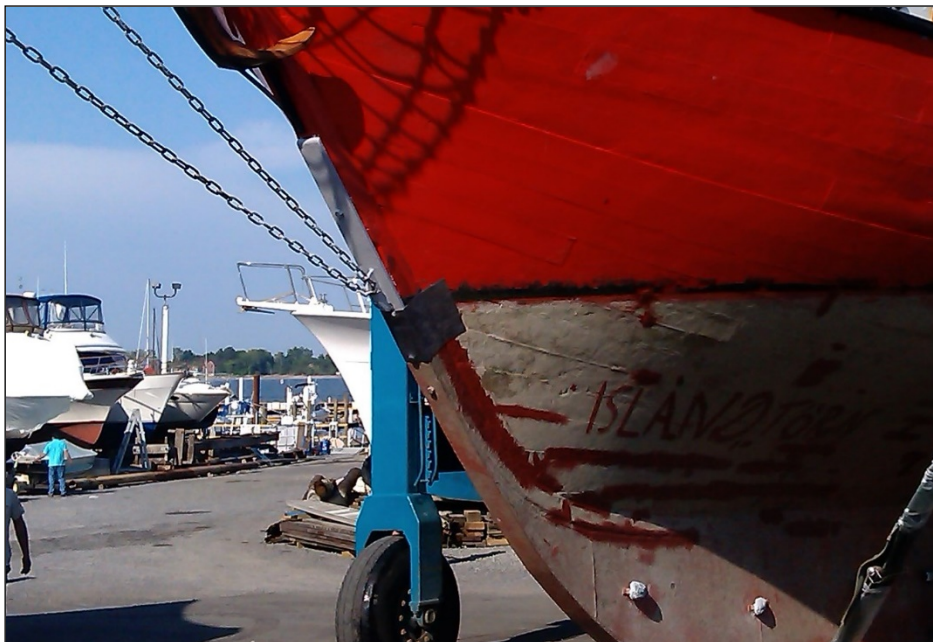
Figure 6: Stem fitting pinned with application of lead

Leakage at the forward stem rabbet below the bobstay mounting was clad with lead plating on the last voyage.

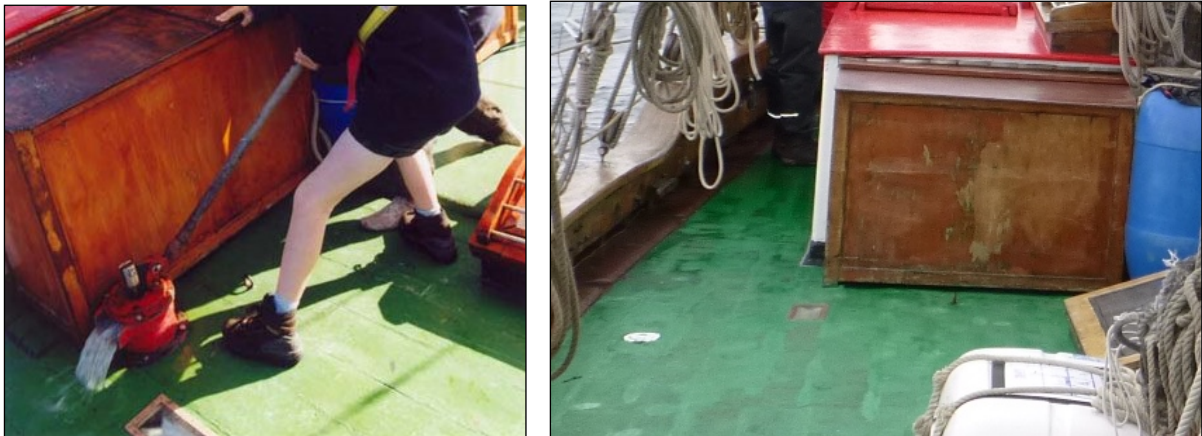
Figure 8: Handle pump

Photos taken in the years prior to 2010 also show a handle pump before the superstructure, which was installed when the vessel was built in Rhodes. Such handle pumps are the most effective because smaller particles in the bilge water do not affect the operation of the pump. This pump was removed because the rubber membrane was faulty and replacement parts were no longer available. In place of that, the Whale Gusher 30 pump below deck but operable from the deck indicated at 3.) was connected to the drainage system of the old handle pump. Pictured below in the photo to the left is the handle pump installed. The photo to the right was taken during the last sailing trip and shows the same place without the pump; the Whale Gusher pump (white circle, connecting point for hand lever) is installed below deck.

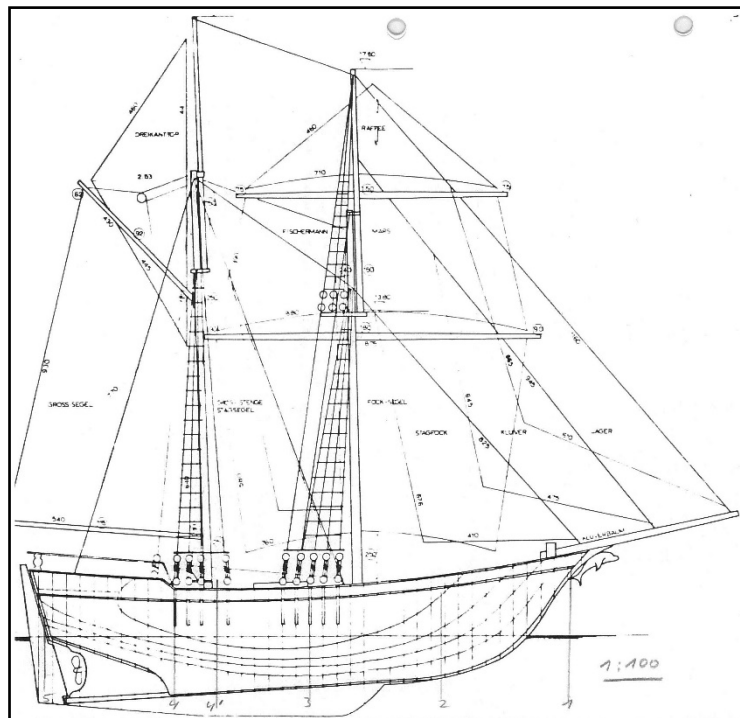
Figure 9: Sail plan and keel

According to the above drawing, the total sail area stood at 179 square metres. Two yards were used on the foremast. A third yard was attached and the sail area increased to about 200 square metres at a later date.

The master boatbuilder concludes that the FALADO VON RHODOS is a lightweight but sound vessel, which was not designed for such a high rig. Therefore, she must be sailed with the utmost caution. Moreover, exposing the vessel to sustained major loads must be avoided. He recommends that the association's committee consider restricting the area of operation, the sail areas at certain wind forces, as well as operation when a certain wind force is exceeded.

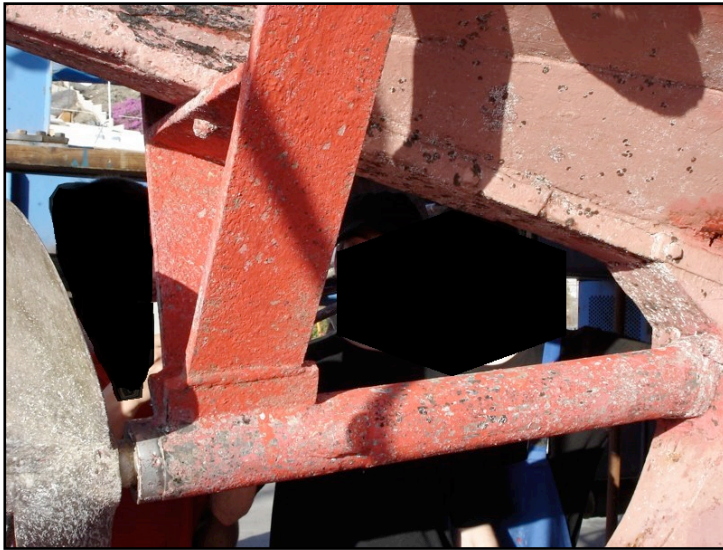
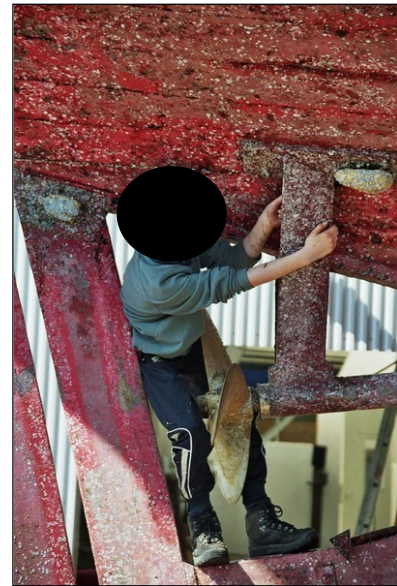
Figure 16: Shaft bracket

The change in the engine's output to 85 HP, then to 147 HP, and most recently to 140 HP bears no relation to the output originally configured and installed for the vessel. Documentation on what modifications were made to integrate this output with the vessel's structure was not available to the BSU. Information given by the skipper indicates that the engine's conversion from 85 HP to 147 HP, including complete conversion of the driving chain, was planned and executed by the Ebbe shipyard in Denmark. Such an increase in output usually requires a modification to the propeller, such as an increase in diameter. Here, the propeller was relocated aftward away from the deadwood in the screw aperture. To absorb the vibrations from the larger propeller, an additional shaft bracket was bolted outside to the keel, as shown in the following photo.

The shaft bracket is attached (not integrally) to the aft stem and hood ends of the planking. It looks as if the entire load from the vibration of the propeller on two bolts, which were inserted into the keel, should be introduced into the vessel's structure. There is no lateral integral connection with the keel and planking. The shaft bracket's lateral bar is evidently bolted to a plank above (photo to the right). Nothing is known about the how this shaft bracket is otherwise attached to the vessel's structure. However, at a frame spacing of 390 mm it is reasonable to assume that bolting is made with two frames, which is not enough for the introduction of a load. The above left photo also suggests that the thickness of the wood on the keel at the stern tube penetration is relatively weak. It was not possible to establish whether the deadwood behind it has now been executed in solid wood.

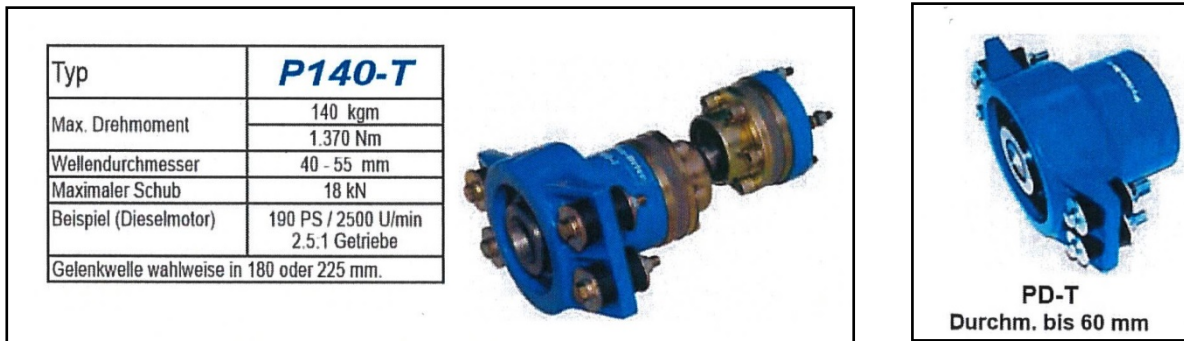
Figure 17: Thrust bearing

In May 2012, damage was discovered on the newly installed shafting after the most recent modifications to the machinery. A new PD-T thrust bearing for a 55 mm shaft was delivered and installed and the shaft seal repaired.

There were no design or manufacturing faults according to information given by the manufacturer of the thrust bearing. The damage was caused when the thrust bearing and the stern tube seal must have been exposed to water inside the vessel. It was not possible to determine precisely whether this water ingress was the result of shaft misalignment, incorrect interpretation or poor production of the design for the introduction of the compressive load into the vessel's structure, or other causes. The BSU was only informed that the FALADO VON RHODOS often had to be put on a slipway after calling at a shipyard due to water ingress in the aft section, in particular. Problems with the tightness of planking below the engine seating were experienced on several occasions, which involved planking separating from the frames and not being properly attached to the stern rabbet, floor or frames.

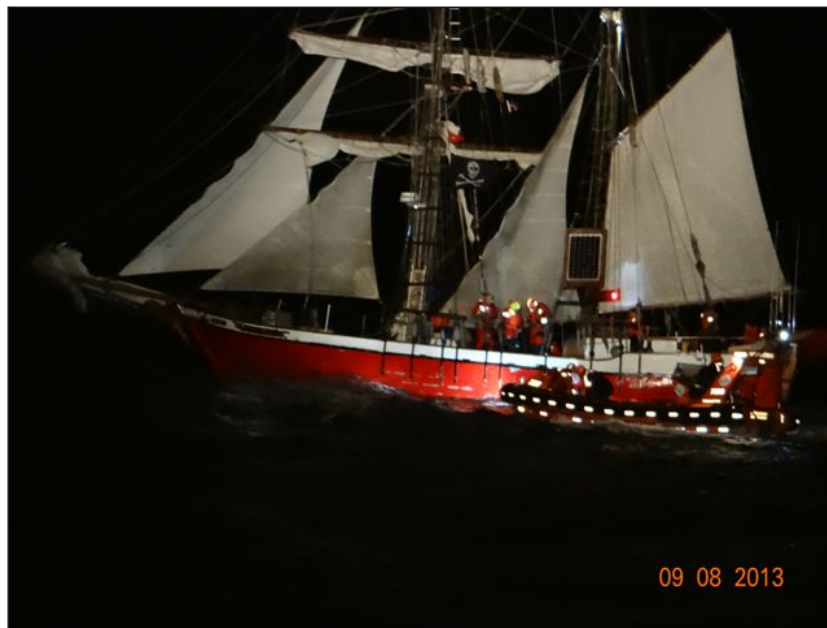
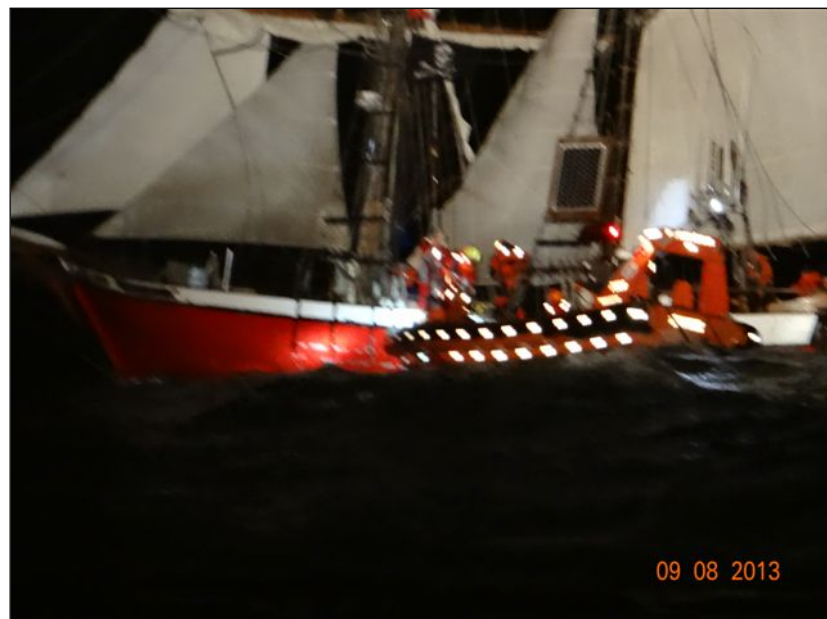
Figure 18: Final photos of the FALADO VON RHODOS

On the following photos, which were taken during the rescue operation, it looks as if there is a significant amount of paint peeling in the area of the chainplate attachments (white vertical stripe). This suggests that the longitudinal joints in that area have cracked due to the load of the mast, which may have led to leakage. Indeed, a systematic search for the cause of the water ingress was carried out. However, the crew did not isolate any damage that viewed alone could be regarded as the cause of the water ingress.
