Bundesstelle für Seeunfalluntersuchung
Federal Bureau of Maritime Casualty Investigation
Federal Higher Authority subordinated to the Ministry of Transport
and Digital Infrastructure

Investigation Report 266/14

Serious Marine Casualty

**Foundering of PONTON 1
on 13 August 2014
north of Darßer Ort**

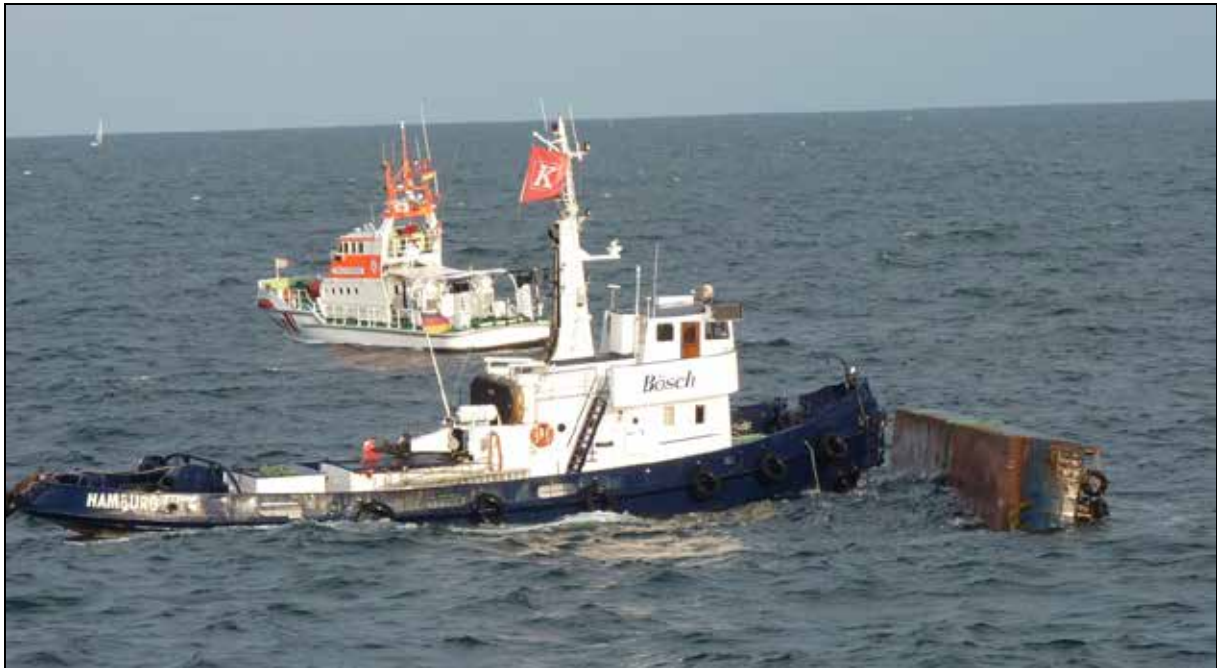
Figure 6: The PONTON 1 has capsized

It was no longer possible to put the plan to use bilge pumps into effect, as the PONTON 1 capsized over her port side at 0650 and then floated on her longitudinal side. The cargo was so well secured that it remained on deck virtually undisturbed.

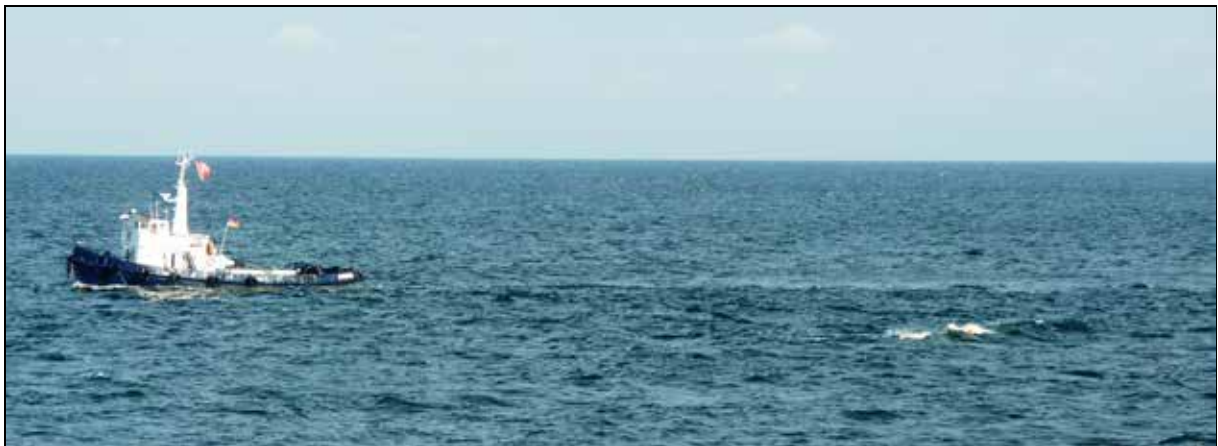
Figure 7: The PONTON 1 has foundered

The towline parted at 0710 and the PONTON 1 sank to a depth of some 10-12 m at 0745. Two lines had been attached prior to that, each with a red buoy attached to its end, and the scene of the accident was thus kept visible on the surface.

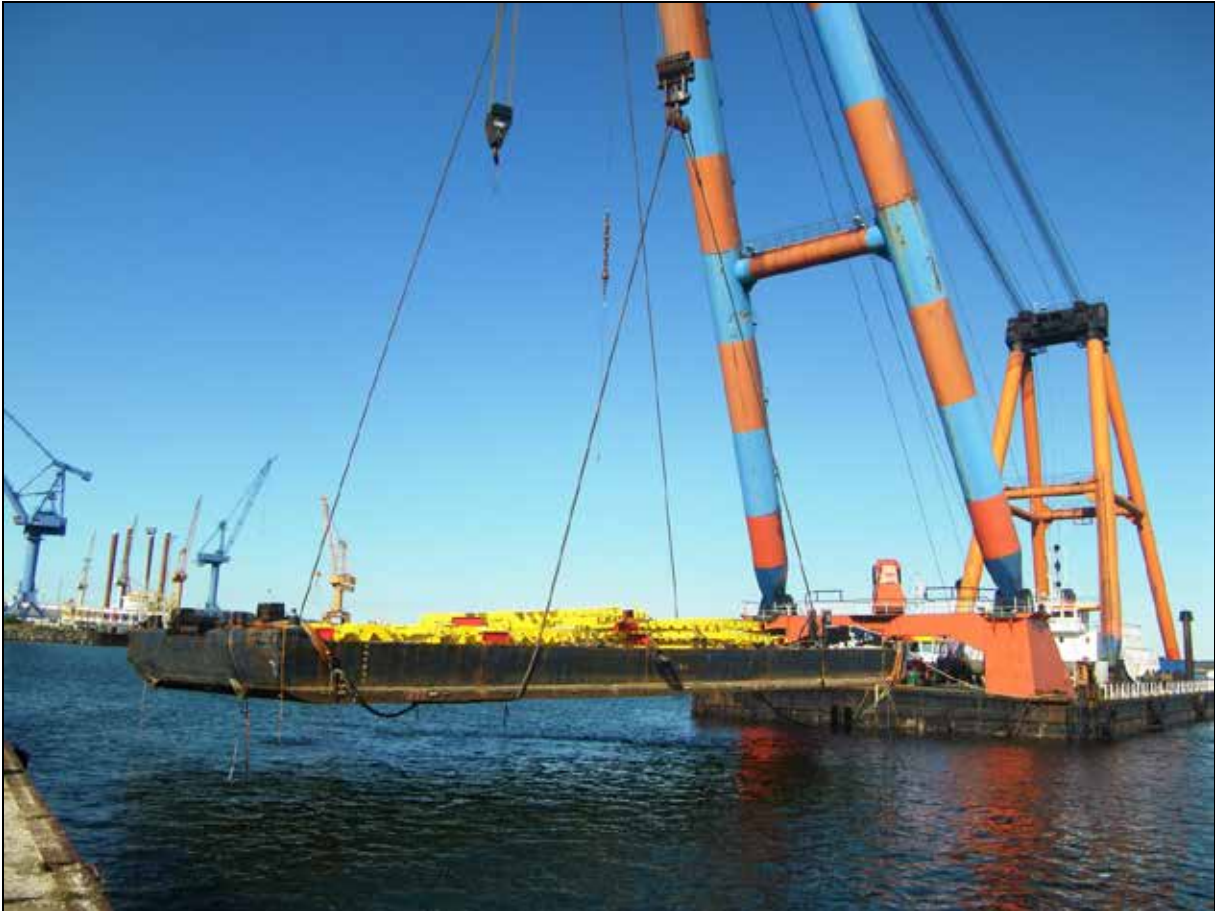
Figure 11: PONTON 1 is put ashore

Approval to put down the pontoon at berth 10 of the Nordic Yard in Warnemünde was finally given at about 1500. It took another two hours until the pontoon was finally put down. There were no complications when she was lifted out. However, it was necessary to wait until the water that had entered drained out through the cracks caused by the salvage cables.

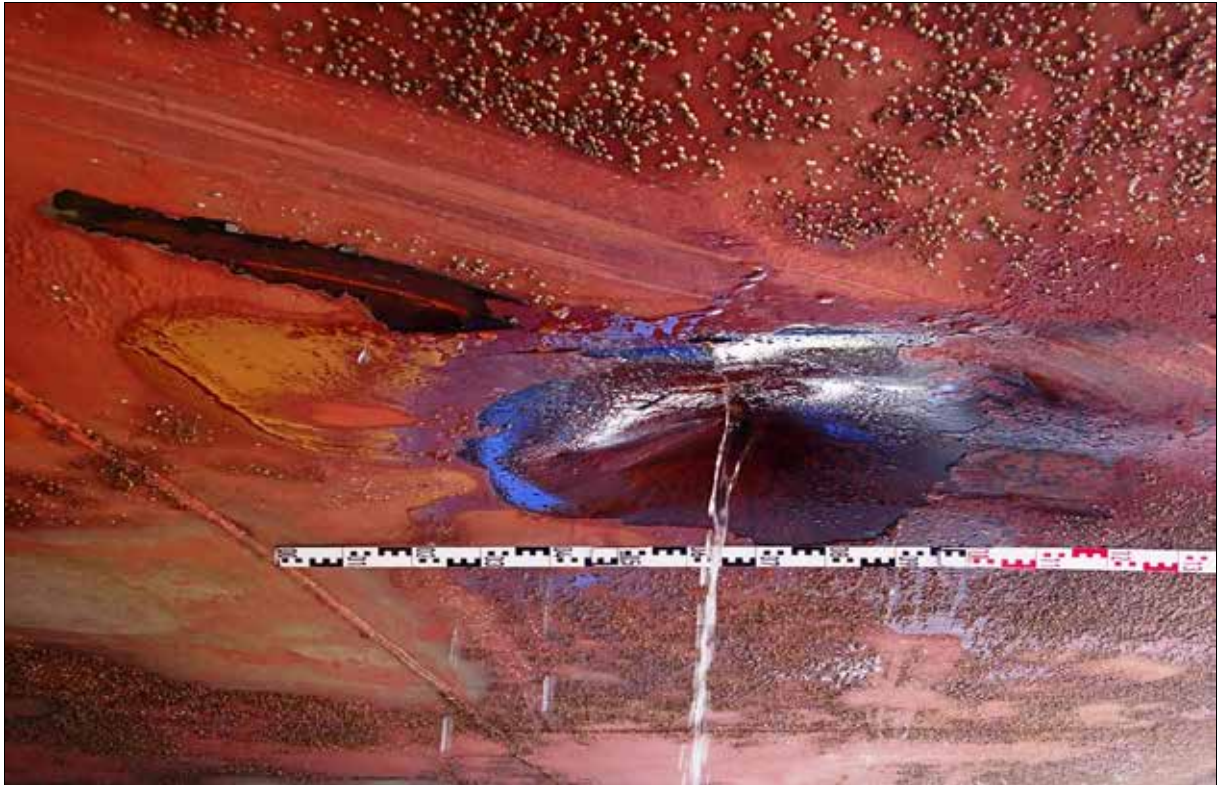
Figure 12: Leak in the bottom of the PONTON 1

The apparent leak was about 13.5 m from aft and about 1.40 m from the starboard side. The inward dent was virtually round and deeper towards the middle, where the maximum depth measured was about 13 cm. The length of the crack was about 8-10 cm there and bent.

Paint had flaked off in the vicinity of the dent and the pontoon's steel looked dark grey. It was evident that scale was still firmly adhered to the surface of the steel. Loose rust deposits had formed on this scale.

The ridges in these areas point to a metallic object that may have caused them. Paint residues from another source were not found, however.

Indeed, it is likely that the leakage found is the primary cause of the pontoon foundering, but it is not directly related to the time at which the leak formed. The increased rolling motions indicate that a large amount of water must have already been in the space during the last voyage.

It was no longer possible to establish exactly when the leak in the bottom of the PONTON 1 formed and what caused it. Due to the relatively low inflow, it must have formed at least 3.8 days before the pontoon foundered, however.

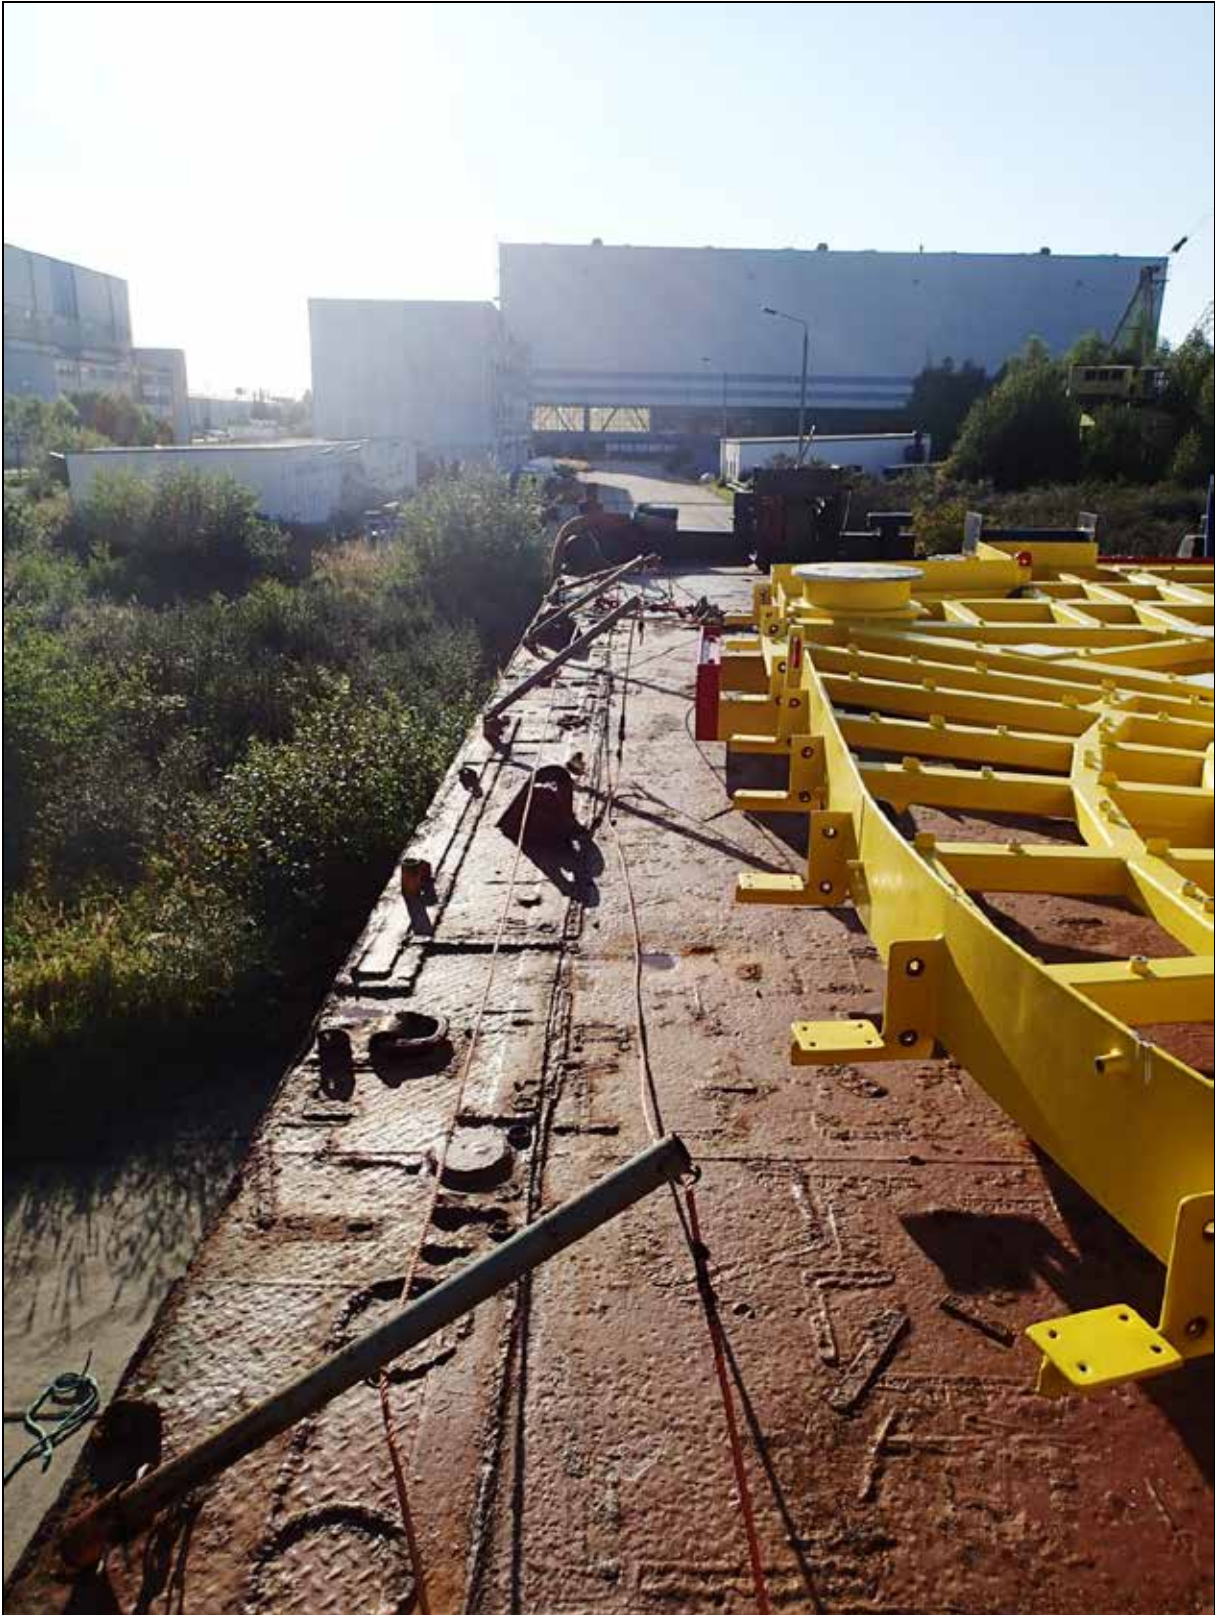
Figure 13: Damage on deck

The pontoon was ultimately released and the investigators were able to go on deck. The cargo, consisting of four platforms to enable access to a wind turbine, slipped only slightly and was hardly damaged. Each of these rings weighed about 10 t. The railing around the pontoon was deformed more than anything else.

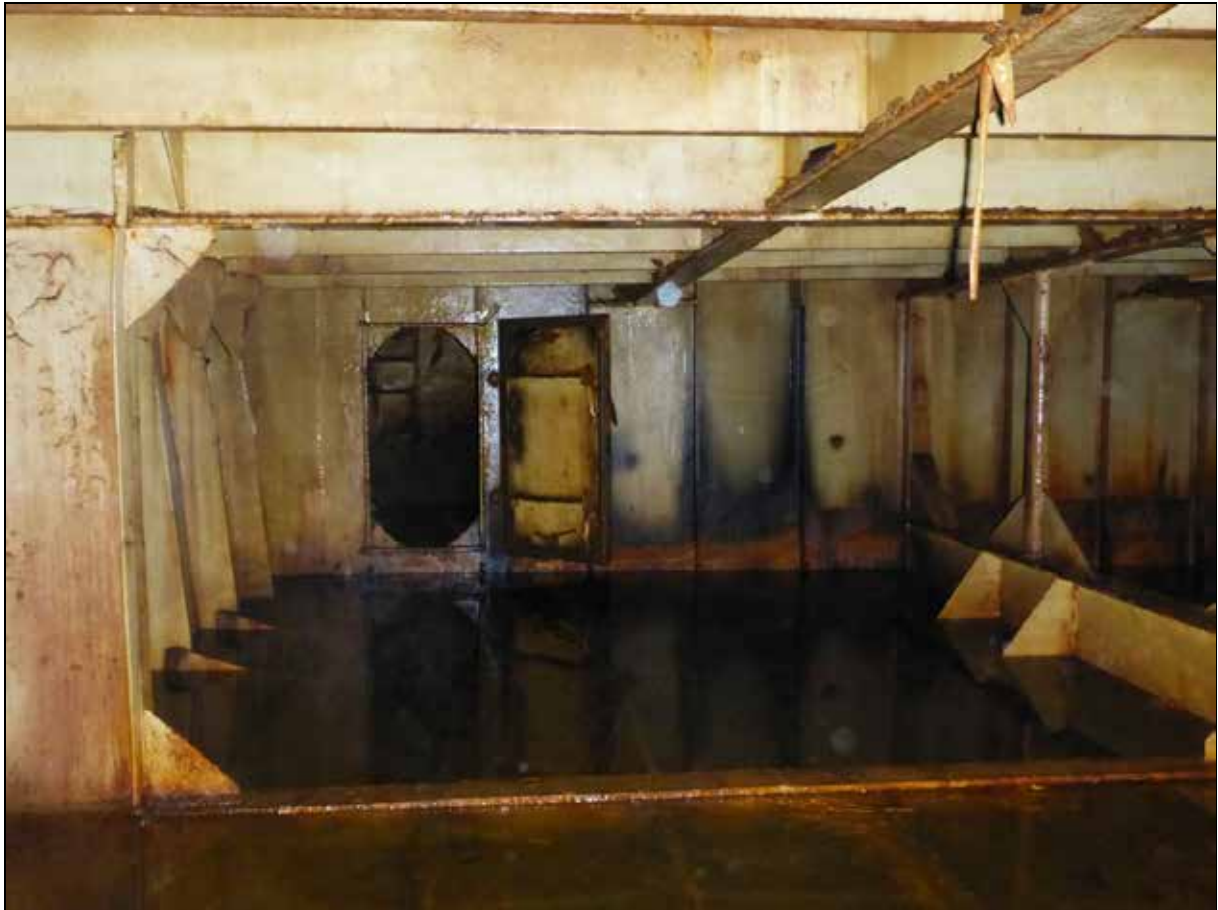
Figure 14: View inside

There are four transverse bulkheads, which can be accessed through watertight doors. Each bulkhead has a door on both sides. Each second door was open (starting at forward port open, starboard closed). The longitudinal bulkhead in the middle of the pontoon is used only for stabilisation. Consequently, it is not watertight and has a number of openings. Blackening's were visible on certain sliding bolts in the bulkheads, indicating that the bolts had been made serviceable with an open flame.

Soot deposits were visible on certain sliding bolts in the bulkheads, indicating that the bolts had been made serviceable with an open flame. It is evident that these sliding bolts were very rarely used.

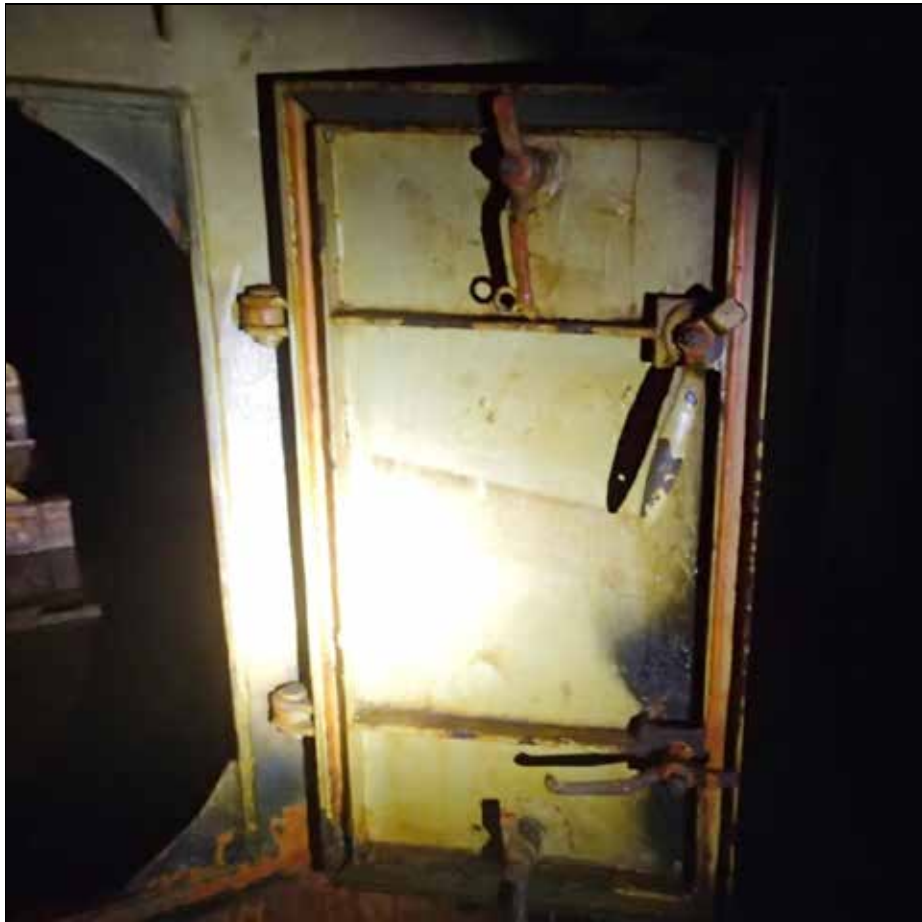
Figure 15: Internal door (bulkhead)

All the seals found on the supposedly watertight doors (see Figure 15) were defective (brittle, incomplete).

Even if the doors were closed, the worn seals on the supposedly watertight doors would not be capable of keeping out water completely.

The Federal Bureau of Maritime Casualty Investigation recommends that Robert Krebs KG GmbH & Co. encourage its ship's commands to ensure that the watertight integrity of their ships is always established.

The Federal Bureau of Maritime Casualty Investigation recommends that the ship's command of the BÖSCH maintain the watertight integrity of its tow at all times.

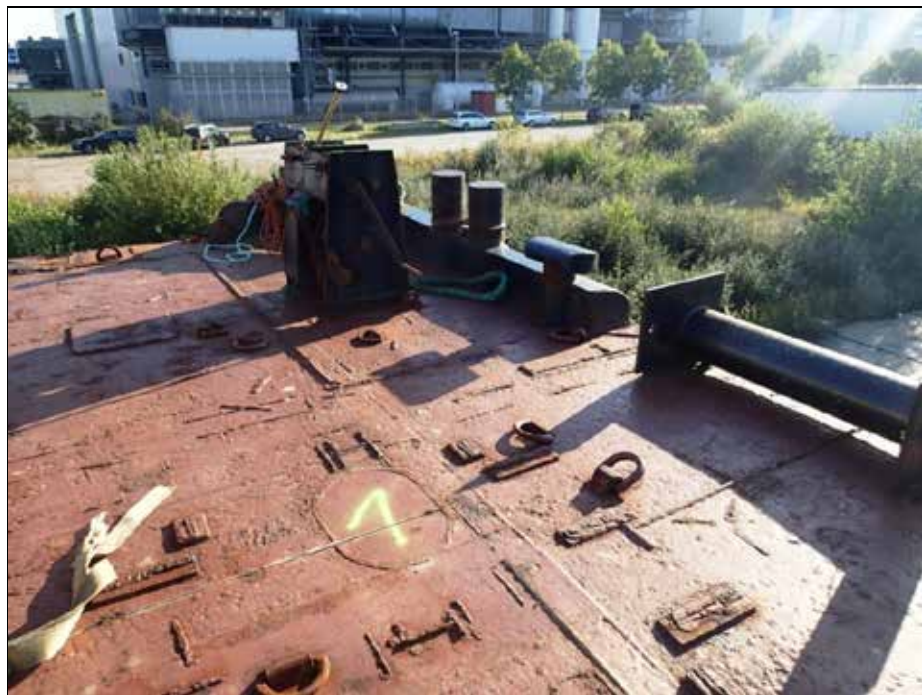
Figure 16: Example of a manhole welded closed

The manholes on the main deck for entering the various compartments from above were welded closed (see Figure 16).

When PONTON 1 was converted in 1967 such that the manholes on the main deck were closed and, in place of those, doors were used in the internal transverse bulkheads, GL approved this with the proviso that the doors in the transverse bulkheads be permanently closed and opened only for a short period when necessary. Each second door was open at the time of the accident. Added to that is the fact that the longitudinal bulkhead in the middle of the pontoon is used only for stabilisation and therefore not watertight. This makes water ingress even more dangerous, as the free surface in this area is increasing constantly.

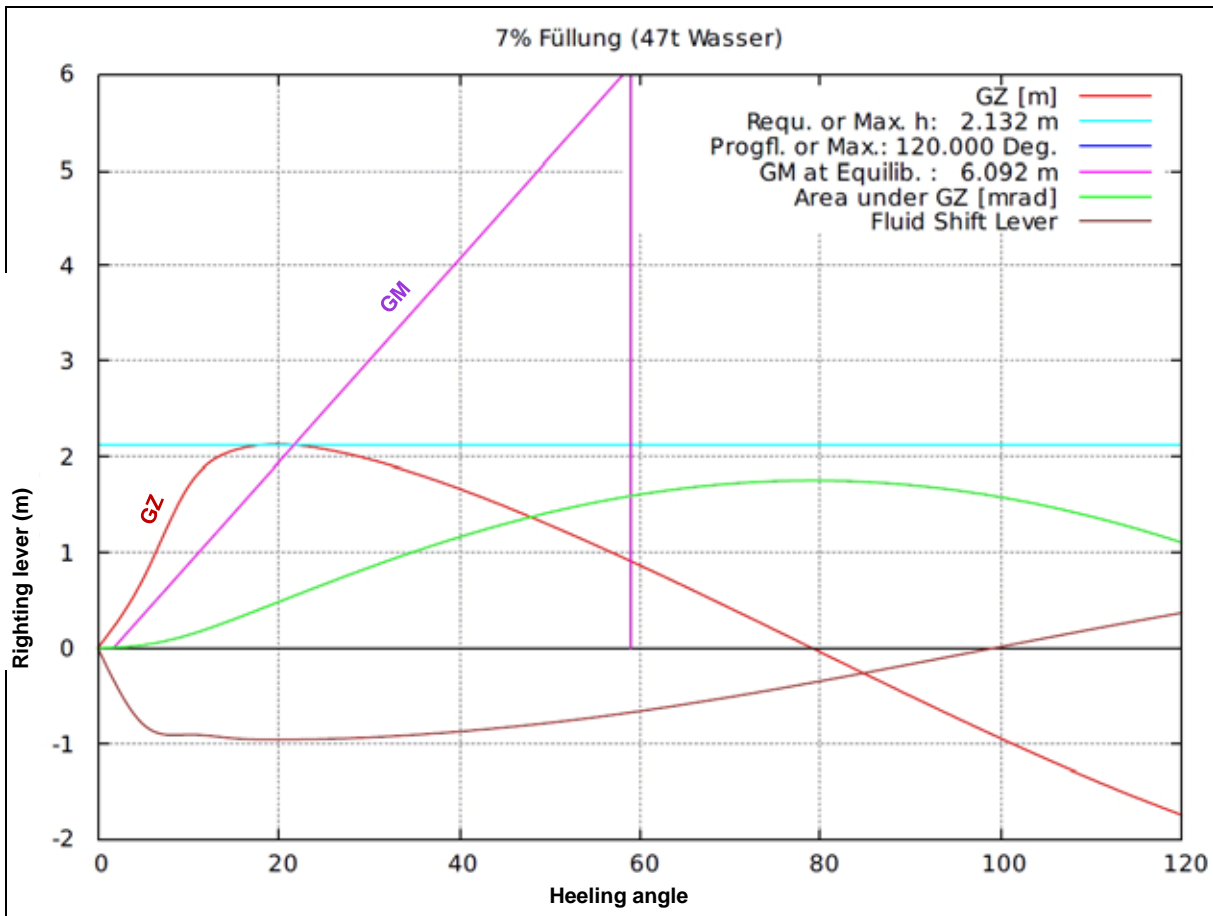
Figure 17: Righting lever arm curve at 47 t of water

With 47 t of water in the pontoon the floating condition is stable, i.e. she still has a GM³ of 6 m and a sufficient area under the righting lever arm curve (see Figure 17).

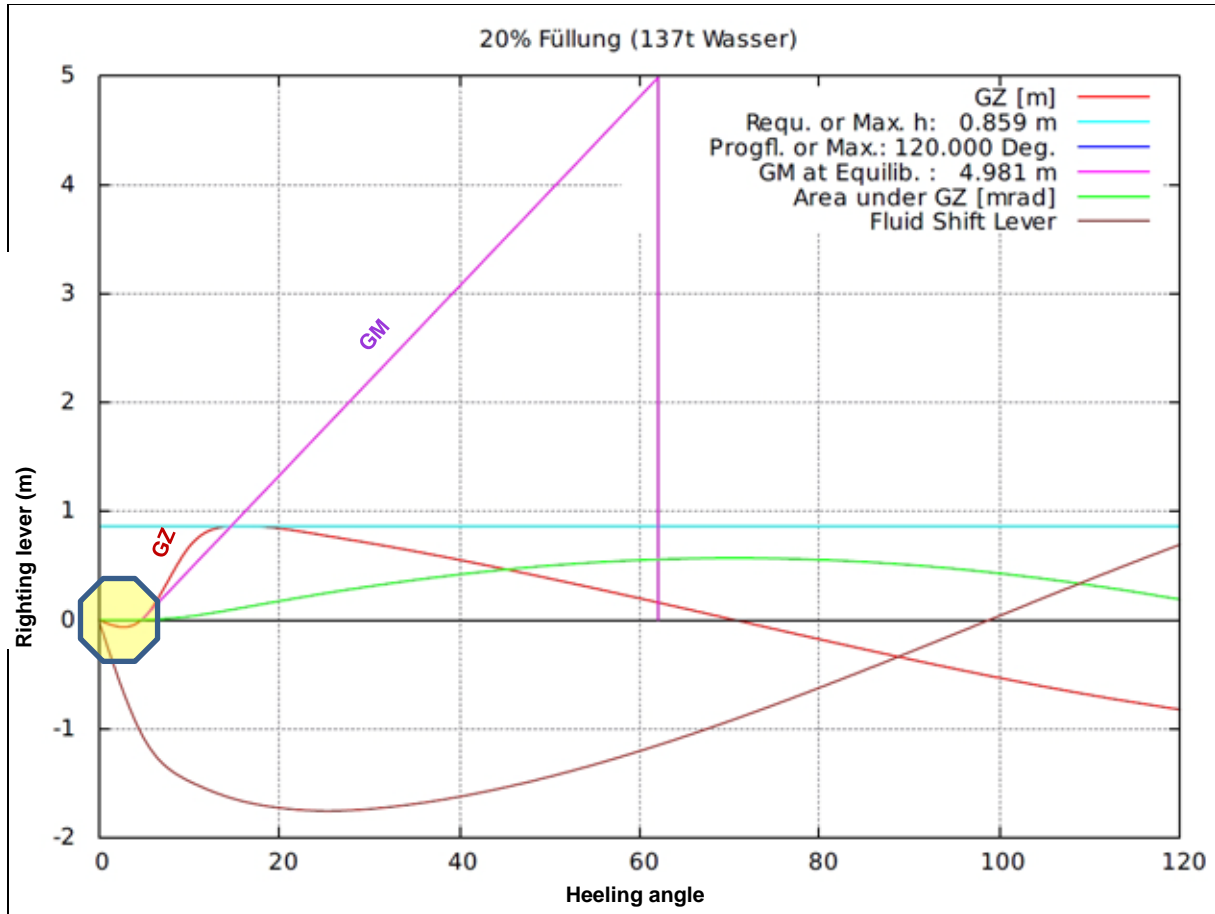
Figure 18: Righting lever arm curve at 137 t of water

When the pontoon is 20% (137 t of water) full, a condition arises in which she tends to roll back and forth between the two equilibrium positions. This would explain the rolling motion during the last voyage (see

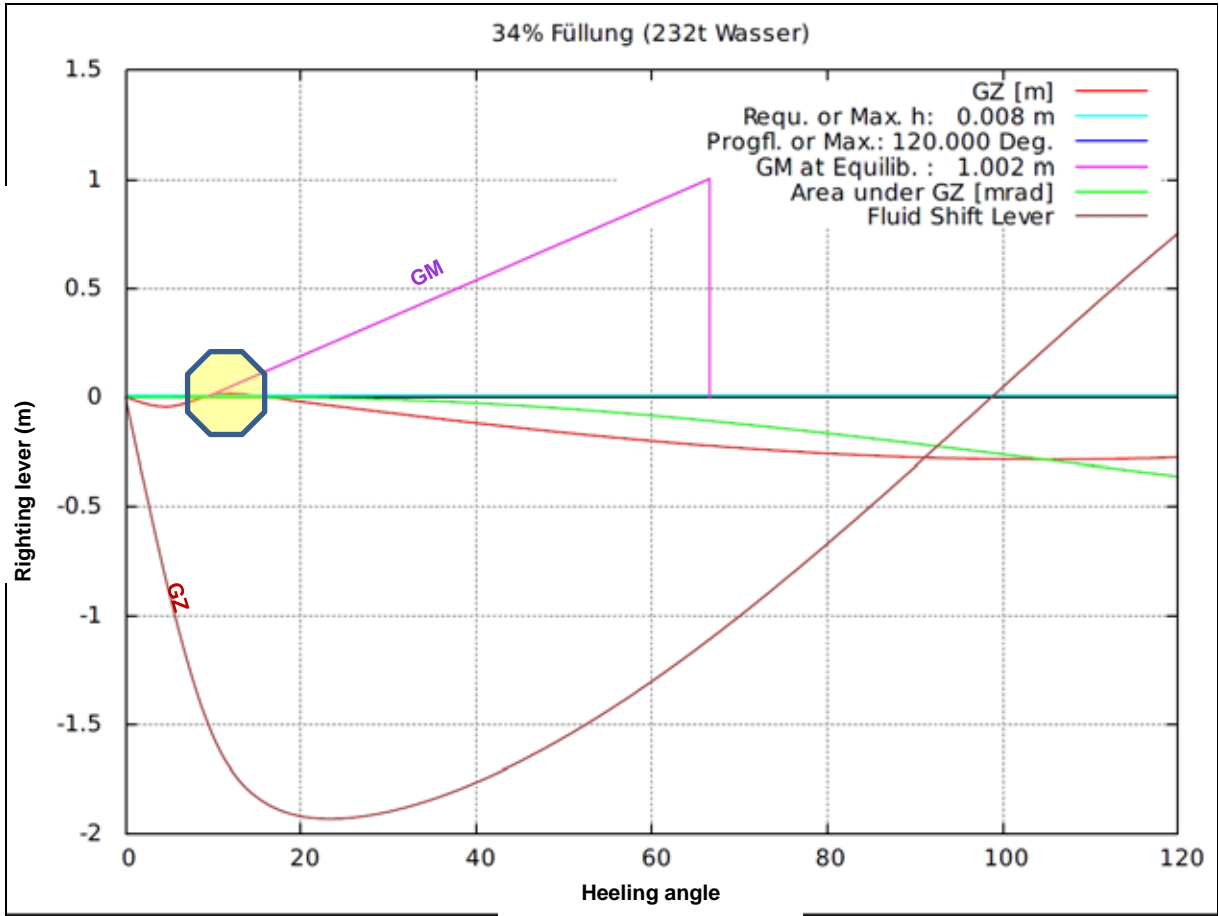
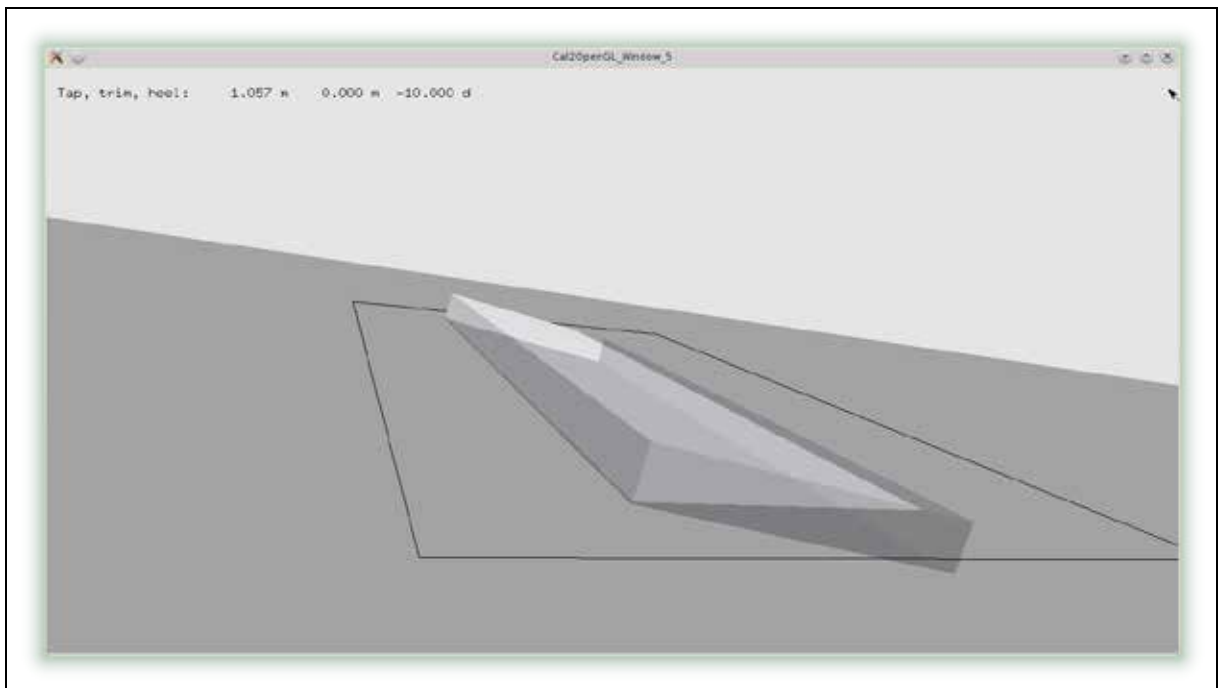
Figure 19: Righting lever arm curve at 232 t of water

The pontoon will roll over when she is 34% (232 t of water) full (see

232 t : 2.54 m³/h = 91.34 h : 24 h = 3.8 days

This means the leak must have formed at least 3.8 days before the accident.

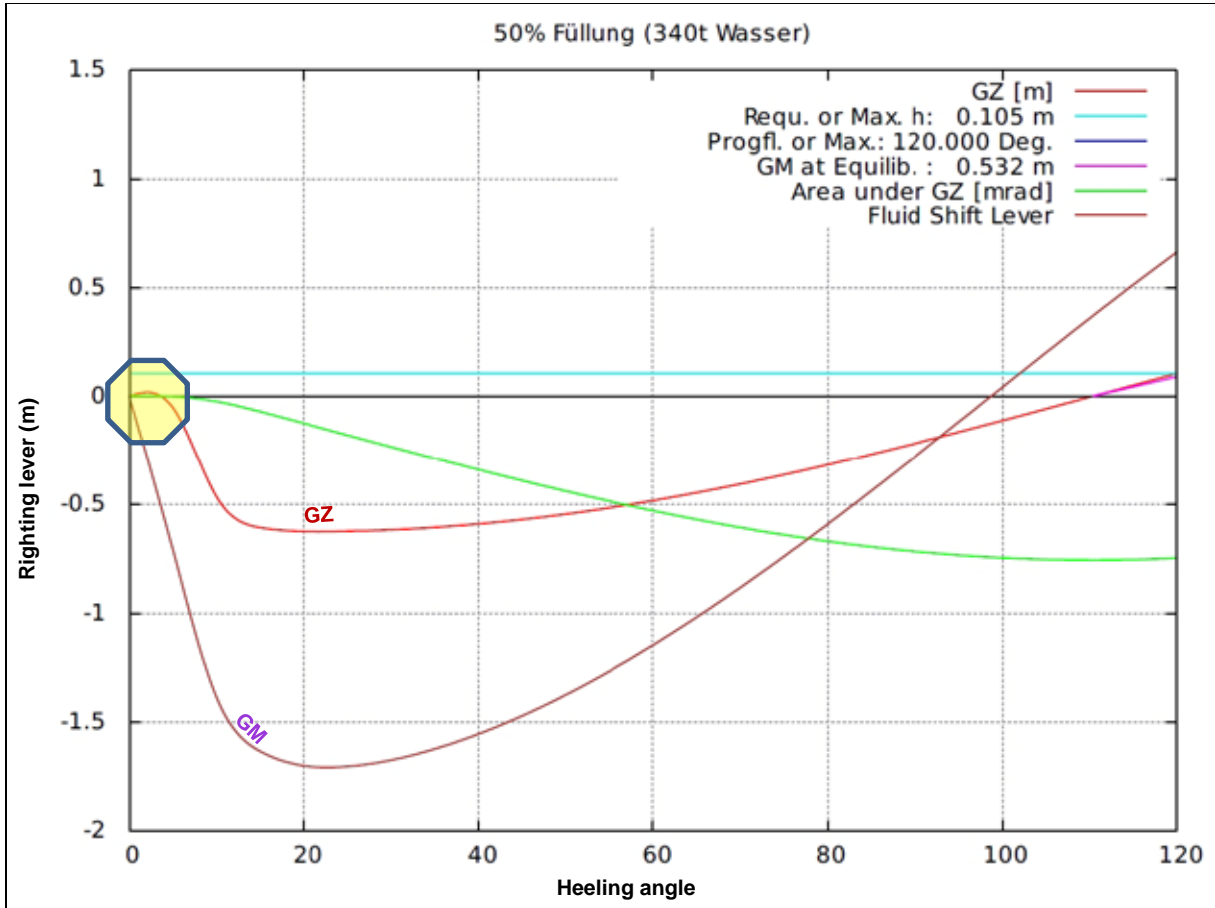
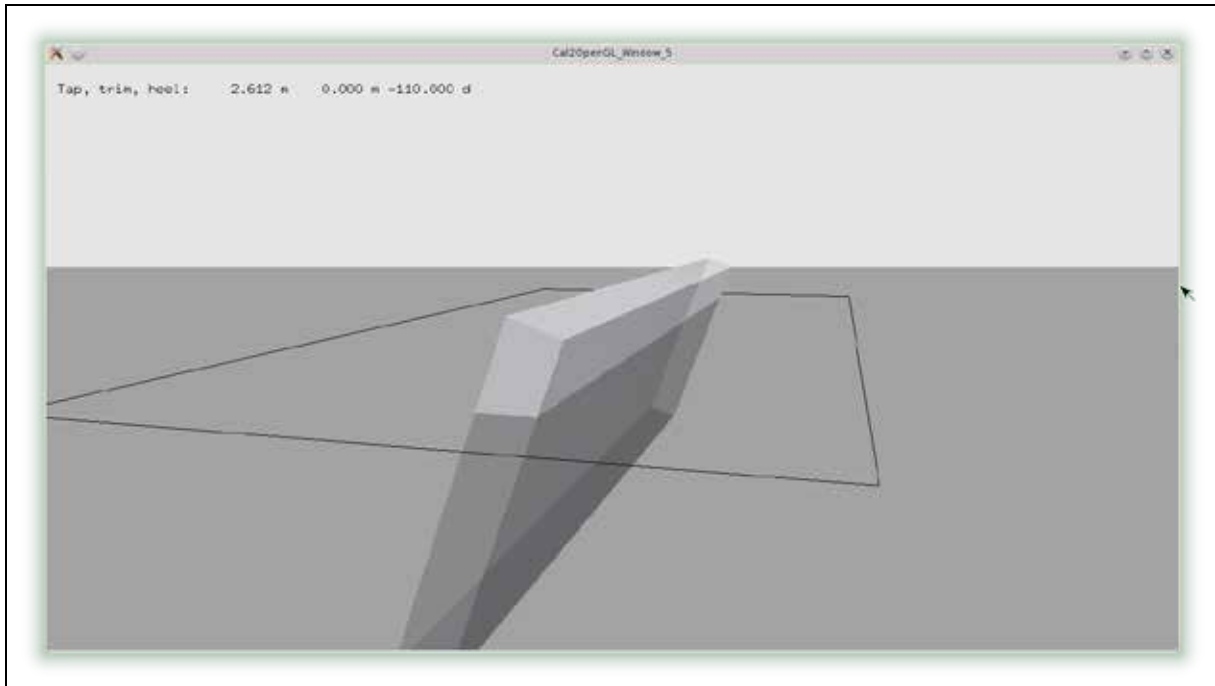
Figure 21: Righting lever arm curve at 340 t of water – capsized

After the pontoon rolled over, water continued to enter through various other openings, resulting in an equilibrium position of about 110° when she was 50% (340 t of water) full (see
