Investigation Report 272/14

**Very Serious Marine Casualty**

**Fatal accident**  
**on board the MV MAERSK SURABAYA**  
**on 1 September 2014 off Shanghai**

28 August 2015

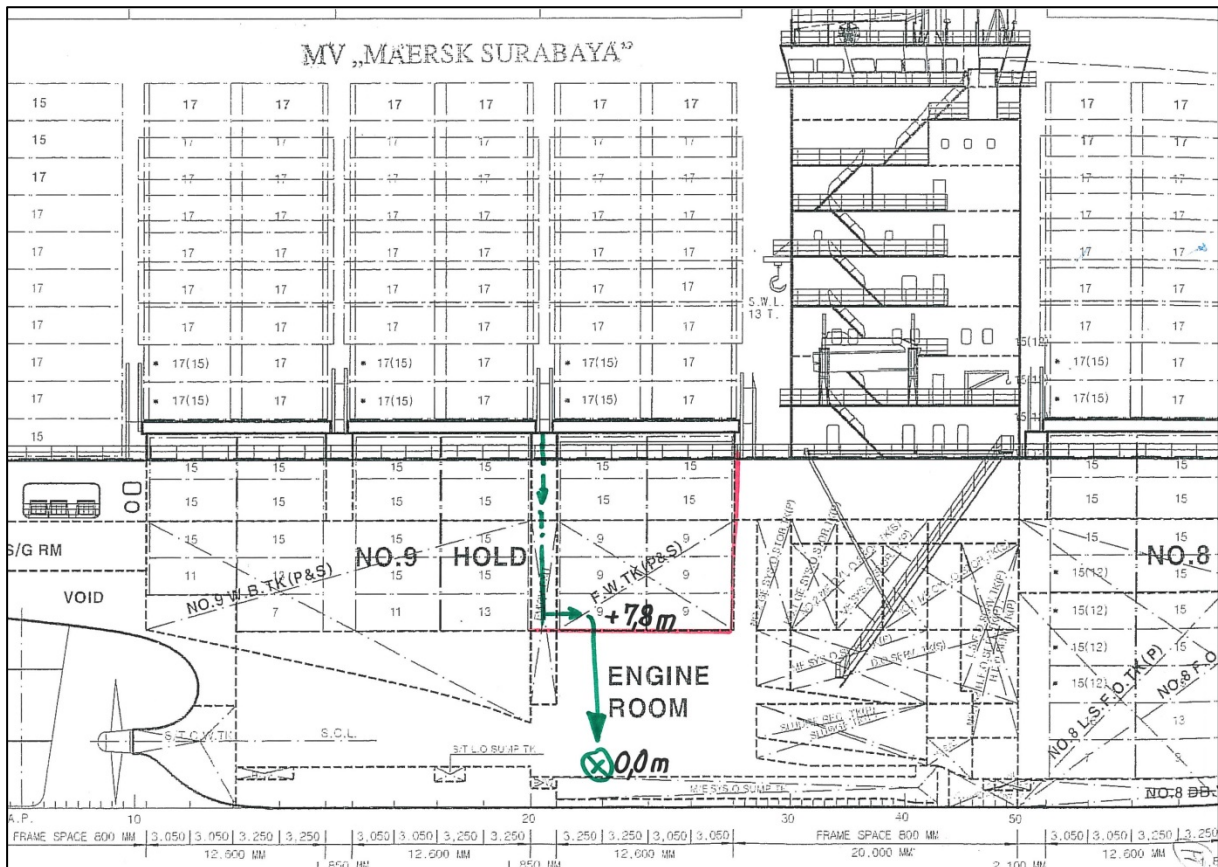
Figure 3: Extract from the general arrangement plan (side view)

The first section of cargo hold 9, which is located directly aft of the bridge, contains casing of 7.8 m in height from the engine room, which is located before it. This casing runs longitudinally from the aft engine room bulkhead, frame 25, up to the transverse passageway, frame 20 (see red shading). The casing is about 15 m in breadth and only in the middle laterally. The casing does not run down the sides and is open for a depth of about 7.8 m (three container layers) to the top of the tank.

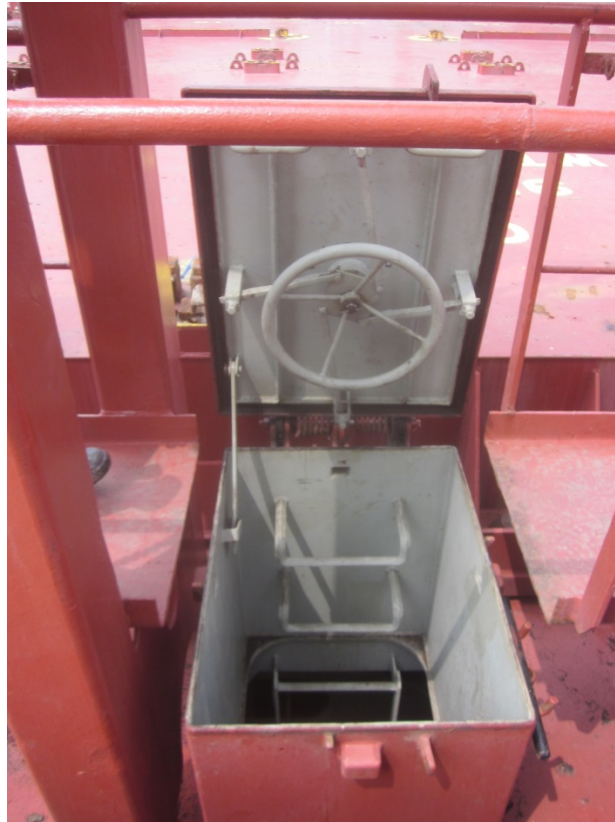
Figure 5: Access to cargo hold 9 from the main deck

The cargo hold is accessed from the main deck. The transverse passageway and decks can be entered using a ladder via a small hatch cover. Further access to the deck containing the engine room casing is beneath the main deck five container levels lower. A crossbar secures access to the deck containing the casing. The lowest deck, the tank deck, is accessible from the transverse passageway via other ladders on the port and starboard sides.

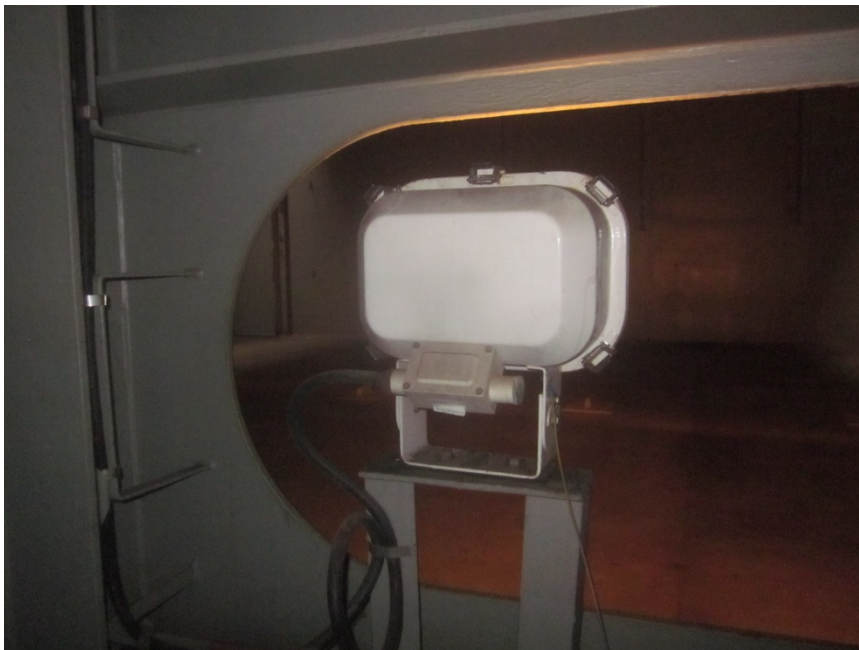
Figure 7: Central main floodlight at the transverse passageway

The central main floodlight is installed in the transverse passageway about 1.50 m above the deck containing the engine casing. This light is accessible from the transverse passageway without tools or opening the crossbar/entering the deck containing the engine casing. The electrician apparently fixed this light by replacing the light source. The deckhand saw that the lighting was now on in the middle when he climbed into the hatch at 0830 or shortly after. At this point, the bosun had already begun cleaning on the starboard side of the deck containing the casing and instructed the deckhand to collect the hose and nozzle from the port side. The deckhand then went to the deck containing the casing and while picking up the hose saw the electrician lying prone about 7.8 m deeper on the tank deck.

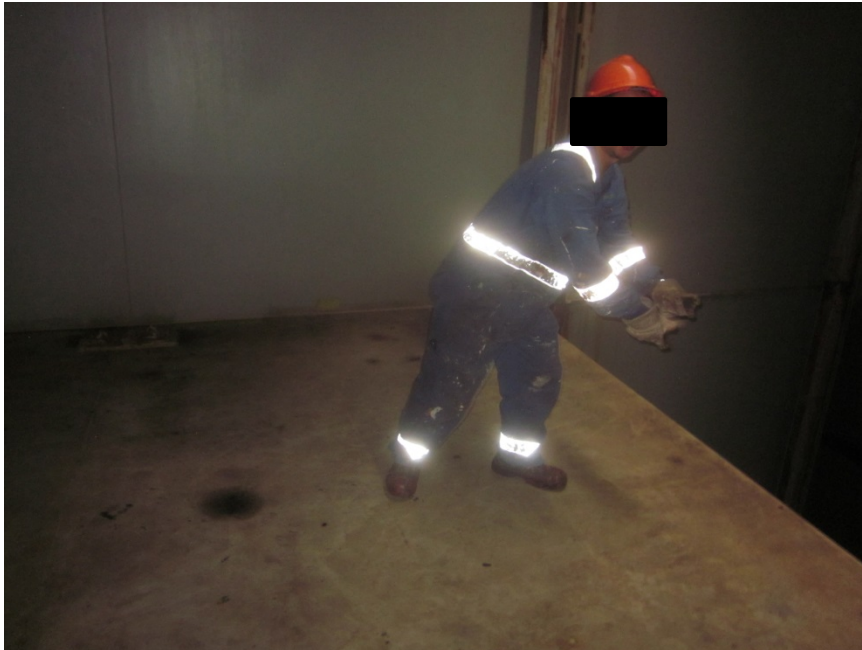
Figure 8: Image of the deckhand picking up the water hose and discovering the electrician

It is not clear why the electrician went onto the deck containing the engine room casing. It is reasonable to assume that he wanted to count the defective light sources after carrying out the repair on the central main floodlight so as to collect them from the store. It is possible that he stumbled on the water hose or otherwise slipped in the process and fell onto the tank deck.

None of the three seamen was wearing fall protection equipment.

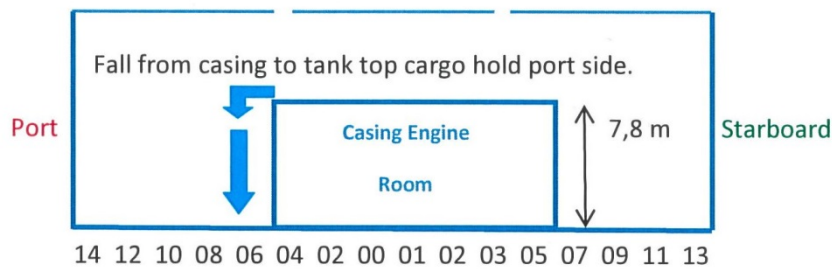
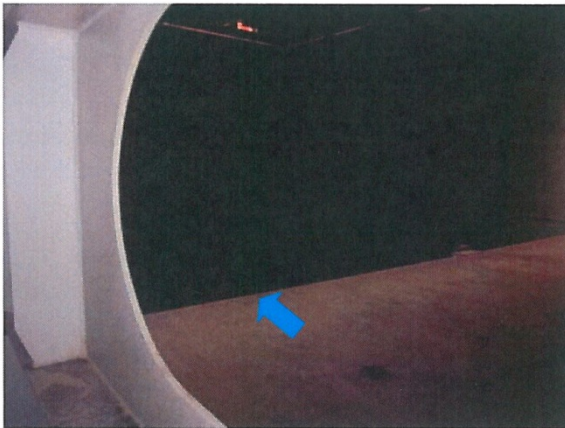
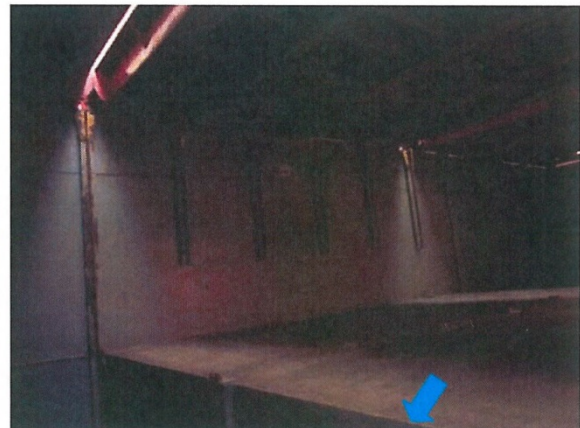
Electrician checked and repaired illumination and spot lights in cargo hold no. 9 (behind accommodation). Hold no. 9 contains an engine room casing (7,8 m = 3 container high). After change of a spotlight bulb he walk on the engine room casing (reason unknown – assumedly to check lightning port side of walkway) and he felt on tank top. He suffered mortal injuries. Directed initiated first aid measures and reanimation carried out professionally but without success.

- Areas with potential of falling from high shall be tiger marked.
