Bundesstelle für Seeunfalluntersuchung
Federal Bureau of Maritime Casualty Investigation
Federal Higher Authority subordinated to the Ministry of Transport
and Digital Infrastructure

Investigation Report 276/14

**Collision in the Kiel Firth
at Friedrichsort between the
MV FRANCISCA and MV RMS BREMEN
on 5 September 2014**

4 September 2015

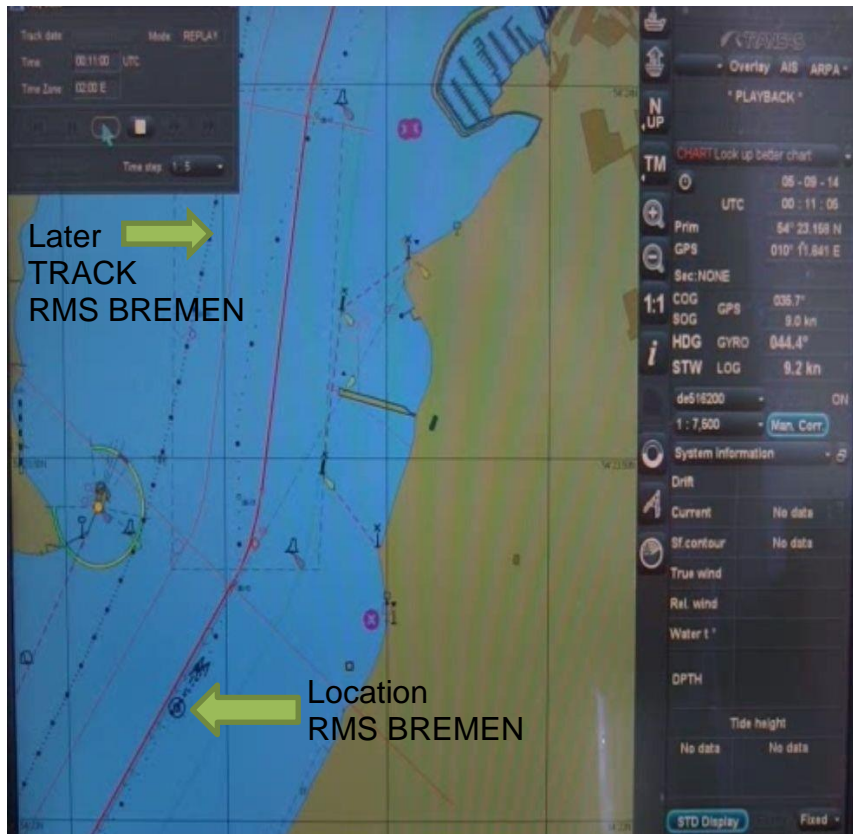
Figure 4: RMS BREMEN's ECS – scene of the collision at 021105

Neither the reproduction of the electronic charts nor the drawing made on the FRANCISCA provide insight into the exact scene of the collision. Only the time of the collision is consistent. At 021105, the RMS BREMEN is located far to the south-east of the Friedrichsort beacon, while the drawing made on the FRANCISCA indicates that the scene of the collision is shortly after the planned course alteration at the beacon. Consequently, the BSU requested radar and AIS recordings from Vessel Traffic Service Travemünde. Regrettably, no radar recordings were available, as they are deleted in the ring buffer after about a month. Consequently, there was no second system to verify the GPS and AIS data. A type-tested GPS receiver was installed on board each vessel. The accuracy of the GPS positions received is 8-13 m. DGPS receivers, which can fine tune GPS positions to about 3 m, were not installed. The AIS data recorded by the vessel traffic service were forwarded to the Federal Waterways Engineering and Research Institute (BAW) in Hamburg for analysis. The BAW confirmed that no collision would have occurred according to the data pool, which indicated that the vessels would have passed one another at too wide a berth.

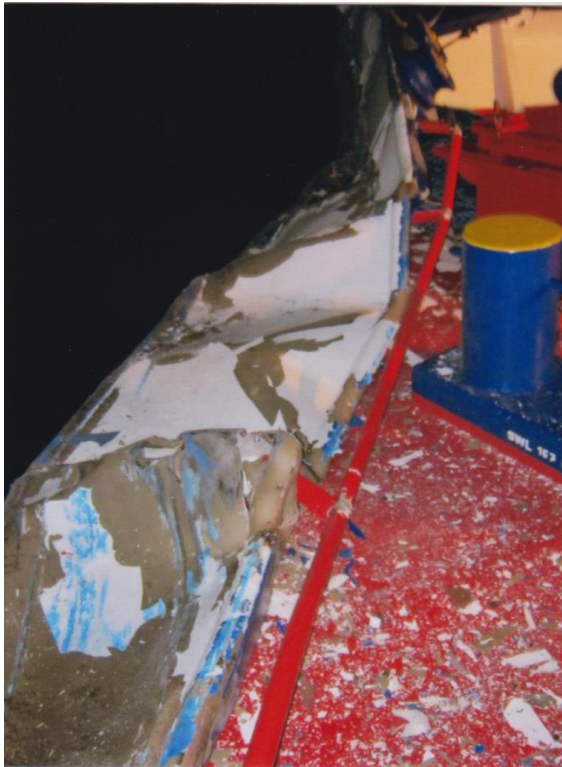
Figure 7: Damage to the FRANCISCA

The fore section of the FRANCISCA was cracked, buckled, and dented above the waterline on the shell plating between the bow and frame 130. She also exhibited deformations on the port side of the bulwark. The forecastle's watertight integrity was impaired. The detention order was issued because the officers on watch did not observe the hours of rest, drills and exercises were not shown in the time sheets, and there were inconsistencies between the watchkeeping plan for lookouts and the hours of work in port. On a six-by-six-hour-cycle, there were no adequate hours of rest possible in a two-watch system (one of which at least six continuous hours) for the master and chief officer. On 1 Aug., 2 Aug., 23 Aug. and 24 August the rest hours of one able bodied seamen were interrupted three times and less than 6 hours. The rest hours on days with fire and boat drills were not recorded. An audit of the flag State according to the safety management system and the ISM Code was absent. An emergency exit to the aft weather deck was locked and could not be opened. The detention order was lifted on 15 September 2014 and the FRANCISCA was able to proceed, subject to conditions, to a shipyard within internal waters.

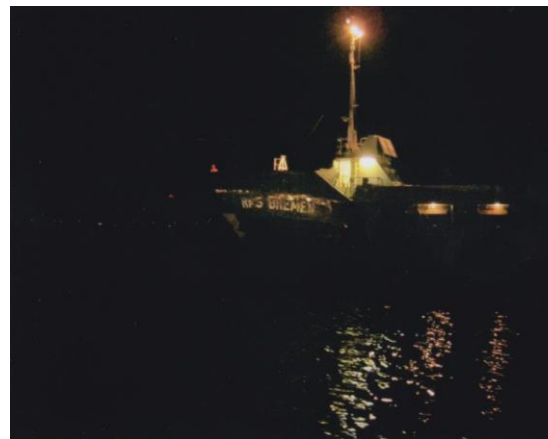
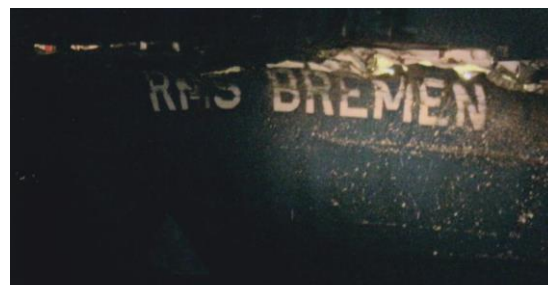
Figure 8: Damage to the RMS BREMEN

The fore section of the RMS Bremen was buckled and cracked on the bulwark and shell plating above the waterline between the bow and frame 113 on the port side. The seals and air pipes on the tanks were buckled, cracked or destroyed. The deck was dented between frames 68 and 72 and the weld between a bollard and the deck was damaged. The aft deck was dented and cracked between frames 11 and 20. The guard rail on the port side was destroyed along its entire length. The bow thruster was damaged and watertight integrity was impaired in the fore section, bow thruster room, and superstructure. The RMS BREMEN was permitted to proceed, subject to conditions, to the closest shipyard within internal waters. In contrast to the FRANCISCA, a five-by-seven-hour watchkeeping plan was kept on the RMS BREMEN. This means that from a procedural point of view it was possible to observe the hours of rest with the same manning as the FRANCISCA.²

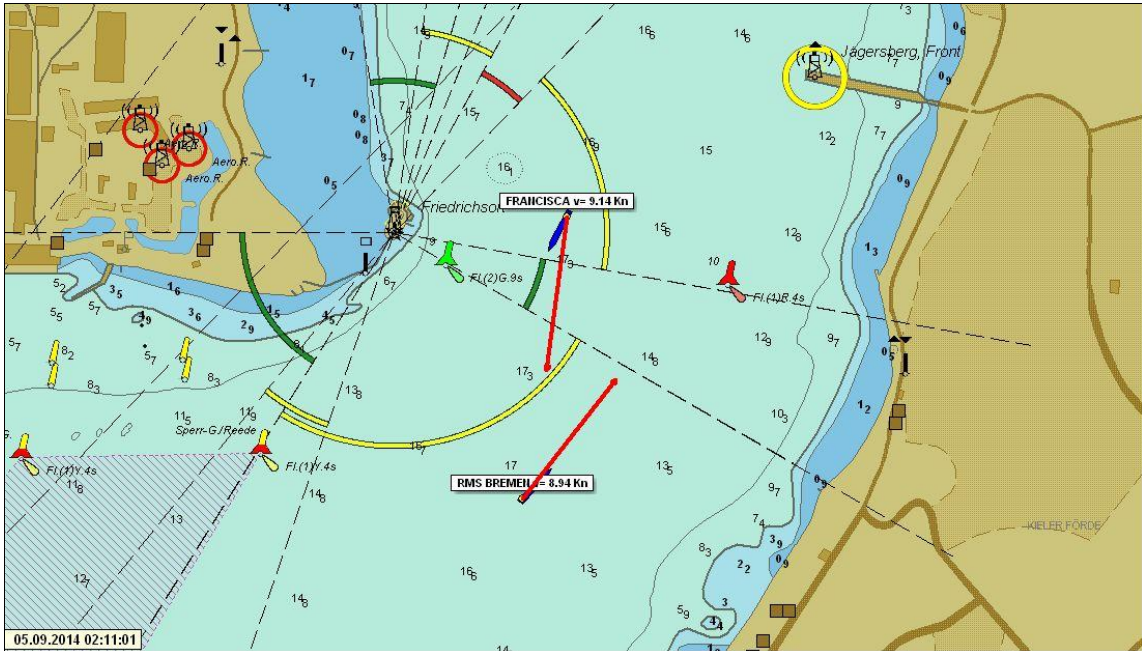
Figure 12: Scene of collision as per AIS with electronic chart, BAW

The BAW analysis shows the COG/SOG vectors at the time of the collision. The GPS receiver worked properly on each vessel, as can be seen from the reference positions in Fig. 13 with electronic chart.

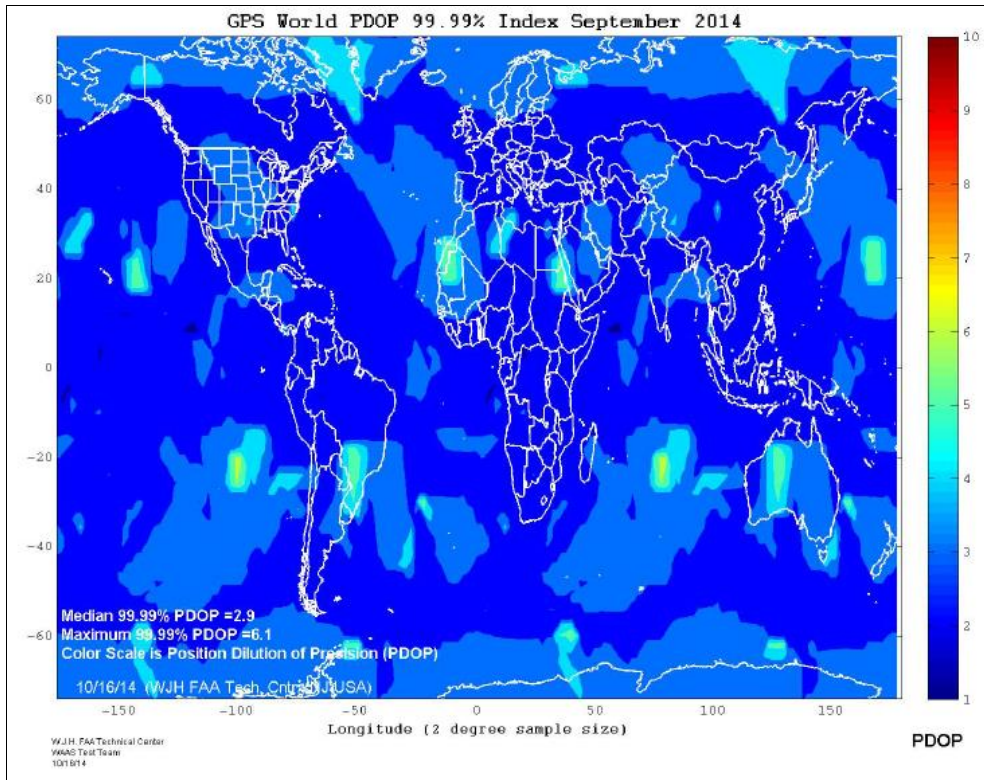
Figure 15: PDOP measurement

Position dilution of precision (PDOP) world map (parameter to assess the accuracy of a three-dimensional GPS measurement). The PDOP value for Kiel Firth is between one and two, meaning accuracy was high.

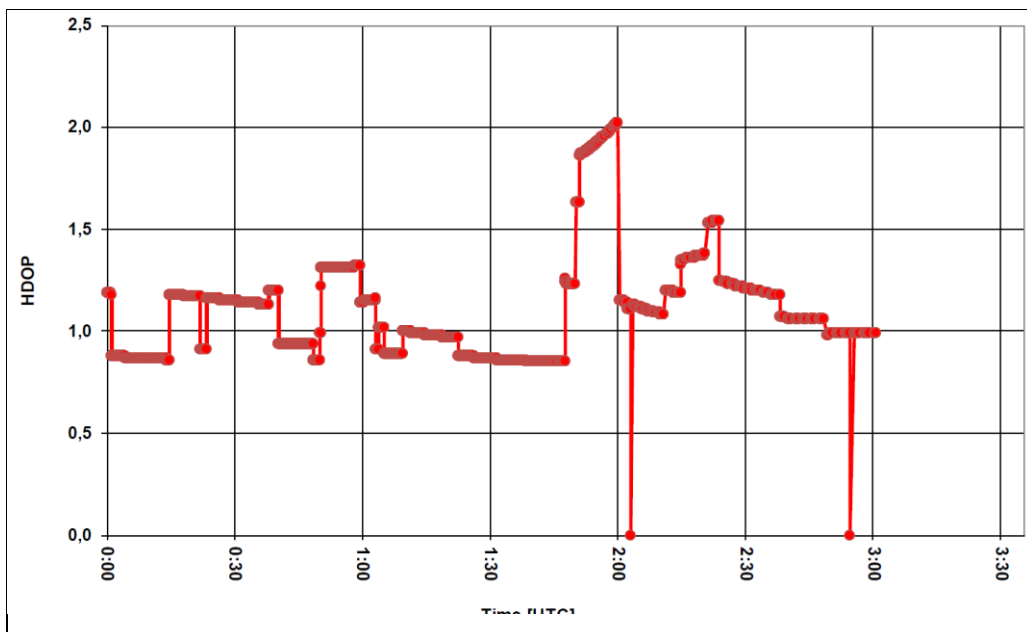
Figure 16: HDOP measurement

Horizontal dilution of precision (HDOP – parameter to assess the accuracy of a two-dimensional GPS measurement), 05/09/2014 – 0000-0300 UTC (Hemisphere GNSS receiver recording). The HDOP value stood at 0.8 at the time of the collision, meaning accuracy at the scene of an accident was high.

A slight deterioration of the available satellite constellation at about 0200 UTC in the vicinity of the scene of the accident is apparent in the simulation. It is not sufficient to explain deviations of more than 20 m, however. Two GPS receivers type tested for maritime shipping did not exhibit any failures or anomalies.

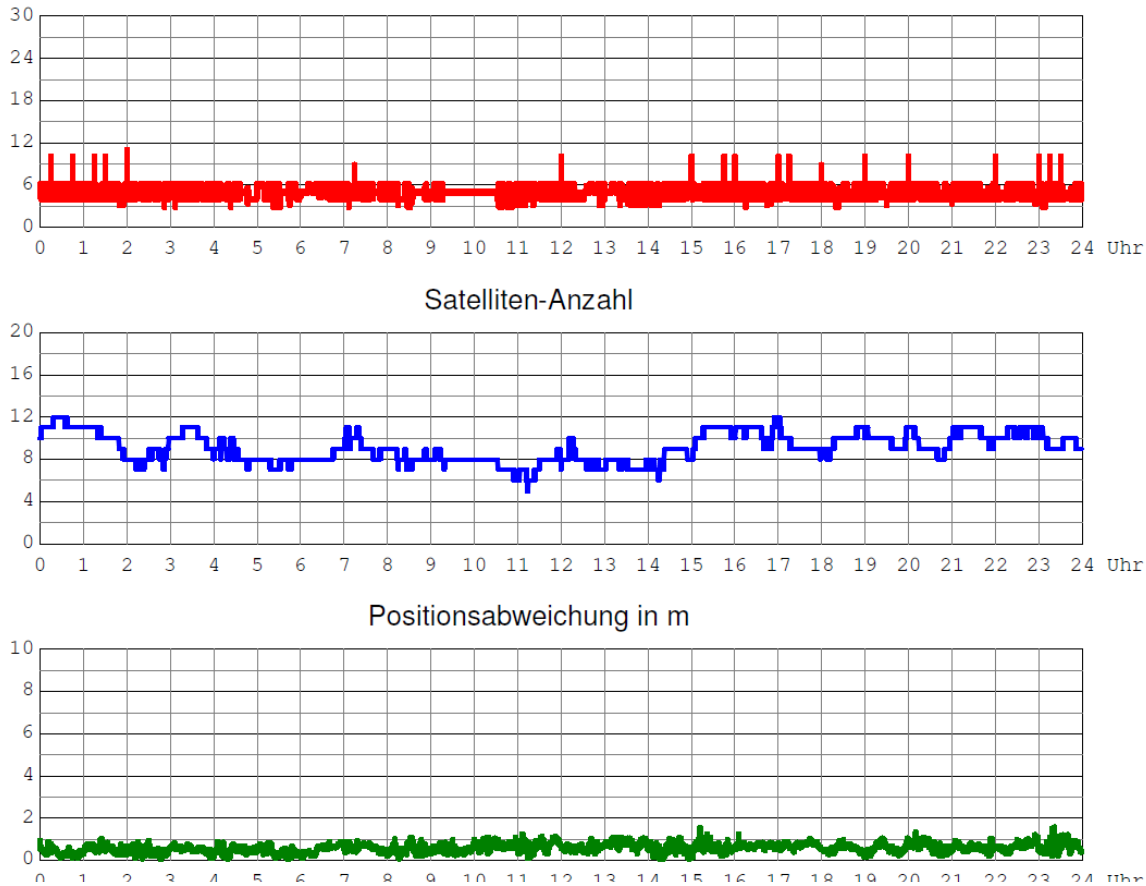
Figure 17: DGPS measurement

The analyses show the DGPS measurements made in the course of a typical day on a standard receiver. No anomalies are evident. The maximum positional error (scatterplot) was only 1.58 m on 5 September 2014.

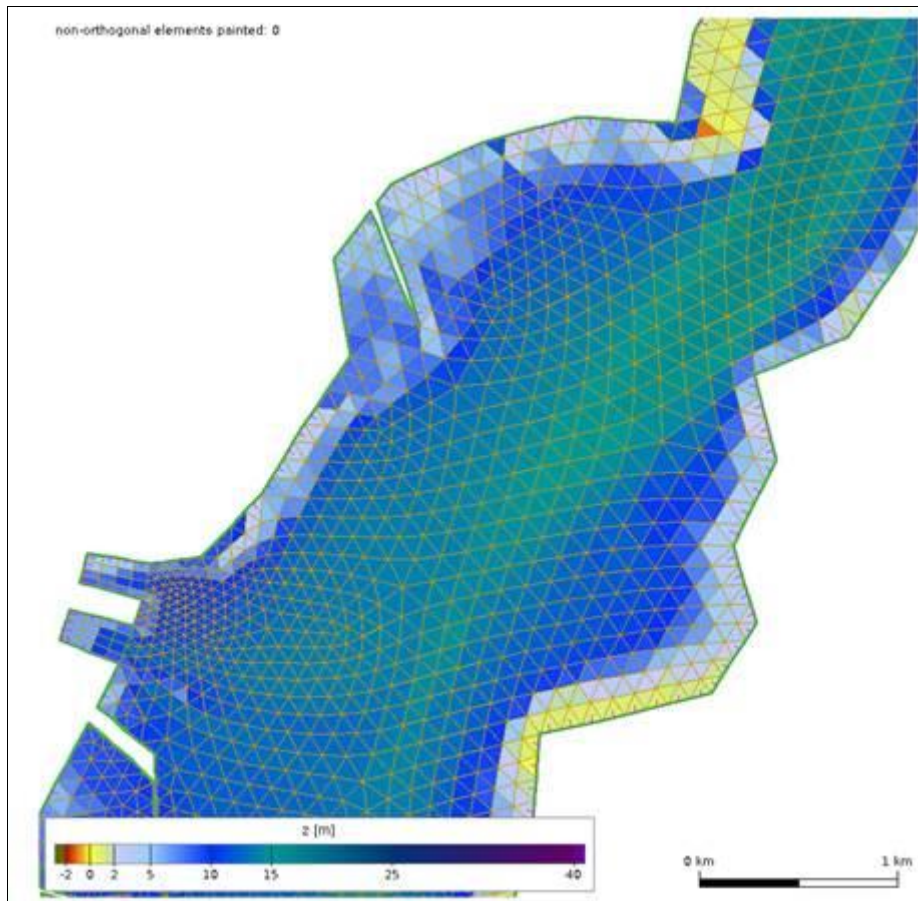
Figure 22: BAW grid model, Kiel Firth

The BAW operates a Baltic Sea model. The present grid width of one element in the Kiel Firth is about 100 m and a current value is calculated for each one. This grid spacing would be too great for an accurate assessment of the current patterns in the Friedrichsort narrows. To do that, the grid width would need to be fine-tuned by a factor of three and the model's parameter control data included. At present, the BAW has neither the need nor resources for this sea area. The computations, data editing, and reporting would take two to three weeks at least and can only be scheduled with the numerical model experts well in advance.

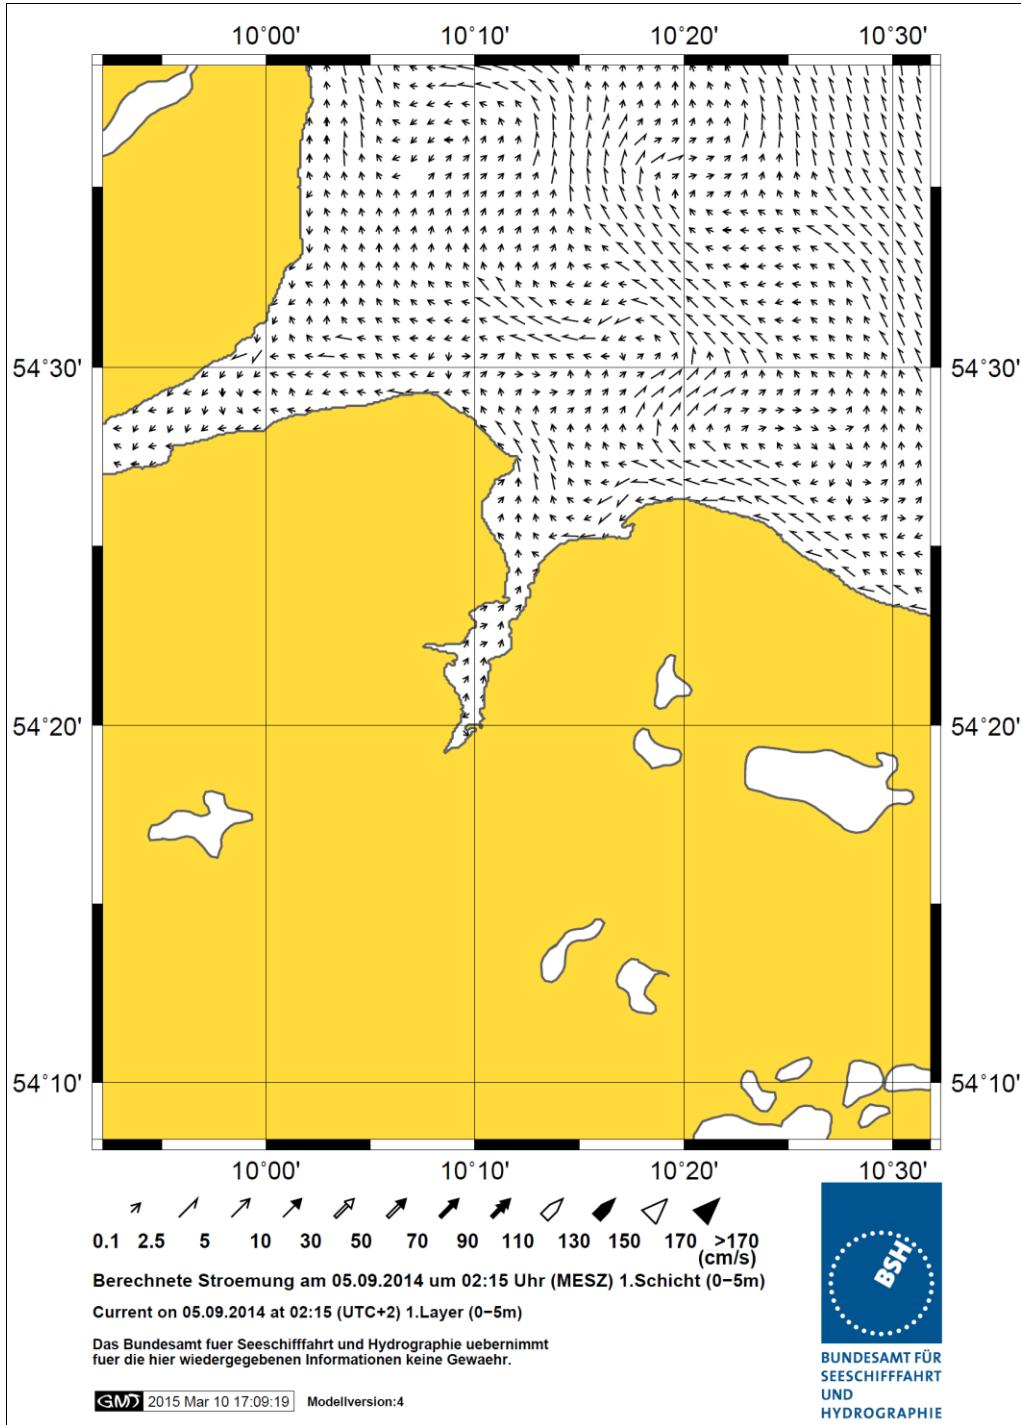
Figure 23: BSH model showing the computed current

The BSH circulation model's resolution in the Friedrichsort narrows is 900 x 900 m, which means that the conditions in the Kiel Firth are only poorly recorded. Even though it is not possible to compute details of the current in the Kiel Firth, it is at least possible to recognise that the currents were generally very weak in this region at the time of the collision. Inasmuch, the current had no significant impact on the course of the collision.

According to the BSH's model, the strength of the north-easterly setting current was no more than 10 cm/s. The BSH's Ostsee-Handbuch (sailing directions for the Baltic Sea) 20031 specifies a maximum current velocity of 2.5 nm/h for the Kiel Firth in the Friedrichsort narrows. An outgoing current reportedly forms in south to westerly winds and an inflowing current in north to easterly winds. The most frequent variations in the water level reportedly occur in autumn and winter. They rise up to 1.5 m in north-westerly to south-easterly winds, peaking in north-easterly winds, and drop up to 1.5 m in south-easterly to north-westerly winds, peaking in stormy south-westerly winds.

The BSU recommends that the BSH, as publisher of official navigational bulletins, make available a circulation model of the Kiel Firth with a resolution of up to 100 m and at least 20 m for the Friedrichsdorfer Narrow and the area of the Kiel Canal on the Internet and revise the information in its sailing directions for this area.
