Investigation Report 364/14

Very Serious Marine Casualty

**Fatal accident due to a rescue
boat on the MTM WESTPORT falling from
height during a boat manoeuvre on the
Outer Elbe roadstead
on 21 November 2014**

20 November 2015

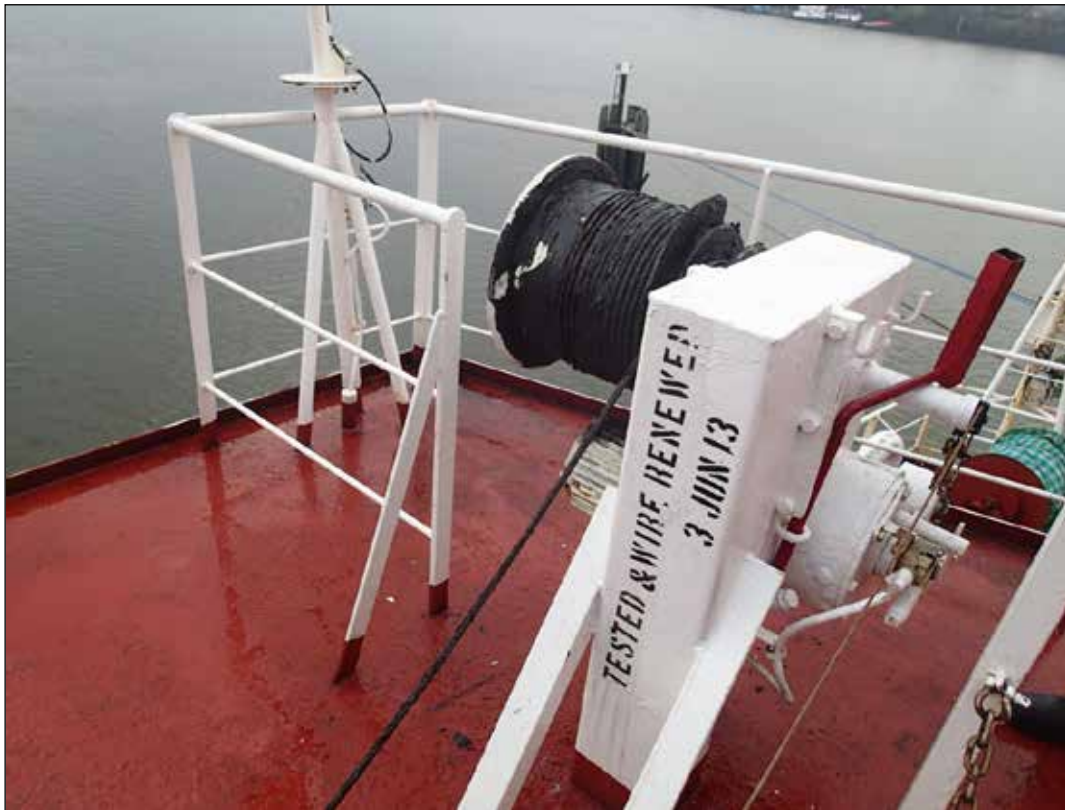
Figure 13: Winch marked with the last cable replacement

There is an indication on the winch that the cable was renewed on 3 June 2013 (see Figure 13), which is confirmed by neither the service report of the same date nor by evidence of a corresponding cable certificate on board. It is possible that the wire rope was not replaced on 3 June 2013 but only turned. Turning a davit system's cable after 2.5 years was common practise in the maritime industry. The SOLAS CONSOLIDATED Edition 2009 altered this practice to the effect that the cable must be replaced after five years. Service providers are required to observe the annual maintenance instructions provided in the IMO's MSC.1/Circ. 1206 Rev.1. This means the service company should have carried out the following inspections on the cable as part of the annual service on 31 May 2014:

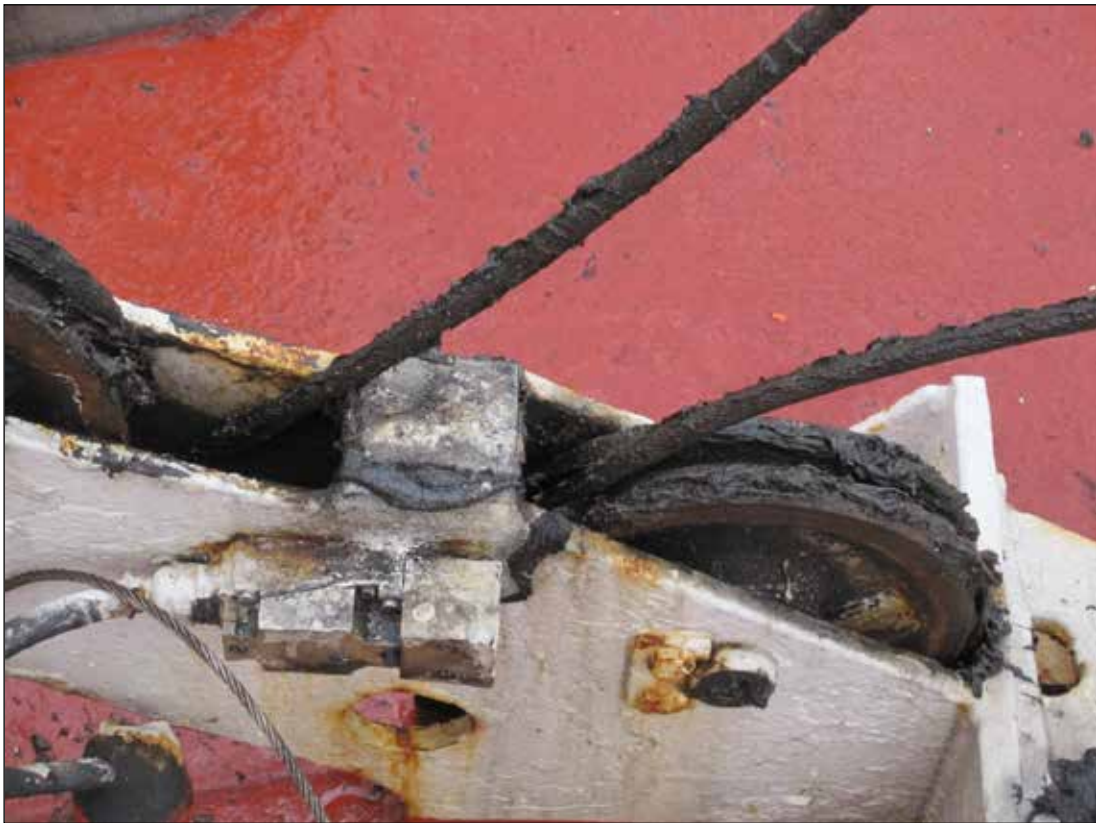
Figure 14: Grease on cable, guide pulley, and in the housing

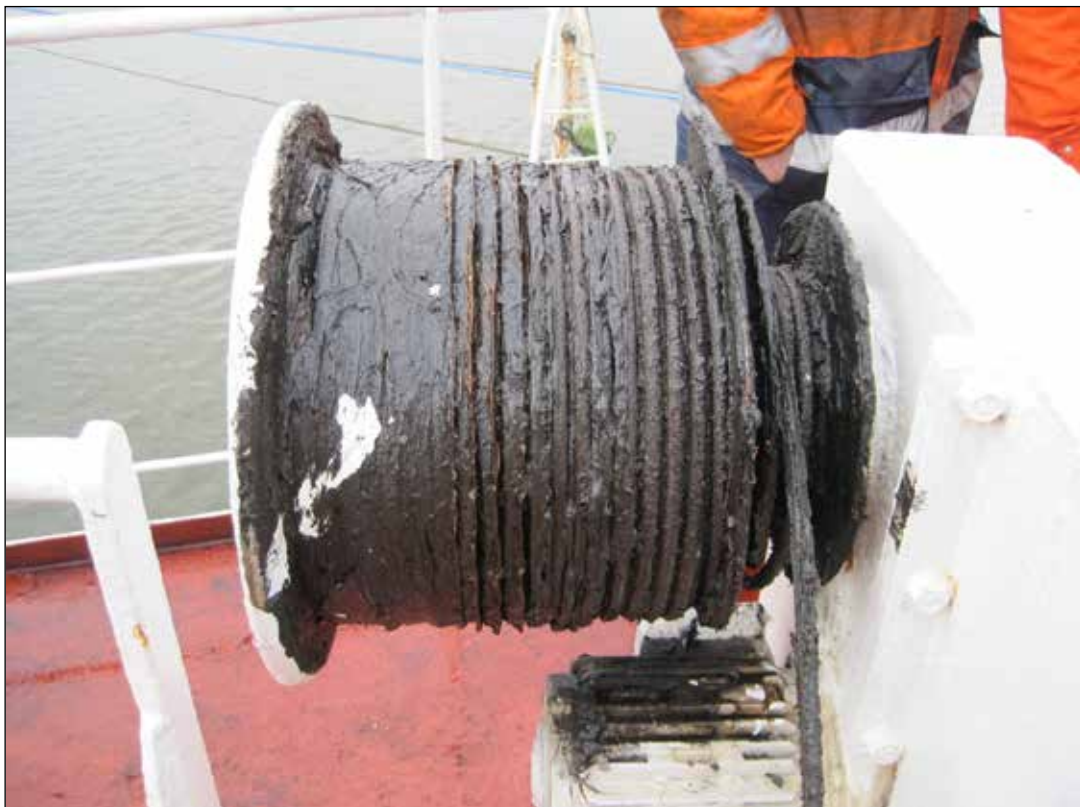
Figure 15: Winch with heavily greased cable

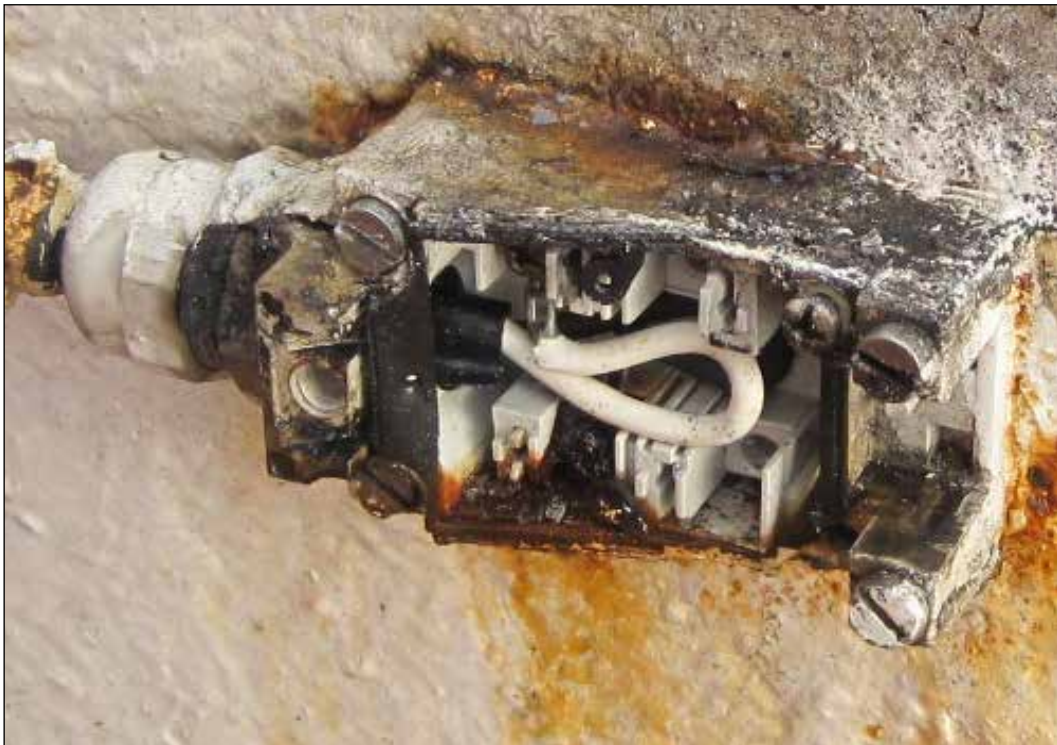
The davit system was equipped with an electrical limit switch, which switches off the winch's electrical system shortly before the limit is reached when the davit system is being retracted to prevent the cable, winch, and possibly steel structure from being overloaded. This limit switch was out of order. The rubber seal was damaged, the internal contacts corroded, and there was water in the switch. A second switch of the same type integrated with the system on the winch for shutting off the electrical system when a winch crank is inserted was also damp inside and had a defective seal (see Figures 16 and 17).

Figure 16: Corroded limit switch with defective seal

The Federal Bureau of Maritime Casualty Investigation recommends that the ship's command of the MTM WESTPORT permit the bypassing of limit switches under no circumstances whatsoever. They constitute an indispensable safeguard.

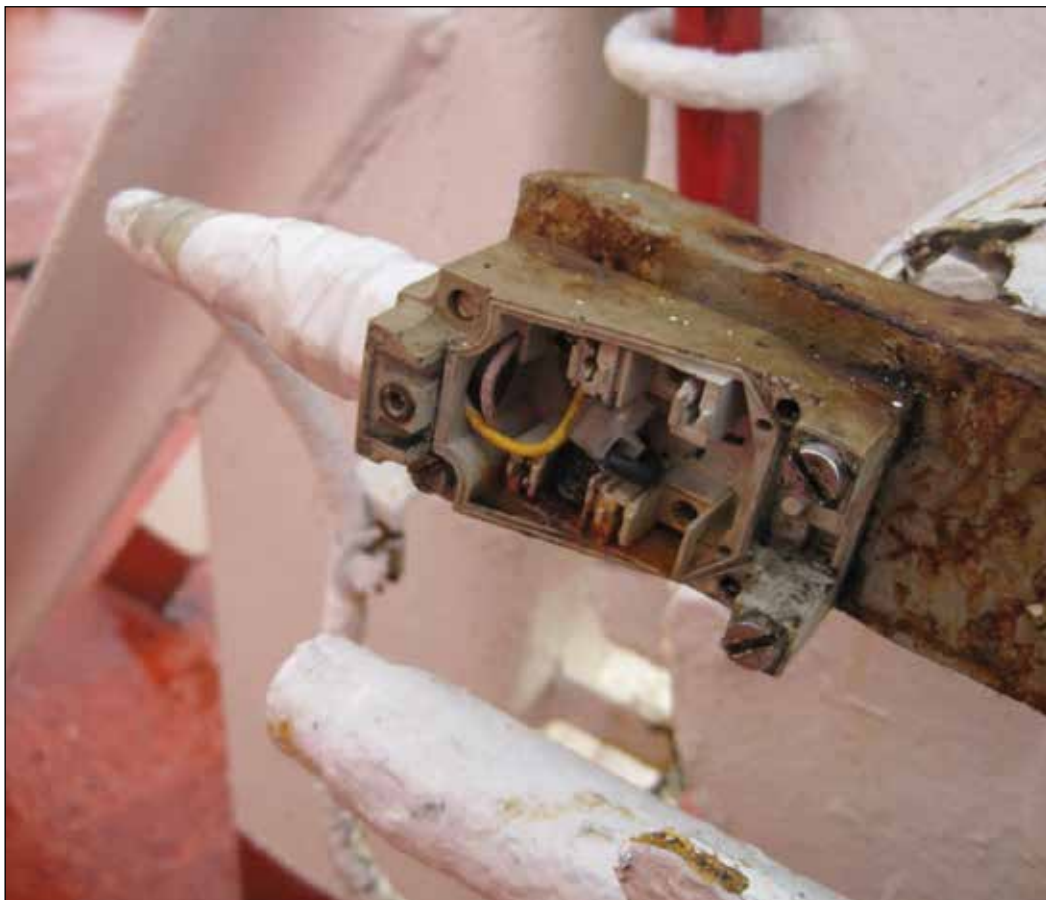
Figure 17: Corroded switch on the winch

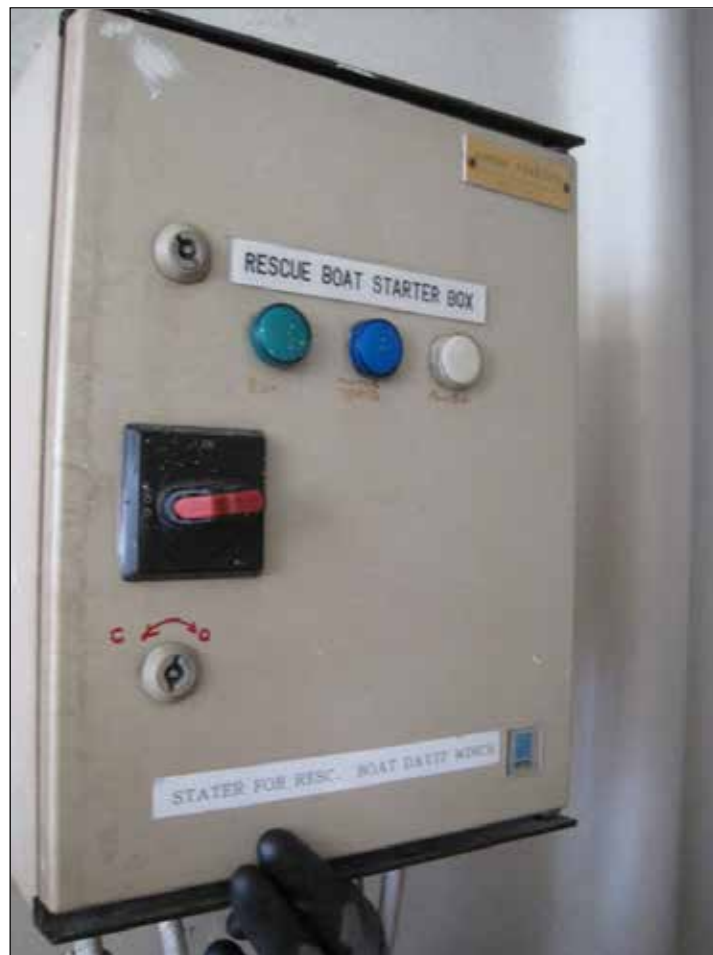
Figure 18: Control panel for the electrics on the poop deck

Moreover, the two limit switches discussed above and the electrical hoist/emergency shutdown pushbutton had been bypassed in the control panel for the electrics (labelled 'RESCUE BOAT STARTER BOX'), which is located on the poop deck in the entrance corridor to the engine room, using a cable bridge. When the master switch on the control panel for the electrics was set to ON, the winch started to rotate at hoisting speed immediately. The emergency shutdown pushbutton on the first superstructure deck next to the davit system was out of order. This was also bypassed in the control panel for the electrics using a cable bridge. The electrician claimed to have produced these bypasses only after the accident. It should be noted that although the operator of the electrical hoist/emergency shutdown pushbutton can see the davit system, he cannot see the surface of the water.

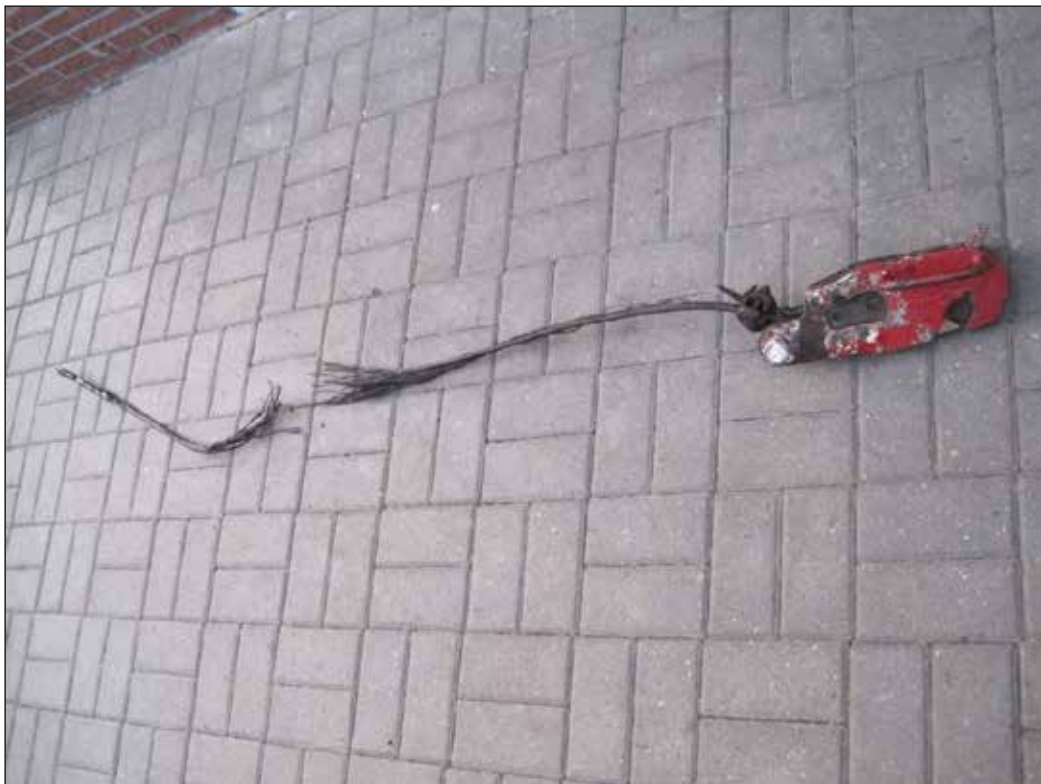
The WSP seized the RH 1.5 off-load hook, including the two parted wire rope ends. The cable parted about 700 mm above the hook. That the cable was passed through the hook improperly is particularly striking. It was not passed through the hook centrally, as intended, but rather laterally towards the inner cable pocket. Both the piece of cable diagonally inserted and the piece of cable exiting from the cable pocket at the same position are secured with a cable clamp. Pressure marks, which vary by about 36° inwardly from the perpendicular of the cable actually intended, are visible on the hook's two lateral supporting bolts. Apart from proving that the cable was attached incorrectly for an extended period, these pressure marks also demonstrate that a high pressure must have acted on the davit head hook.

Figure 22: Hook with parted cable end

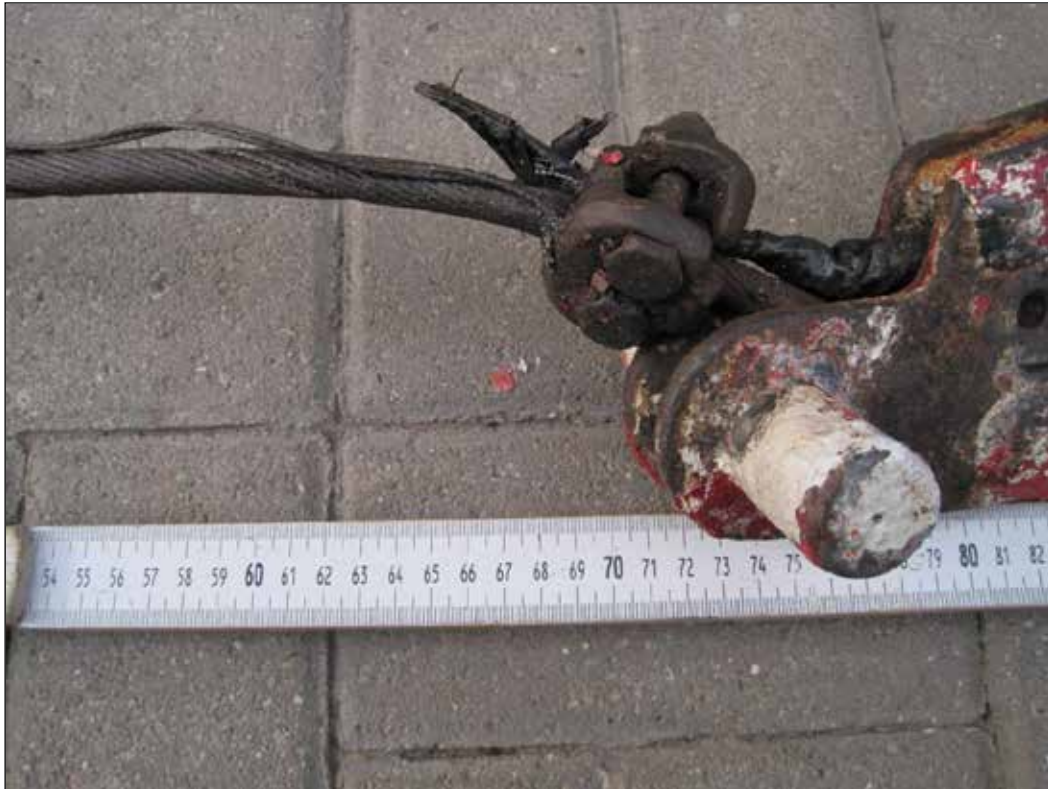
Figure 23: Inclined cable clamp

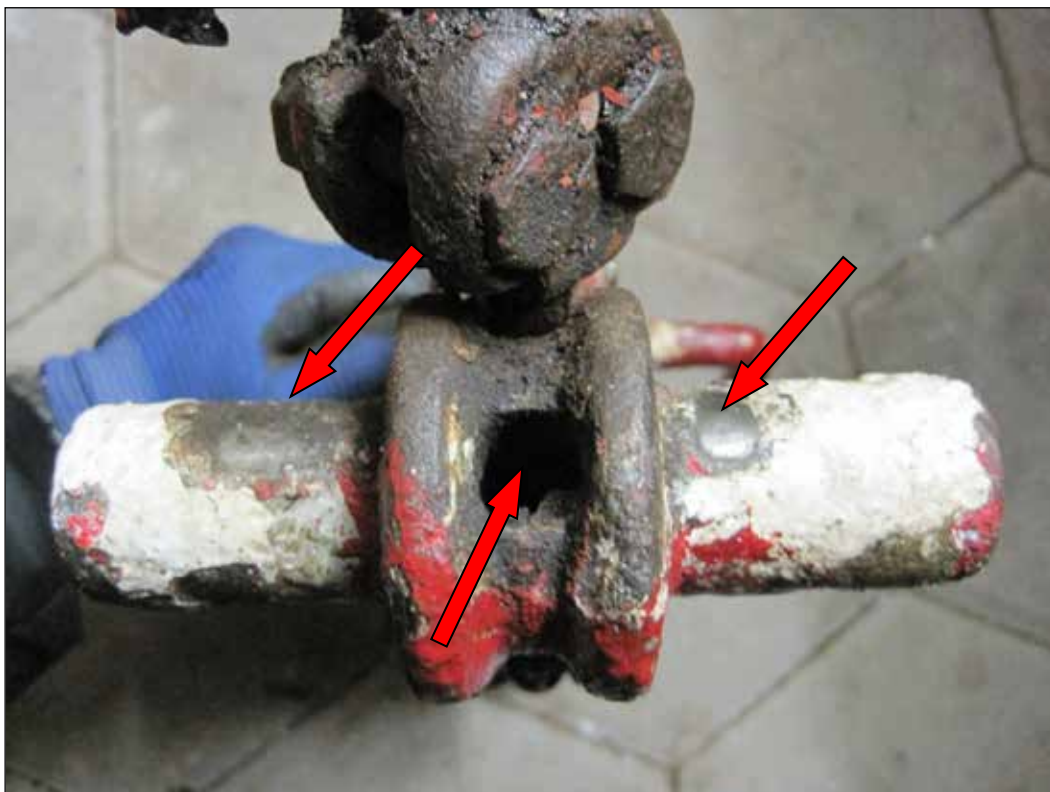
Figure 24: Cable mounted improperly on the hook. The 12-mm diameter cable should have been passed through the middle hole in the hook. Laterally, the pressure marks are visible under 36° from the vertical plane

The type RH 1.5 off-load hook was not attached to the davit system's wire rope properly at the time of the accident. Based on this investigation, the BSU concludes that the crew of the ship reattached the hook improperly most recently when the wire rope was turned on 3 June 2013. Due to the cable being improperly attached in this manner, the hook does not hang vertically but is always slightly inclined, as the load-bearing cable is passed through the hook laterally (see Figures 23-25). Page E 7/16 of the INSTRUCTION MANUAL SA 1.5 Davit shows the correct assembly. A further consequence of this improper assembly is that the cable clamp integrated with the lateral cable exit rests against the cable sheave when the davit system is retracted. This means that the hook cannot slip inwards on the davit head, as provided for in the design. The measured angle at which the hook meets the davit head of about 36° is also determined in the theoretical reconstruction of the interaction between the davit head and hook and thus credible. The documented dents on the hook attachment points are indicative of considerable pressure.

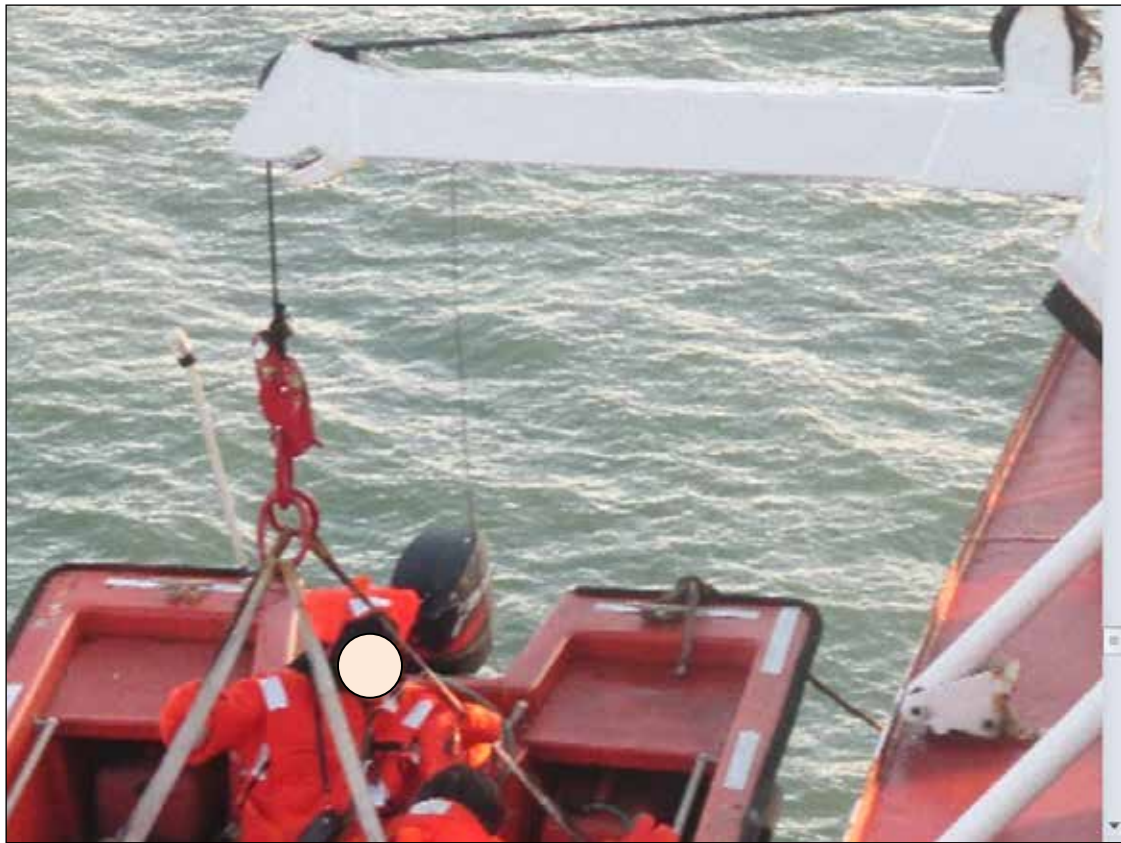
Figure 25: Photograph taken by the crew before the accident. That the cable was mounted improperly on the hook is confirmed here. Analysis of the photographs revealed that the attachment point of 36° on the davit head also seems credible

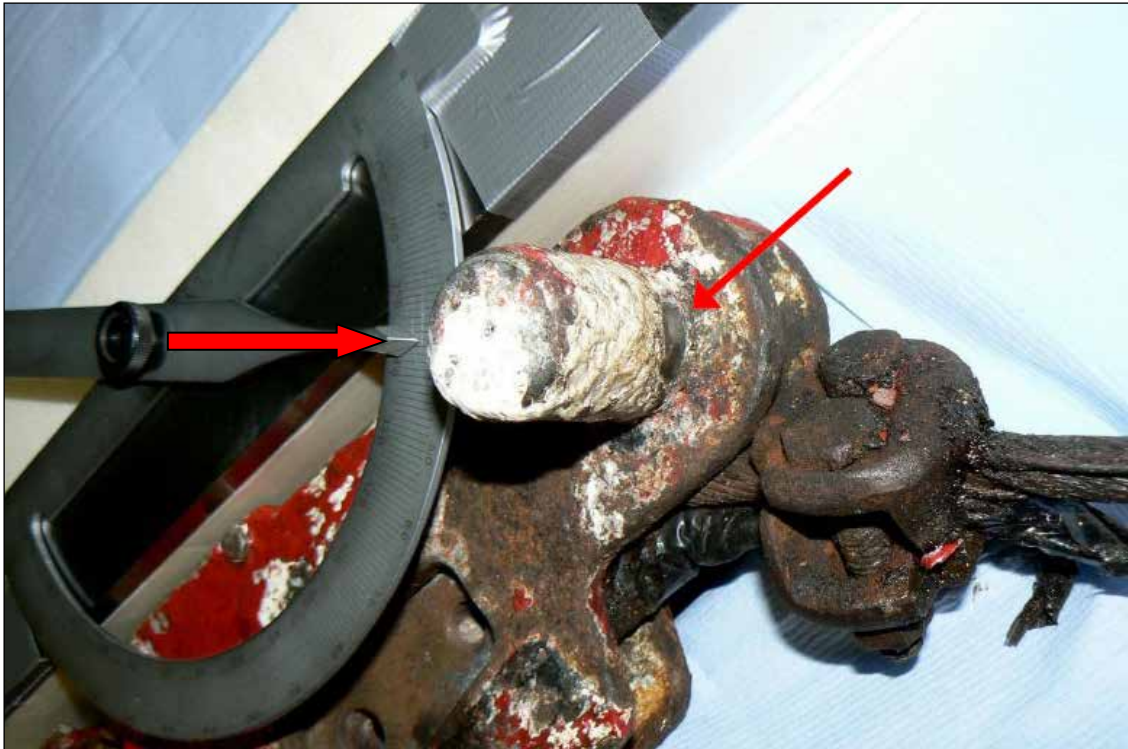
C. The load-bearing residual cross section failed as a result of ductile (deformed), forced ruptures. The cable's strands are heavily corroded in the vicinity of the failure. In addition to the outer strands, the corrosion is also visible on the inner strands at higher magnification. Based on the advanced corrosion, the condition of the wire rope in the vicinity of the failure could certainly be classified as fit for disposal according to DIN ISO 4309. It is possible that the load on the cable was increased due to the poor attachment of the hook. The attachment pressure point at the base of the hook was measured at 36°.

Figure 26: Determination of the angle of the attachment pressure points of the hook on the davit head of 36°

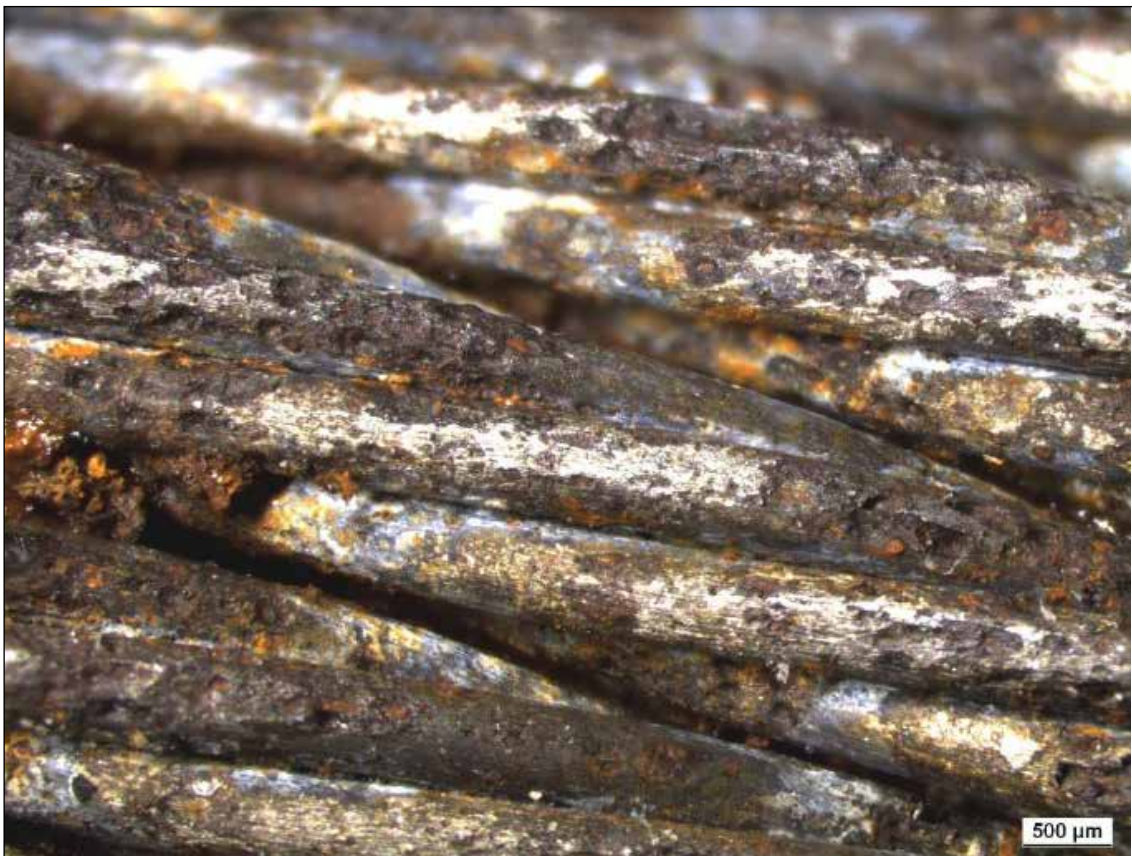
Figure 27: Corroded surface of the cable after being cleaned with kerosene

Signs of heavy corrosion were found in the vicinity of the cable failure, which reduced the structural strength of the cable cross section. The strength test of the cable revealed initial signs of failure at a load of **70 kN**. The cable sample used for this tensile test was taken from the protected winch drum, however. The area of the rope failure responsible for the accident is located at the top of the davit system. This area is difficult to see and not readily accessible for applying grease properly or checking the cable in the stowed position. Furthermore, the wire rope is exposed and highly vulnerable to environmental influence at this point. Based on the documented signs of corrosion in the area in which the wire cable failed, it is reasonable to assume that the actual breaking load in this failed part of the cable on the top edge of the davit system was much lower. This means that the cable's safety factor was reduced even further at the time of the accident.

The Federal Bureau of Maritime Casualty Investigation recommends that MT Maritime Private LTD. only provide wire ropes that conform to the manufacturer's specifications. Furthermore, the crew should be trained in corrosion protection and the replacement of wire ropes regularly.

The Federal Bureau of Maritime Casualty Investigation recommends that the ship's command of the MTM WESTPORT verify that every wire rope is fit for purpose prior to use. Furthermore, the crew should be instructed in corrosion protection and the replacement of running rigging regularly.

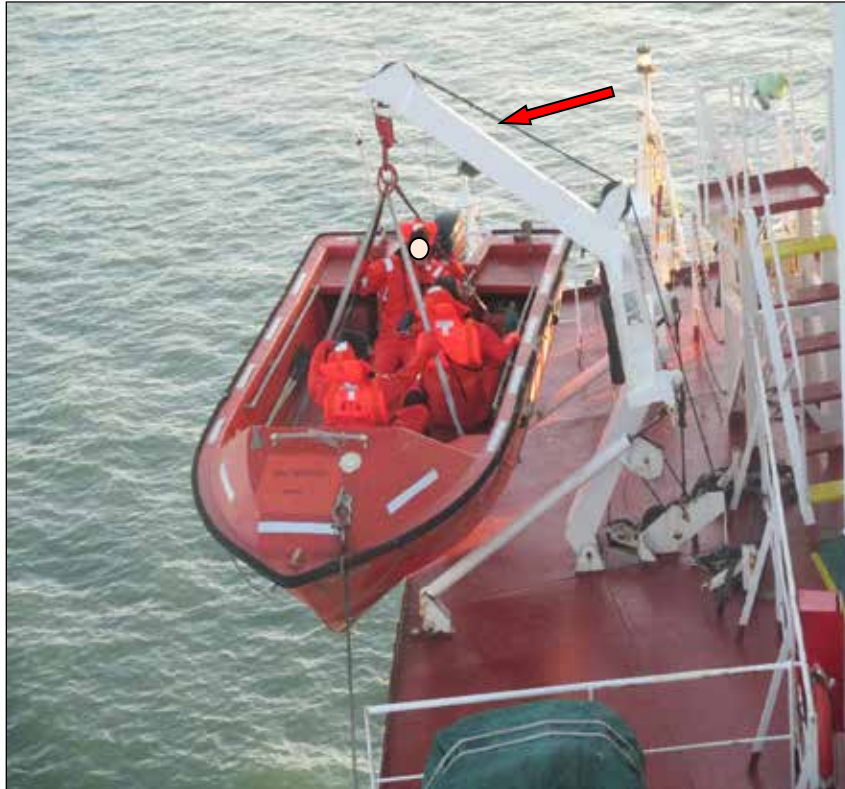
The ductile, sudden failure of the davit system's corroded wire rope between the two upper guide pulleys caused the rescue boat to fall from a height of some 13 m to the surface of the water.

Figure 28: Approximate position of the cable failure immediately before the accident

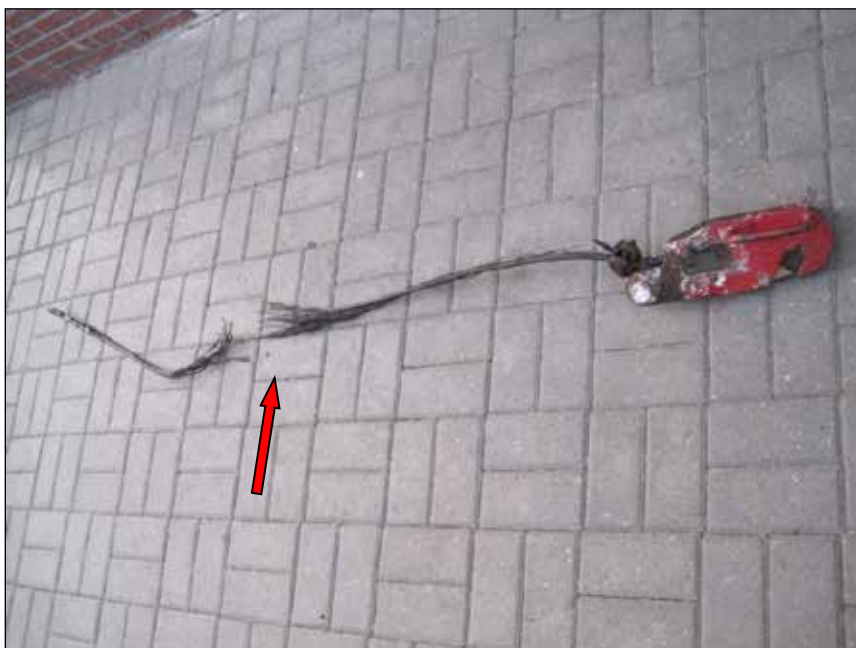
At about 0912, the last time the davit was hoisted, the wire rope parted suddenly between the two upper guide pulleys at a point that is about 700 mm from the top edge of the hook. Since the hook rested on the upper jaw of the davit head, the boat did not drop immediately. The davit head released the hook and the boat dropped down to the surface of the water only after the spring-loaded cylinders had extended the davit completely.

Figure 29: Position of the cable failure 700 mm above the hook

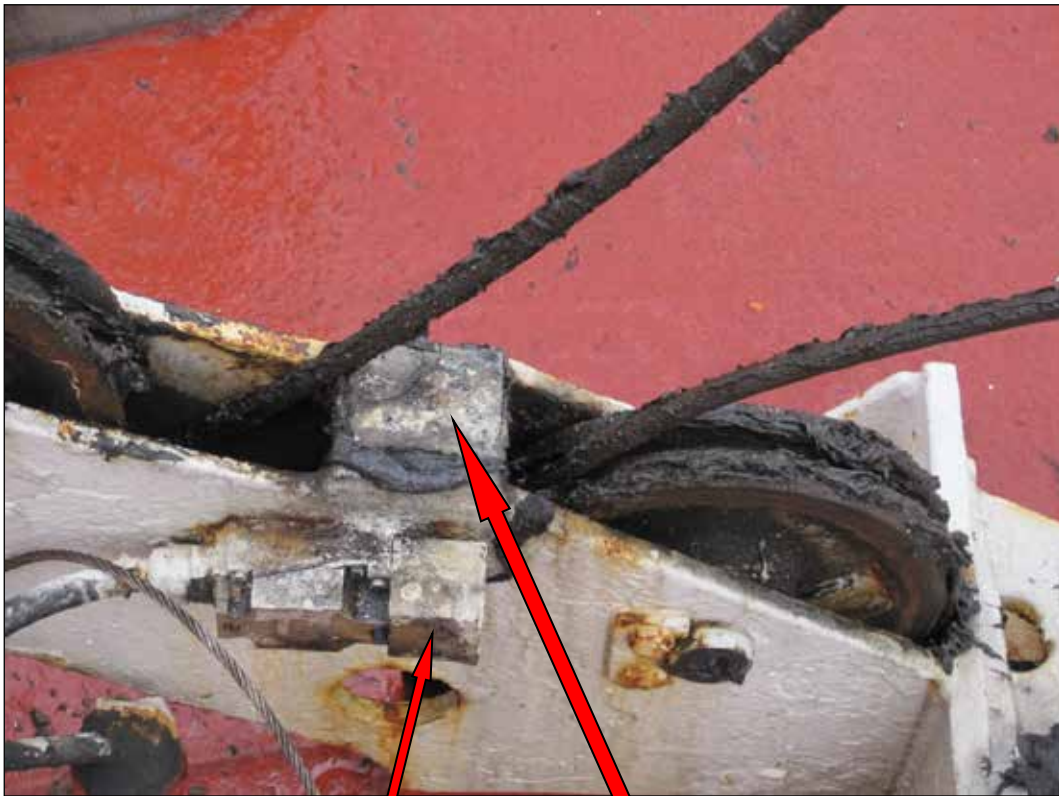
The limit switch on the davit system is defective and corroded. It cannot turn off the davit system before the limit is reached. The limit switch is intentionally bypassed in the control panel for the electrics, otherwise the electrics would have short circuited and it would have been impossible for the winch to work electrically.

Figure 30: Defective limit switches with the support surface for the davit's limit above.
The grease has been completely forced out here

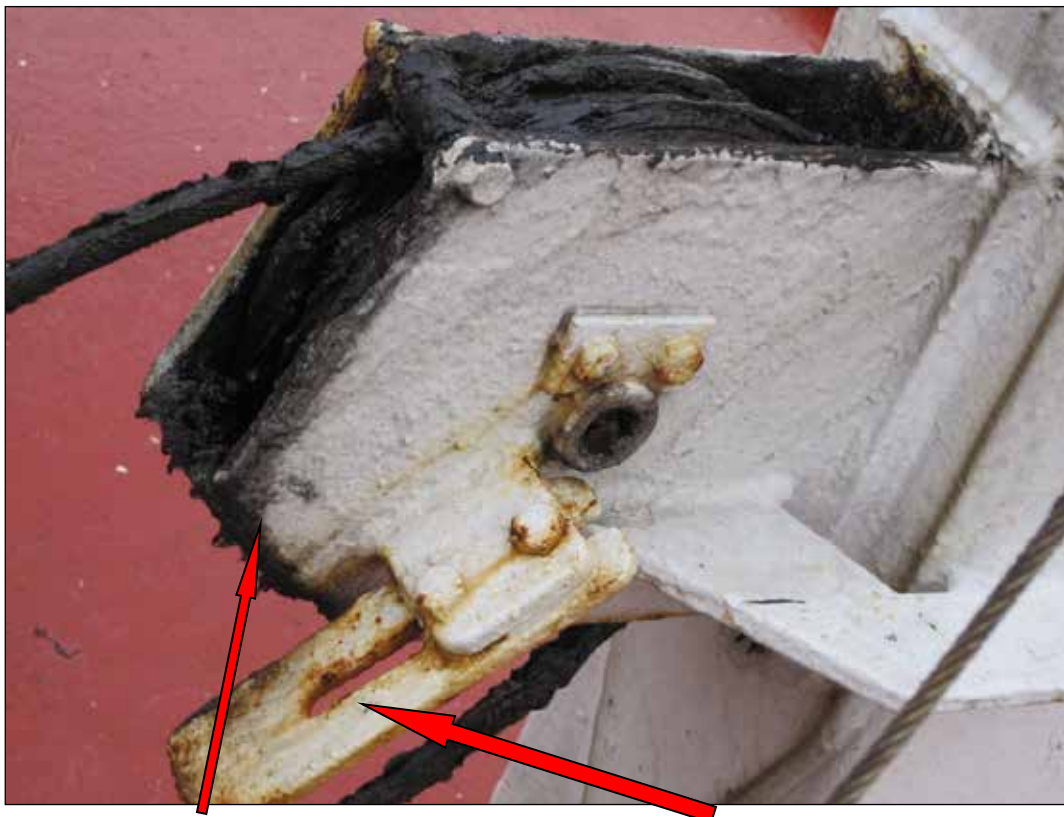
Figure 31: Limit switch's companion part with the support surface for the davit's limit next to it

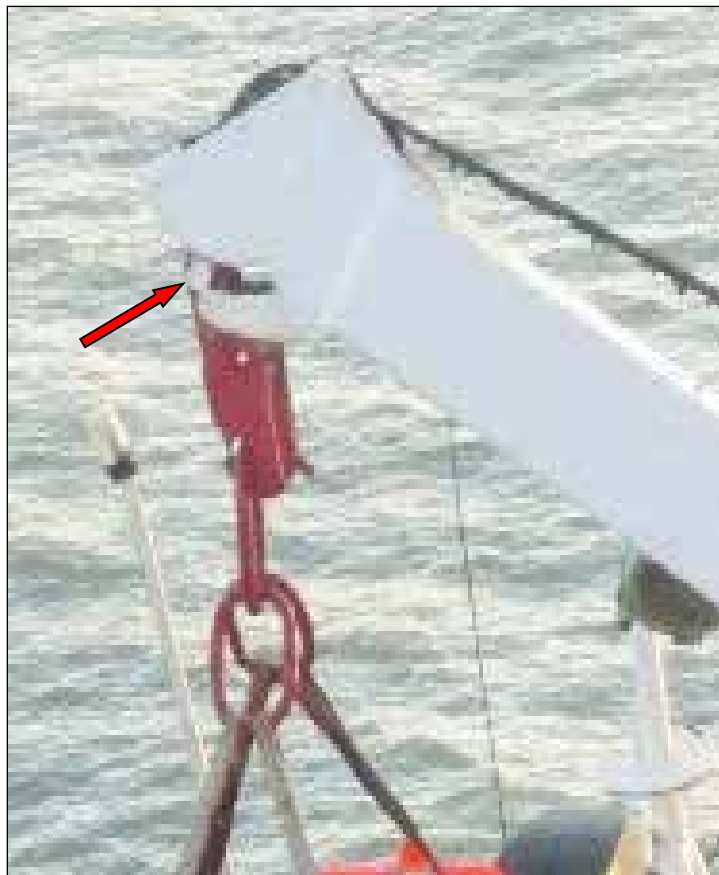
Figure 35: Immediately before the accident – the hook cannot retract further because the cable clamp is resting against the upper guide pulley

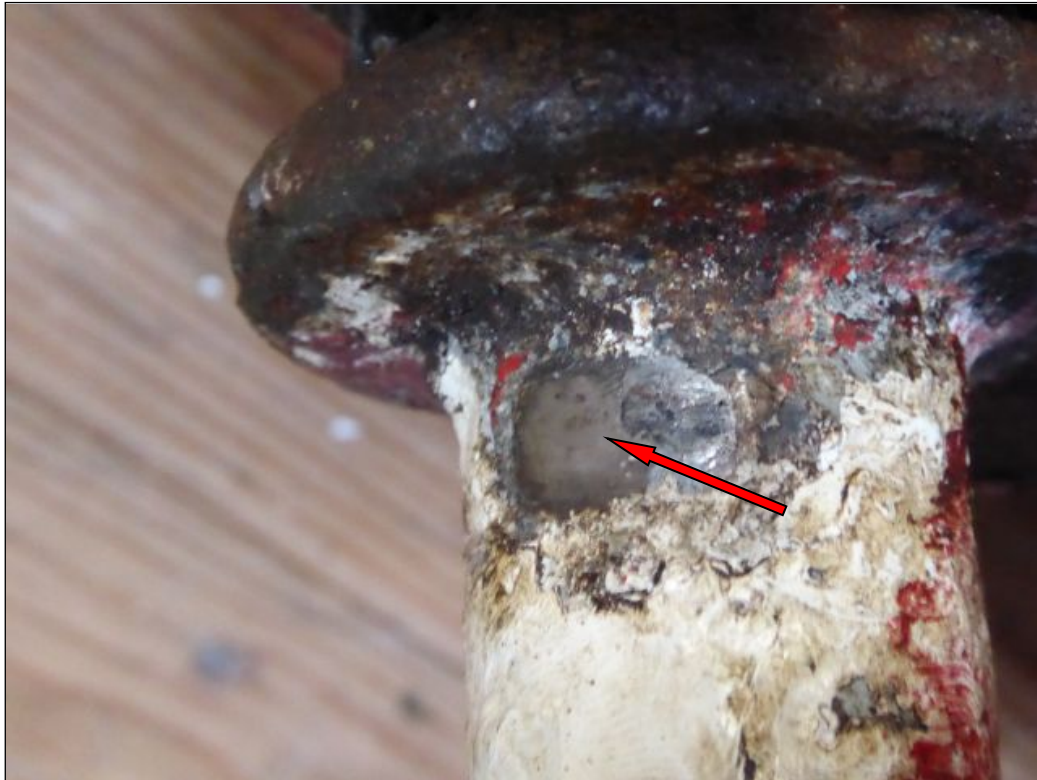
Figure 36: Dents on the attachment points on the hook

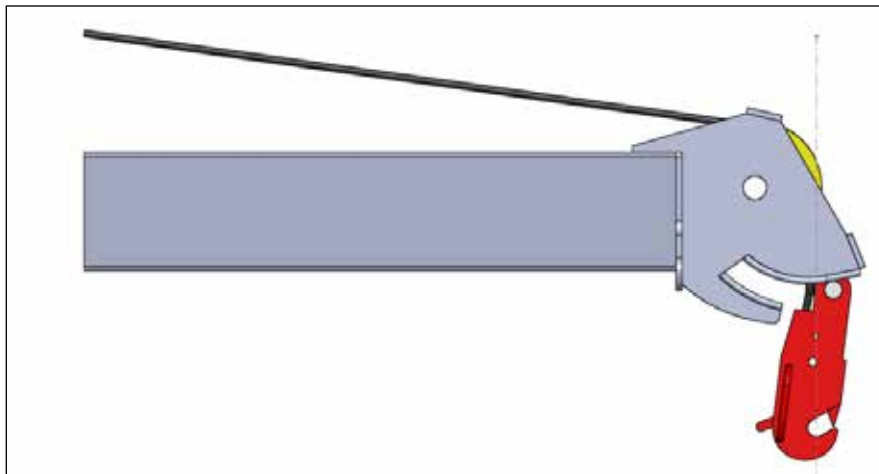
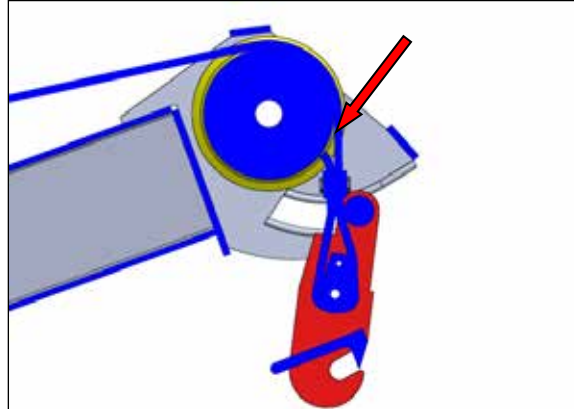
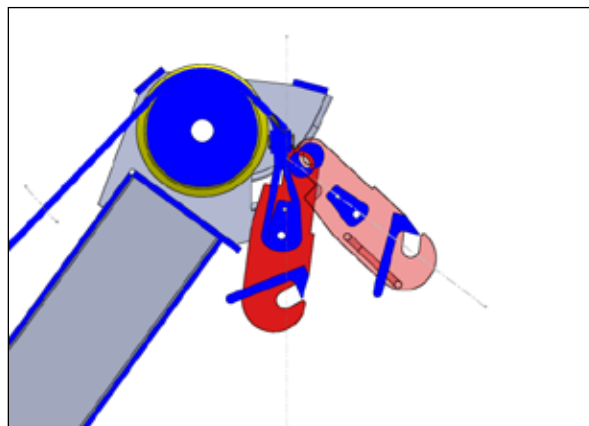
1. End of the hoisting process in the 'Davit fully extended' position (90°):

2. Turning in of the davit system until the cable clamp is resting on the upper cable sheave at about 70°:

3. Further turning in of the davit system up to the maximum limit (about 36°). At the same time, the boat turns the hook around the cable clamp's attachment point on the guide pulley. It is possible that a further load was produced by moment and necessary cable extension.

It is not possible to prove that an increase or transfer of force resulted from the fact that the hook was attached improperly. It can be concluded with certainty that the hook was not attached properly. Consequently, it is possible that the attachment of the cable clamp/cable on the guide pulley caused damage to the cable earlier.
