# Summary Investigation Report 373/13

**Serious Marine Casualty**

Collision while mooring between the MV MERWEBORG and the ro-ro MV CAROLINE RUSS at Steubenhöft in Cuxhaven on 12 December 2013

1 December 2014

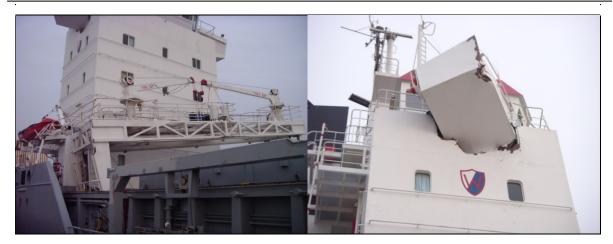
Figure 6: Gantry crane, rescue boat Figure 7: Starboard bridge wing

There were no injuries and no pollutants escaped during the accident. The MERWEBORG's starboard wing was torn and bent backwards. The deck beneath that was dented. The frame of the starboard side window was deformed. The starboard davit of the rescue boat was broken and the boat deck with boat damaged. The gantry crane was lifted out of its guideway and damaged. The forecastle with guard rail and cable tier was dented. The CAROLINE RUSS's forecastle sustained two tears of 4-5 m in length about 7 m above the waterline and her gangway was damaged.

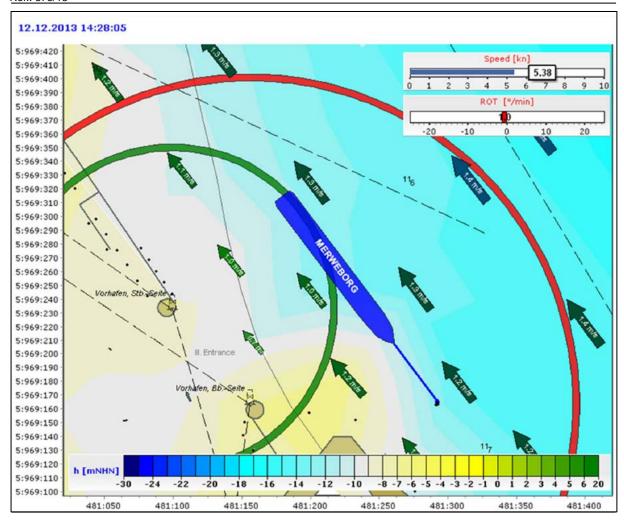
The MERWEBORG's running speed level with the entrance to the outer port stood at about vSOG » 5.4 kts at an ebb current velocity of around ve » 1.2 m/s (= 2.3 kts), meaning the speed through water calculated was about vSTW » 7.7 kts (Fig. A; time: 142805). The ship sailed virtually in the opposite direction to the depth-averaged current vectors, meaning an almost even flow around the hull was to be expected. According to the gauge at Steubenhöft, the tide level stood at -1.32 MASL, the actual depth of water at the ship was h » 11 m on average at a distance of L » 100 m from the entrance, decreasing to around h » 8 m in the middle of the port entrance. The turning motion to port of no more than ROT P =  $5^{\circ}$ /min (142744) was reduced to some ROT P =  $1^{\circ}$ /min within 21 s.

Evaluation: Effective interactions of the MERWEBORG, running at d = 7.3 m, with the bathymetry, the quay facilities, as well as the elevated ro-ro ramp could not be derived from the data prepared. Cross currents from the outer port exit as a result of the ebb current cannot be derived from the current computations of the BAW's 3D HN model.

Figure A: ENC position of the MERWEBORG at a speed of roughly vSTW » 7.7 kts off the outer port with overlaid depth-averaged current and bathymetric data from the BAW's HN model (2010)

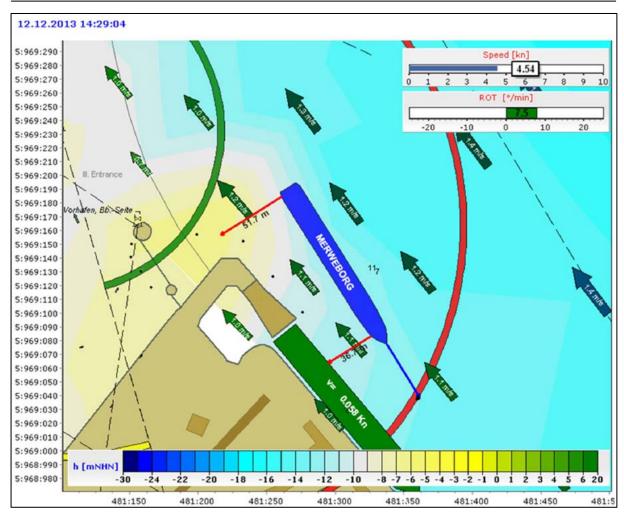
The MERWEBORG passed the entrance to the outer port one minute later (Fig. B; time: 142904); a course difference of about +5° to starboard was now determined. The speed through water calculated at a depth-averaged ebb current of ve » 1.1 m/s (= 2.1 kts) was about vSTW » 6.6 kts. The present PASSING DISTANCE of the bow to the moored CAROLINE RUSS (d = 5.9 m) stood at some 37 m, the stern to a theoretic line along the moored vessel roughly 52 m. During the passage of the outer port entrance, as well as the shoals located to the south-east of that with present water coverage of roughly h » 5-6 m, the vessel turned from port ROT P = 1°/min to starboard ROT S = 7.5°/min. At this point, based on the underlying depth-averaged current data from the HN model, the inflow to the MERWEBORG came from an angle of about 6°.

Evaluation: The reversal of the turning motion of the ship from port to starboard is not due to interaction between the vessel and shoals to the south-east of the outer port entrance, the latter would have intensified the turn to port. The tidal oblique inflow of about 6° did not cause the strong development of the turning motion from port to starboard, either.

Figure B: ENC position of the MERWEBORG at a speed of roughly vSTW » 6.6 kts off the outer port with overlaid depth-averaged current and bathymetric data from the BAW's HN model (2010), as well as computed distances to the moored vessel

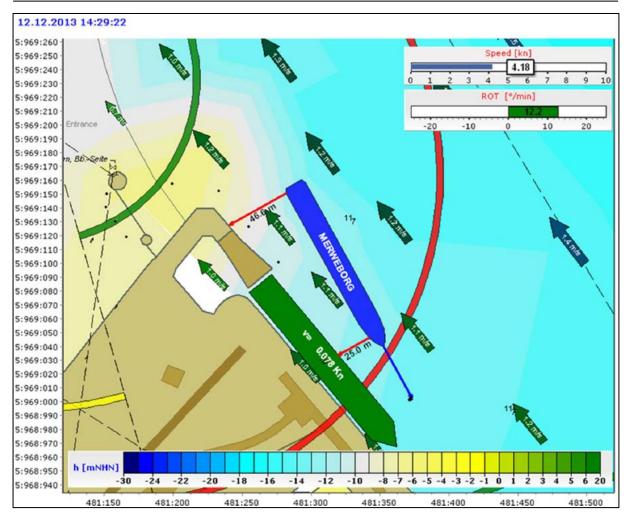
Within only about 20 s, the turning motion to starboard increased to the maximum of ROT S =  $12.2^{\circ}$ /min (Fig. C; time: 142922). The speed through water was marginally reduced to some vSTW » 6.3 kts, the depth-averaged tidal stream was roughly ve » 1.1 m/s (= 2.1 kts), still at an inflow angle of approximately  $6^{\circ}$ . The PASSING DISTANCEs to the CAROLINE RUSS (d = 5.9 m) or to a theoretic line along the moored vessel now stood at some 25 m (bow) and 47 m (stern).

Evaluation: The increased turning motion to starboard is caused neither by bank effects, a ship/ship interaction, nor by the tidal oblique flow.

Figure C: ENC position of the MERWEBORG at a speed of about vSTW » 6.3 kts off the outer port at maximum ROT to starboard with overlaid depth-averaged current and bathymetric data from the BAW's HN model (2010), as well as computed distances to the moored vessel

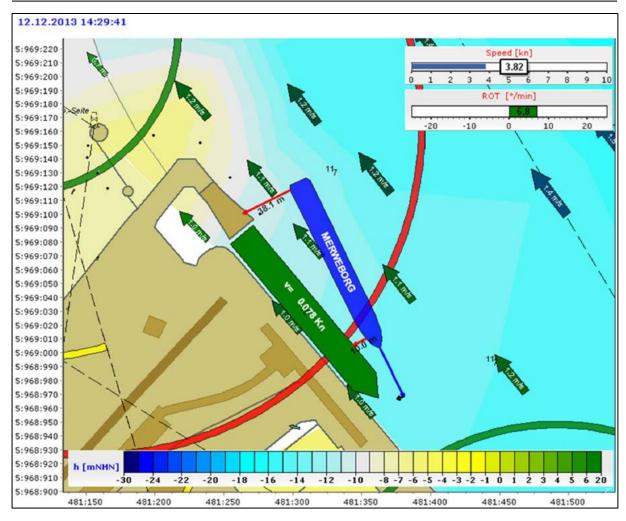
After about another 20 seconds (Fig. D; time: 142941), the MERWEBORG was roughly level with the CAROLINE RUSS at a speed of about vSTW » 5.9 kts and shallow angle of about 15° towards the bow of the moored CAROLINE RUSS (d = 5.9 m). At this point, the inflow to the MERWEBORG (d = 7.3 m) came from an angle of about 14° on the port side with a depth-averaged tidal stream of roughly ve » 1.1 m/s (= 2.1 kts). The distance from the MERWEBORG to the CAROLINE RUSS was about 10 m at the bow. The stern was roughly 38 m to a theoretic line along the moored vessel. The turning motion to starboard was reduced from the maximum to ROT S =  $6.8^{\circ}$ /min at this point in spite of the tidal inflow of about 14°.

Evaluation: It is not possible to infer that hydrodynamic interaction between the MERWEBORG (d = 7.3 m) and the CAROLINE RUSS (d = 5.9 m) facilitated the collision in spite of the passing speed of about vSTW » 6 kts and low PASSING DISTANCE. Possible hydrodynamic interactions opposed the present behaviour of the MERWEBORG. The low distance of the bow may have facilitated the reduction in the ROT to starboard due to the speed-induced pressure distribution at the bow (bow wave).

Figure D: ENC position of the MERWEBORG at a speed of about vSTW » 5.9 kts level with the CAROLINE RUSS with overlaid depth-averaged current and bathymetric data from the BAW's HN model (2010), as well as computed distances to the moored vessel

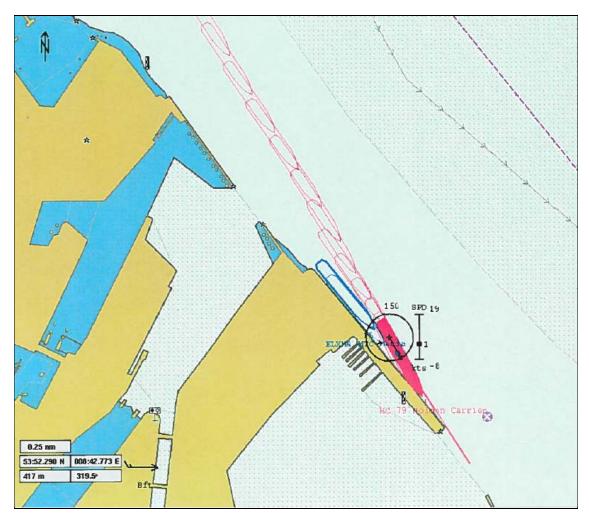
Figure 11: Simulation of the accident at the MTC

On 28 May 2014, several berthing manoeuvres involving Elbe pilots at Steubenhöft under similar conditions to those of the MERWEBORG were simulated at Maritime Training Center in Hamburg. The ebb current was set at 4 kts in accordance with the information then available. The BSH's sailing directions for the North Sea indicate that the tidal streams along the quay facilities set across and at times into the entrances at up to 5 kts. The manoeuvre is shown in the form of a time lapse in Fig. 10. For reasons of simulation, a current setting away from the pier had to be taken into account while berthing at Steubenhöft. It is striking that during this manoeuvre, at 1-2 kts SOG, the vessel sailed much slower, closer and more parallel to the pier than during the accident. The current model at the Steubenhöft berth was reportedly not true to reality. In particular, manoeuvres had to be continuously corrected when berthing. Hydrodynamic interactions were reportedly not sufficiently accounted for in the model. Nevertheless, a different approach of pilots is clear: they did not take the direct track from the fairway to the berth. The direct approach at smaller distances and a speed of 5.5 kts resulted in a collision in the simulator, too (see Fig. 11).

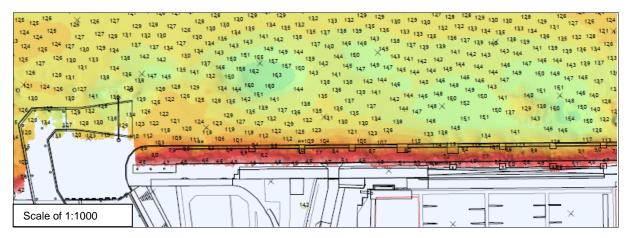
Figure 13: Port authority's sounding chart of 5 December 2012, Steubenhöft, scouring (green areas)

The latest sounding charts, hydrodynamic analyses, and the experience of the Elbe pilots make it possible to improve and adapt the Steubenhöft model for ship-handling simulators, meaning simulation of the hydrodynamic effects can be more in line with reality. It is not possible to demonstrate any hydrodynamic effect under the pier because of the stilt design. In the area of the entrances to the outer port and Amerikahafen, there are smaller outgoing and incoming currents in the different water layers. Larger vessels can be caught amidships by the Elbe's current in the entrances. It is necessary to observe the morphology of the seabed (sand accumulation, scouring) of the ro-ro berth, as well as at Steubenhöft berth.
