Summary
Investigation Report 43/14

Serious Marine Casualty

**Collision between the MV BIMI and
MV BARENT ZANEN
in the Medem roadstead
on 1 March 2014**

19 January 2015

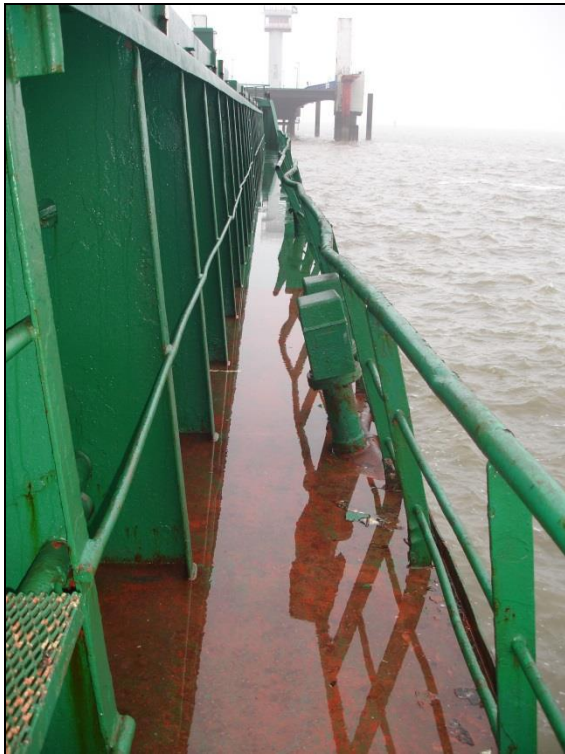
Figure 4: Guard rail damage (BIMI)

It was found during the classification society's survey that 15 m of the starboard guard rail was buckled, ballast water tanks and fan cowls were dented, and all the propeller blades were torn. No pollutants escaped.

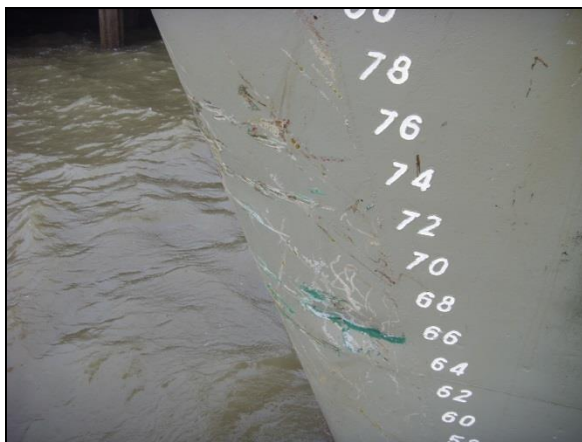
Figure 6: Bow damage (BARENT ZANEN)

The BARENT ZANEN weighed anchor at 0800. At 0843, she made fast at Steubenhöft in Cuxhaven, where the damage was assessed. Only light paint abrasions were found on the ship's side and in the area of the stem. A larger paint abrasion and a dent was found on the port shoulder. The platform with drain pipe on the port side of the main deck was also damaged.

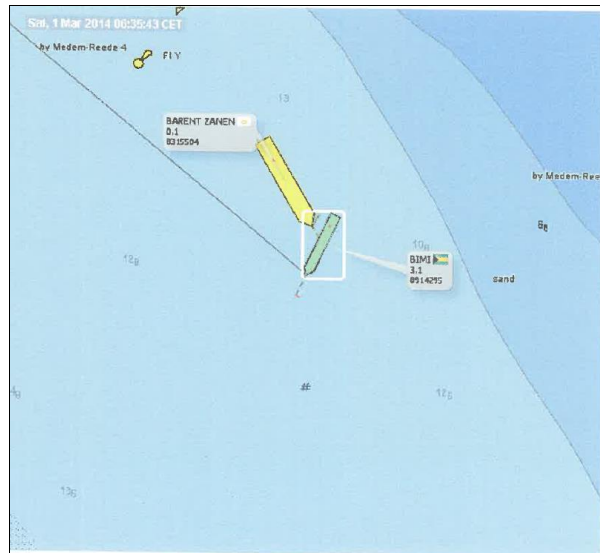
Figure 8: AIS 063534, collision

According to the AIS recordings, the BIM I starts to drift at 0.7 kts at about 062135. At 063042, only 0.2 kts is measured. It is possible that the effect was caused by the use of engine and bow thruster or the anchor still on the ground. However, according to statements given, the engine did not start until 0634. At 063214, the drift had already reached 3.1 kts. At 063434, the drift peaked at 3.4 kts. The collision occurs at 3.1 kts speed over ground at 063534 and the bow's turn to port is clearly visible. Evidently, there is contact with the BARENT ZANEN's anchor chain. After several attempts, the BIM I tried to separate and scraped along the anchor chain and port side of the BARENT ZANEN. It was not possible to start the main engine from 0645 onwards. According to statements given, the anchor was let go again at 0648. Nevertheless, the AIS recordings indicate that the BIM I's drift had reached 4.3 kts at 070022. The anchor gripped at 070022. The drift is measured at 0.3 kts.

HDG 206°, COG 309.9°, SOG 3.1 kts

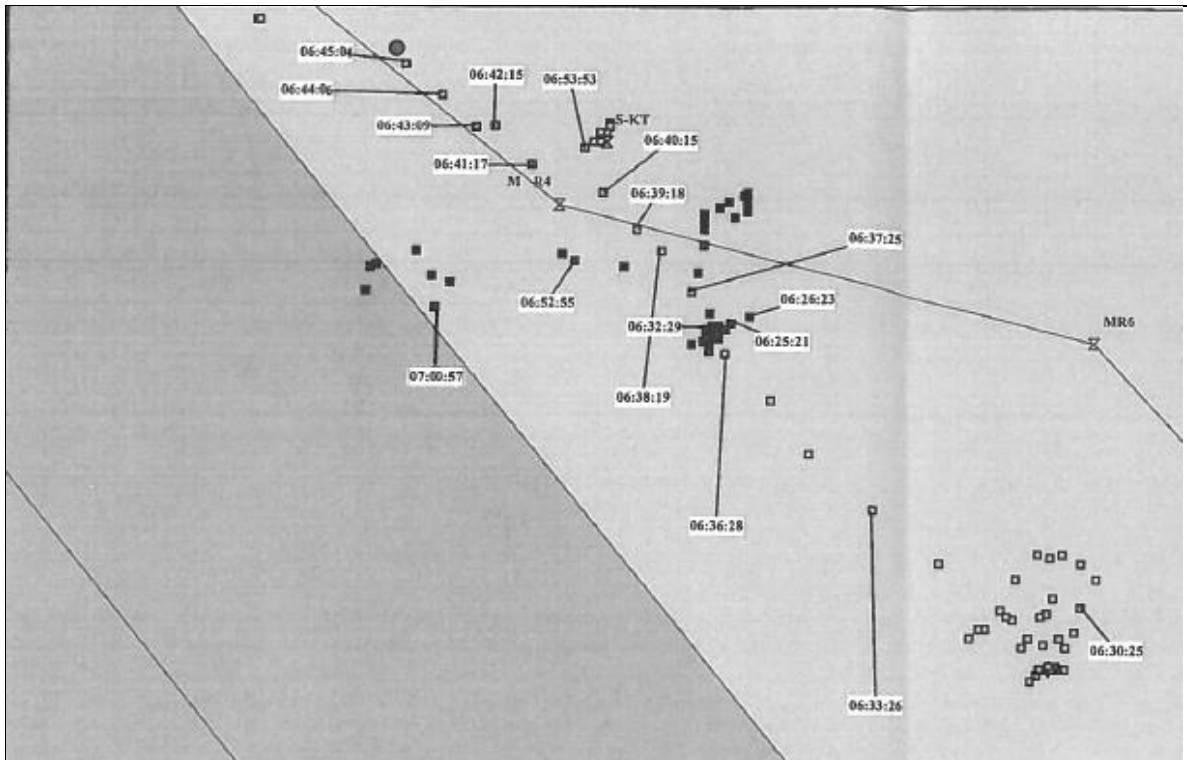
Figure 9: VTS radar plot, collision 063628, COG = 322°, SOG = 2.6 kts, maximum drift = 3.8 kts

The radar measurements show significant movements at the BIMI's anchorage.

The BIMI collided with the suction dredger BARENT ZANEN in the Medem roadstead in dense fog because her anchor lost its grip, the main engine was not ready on time and later failed, as well as because of the strong maximum drift of 3.8 kts, as measured by the VTS radar system. No attempt was made to stop the drift by letting go the second anchor or deploying additional chain length. Instead, attempts to start the engine as quickly as possible were made in vain. It was reportedly not ready to start until two minutes before the collision at 0634 and because of its late use was ineffective in terms of preventing the vessel from scraping along the anchor chain and port side of the BARENT ZANEN, however. The advising Elbe pilot responded with a "No" when the master suggested the deployment of additional anchor chain when the vessel was drifting. He relied on information that the engine would reportedly be ready for use in ten minutes. Unusual for the weather conditions, the swaying was observed shortly after the change of watch at 0600. The BIMI was damaged on the superstructure, deck, and screw during the collision. The BARENT ZANEN had abrasions on the shell plating and a drain pipe was damaged. No pollutants escaped.

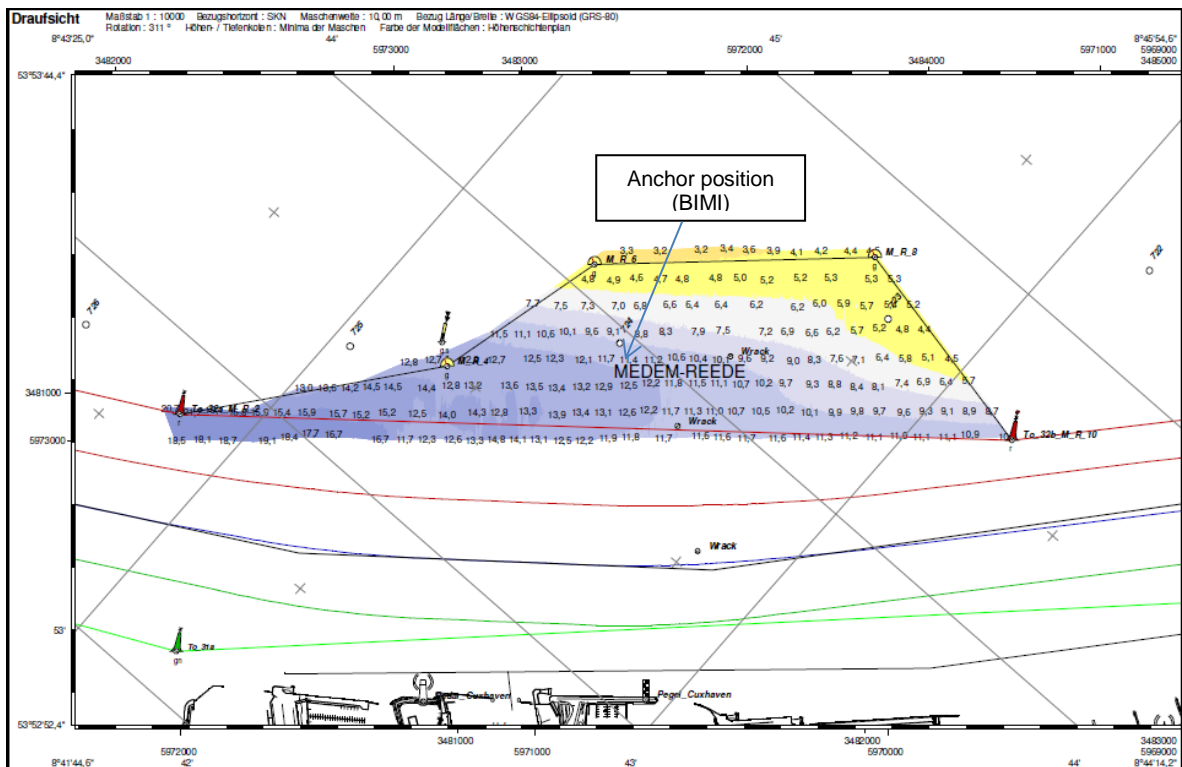
Figure 10: Sounding chart of WSA Cuxhaven dated 14 February 2014

The BIMl is located at a water depth of 11.6 m (echo sounder measurement of 6.1 m plus draught of 5.5 m). The measurement is consistent with the sounding chart.

A total of two vessels were located in the anchorage area and there would still have been room in the south-eastern area of the roadstead on the 10 m line (see Fig. 10, sounding chart). Inasmuch, a greater and in relation to the direction of the current more offset distance to the BARENT ZANEN could have been selected to reduce the risk of collision in the event of drifting. However, the BIMI's only anchor manoeuvre was carried out properly. The distance to the BARENT ZANEN was originally 3 cbl and four shackles of chain length were deployed. At a chain length of 25 m/shackle, about 100 m of chain length were deployed. The water depth at the BIMI's anchor position was about 11.5 m and as a rule of thumb the chain length deployed should be 5-6 times the water depth, i.e. about 60-70 m. However, the anchor will hold only if both flukes of a stockless anchor are well embedded and the forces can spread over the anchor chain parallel to the anchor ground. It is likely that did not happened in the present case, possibly due to scouring (see sounding chart). Once the flukes twist in the anchor ground and the stockless anchor embeds itself at an angle instead of parallel, a vertical direction of pull occurs, which may cause the anchor to spin. The radar plot (see Fig. 9) indicates that the BIMI's anchor position was changing by the minute, until it started to drift with the current at 0631. This unusual swaying was observed on the bridge and attempts were made to start the engine.

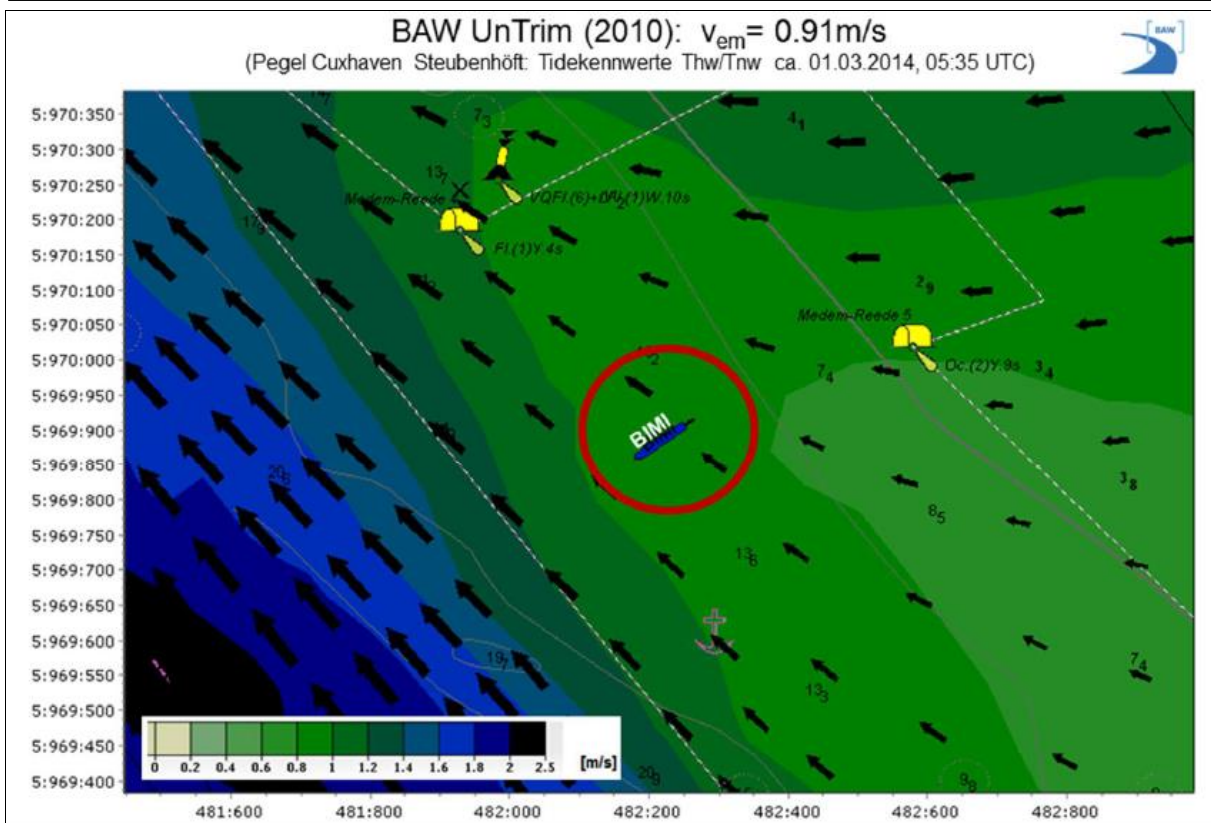
Figure 11: Current computation by the BAW

Hydrodynamic numerical computations using the latest model of the BAW (2010) reveal depth-averaged current velocities of approximately $v_{em} \gg 0.91$ m/s (approximately 1.8 kts) for similar water level conditions at Cuxhaven-Steubenhöft as on 1 March 2014 in the Medem roadstead about one hour before LWL. The wide-ranging current patterns computed for the drifting vessel BIMl (red circle) are illustrated in the following figure.

Since by the nature of things no measurements are available for 1 March 2014 and due to the natural morphological development of the Outer Elbe in the area of Klotzenloch – Kratzsand – Medem Channel, it is not possible to make far-reaching conclusive statements about the current patterns in the Medem roadstead at the time of the accident.

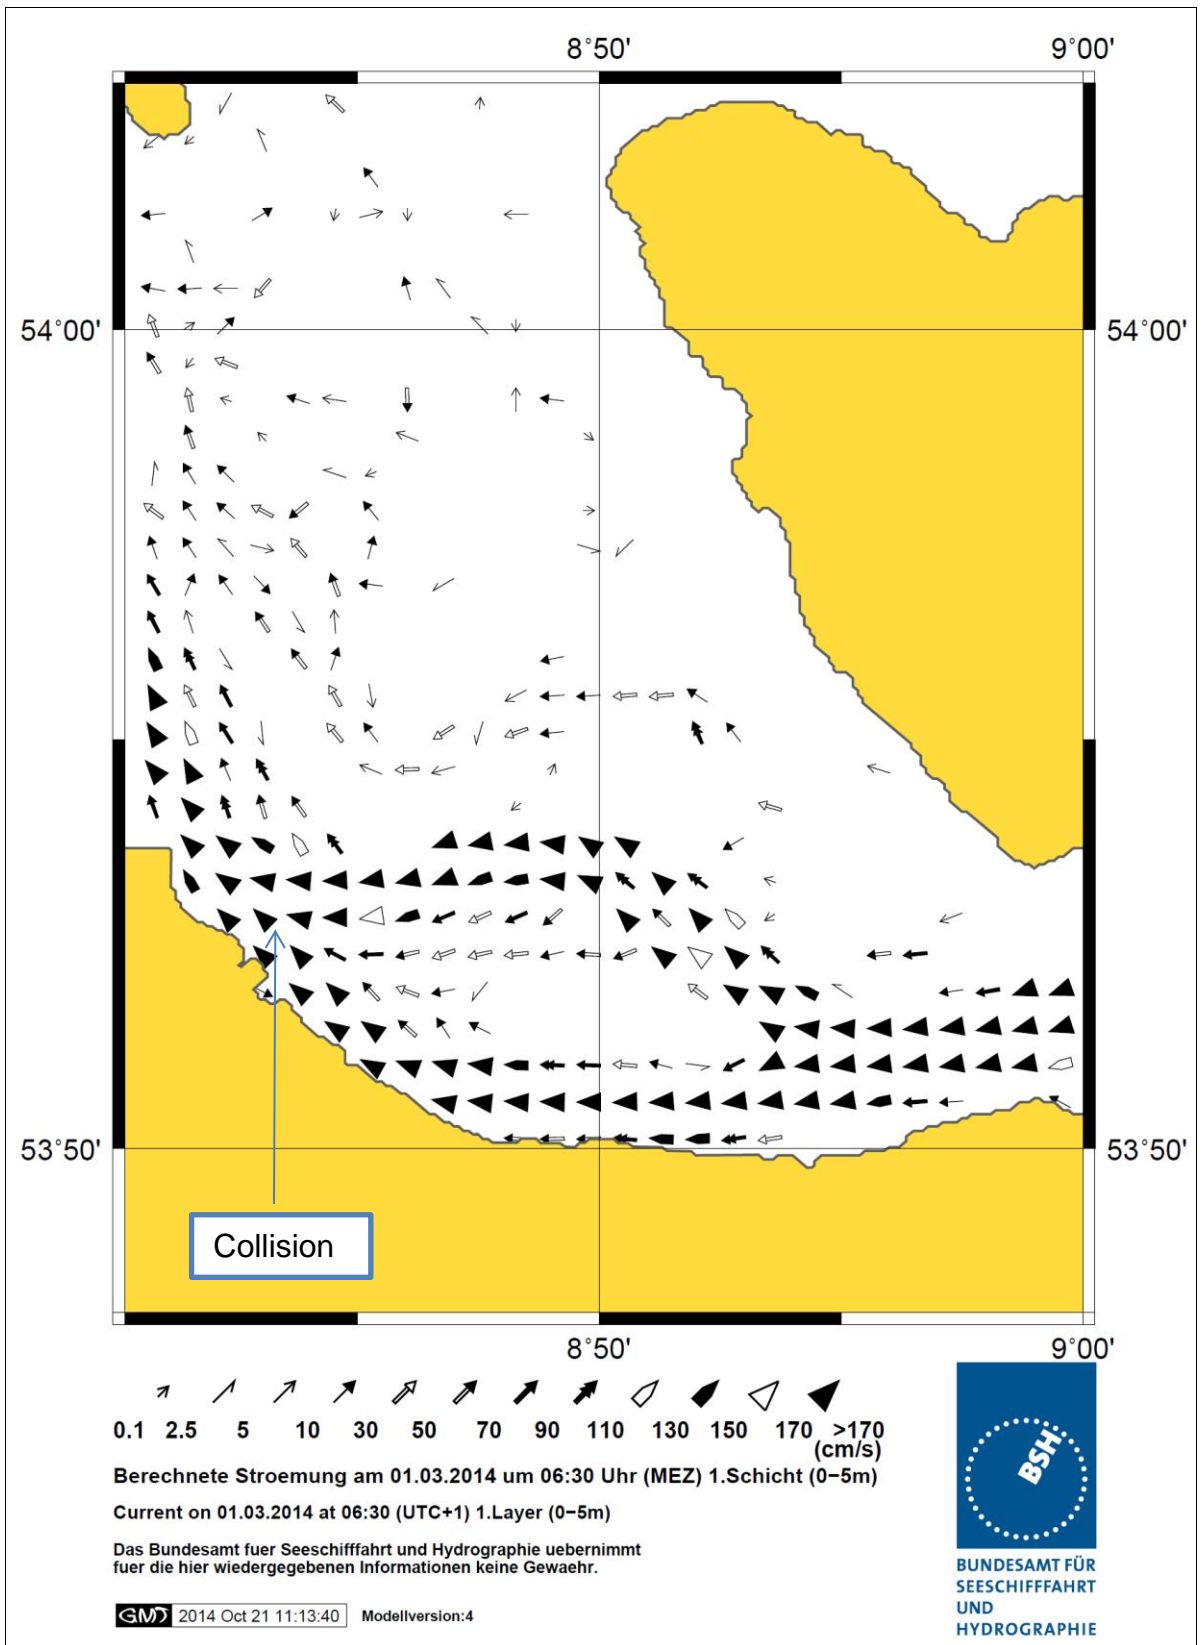
Figure 12: Current computation by the BSH

Since it is not possible to read the current velocities in the chart accurately, the simulated current is extracted at two positions and displayed in a time series in tabular form. The positions selected relate to the anchor position of the BIMBI and the collision with the BARENT ZANEN's anchor chain. The near-surface current corresponds to the column 1.8 m dep. The velocities are in knots and the direction data are the direction of the water's flow. Accordingly, the current is setting to NW if 315° is specified.

If we consider the current at 0515 UTC, for example, it is 2.66 kts at the position of the BIMBI and 3.52 kts at the position of the BARENT ZANEN. As is already evident from the chart, strong current gradients are simulated in the area. Since the bathymetric data in the current model are not up-to-date (from 2006) and it can be assumed the model also contains other inconclusive data, the current velocities of > 3 kts, as derived from the drift velocity of the BIMBI on the morning of 1 March 2014 in the Medem roadstead, can be regarded as completely realistic.

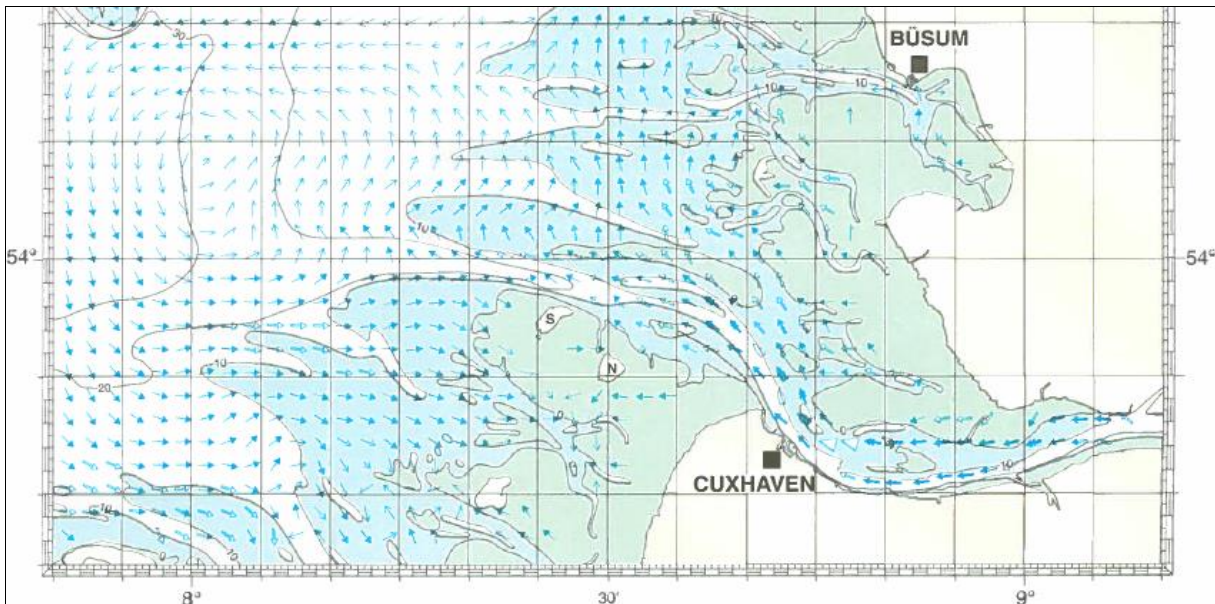
Figure 13: Excerpt from Tidal Atlas 2348

The Medem roadstead is known among pilots as an unsafe anchor ground. Towards the fairway, the anchor ground reportedly consists of firmly compacted sand, fine sand and finally sludge then follow further towards the middle. As can be seen from the sounding chart, the bottom is uneven and the current can set at up to 5 kts. This local knowledge of the pilots is not shown in the official nautical publications. Moreover, the current forces in the 'Der Küstennahe Gezeitenstrom in der Deutschen Bucht' (inshore tidal streams in the German Bight) atlas issued by the BSH (No 2348; see Fig. 13), for example, are not specified accurately enough if the grid resolution is too coarse.

The current arrows finish here at current forces of greater than 3.4 kts. This atlas is referenced in the sailing directions of the BSH (No 20061). Also indicated is that the incoming current occurs one hour and 40 minutes after the occurrence of local low tide and the outgoing current one hour and 30 minutes after the occurrence of local high tide. Here, the ebb current velocity is greater than the flood current velocity. It is stated that the Medem roadstead can be used for vessels up to 140 m in length, cargo handling, bunkering, and vessels carrying dangerous cargo. A note under 'Characteristics' contains a warning that swaying can occur in the fairway. There is no information about the anchor ground. The values of 1.8 and 2.7 kts calculated in the computational models of the BAW and BSH at the BIMI's anchor position are too low and do not reflect the values of up to 3.8 kts actually measured using VTS radar and AIS chain or the drifting BIMI with anchor deployed. Merely at the position of the BARENT ZANEN, the BSH model only calculated 3.52 kts at 0615. It should be noted here that, as indicated, no up-to-date data or measuring instruments were available in either model. Depth-averaged data were calculated at the BAW. They do not reflect the BIMI's draught of 5.5 m.
