Bundesstelle für Seeunfalluntersuchung
Federal Bureau of Maritime Casualty Investigation
Federal Higher Authority subordinated to the Ministry of Transport
and Digital Infrastructure

Summary
Investigation Report 06/14

Serious Marine Casualty

**Grounding of the MV MERITA in the
port of Rostock on 9 January 2014**

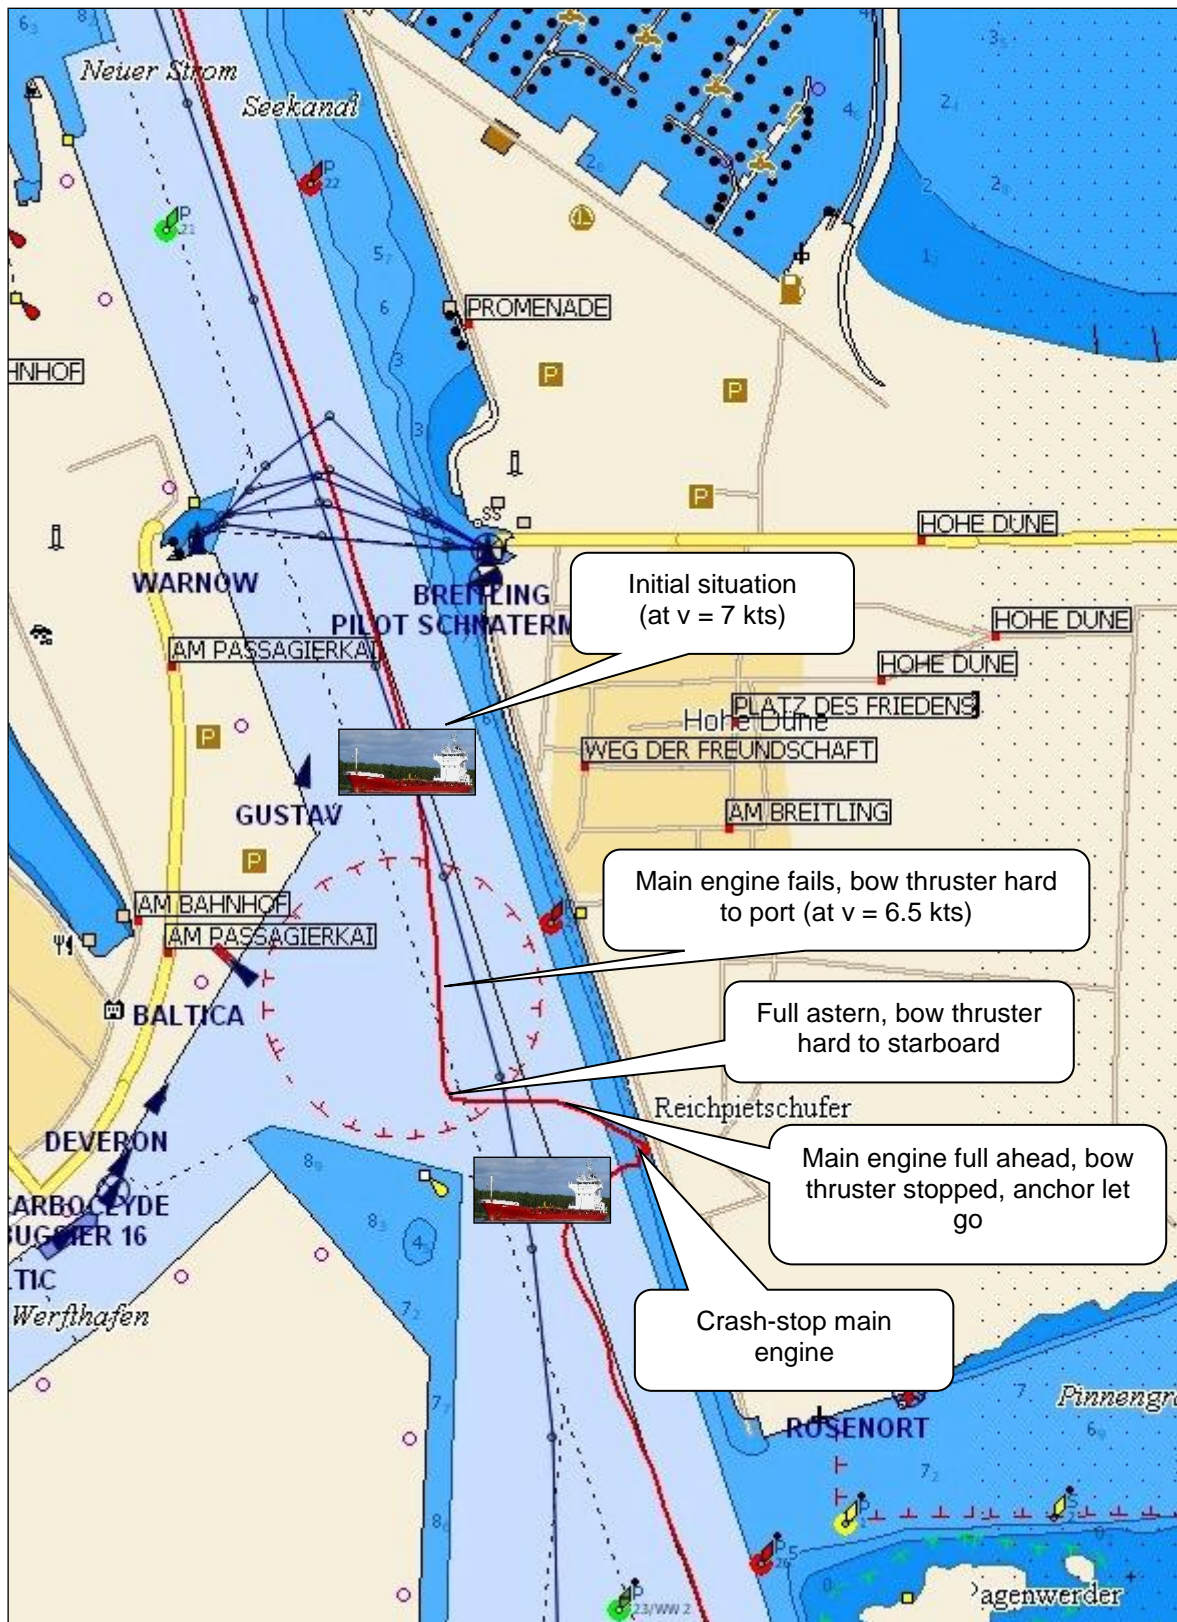
Figure 3: Course of the accident on the S-VDR

The MV MERITA, sailing from Skulte in Latvia to Rostock in Germany, was fully laden with wood. She reached the sea canal to the port of Rostock on the evening of 9 January 2014. At 2050, the pilot boarded and took charge of advising the ship's command. When the passenger pier was passed at 2120, the ship began to turn slowly to starboard. Following that, the pilot recommended that the speed be increased slightly to improve the manoeuvrability of the ship. The chief mate executed this on the engine telegraph. After a few seconds passed by without any response, the pilot said that the bow thruster should be operated hard to port. The MV MERITA's speed stood at about 6.5 kts and she continued to turn to starboard. To prevent a collision with the pier there, the pilot ordered full astern. At the same time, he informed VTS Warnemünde about the incident on VHF. Several seconds later, the bow thruster was set to hard to starboard. The speed ahead dropped continuously but the rate of turn to starboard increased. When the bow was at an angle of roughly 90° to the actual heading line, the pitch was set to zero. There was still no response from the engine, however. The starboard anchor was then dropped and the emergency stop switch pressed (see Fig. 3).

The anchor did not grip, resulting in the stern grounding on the eastern bank of the sea canal at 2124. Two tugs had to be ordered, which then pulled the ship free and towed her to the next berth.

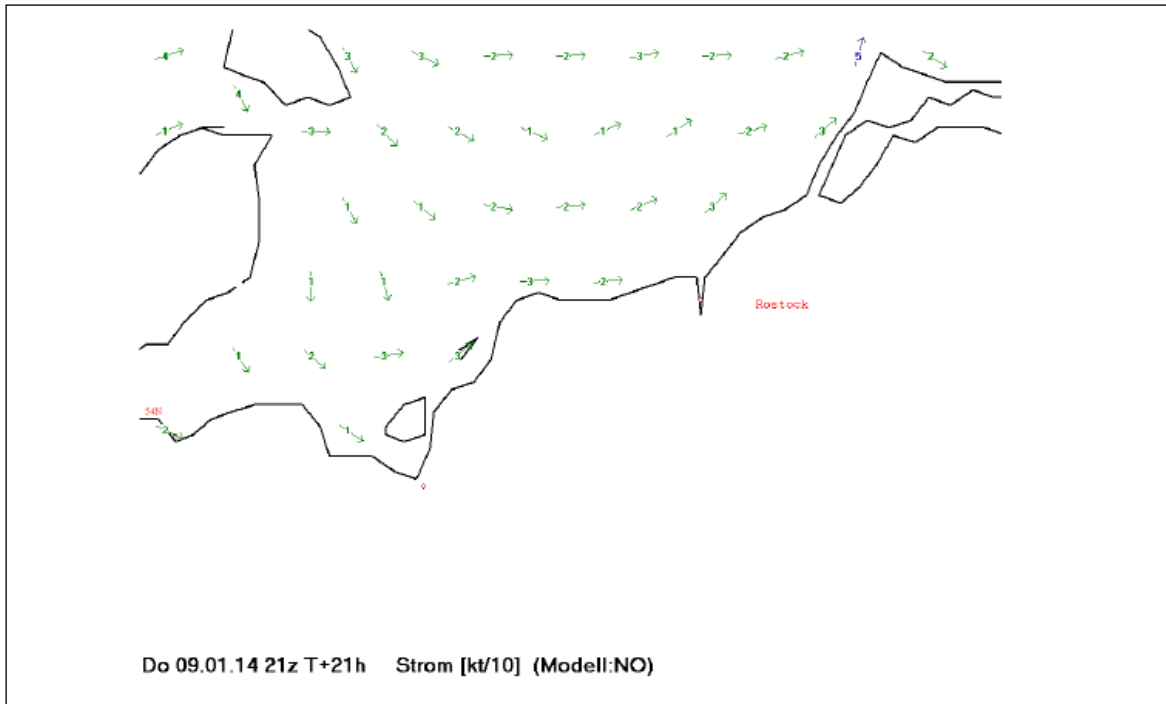
Figure 5: State of the current at the time of the accident

The mean current velocity in the area of the accident was initially 0.1 knots in the layer between 0 and 5 m and increased to 0.3 knots from the west to south-west (Figure 5) at the time of the accident.

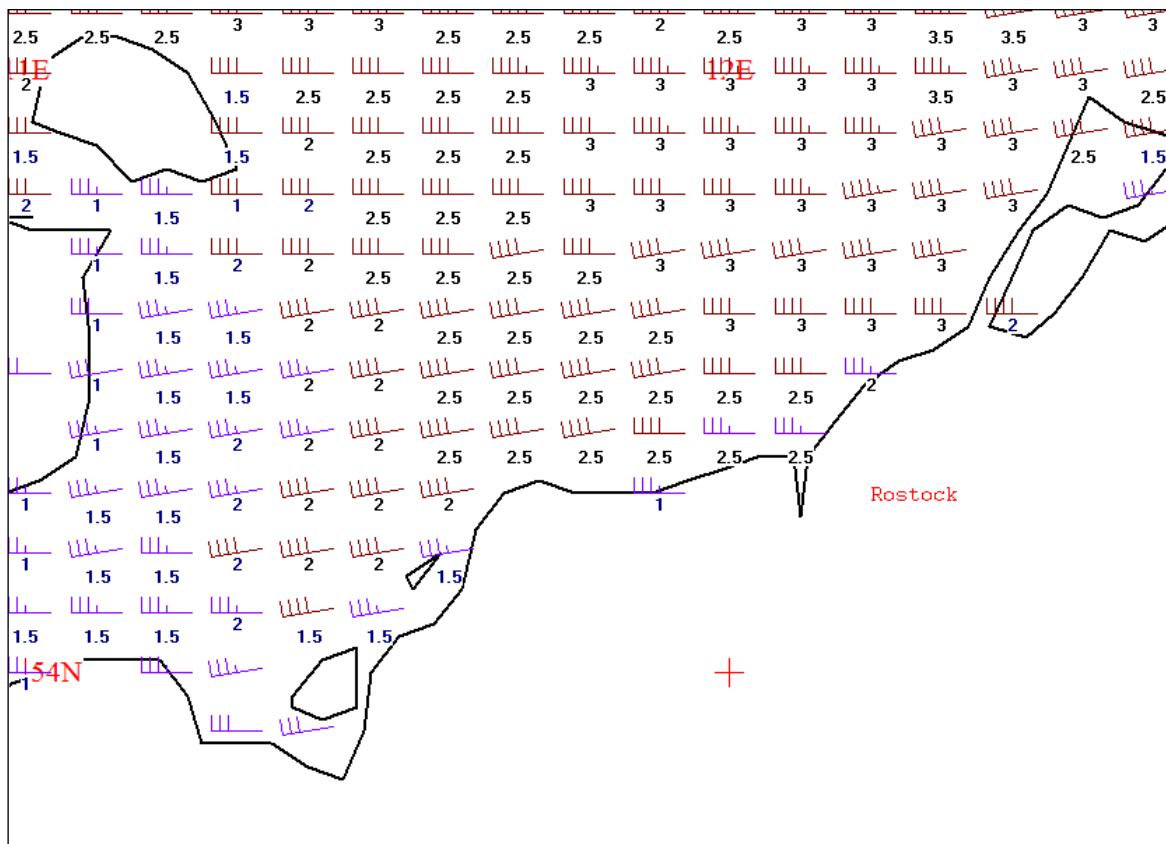
Figure 6: State of the wind at the time of the accident

Here, wave heights of 1.5 to 2 m with south-westerly mean winds of 6 Bft were predicted for the time of the accident. According to the enclosed forecast, the wind was predicted to turn westward with wave heights amounting to 2.5 m (Figure 6) as early as 2100 UTC.

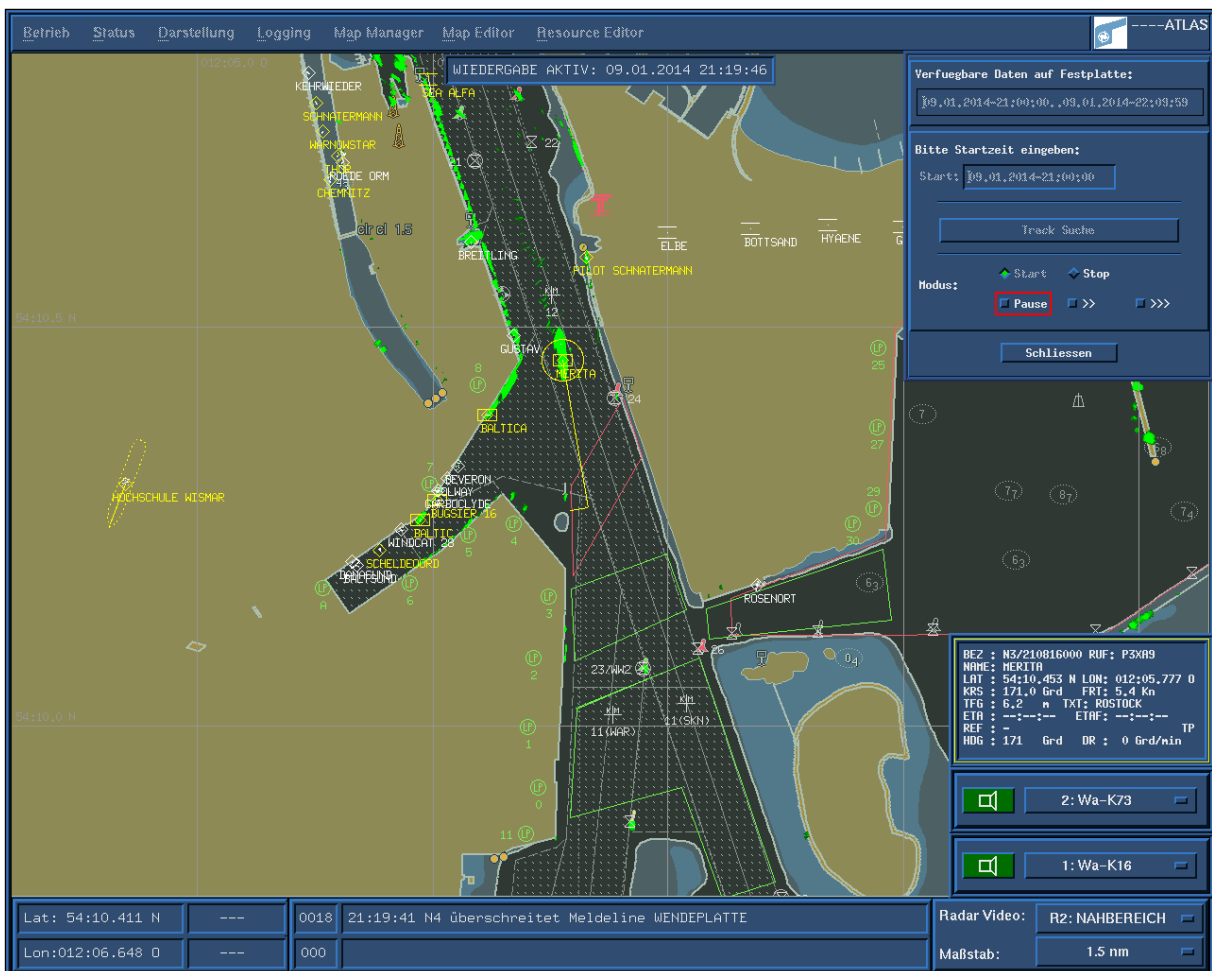
Figure 7: Radar image at 211946

Figure 7 shows the point at which the ship started to turn to starboard. Figures 8 and 9 show the course of the voyage when the ship did not respond to the engine commands. MV MERITA finally grounded on the eastern bank at 2124, as shown in Figure 10.

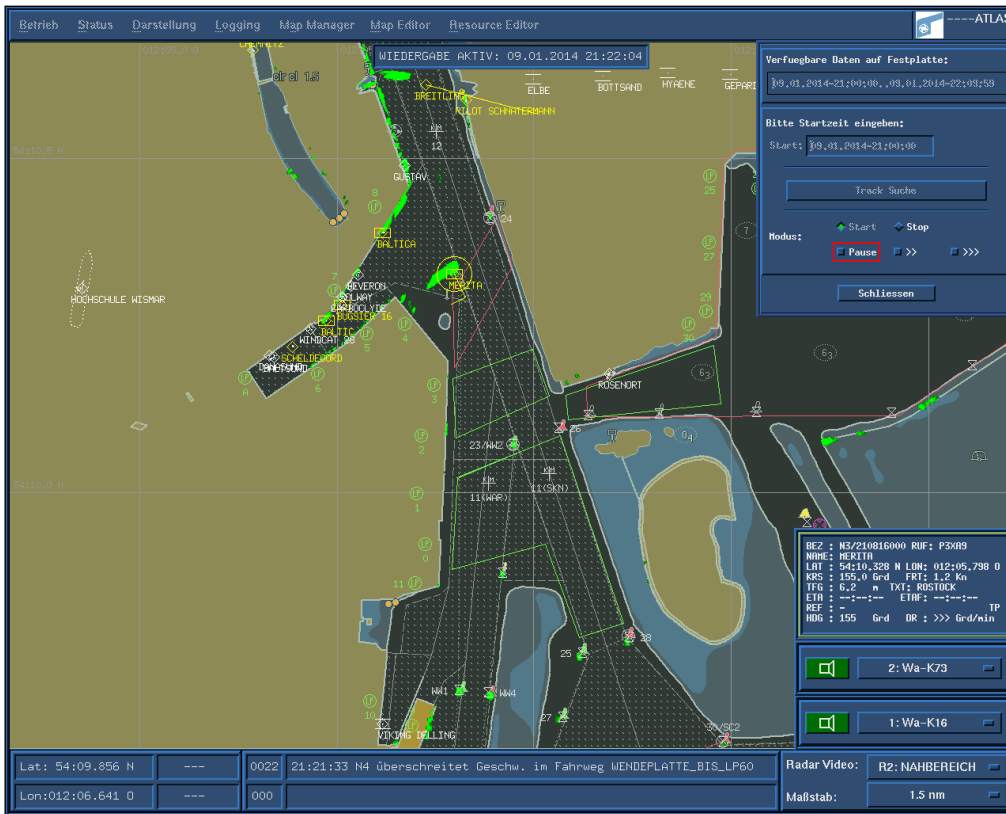
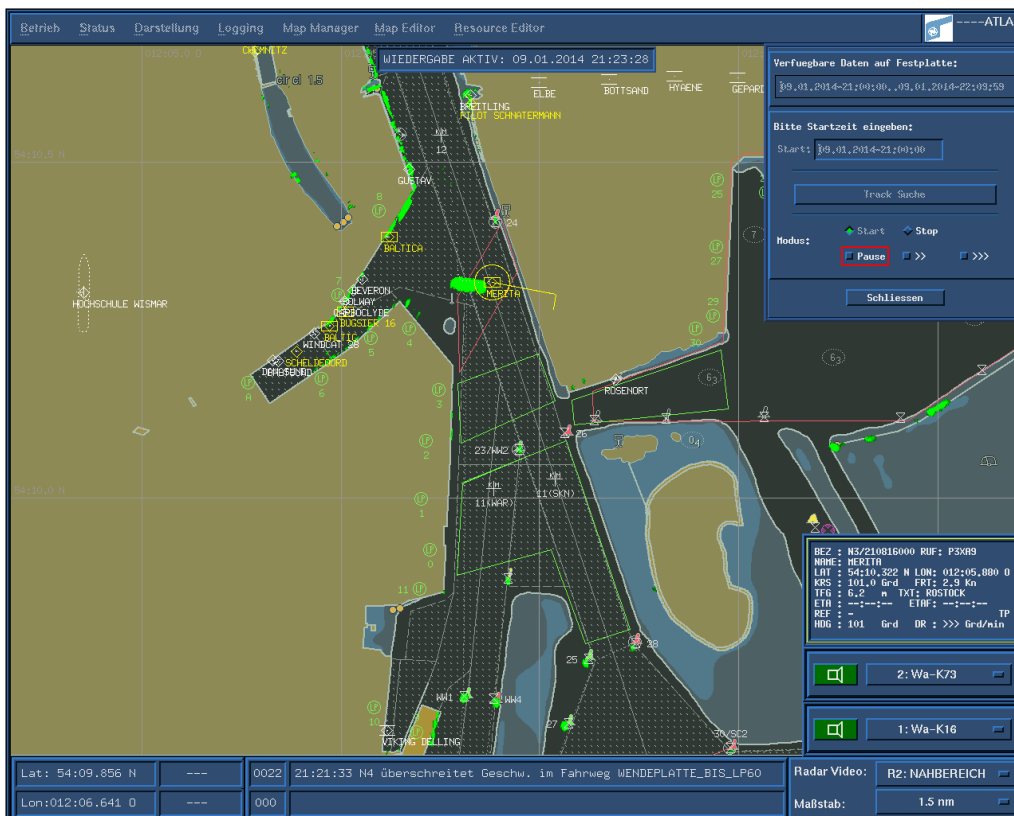
Figure 8: Radar image at 212204

Figure 9: Radar image at 212328

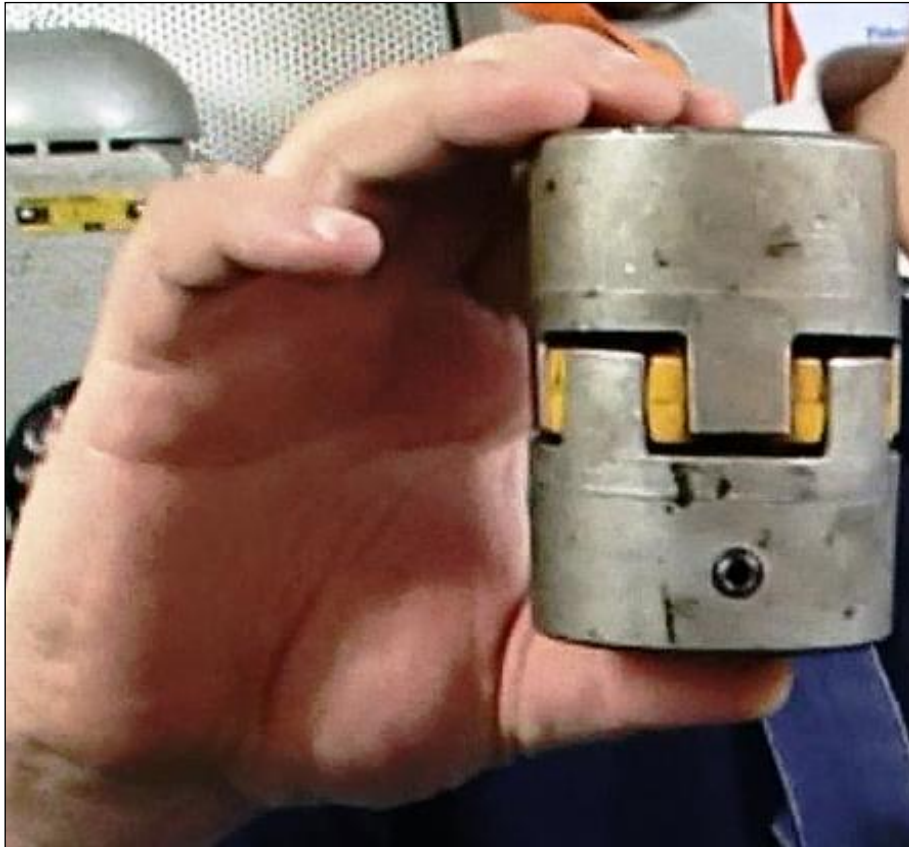
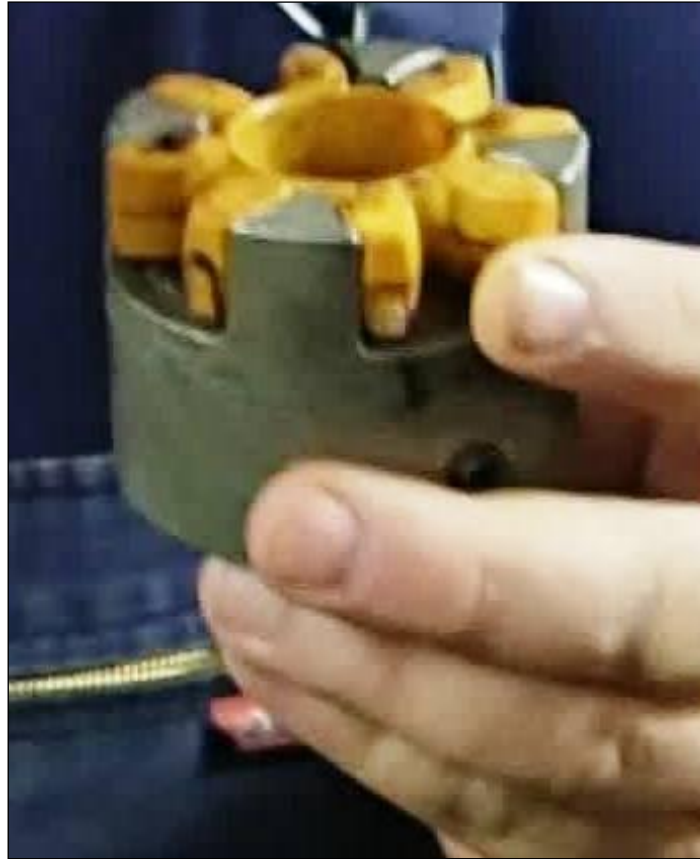
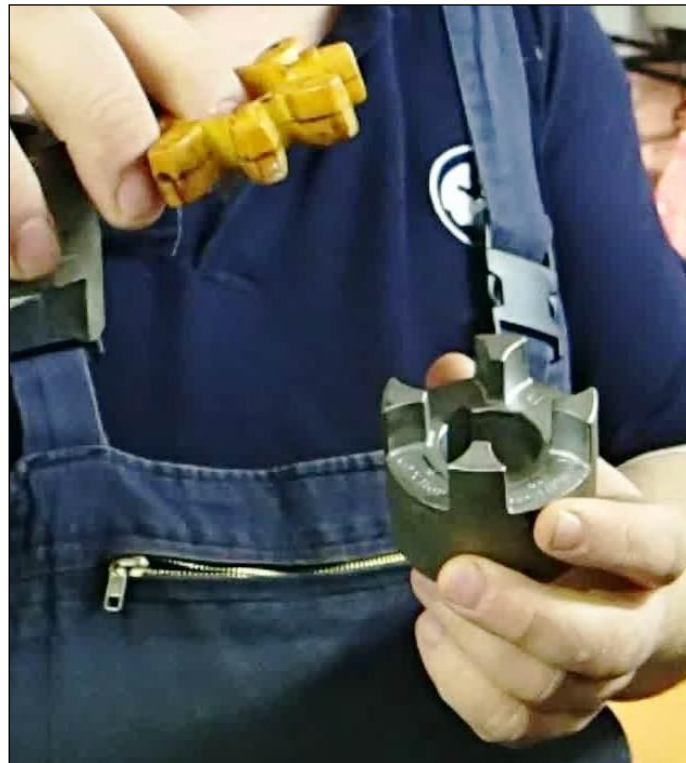
It was finally the chief engineer who explained the reason for this in the engine control room (ECR). Two hydraulic pumps drive the CCP system. One runs continuously and the other is on standby. Each pump has a coupling between its motor and the rotor blades. This coupling consists of a metal cap and plastic insert. The purpose of the plastic insert is to absorb vibrations until it is mechanically worn out (see Figs. 11 to 13), when it should be renewed.

Figure 11: New intact coupling

Figure 12: Section of coupling with plastic buffer

Figure 13: Section of coupling with plastic buffer removed

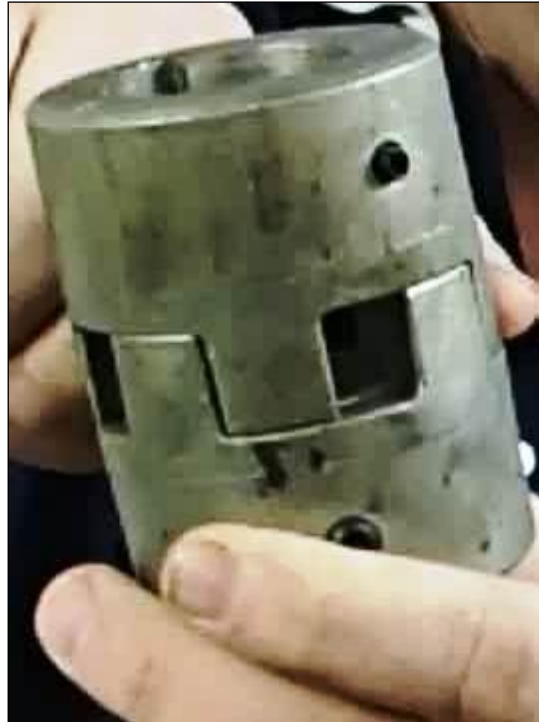
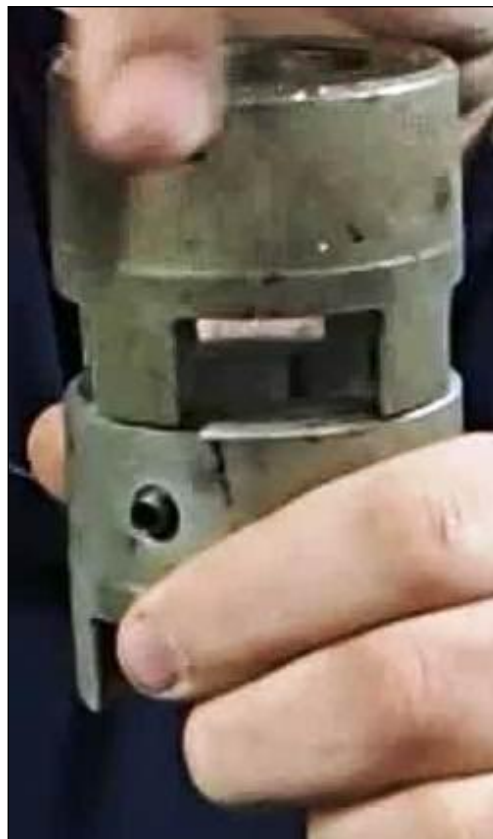
It appears this did not happen in the case at hand. Therefore, after the plastic had worn the metal cap also wore until the connections ran smoothly over each other (see Figs. 14 and 15). Consequently, the rotor blades stopped turning and the pressure in the system dropped. The second pump was actuated automatically but this needed a few minutes until the pressure in the system was sufficiently high again.

Figure 14: Coupling without plastic buffer

Figure 15: Coupling without metal cap

It was possible to determine the cause conclusively. The coupling of a hydraulic pump was worn out, thus interrupting the flow of power from the motor to the rotor of the pump. This caused the CPP system to fail and the ship's command suddenly had no influence on the speed of the ship. The MV MERITA's stern was already grounded by the time the second hydraulic pump had reached its full effect.

According to the ship's maintenance plan, this coupling was renewed in May of the previous year and was not due for inspection for another four months. Therefore, it must be assumed that this coupling did not meet the material standards and thus wore out long before it was scheduled to.
