Bundesstelle für Seeunfalluntersuchung
Federal Bureau of Maritime Casualty Investigation
Federal Higher Authority subordinated to the Ministry of Transport
and Digital Infrastructure

Investigation Report 99/13

Serious Marine Casualty

**Fire on the con-ro carrier
ATLANTIC CARTIER on 1 May 2013 in the Port
of Hamburg**

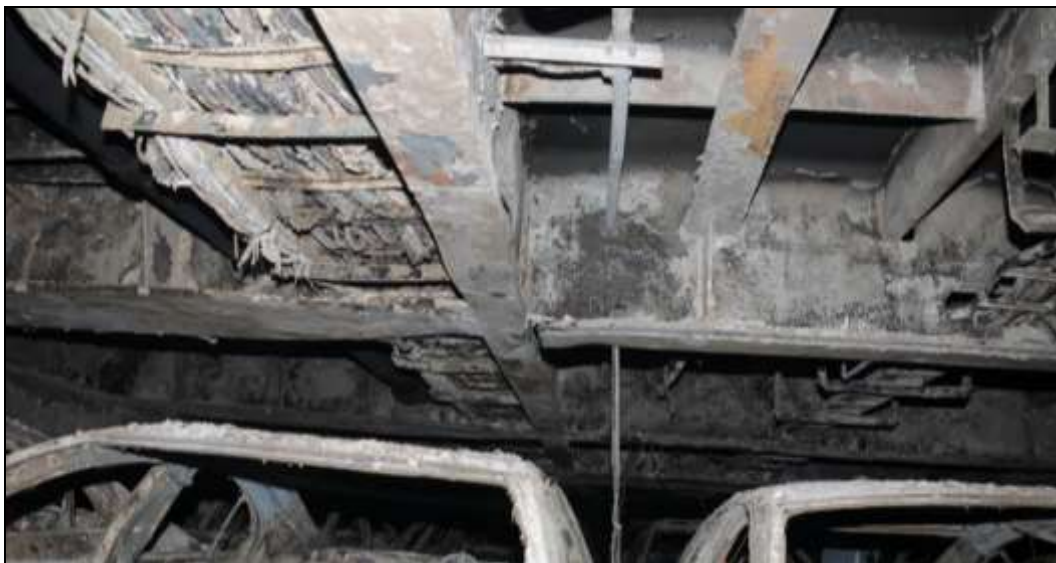
Damage to the ship was essentially limited to fire and heat-related destruction within the forward section of vehicle deck 3, which was primarily affected by the fire, where cable routing that runs along the ceiling was destroyed, supports were deformed, and paint was ruined, in particular (see **Figure 5**).

Figure 5: Effect of fire on the cargo hold ceiling and cable routing

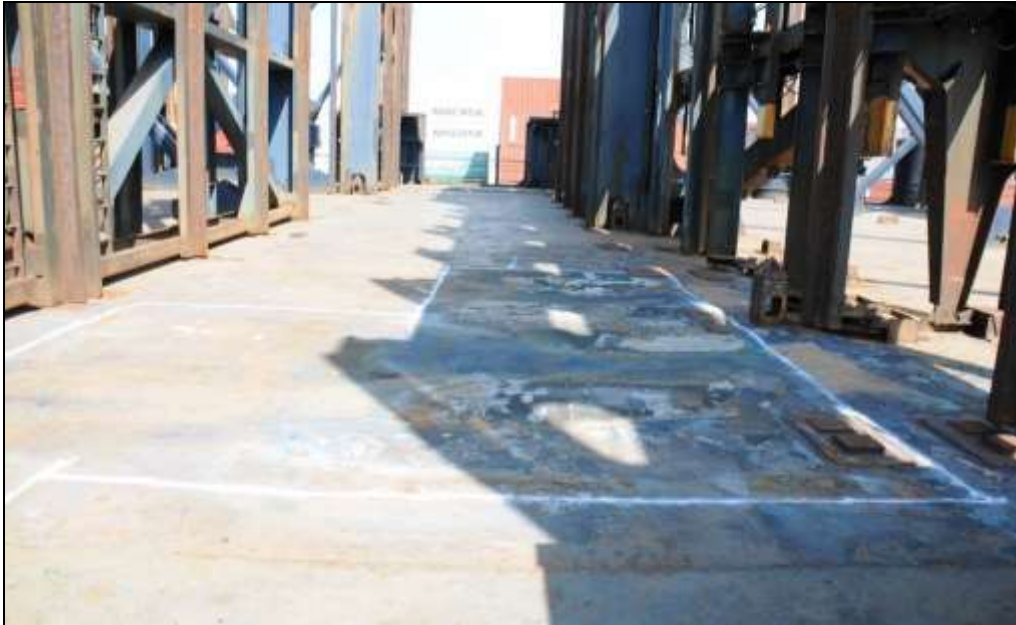
As a result of the immense heat radiation from the burning vehicle deck, parts of the floor of the main deck located above the seat of the fire were deformed (see **Figure 6** below). However, the cell guides installed on the main deck and also the ship's sidewalls were largely spared from the effects of the heat as a result of the cooling efforts, which were initiated immediately after the fire was detected and steadily intensified over the course of the other extinguishing activities.

Figure 6: Heat-induced discolouration and deformation on the floor of the main deck

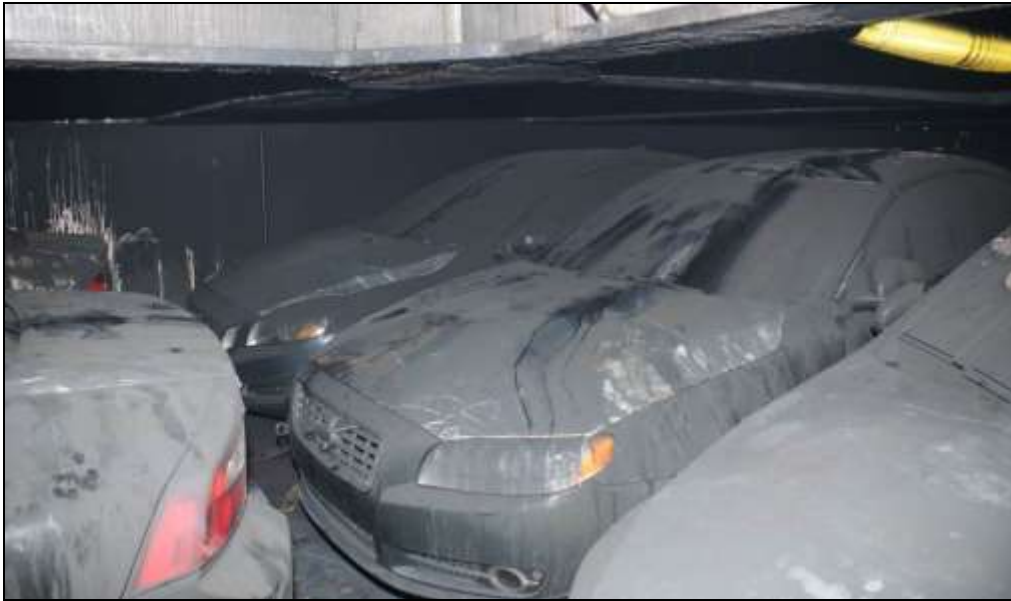
A total of 22 new cars stowed in the aft part of deck 3 B or in the other ro-ro decks affected by the fire only secondarily were so severely damaged by the build-up of heat and/or smoke or fouled by soot that they also had to be scrapped. Due to the damage caused, 38 vehicles could only be used for spare parts. The use of 194 vehicles could be continued after in some instances very extensive cleaning or minor repairs.

Figure 9: Cars severely fouled by soot

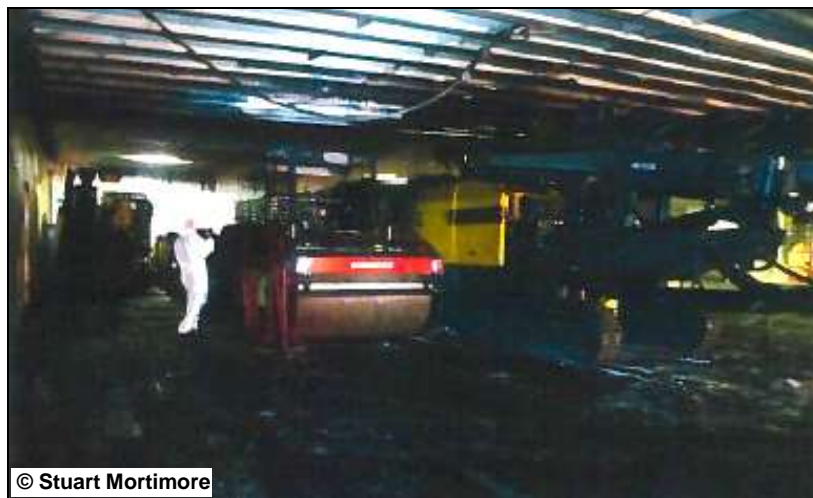
Several commercial vehicles, including a road roller, were stowed directly beneath the forward part of deck 3 B (i.e. on deck 3). The heat radiation emanating from deck 3 B damaged the commercial vehicles to varying degrees.

Figure 10: Damaged commercial vehicles on deck 3¹⁶

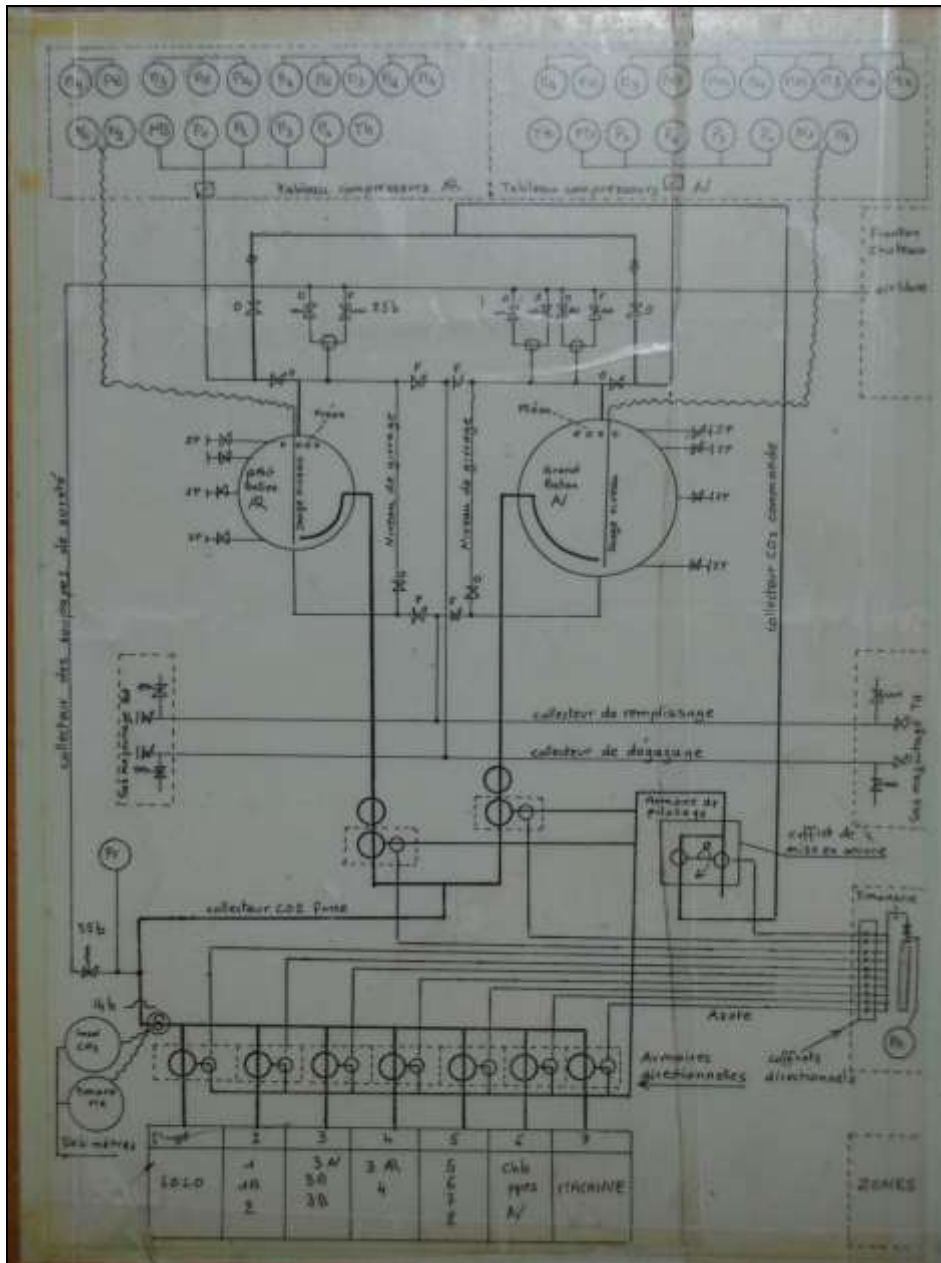
Deficiencies were found during the survey of the CO₂ control room with regard to the signs for the release components and other components of the CO₂ installation. The combination of the original French designations and information in English, as well as the attachment of handwritten notices and signs, some of which can only be placed with difficulty, constitute a problem in relation to a system as relevant to safety as the CO₂ extinguishing system.

Figure 30: Handwritten functional diagram of the CO₂ installation

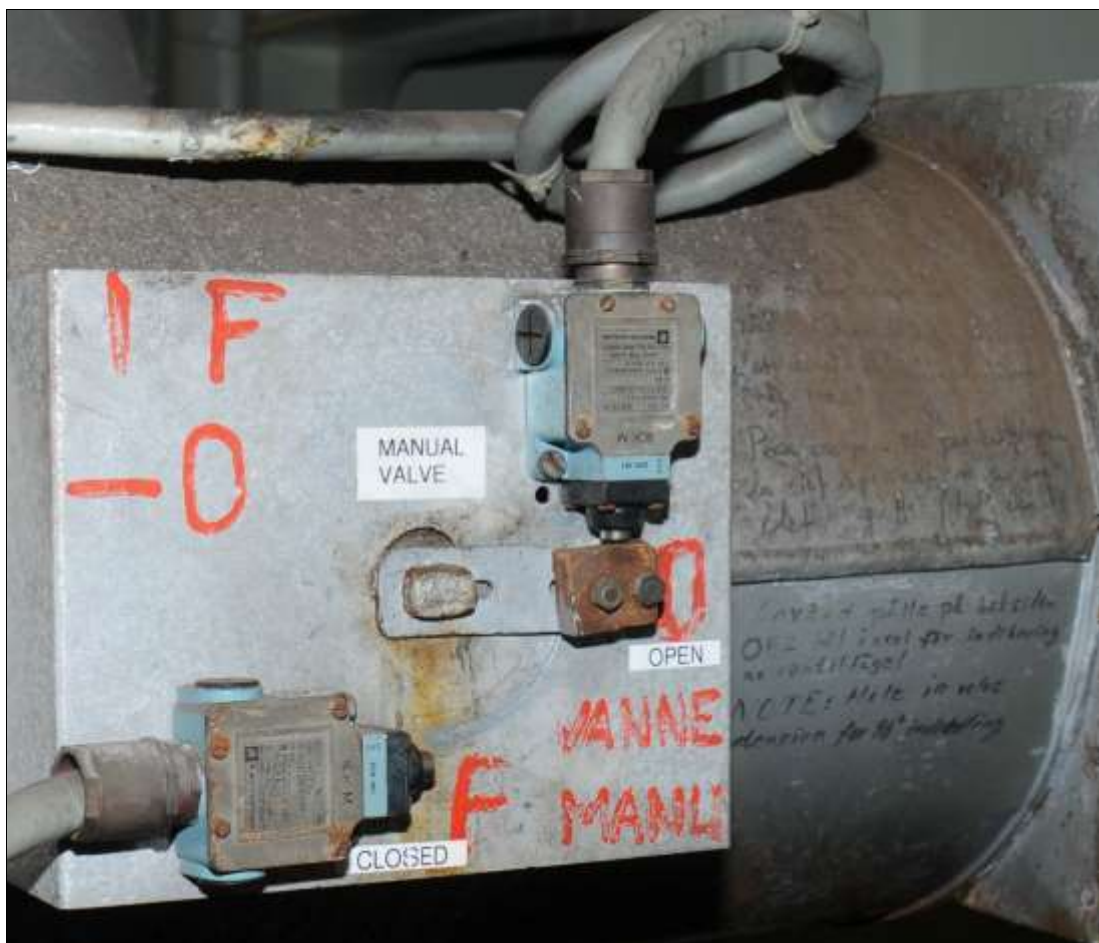
Figure 34: Main tank valve with handwritten operating instructions

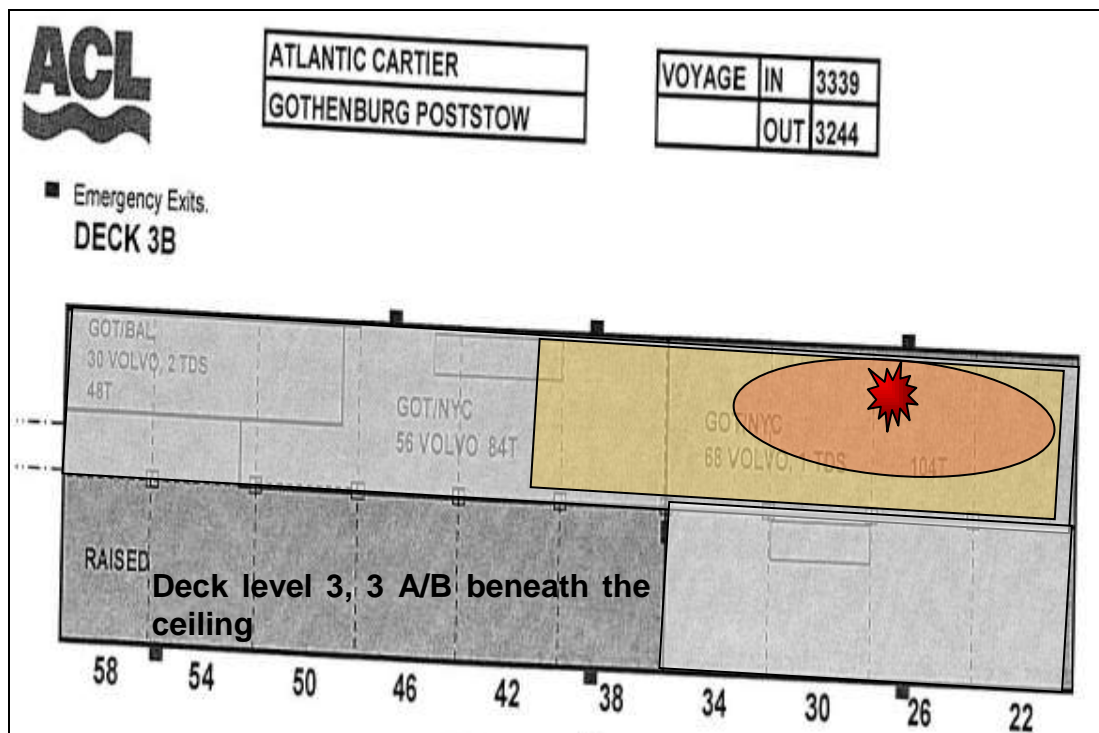
The damage on deck 3 B stretches to below the ceiling in the port area of the slots at bay 22 to bay 38. The area is limited on the port side up to the ships centreline. The starboard side was not loaded. The propagation of heat to the overlying deck 4 was apparent. When considering the extent of the damage, it is particularly striking that there was apparently no substantial fire damage outside the closed deck to the cargo on the upper deck, despite the fire developing rapidly.

Figure 43: Area of fire development (ro-ro loading plan)

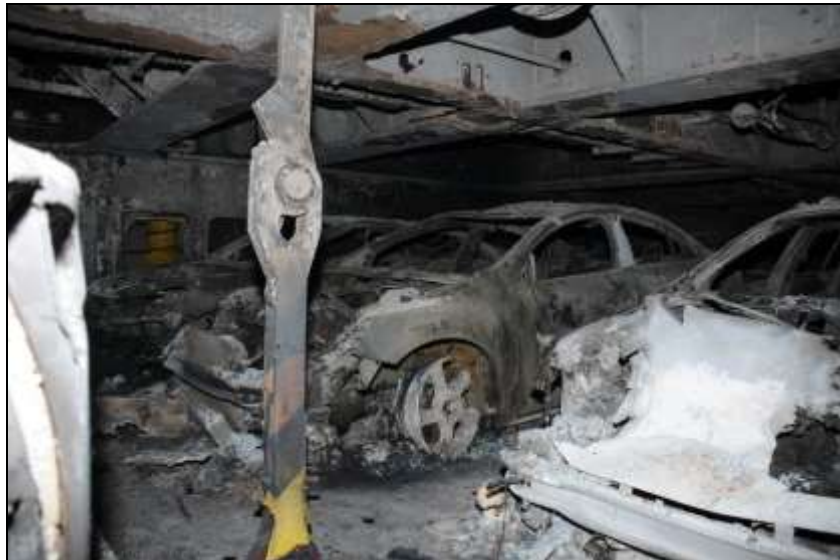
The fire damage on deck 3 B varies, spreading from the apparent seat of the fire in a circular pattern. Despite the relatively long and unimpeded spread of fire, the damage is extremely localised. From that it can be concluded that the fire reaches extreme thermal proportions over time in an affected car; however, the structural condition of new cars stops it from crossing to the adjacent vehicle for an extremely long period, even though the stowage distance is very low (less than 30 cm in places).

Figure 44: Apparent position of the seat of the fire (bay 26)

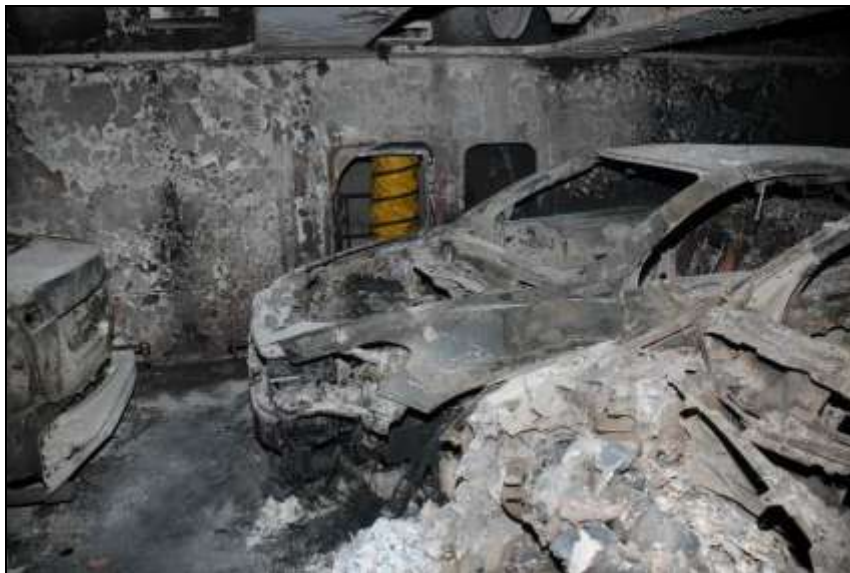
Figure 45: Position of the seat of the fire

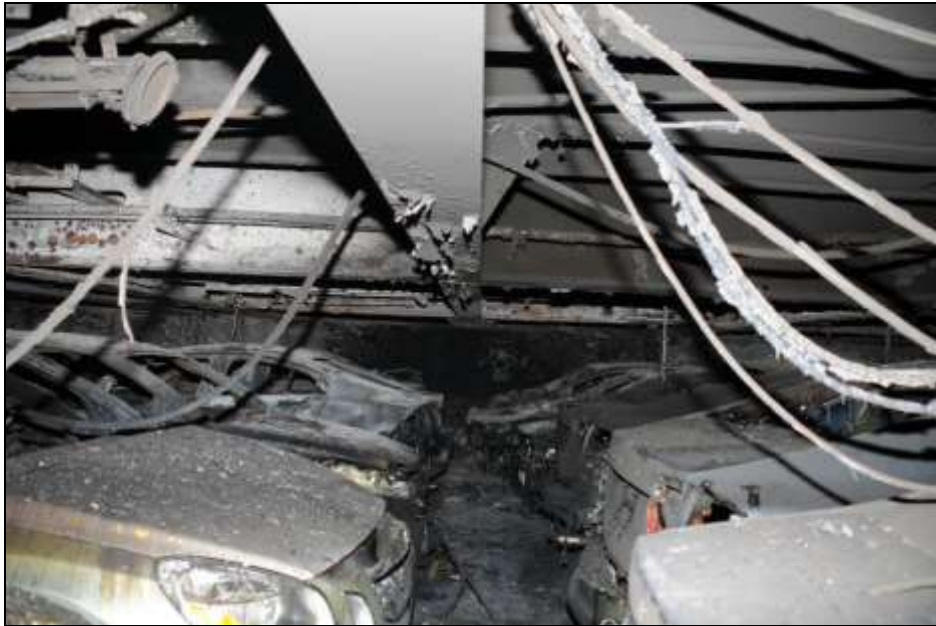
It is remarkable that the fire evidently stayed within a confined area in spite of the considerable intensity. It would seem that the accumulation of gases caused the formation of convective currents in the lower area, too. Due to extreme temperatures, most of the plastic parts on the vehicles and deck installations melted even in areas some distance away (distance of two to three cars), however.

Figure 47: Thermal stress on the deck's ceiling

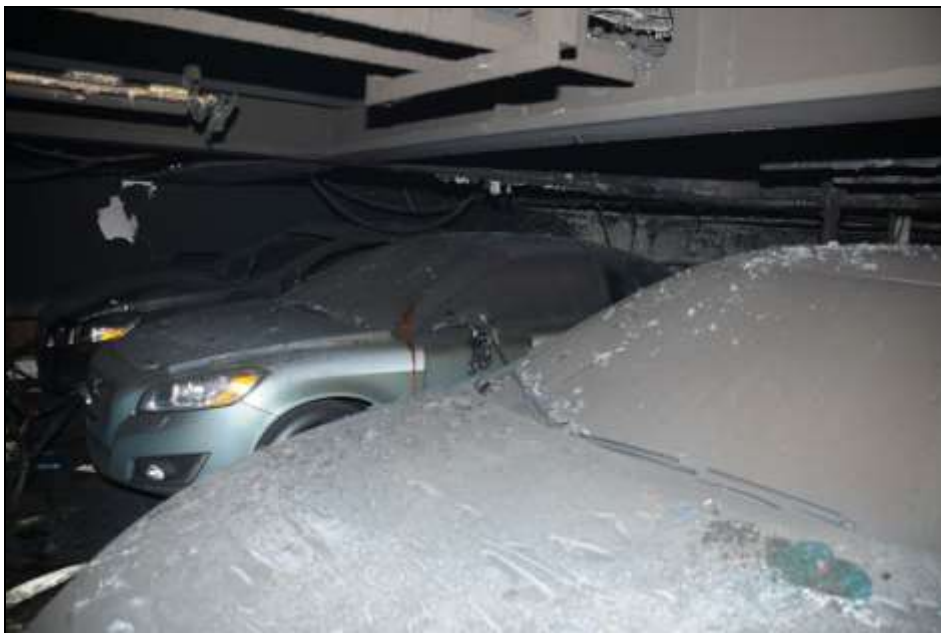
Figure 50: Various traces of damage to adjacent vehicles

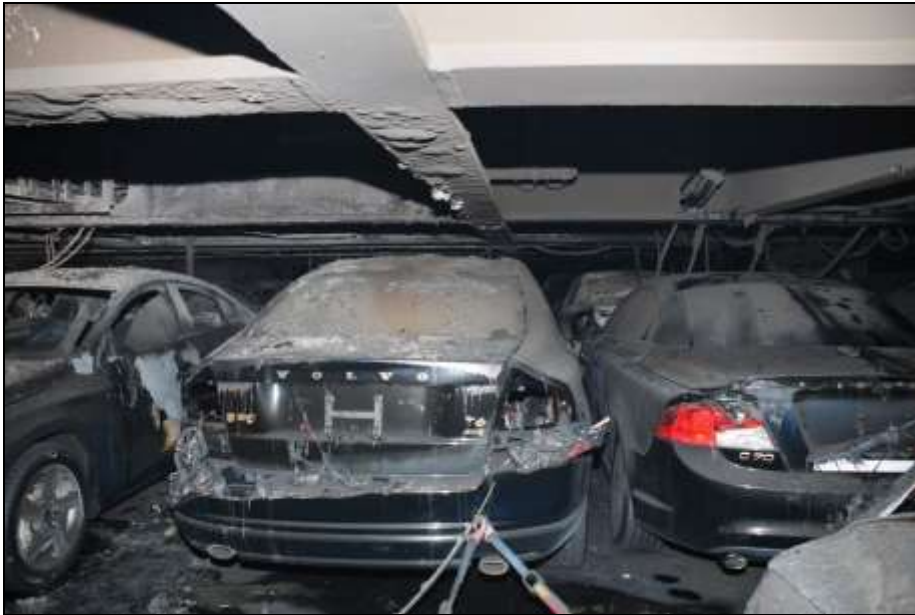
Figure 51: Destroyed plastic parts (in this case the rear lights) on the vehicles

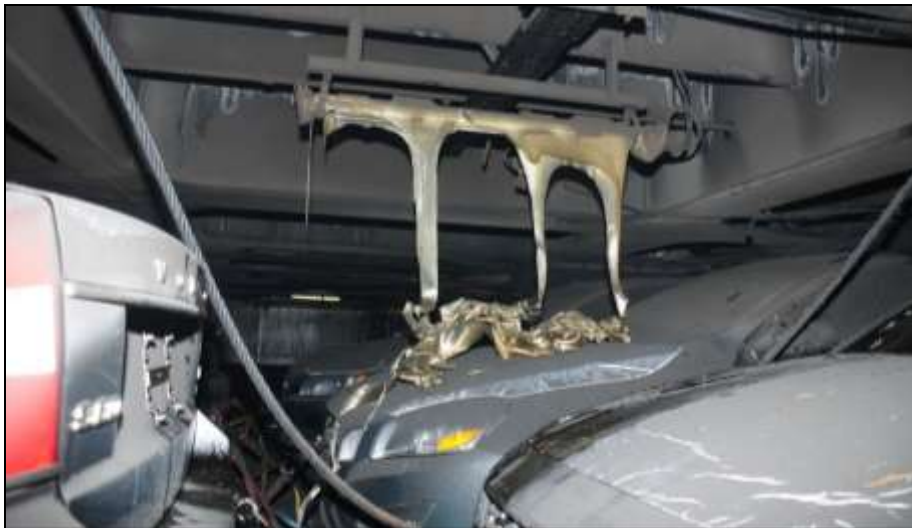
Figure 52: Plastic casing of a ceiling light melted by heat radiation

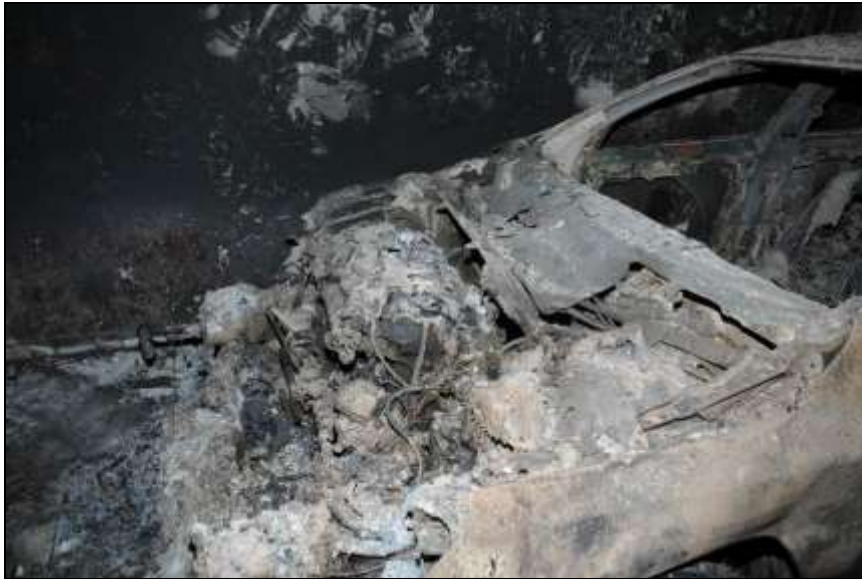
*Metal fires occurred on vehicles in the main fire zone. Occurring at extreme temperatures in excess of 1,000°C, these fires caused the damage found (see **Figure 55** below). Parts of the permanently installed CO₂ low-pressure system were also destroyed in the main fire zone.*

Figure 55: Engine compartment of a car destroyed by metal fire

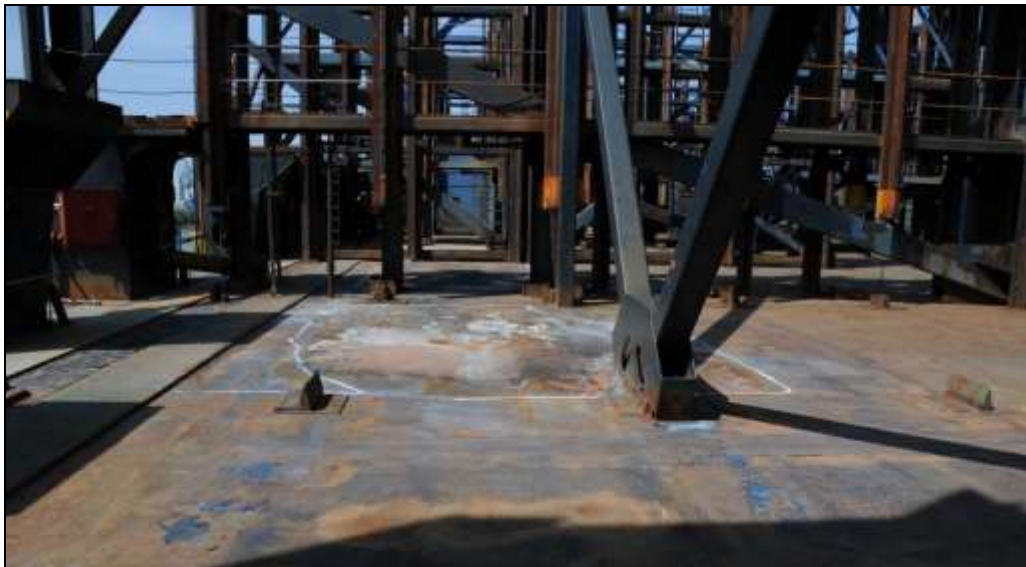
*On the main deck, warping occurred on the floor in the main fire zone. The paint is burnt in places (see **Figure 56**). It is apparent that there was no significant heat conduction vis-à-vis the cell guides on deck, however.*

Figure 56: Warped deck and fire damage in the area of bay 26

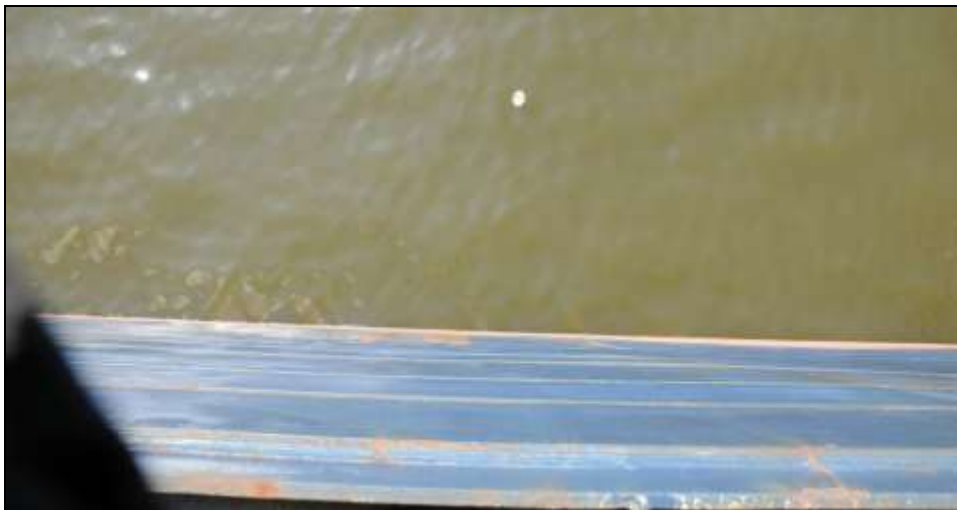
Furthermore, no thermally induced damage was found on the shell plating – not even in the main fire zone.

Figure 58: No thermally induced damage to the hull wall in the area of bay 26 (port side)

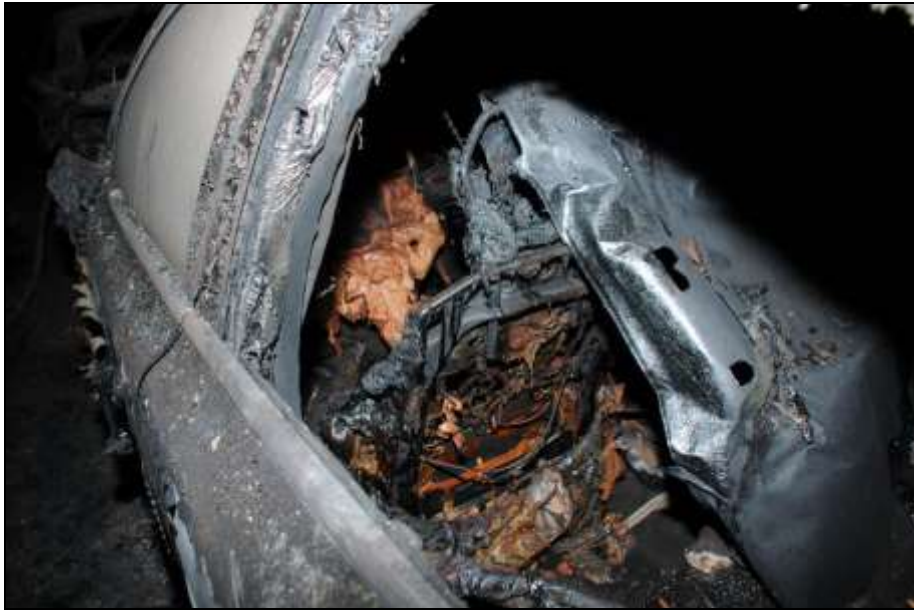
Figure 60: Fragments of a triggered air bag inside a car

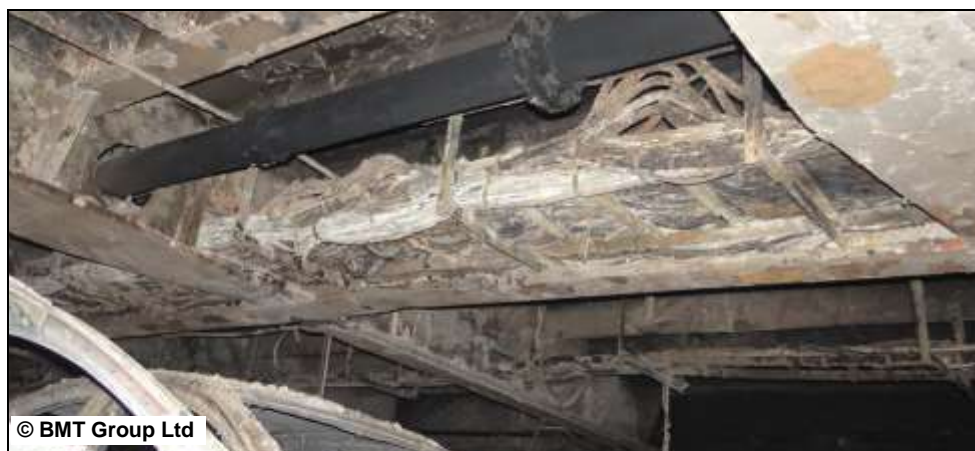
Figure 61: Cable splices on the ceiling of vehicle deck 3 B³⁴

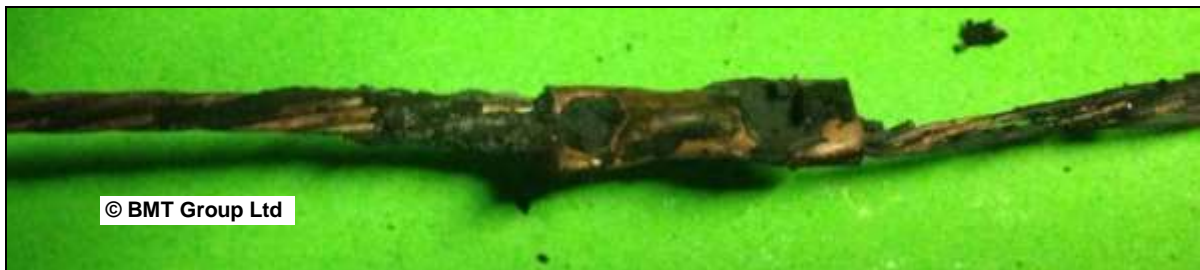
Figure 65: Cable splice with inconsistencies in respect of diameter and number of conductors³⁸

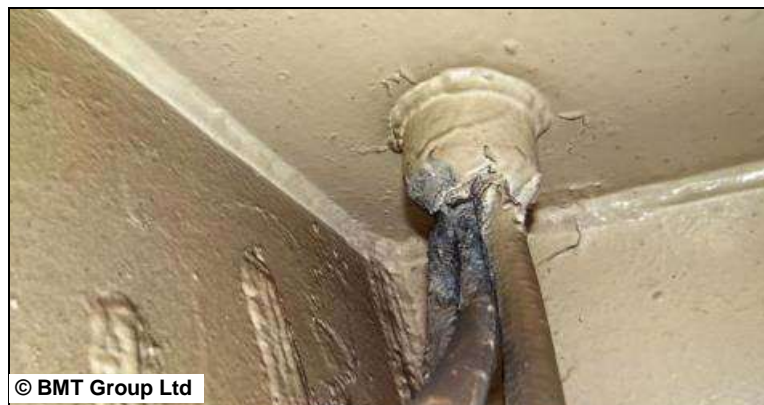
Figure 68: Example of charred cable insulation (3)⁴¹

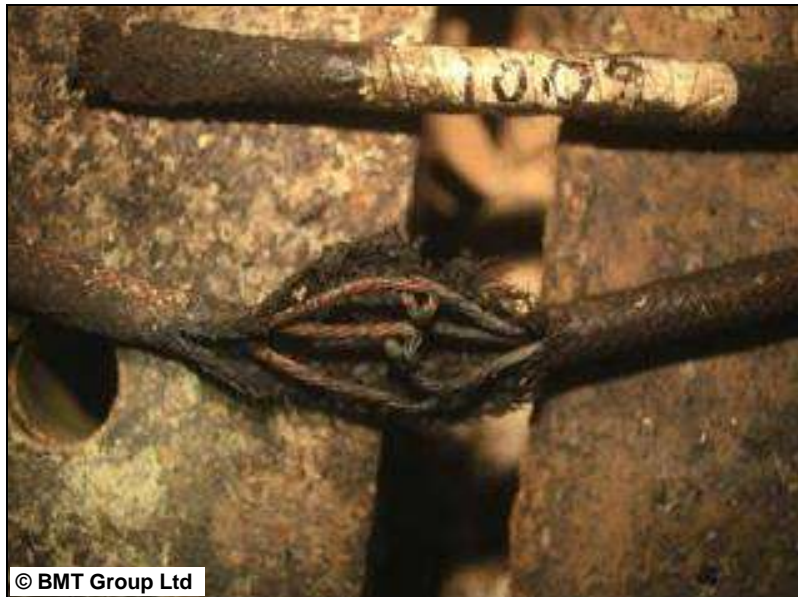
Figure 70: Example of metal conductor within the insulation⁴³

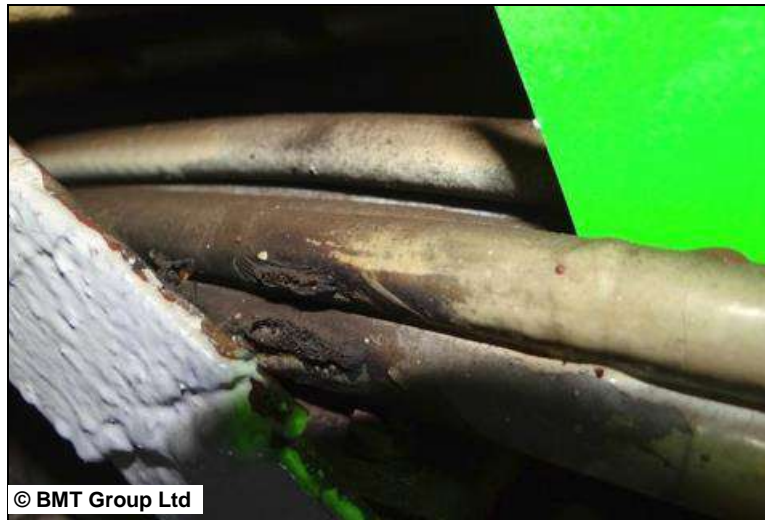
Figure 71: Example of cable insulation damaged by welding operations (1)⁴⁴

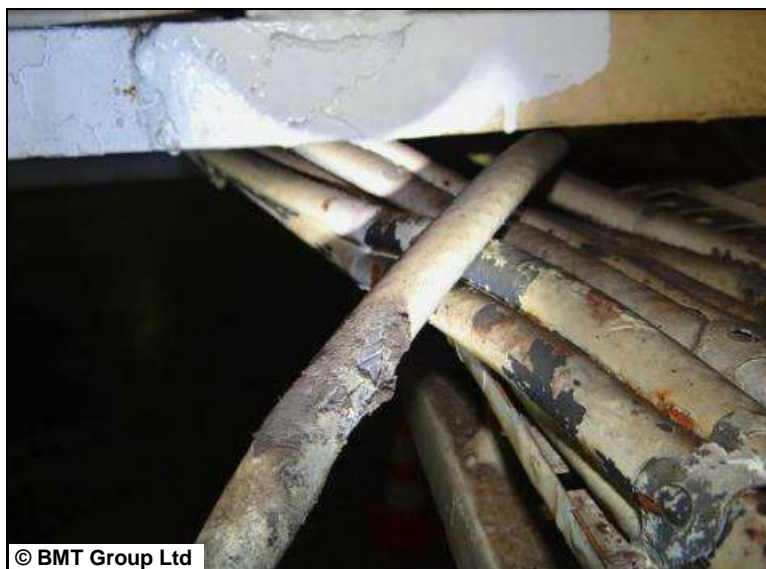
Figure 72: Example of cable insulation damaged by welding operations (2)⁴⁵

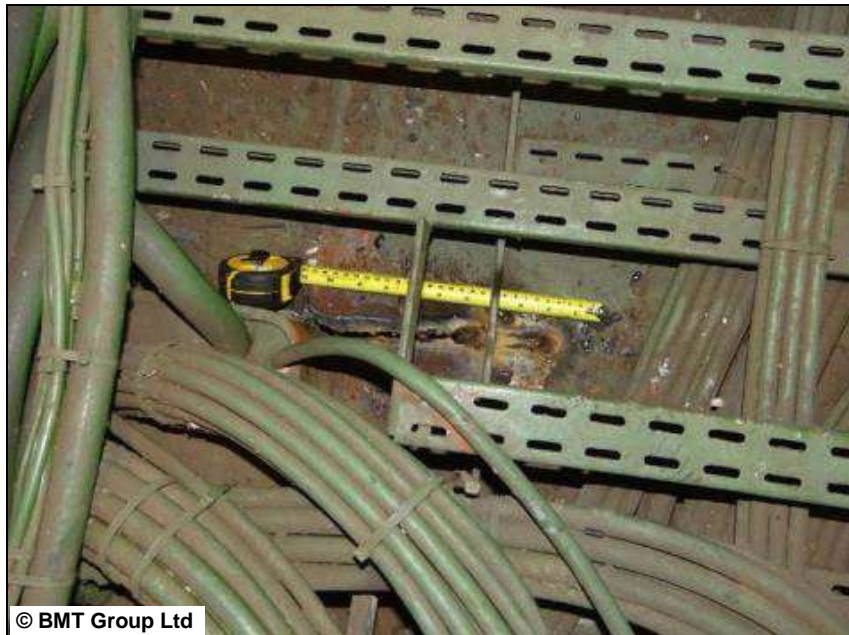
Figure 73: Example of close proximity between welding spot and wiring⁴⁶

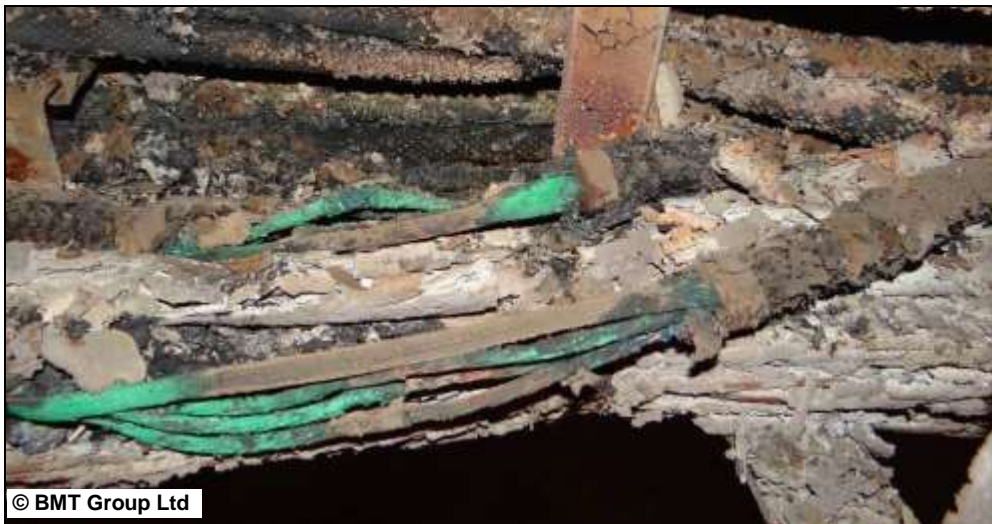
Figure 74: Example of conspicuous signs of corrosion in the wiring⁴⁷

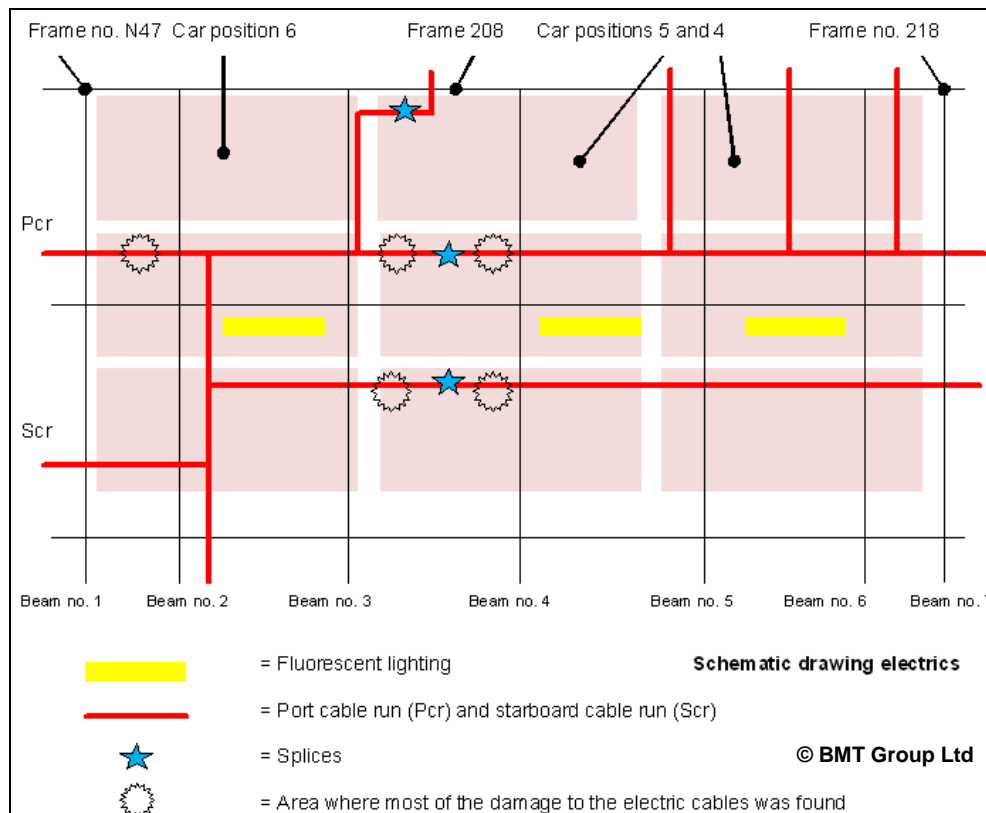
Figure 77: Schematic drawing of the defects in the wiring on deck 3 B⁴⁸

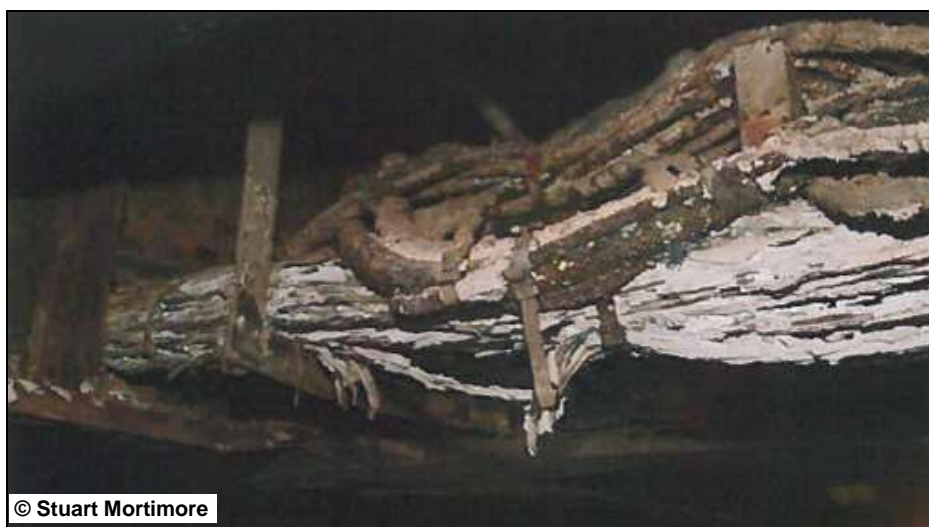
Figure 80: Cable splice above vehicle 5 B⁵³

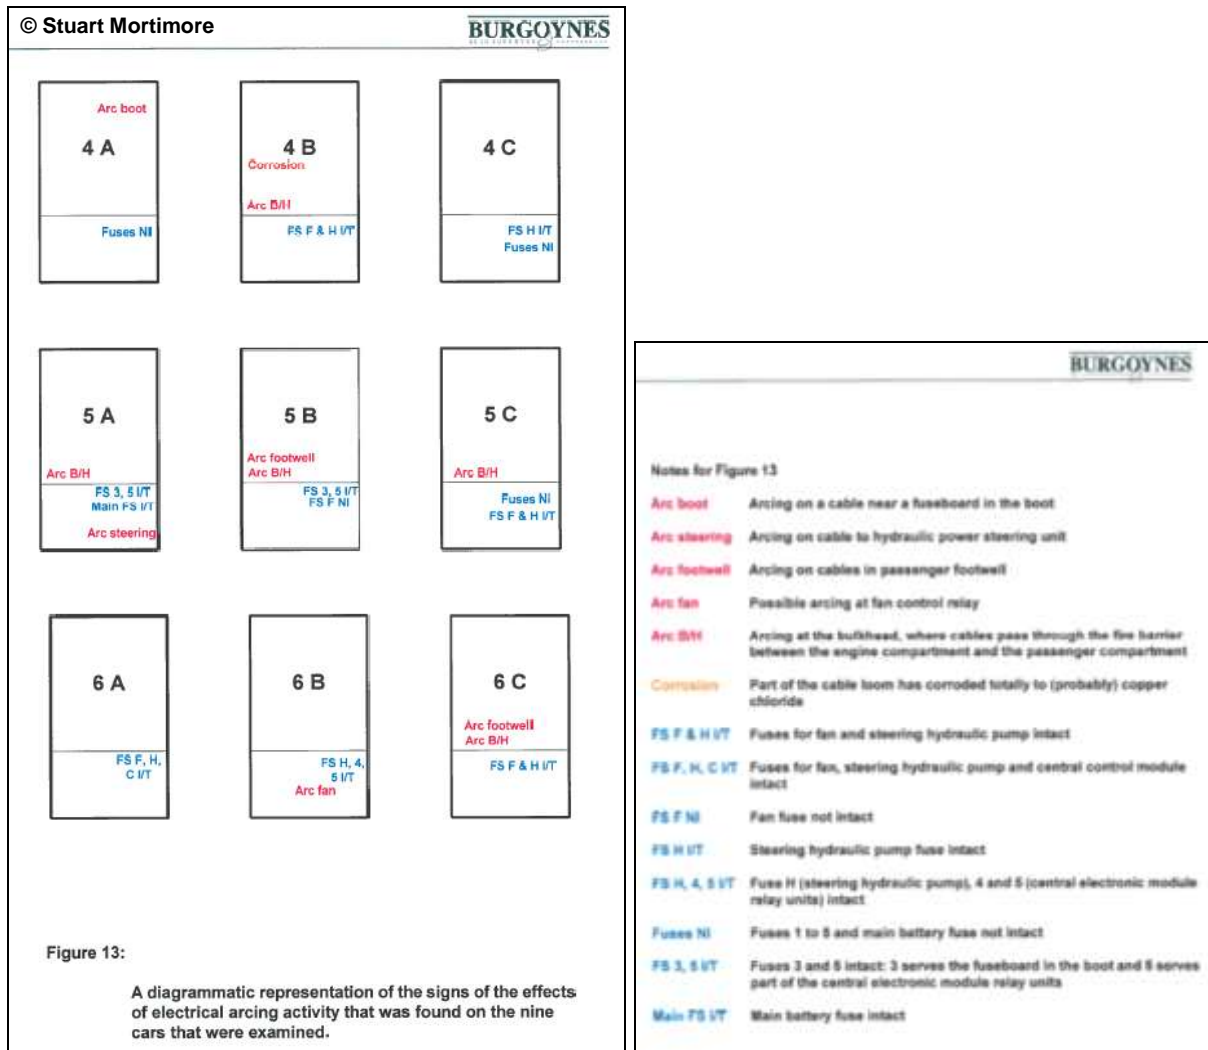
Figure 98: Overview of the identified arcing activities⁷¹

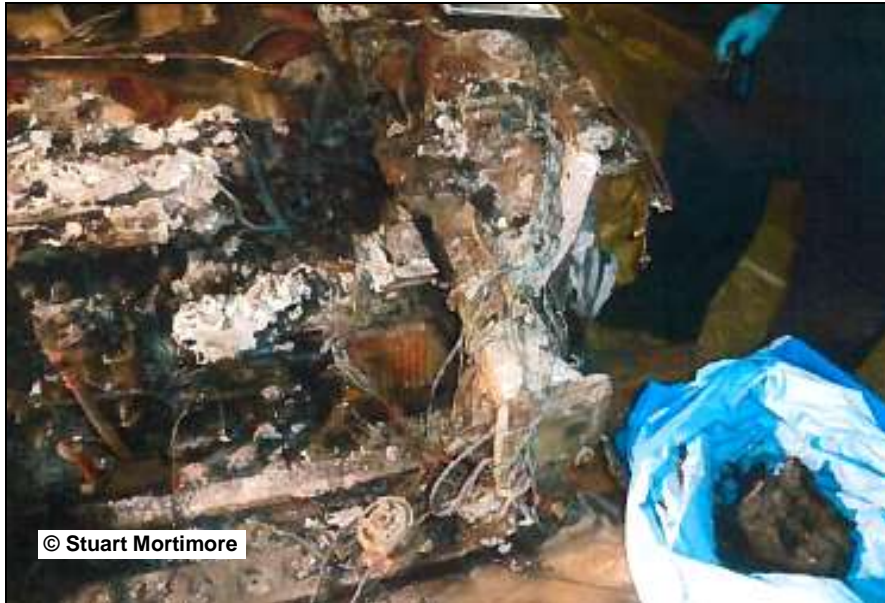
Figure 99: Burnt out engine compartment (example)⁷²

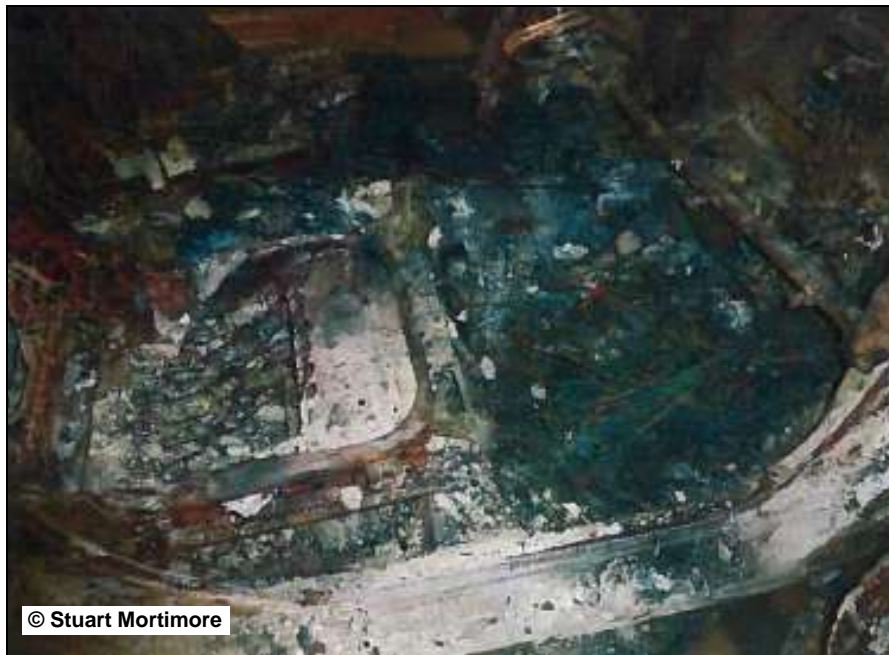
Figure 100: Burnt out passenger compartment (example)⁷³

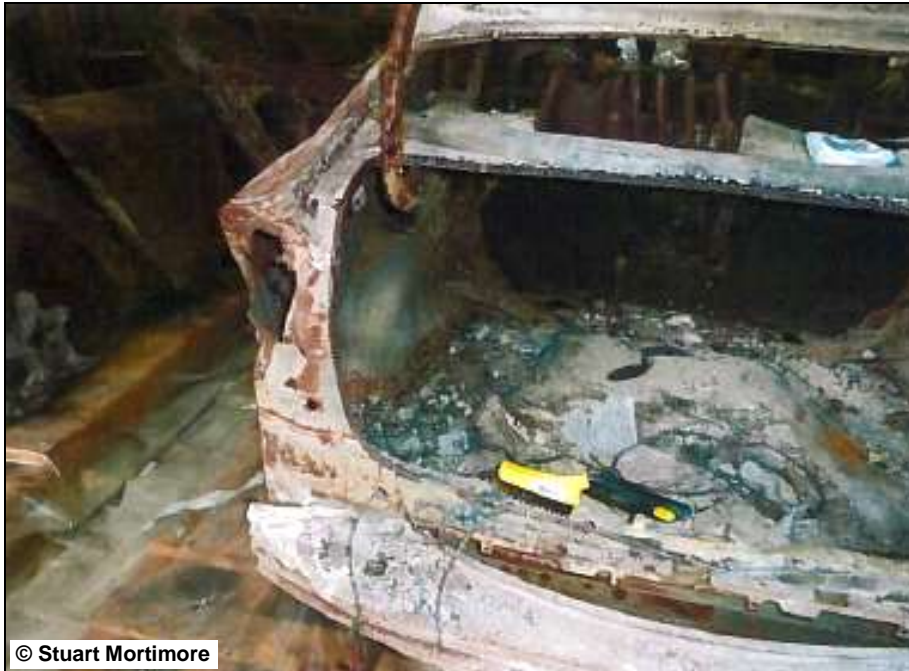
Figure 101: Burnt out boat (example)⁷⁴

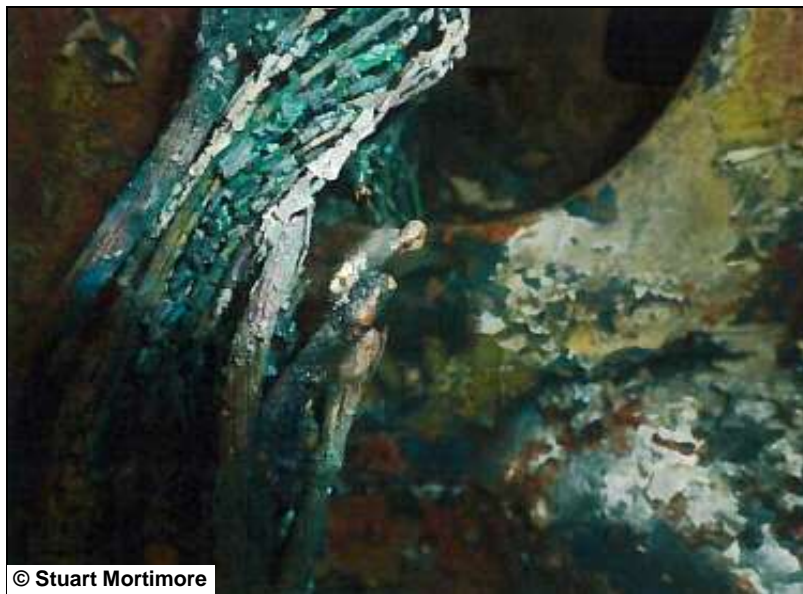
Figure 102: Example of arcing activity caused by electric current (1)⁷⁵

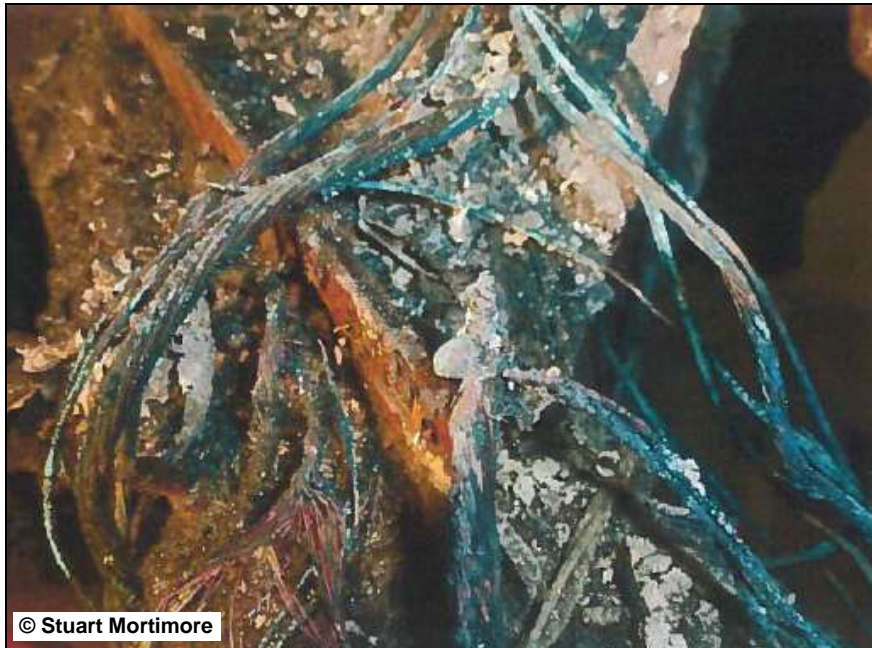
Figure 103: Example of arcing activity caused by electric current (2)⁷⁶
