# **Interim Investigation Report**

pertaining to the investigation report No. 268/15

**Very Serious Marine Casualty**

Fatal accident on board the CMV DUBLIN EXPRESS on 14 July 2015 on the voyage from Caucedo to Rotterdam

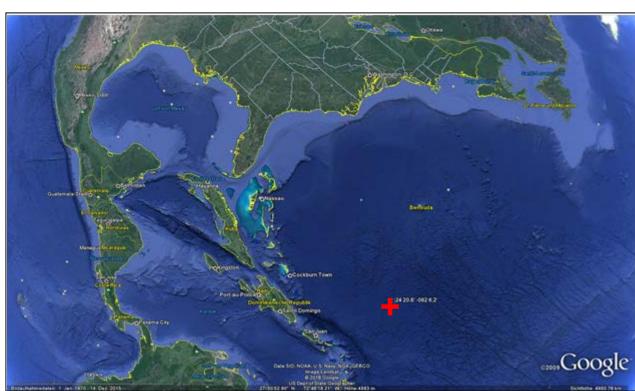
Figure 2: Scene of the accident

At about 1553 (board time) a Philippine welder fell from a ladder while carrying out repair work in the engine room. The seaman was standing on a standing platform of an aluminium ladder located in a height of approx. 1.40 m. After having carried out pipe cleaning work, he was presumably checking the proper screw connection of a pipe connection running above his head. No precautions were taken against a fall from the ladder with respect to personal safety (safety guard at the ladder) and personal protective equipment (fall arrest system).

For unexplained reasons the welder lost his footing when handling above his head, fell backwards on the floor and started to bleed out of his nose and mouth. The two other crewmembers occupied with maintenance work were alerted through the fall noise of the accident which they did not observed directly and immediately informed the ships command.
