Bundesstelle für Seeunfalluntersuchung
Federal Bureau of Maritime Casualty Investigation
Federal Higher Authority subordinated to the Ministry of Transport
and Digital Infrastructure

Investigation Report 16/15

Serious Marine Casualty

Collision between the MV RED7 ALLIANCE and a lock gate at Brunsbüttel on 17 January 2015

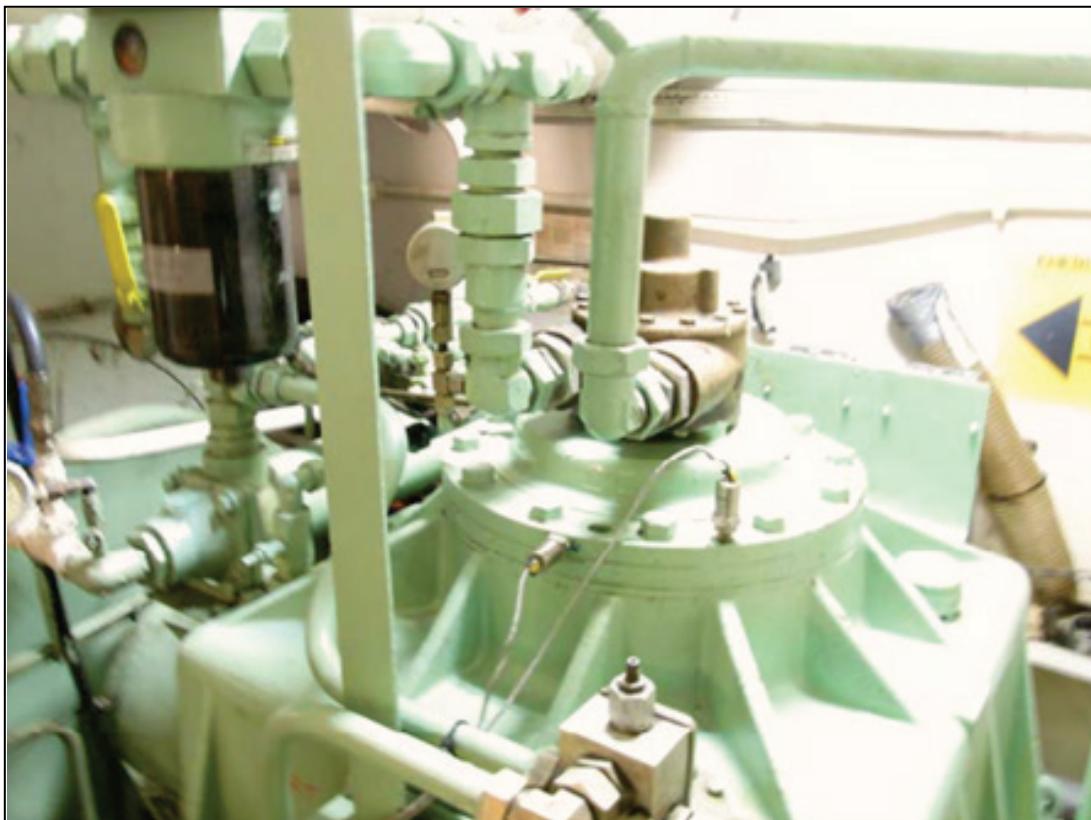
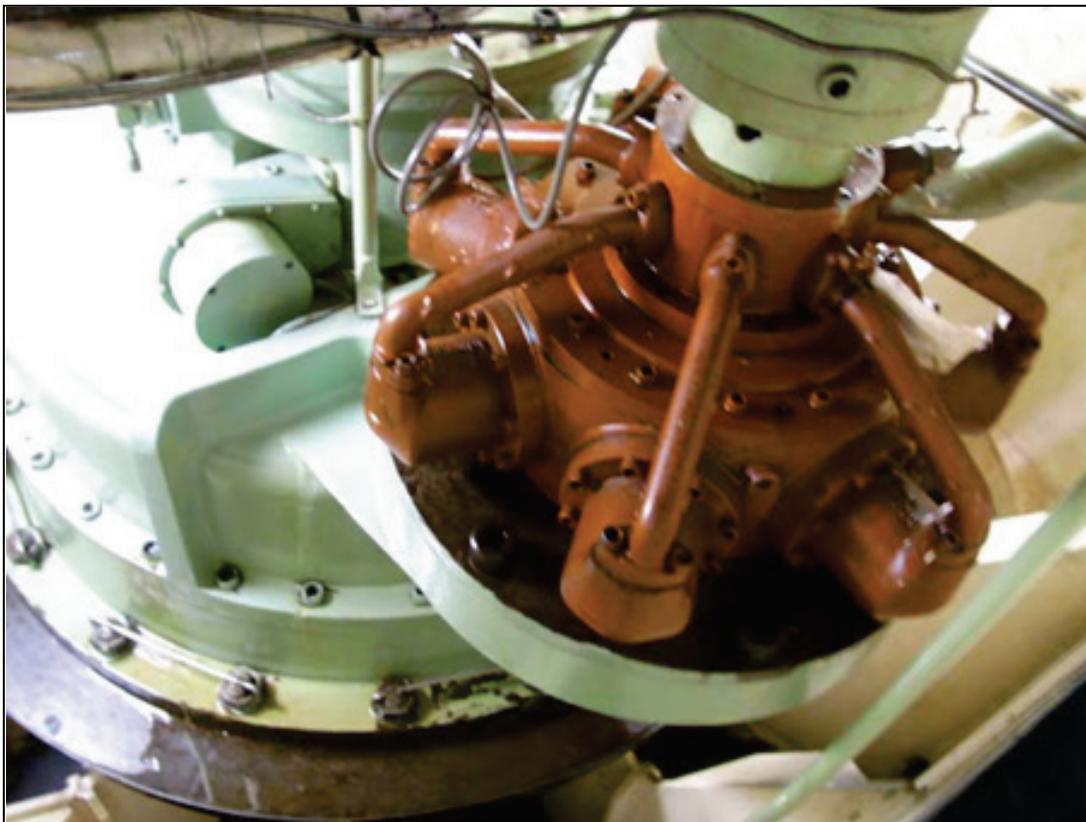
The actuators of the two Gondola (Figs. 5 and 6) and associated hydraulic equipment (pumps and valves) were surveyed externally.

No leaks or traces of a subsequent repair (paint removed from bolted joints, etc.) could be found. Rolls-Royce, the manufacturer, was consulted and found no technical faults after testing every set extensively.

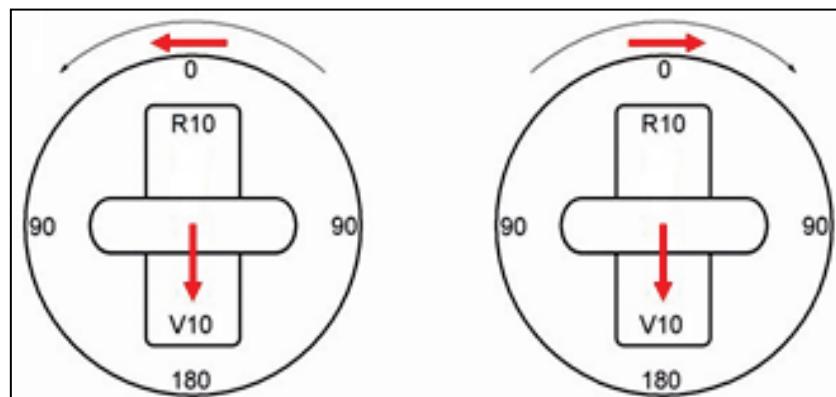
Figure 12: Position of the control levers when moving astern – option 2

The master initiated the sternward manoeuvre on the recommendation of the pilot. In the process, **he must have assumed** that he operated the control levers on both control consoles in manual mode (as per the second option shown in figure 12), and switched **both** control levers by 180°. He thus failed to switch the starboard propulsion, so far working in automatic pilot mode to manual mode.

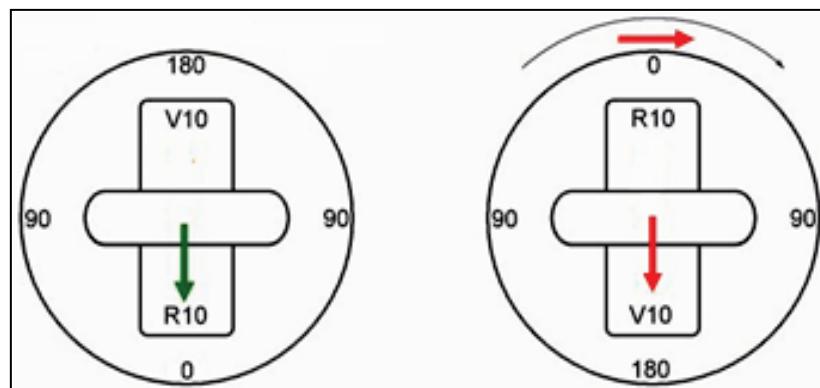
Figure 13: Position of the control levers when moving astern – option 3

The control lever of the rudder propeller operated on autopilot is only rotated about the horizontal axis to 'Full astern' (R 10); the control lever of the rudder propeller operated in manual mode is rotated about the vertical axis to 180° and simultaneously about the horizontal axis to 'Full ahead' (V 10). There may be a response to the helm during this manoeuvre because the rudder propeller is operated in manual mode. Furthermore, the thrusts differ.

The course of the accident is only possible if the two propulsion units – in accordance with the recommendations in the manual – were operated as follows (see page 20 option 3):

Consequently, the accident was caused by an error in operating the starboard propulsion since the master assumed that this Azimuth already operated in manual mode. If he had been aware that this unit operated in the automatic pilot mode he should not have turned the gondola but instead only switched the pitch on "astern" to achieve a stop effect.

The Federal Bureau of Maritime Casualty Investigation recommends that Rolls-Royce Marine A/S develop technical modifications to the propulsion unit controls, to avoid operating errors as the found here.

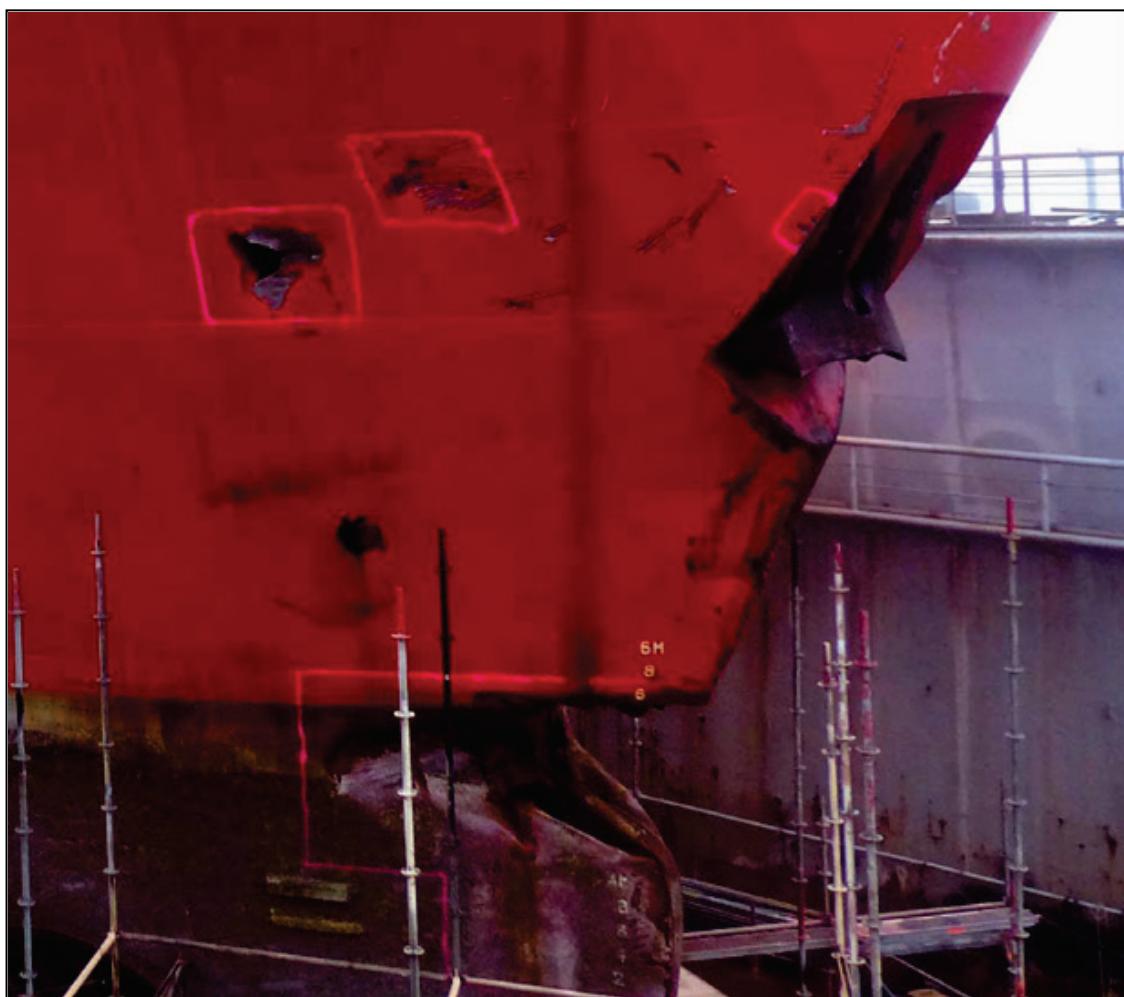
Figure 19: Damage to the bow

A massive cross member in the lock gate damaged the hull level with the water line so severely that water entered the forepeak and the ship lost some of her buoyancy. Furthermore, the end of the upper longitudinal member of the lock gate penetrated the hull level with the bower.

Due to the ship colliding with a massive guide beam belonging to the gate, there was a hole in her bow of approximately 1.4 m in height and 3.3 m in length level with the waterline. The shell plating was cut relatively sharp on the upper edge of this hole and turned inwards on the lower edge.

The damage pattern on the hull and that of the lock gate show that the ship must have turned to port after the collision. In the process, huge forces must have acted for the right fracture point of the upper longitudinal beam to penetrate the hull on the ship's starboard side level with the bower.
