**Bundesstelle für Seeunfalluntersuchung**  
**Federal Bureau of Maritime Casualty Investigation**  
Federal Higher Authority subordinated to the Ministry of Transport  
and Digital Infrastructure

**Investigation Report 180/15**

**Very Serious Marine Casualty**

**Master of the  
MV HANJIN MIAMI  
missing in the Indian Ocean  
on 16 May 2015**

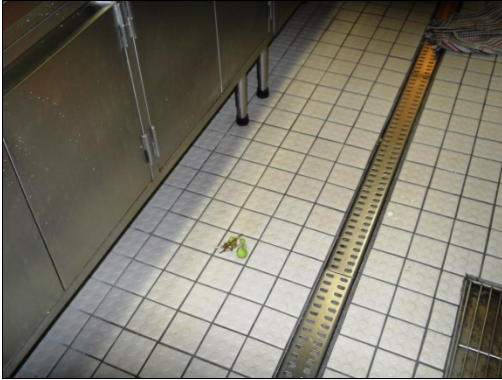
Figure 6: Master's primary key

The master normally keeps the primary key on his person. Since he did not appear for supper, it is likely that he went to the galley again to eat supper. This must have happened after 2000 on 15 May. Reportedly, nothing was noticed during the night-time two-hourly rounds of the superstructure by members of the watch.

The primary key was not found until early in the morning at about 0530 on 16 May by the cook, after which the steward took it to the chief officer on the bridge.

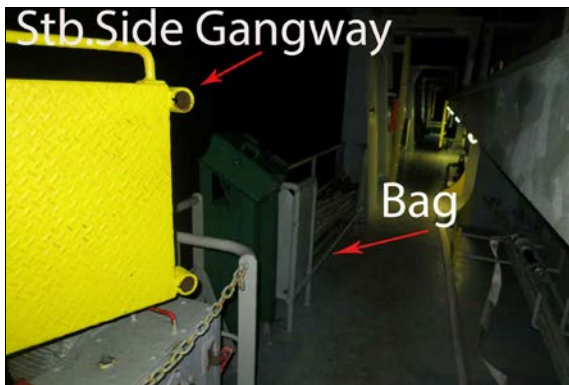
Figure 7: Position of the bag

With regard to the bag, the crew had no plausible explanation. It seems obvious that it had not been used for a long time. It could have been a post bag used as a practical means of transferring utensils to smaller boats, for example.

As regards the disappearance of the master, the BSU attaches no particular significance to the bag weighed down by a twist lock, which was concealed beneath the lashing rods in the vicinity of the gangway. Since none of the crew members had seen it before, it seems obvious that it was only found during the repeated search for the master. This bag had a line attached and was designed so that it could be used as a post bag to make it easy to move utensils from on board the vessel to a smaller one. The twist lock weighed 6.5 kg and could have been used to stow the bag safely. The disappearance of the master was not discovered until the morning after. It was unusual that the door to his berth had remained open during the night. The crew did not check if anyone was in the berth. The chief engineer, who resides on the same deck, did not go to bed until about 0400 in the morning because he had to oversee maintenance work on the auxiliary diesel generators carried out by an external company in the engine room. However, he was not concerned but rather confident that his important message regarding the delivery of spare parts to Suez had been sent.

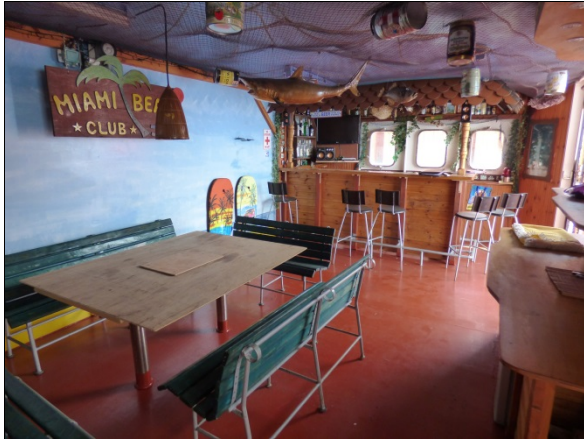
Figure 15: Bar on the port side of E deck

The BSU was sent photographs made on board the HANJIN MIAMI of the aft superstructure. They show the crew's self-built bar and the passageways in the area of the lifeboats, which lead directly to the outboard edges and are not protected by railing in places due to the design. Without the protection of the 1 m-high railing, the master could have fallen overboard there. It should be noted at this point that it was dark and the Moon was waning.

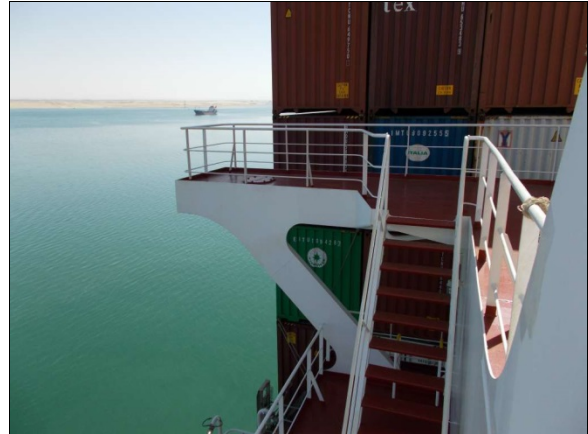
Figure 16: Transverse passageway on the starboard side

Taking the direct route to Suez, the HANJIN MIAMI was situated on the boundary with the presumed piracy area. Consequently, the superstructure was already blacked out, the exterior doors locked, and night-time rounds had been ordered. Going around would have taken the master from the galley through the service corridor on B deck outside to one of the lifeboat stations, where it would be possible to go to the outboard edge without the protection of railing. One reason would be the noises caused by safety lines and lashing on the lifeboats and davits, for example. He may have slipped and fallen overboard while inspecting something there in the dark. It is also conceivable that he had locked himself out of the superstructure because the outside door had been locked again from the inside in the meantime. Then he must have passed one of the lifeboat stations without a torch or radio so as to attract attention on the transverse passageway at the forward edge of the bridge.

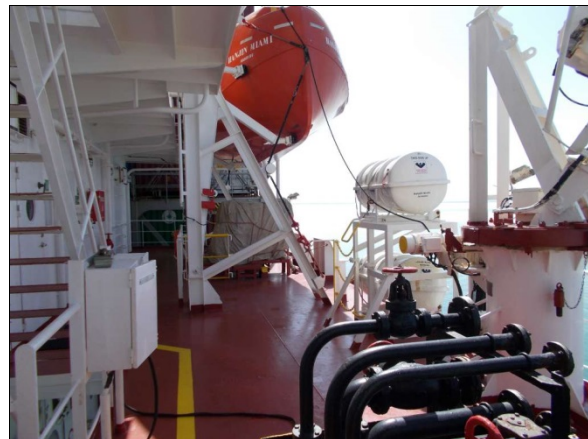
Figure 18: Lifeboat on the port side

In the final analysis, the BSU concludes that it is not possible to determine the cause of the master's disappearance from the vessel on the high seas. During an inspection carried out in the dark, possibly at the lifeboats, the master may have fallen overboard while proceeding from the galley to the bridge. After analysing the facts, it believes that this scenario is most likely from a seafaring perspective. There was no credible evidence for a criminal offence or suicide.
