Bundesstelle für Seeunfalluntersuchung
Federal Bureau of Maritime Casualty Investigation
Federal Higher Authority subordinated to the Ministry of Transport
and Digital Infrastructure

Investigation Report 203/15

Very Serious Marine Casualty

Fatal accident
on board the FV ORTEGAL TRES
on 27 May 2015 off the Shetland Islands

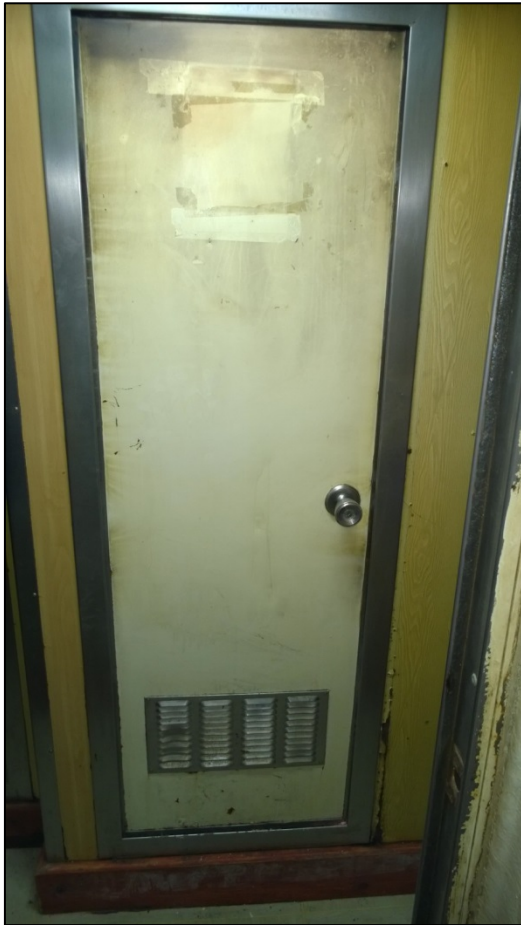
During the evacuation of the casualty and the extinguishing work, the witnesses noticed a strong smell of burning rubber. The fire broke out in the cabin and was evidently caused by an electric household fan on which the casualty had probably dried his rainwear and rubber boots.

Figure 5: Cabin door

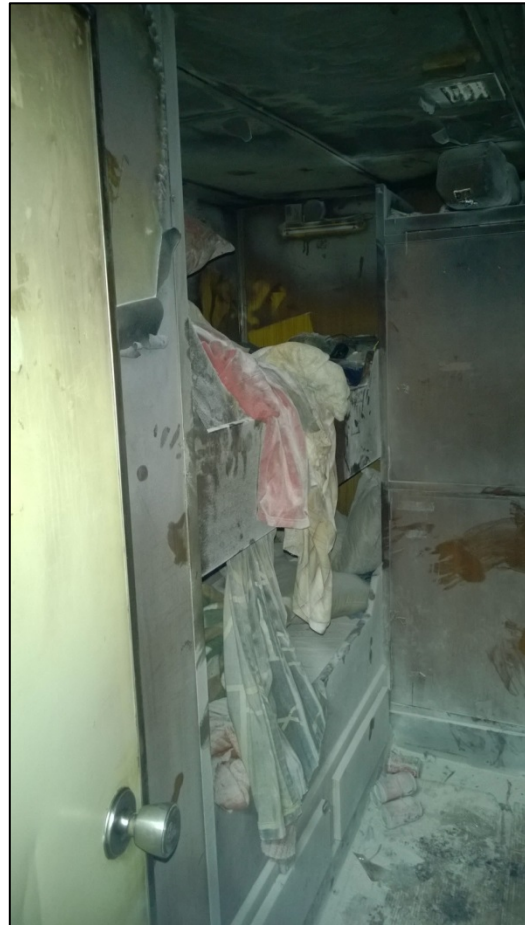
Figure 6: Casualty's berth

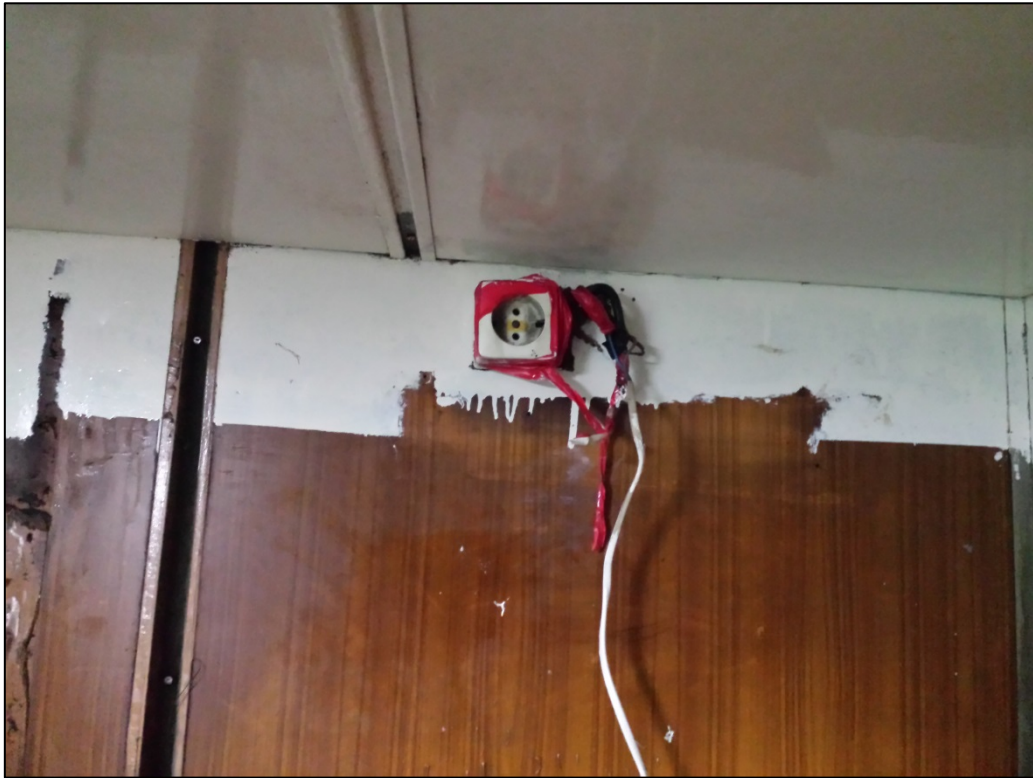
As a result of the flag State inspection by the Ship Safety Division (BG Verkehr), a prohibition to leave port was issued because the investigation revealed that the entire installation of the electrical cable connections and wiring in the accommodation and work area was in an unacceptable condition. The extractor hood in the galley was filthy and unacceptable in respect of fire safety. All in all, the general condition of the ship was so poor that it appeared that the safety of the ship, the crew, and the environment was not guaranteed if she set sail.

Figure 7: Socket in the cabin

The owner replaced most of the electrical system in the cabins, which are to be inspected on a weekly basis in the future so as to prevent possibly unauthorised modifications to the cables or the installation of unauthorised electrical appliances.

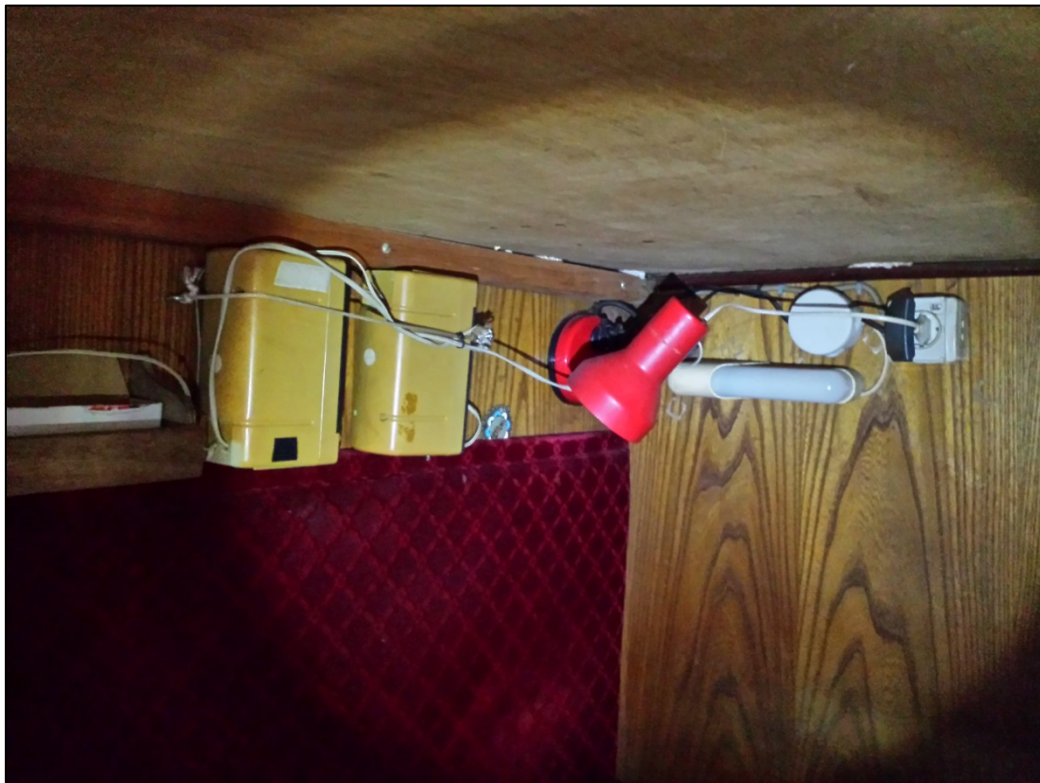
Figure 8: Additional wiring

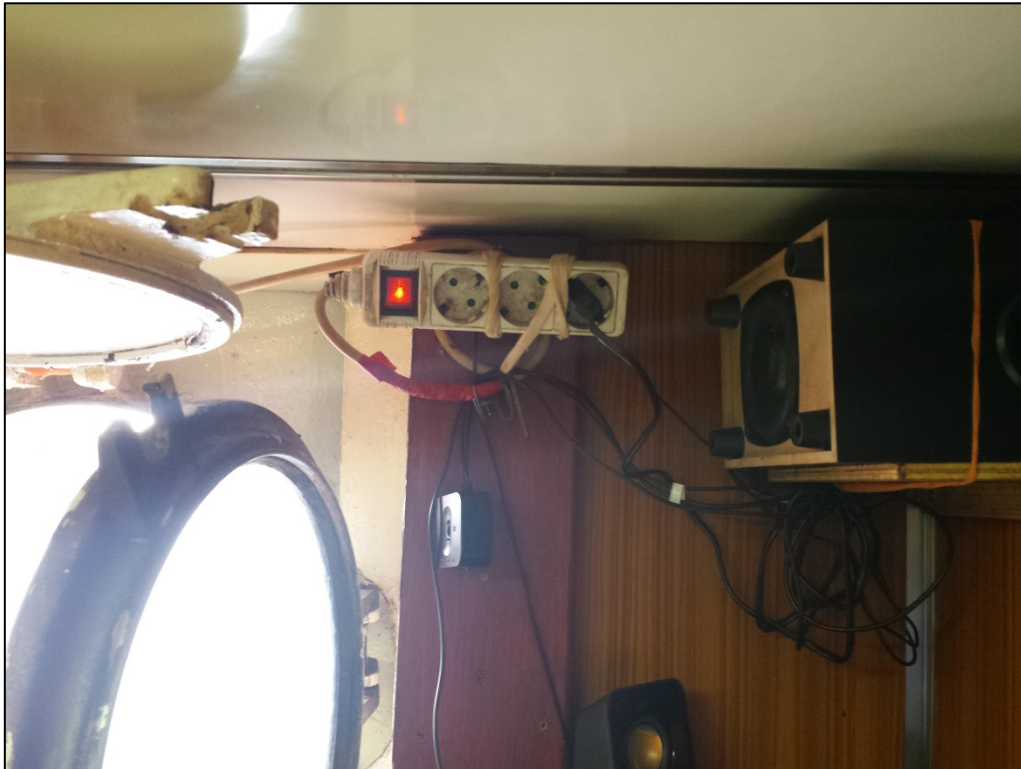
Figure 9: Socket strip on the bridge

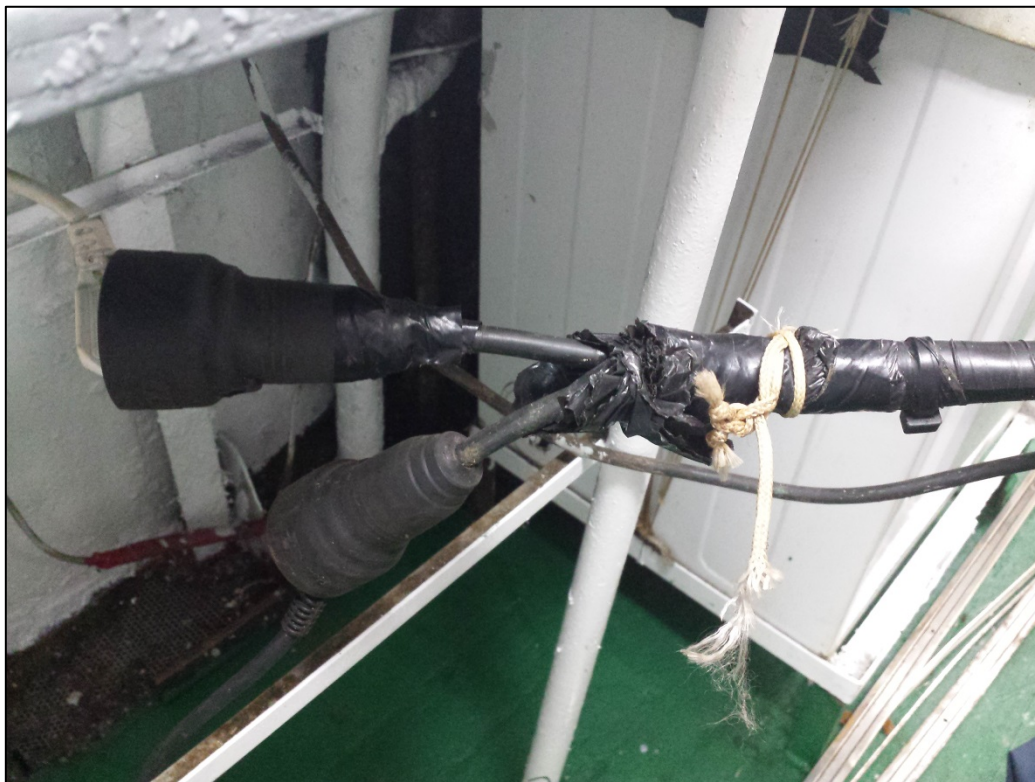
Figure 10: Plug on the main deck
