Investigation Report 330/13

**Serious Marine Casualty**

**Collision between the MT CORAL IVORY and  
MV SIDERFLY on 28 October 2013 in the  
Kiel Canal**

15 March 2016

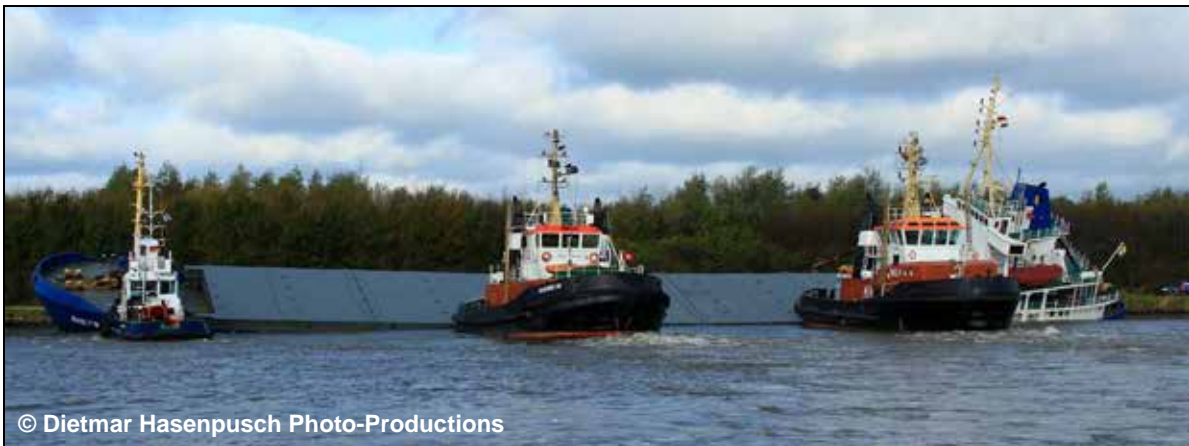
**Figure 4: Stabilising the SIDERFLY on the canal embankment**

Two tugs that had arrived at the scene of the accident shortly after the collision managed to push the **SIDERFLY** temporarily against the northern canal embankment and prevent the ship, which was listing at more than 20 degrees to the port side, from foundering.

A huge technical water-based and especially shore-based effort in the hours and days that followed made it possible to first stabilise the distressed vessel on the northern canal embankment and then make her temporarily buoyant (see **Figures 4 f.**).

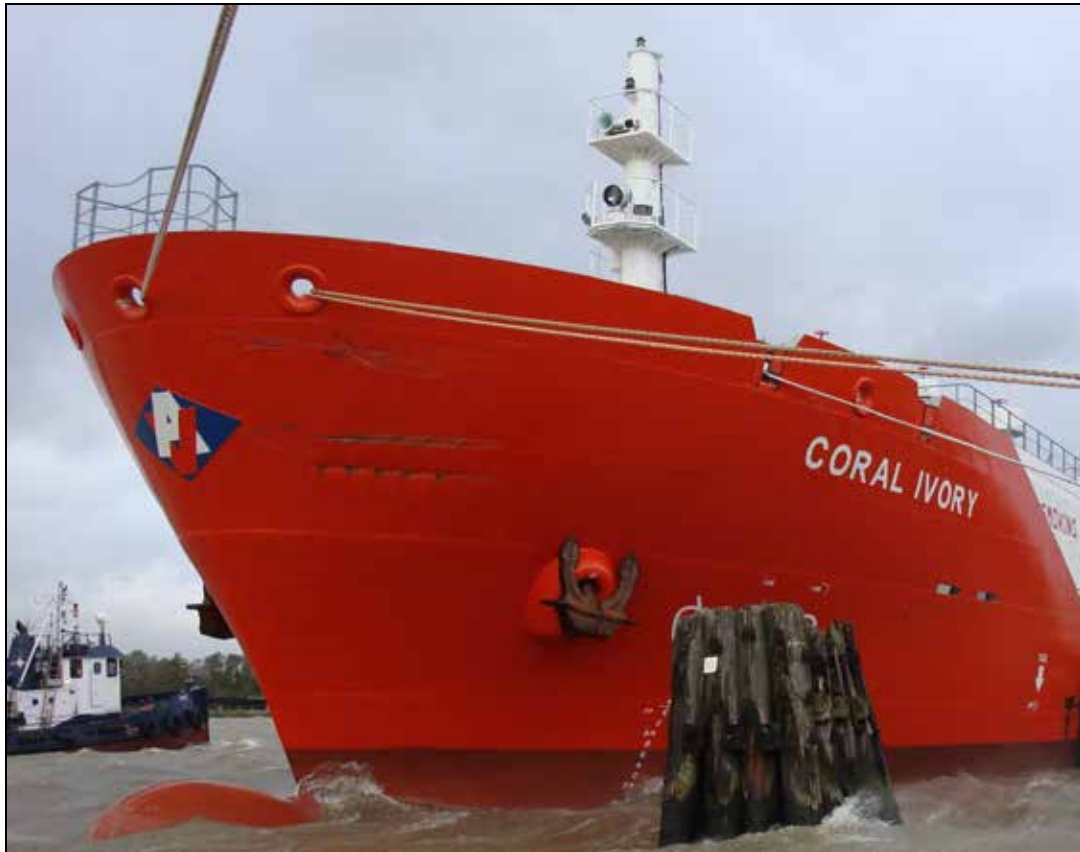
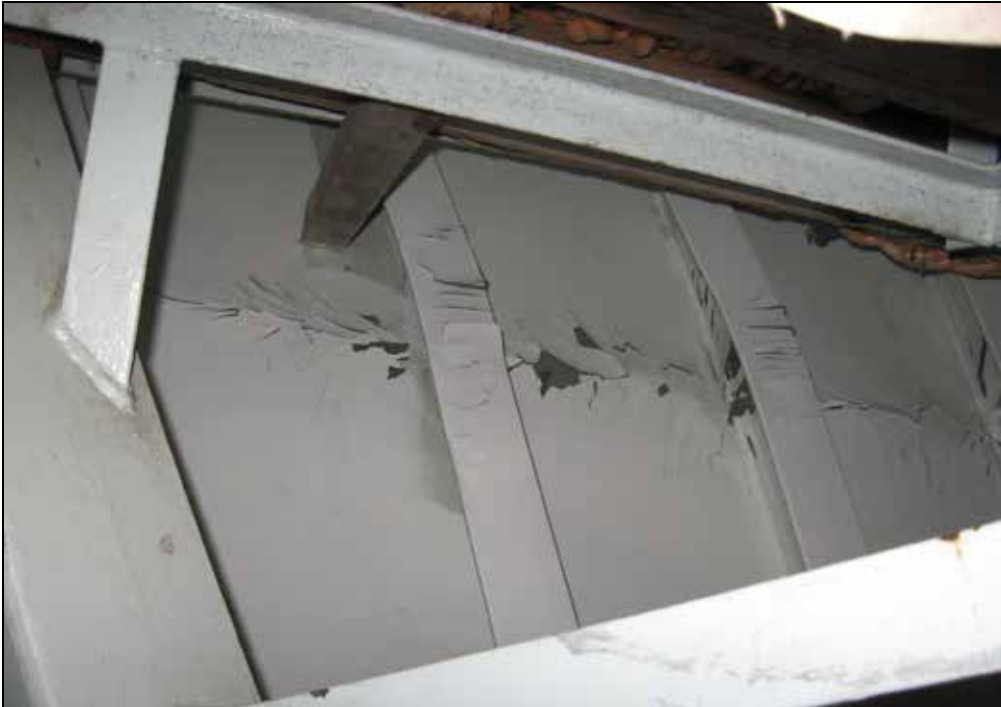
The CORAL IVORY sustained minor damage above the waterline in the area of the port side of the stem (**Figures 6 f.**) during the collision with the SIDERFLY. Apart from that, only the ship's ice-strengthened bulbous bow was deformed – also only slightly (**Figure 8**).

Figure 6: Damage to the CORAL IVORY's stem

Figure 7: Damage to CORAL IVORY's stem (view inside)

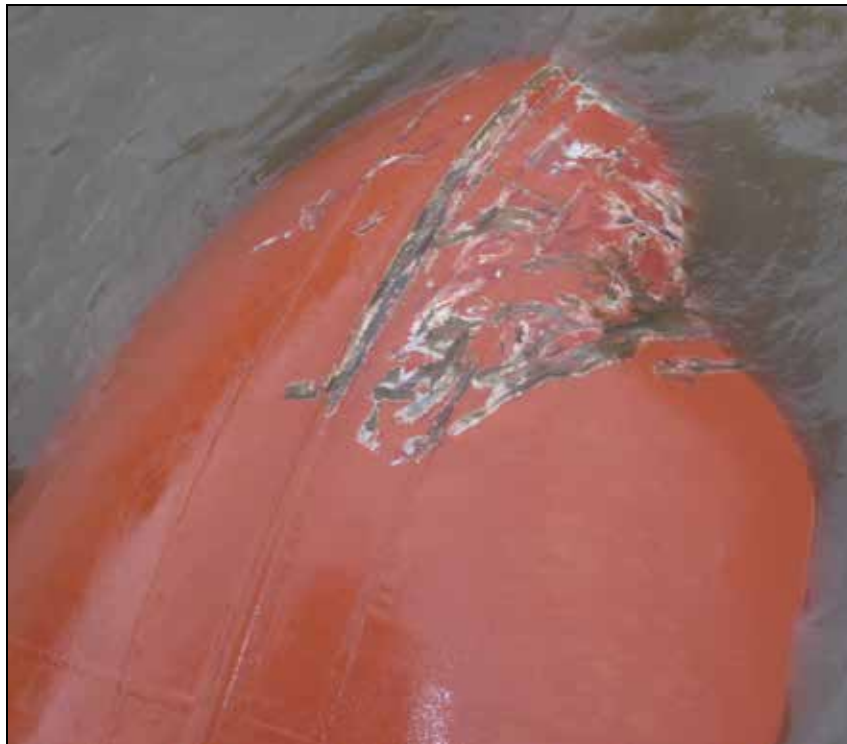
Figure 8: Damage to the CORAL IVORY's bulbous bow

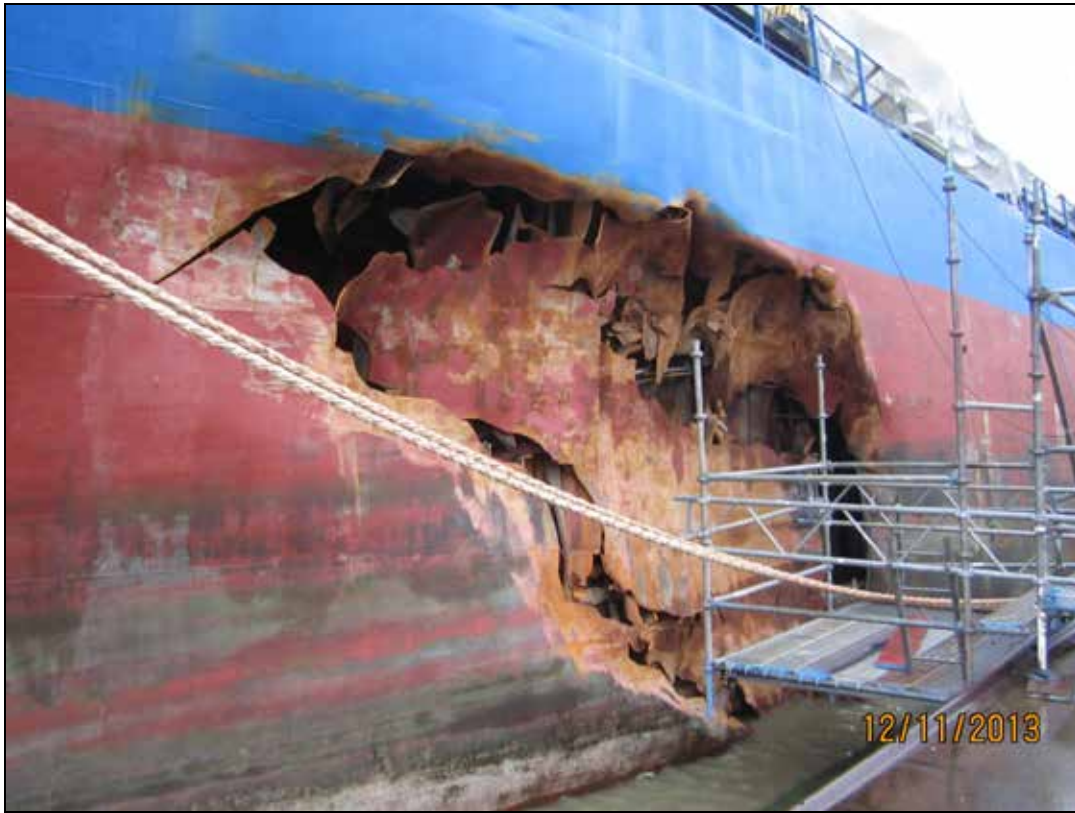
forward section. This resulted in a hole of some 6 m in length and some 4.5 m (Figure 9) in height in the hull.

**Figure 9: Hole in the SIDERFLY's hull (port side)**

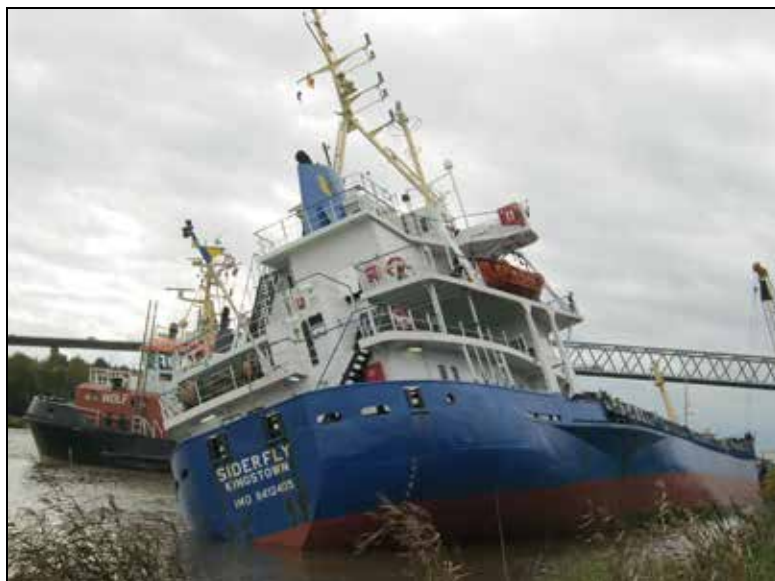
There was inevitably water ingress in several ballast tanks, in a void space, as well as in cargo hold 1 of the ship, which has only two cargo holds. The SIDERFLY started to list to port rapidly and it was due only to the tug deployment that she did not founder.

**Figure 10: MV SIDERFLY listing to port**

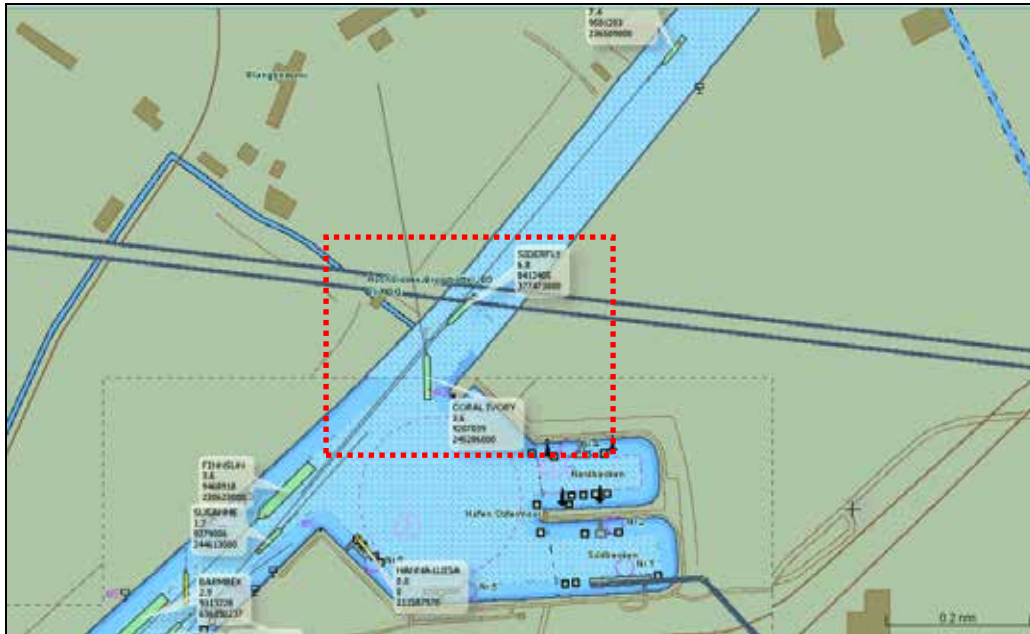
**Figure 16: AIS-based traffic situation at 0256**

The screenshot at about 0256 (**Figure 16**) suggests that the CORAL IVORY is still fully committed to attaining a heading lengthways to the canal before the passage of the SIDERFLY. However, it is also clear that the now available distance to the oncoming vessel of only 0.1 nm is barely sufficient for that. This is all the more true because the local conditions make it impossible for the SIDERFLY to evade to the north.

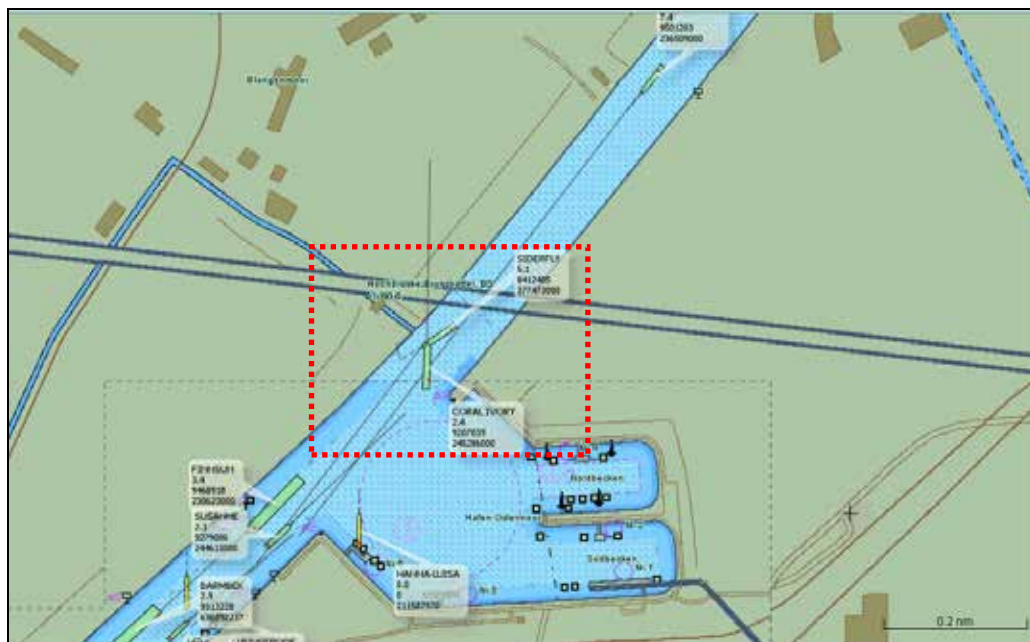
**Figure 17: AIS-based traffic situation at 025630**

The inevitable collision between the CORAL IVORY's bow and SIDERFLY's port side shown in **Figure 17** occurred at about 025630.

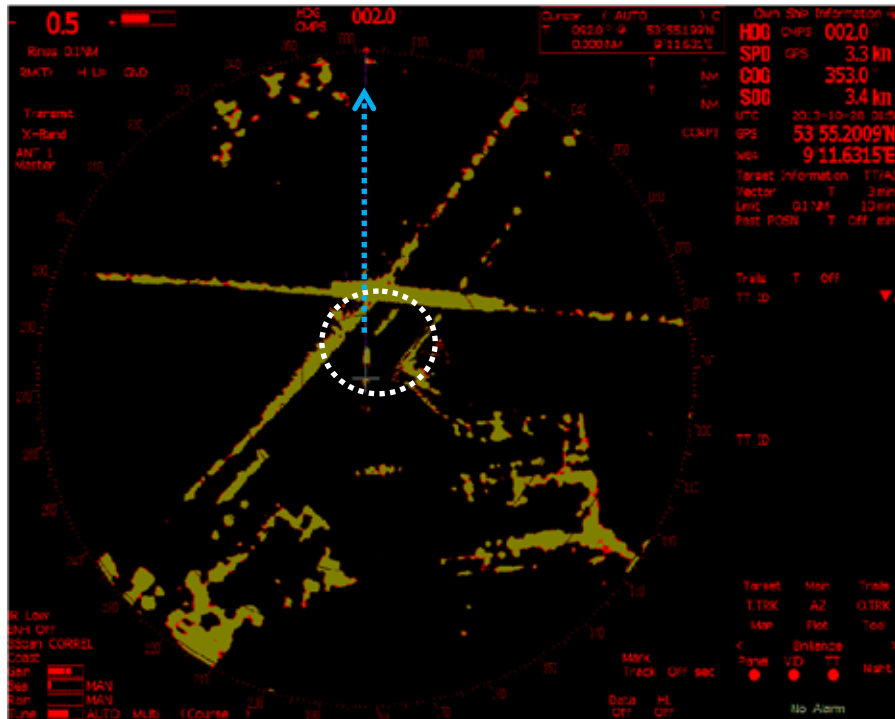
**Figure 25: CORAL IVORY – radar image at 025609**

It is clear in the following radar image, which illustrates the immediate approach of the vessels at 025609 (**Figure 25**), that the heading (course steered – blue dashed line) of the CORAL IVORY is still some distance from a course that matches the course of the canal.

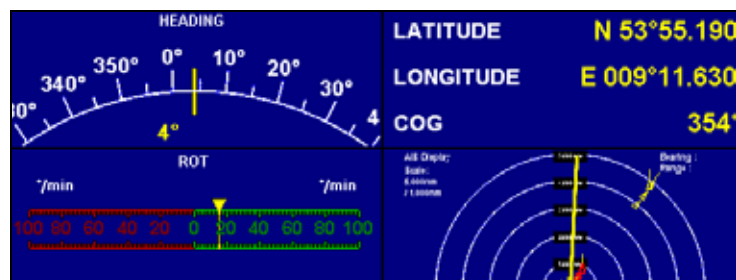
Figure 31: CORAL IVORY – ROT at 025615

Shortly before the collision (see **Figure 31**), the ROT had finally dropped to values of less than 20°/min. in spite of the hard to starboard rudder angle and use of the bow thruster. At this point, the SOG was still just over 3 kts.

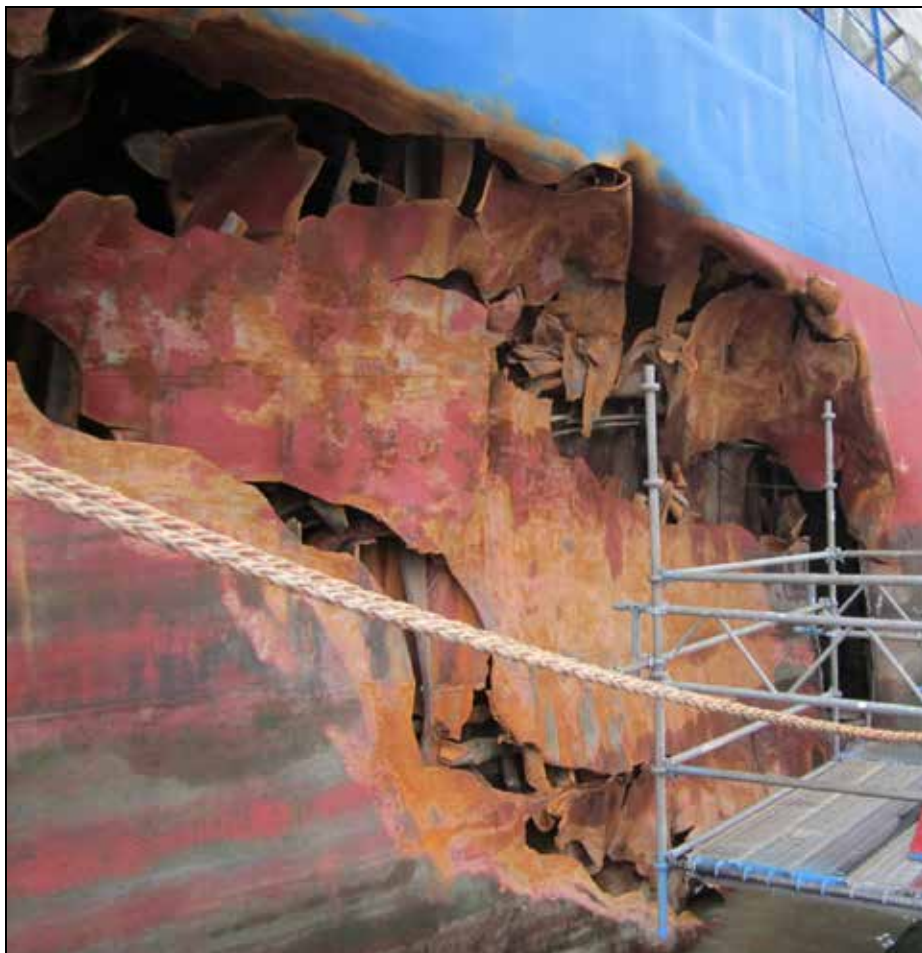
**Figure 41: Hole in the SIDERFLY's shell plating (port side)**

*A hole in the shell plating was located on the port side of the ship's forward section between frames 100 and 105. The length of this hole was about 6 m and the height about 4.5 m. The shell plating and reinforcement in this area were damaged by the CORAL IVORY's bulbous bow (see **Figure 41**).*

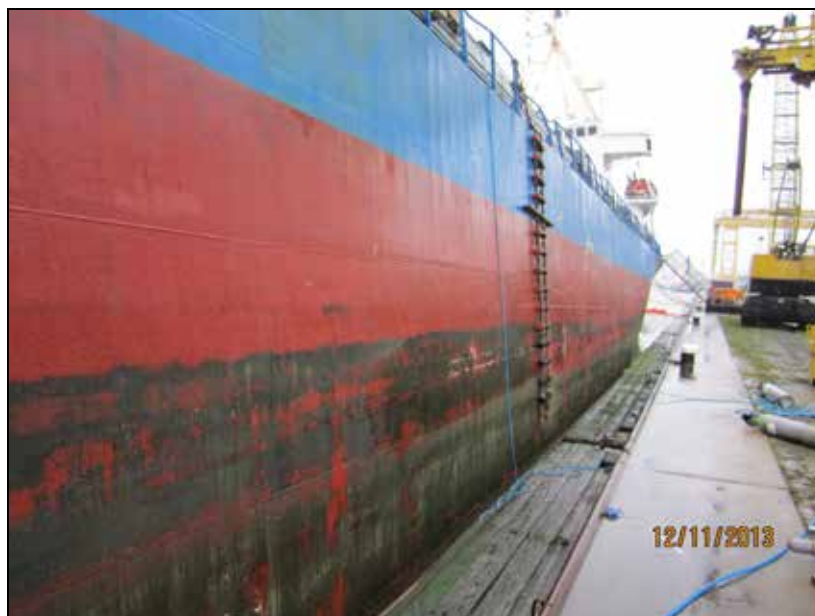
**Figure 42: SIDERFLY's shell plating (port side)**

As far as was visible during the survey, the topside shell plating on the port side was intact (see **Figure 42**).

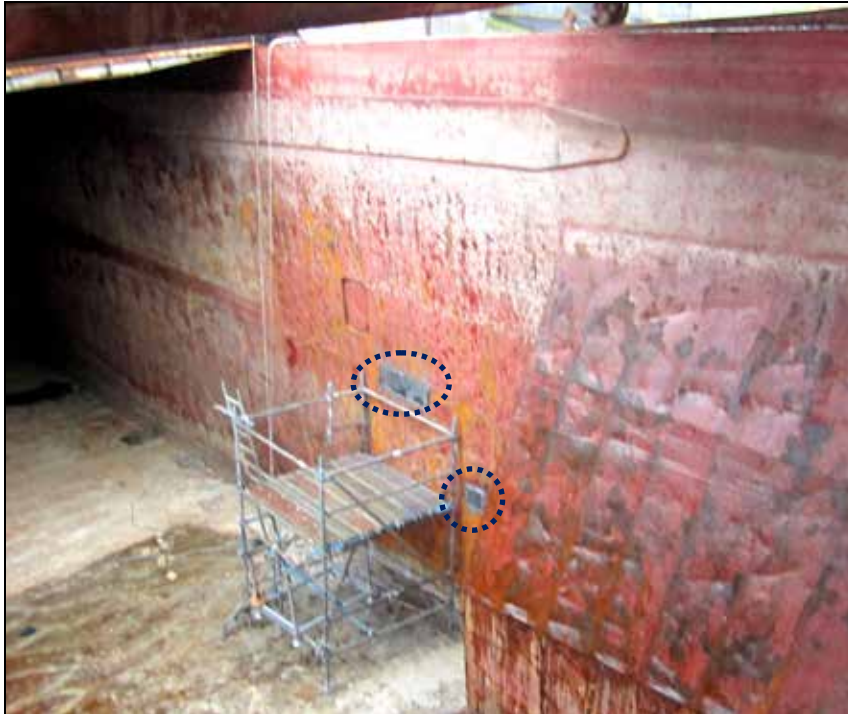
**Figure 43: Holes in the cargo hold bulkhead (cargo hold 1 on port side)**<sup>30</sup>

Four repaired holes were found in the port side longitudinal bulkhead of cargo hold 1. At the time of the survey, they had already been welded closed using steel plates (see **Figure 43** by way of example).

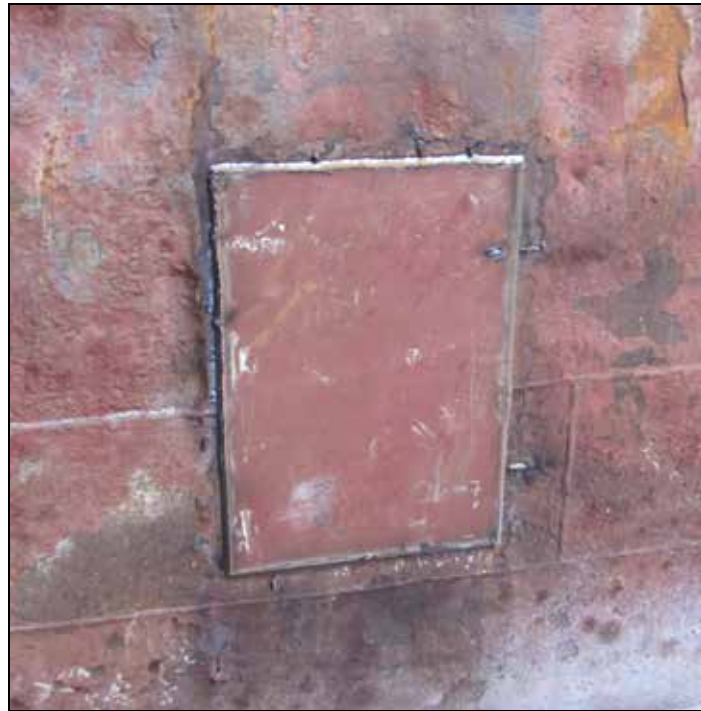
*By comparison to the holes in the cargo hold bulkhead caused by the collision, the leakage at the manhole covers was reportedly negligible, however.*

**Figure 44: Manhole cover welded closed using a steel plate**

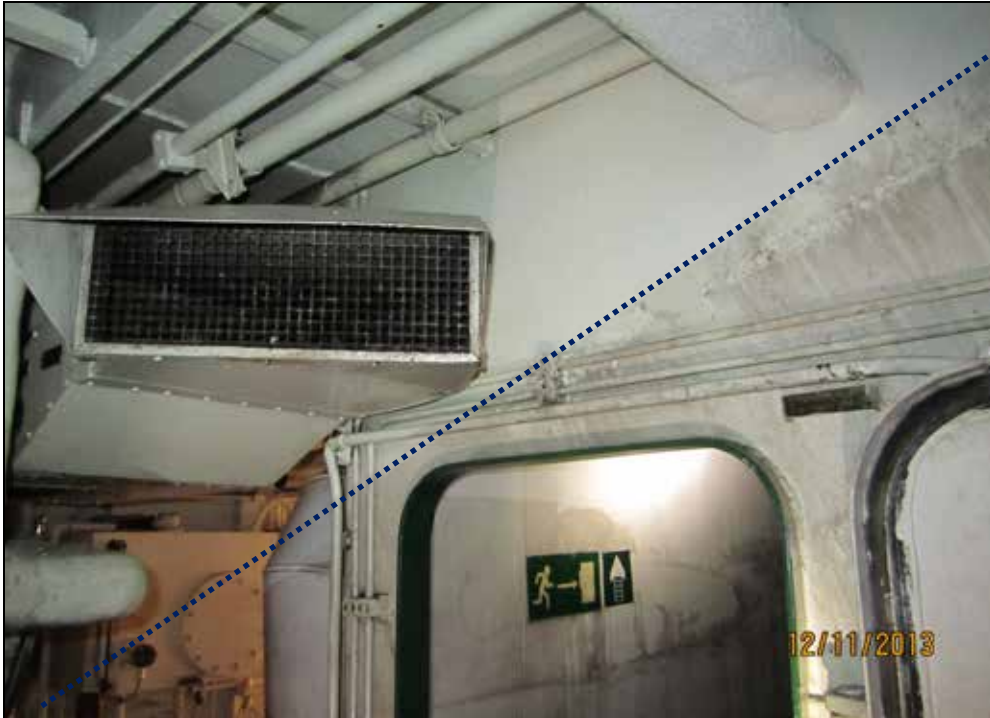
Figure 45: Evidence of the increasing flooding towards the port side of the engine room

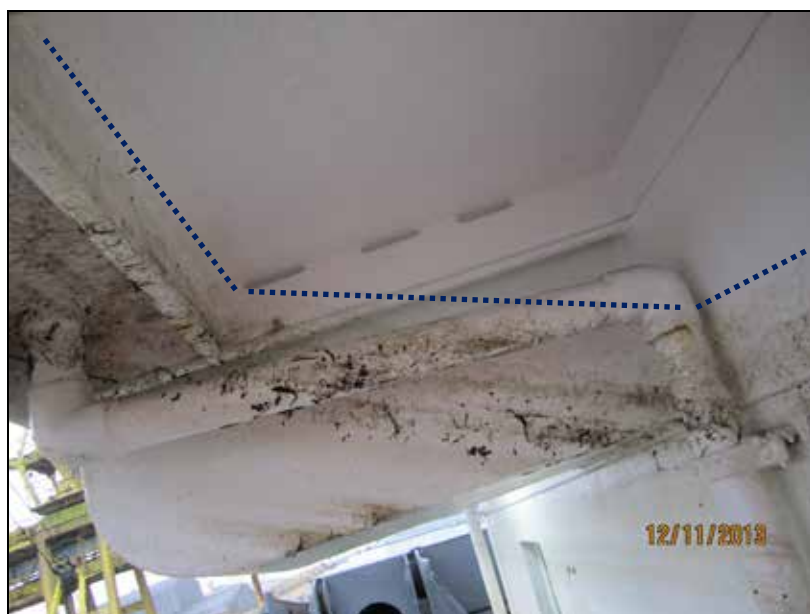
During the salvage operation, the water level on the port side of the ship reached a height that in all likelihood allowed water from the canal to enter the engine room via the exterior doors of the main deck and through the accommodation area.

Figure 46: Limit of maximum immersion on the port side of the SIDERFLY

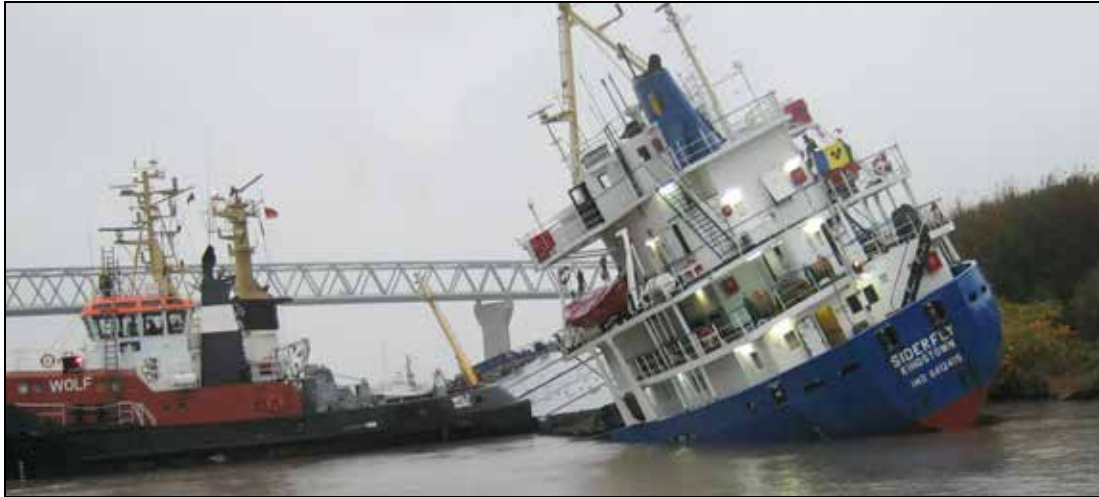
Since the tugs inevitably pushed against the ship level with the hatch cover when the *SIDERFLY* was made fast on the port side, the hatch covers were lifted slightly (see **Figure 48**). This neutralised the watertight integrity of the hatches.

**Figure 48: Tug-induced load on the hatch cover**
