Investigation Report 337/14

Very Serious Marine Casualty

**Fatal accident on board the
MV SILVER PEGASUS
in the port of Brake
on 20 September 2014**

13 July 2016

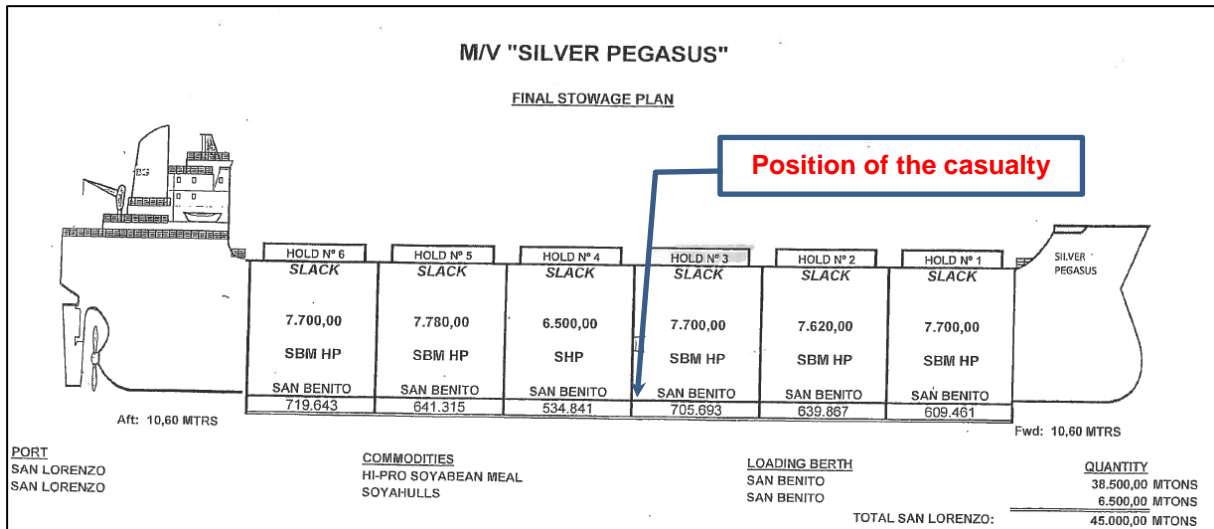
Figure 4: Stowage plan showing the scene of the accident

The MV SILVER PEGASUS, sailing under the flag of Panama, had been situated at the South Pier of the J. Müller Terminal in the port of Brake since 16 September 2014. The loaded soybean meal was discharged completely. The cargo was discharged completely from CH3 on 20 September at 0000. The watchkeeping second officer had been tasked with checking each discharged cargo hold for damage. Therefore, he climbed down the ladder at the aft edge of CH3. Prior to that, he had instructed the able bodied seamen on watch to close the hatch cover of cargo hold 4. The second officer did not reply when they tried to confirm this was done on VHF. The able bodied seamen then searched for him and found him lying on the floor of CH3 at about 0030. While one able bodied seaman also climbed down and established the second officer's severe injuries there, the other ran to the cargo office to alert the master and crew. The crew hurried to the cargo hold immediately to provide first aid. The master called an ambulance via the terminal's staff. This arrived at the ship at 0110 and the emergency physician took charge of the medical treatment. The second officer was lifted out of the 24-metre deep cargo hold with the help of a crane belonging to the terminal at 0140 and placed on the pier. The ambulance took him to the nearest hospital. The injuries to the head and torso were so severe that the second officer succumbed to his injuries at 1742.

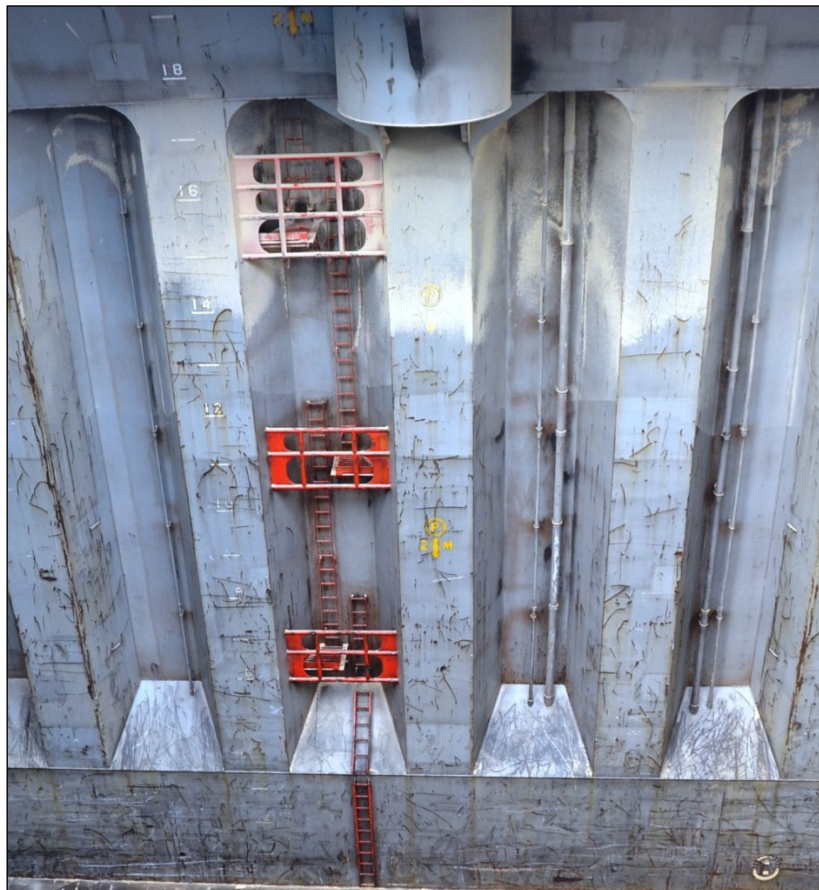
Figure 5: Vertical steps at the aft edge of CH3

Since the casualty was lying on the floor at the aft edge, it is reasonable to assume that he fell from this ladder. This is also supported by the fact that he had previously instructed his two able bodied seamen on watch to close cargo hold 4. The ladder is fixed to the cargo hold wall vertically and separated by three platforms, which are positioned at regular intervals to one another. The ladder does not have any safety measures, such as a safety cage or handrails. Towards the bottom, at a height of three to six metres from the floor, the ladder runs along the wall at an angle and is then vertical again for the last few metres to the floor.

Since no buckling was evident on the platforms or their railings, it is very likely that the second officer fell after he had climbed through the opening on the lowest platform. If he was higher up when he fell, then he would have to land on one of the platforms or buckled the railing there significantly. He would have succumbed to his injuries immediately if he fell unimpeded from a greater height.

The vertical ladder at the aft edge is consistent with the regulations of the ship's classification society. A section towards the bottom is at an angle and represents an additional hazard, however.

The Federal Bureau of Maritime Casualty Investigation recommends that the ship's command of the SILVER PEGASUS instruct its crew to use only the spiral steps when entering cargo holds.

The Federal Bureau of Maritime Casualty Investigation recommends that the owner of the SILVER PEGASUS consider installing personal fall protection equipment on the cargo hold ladders to arrest a fall.

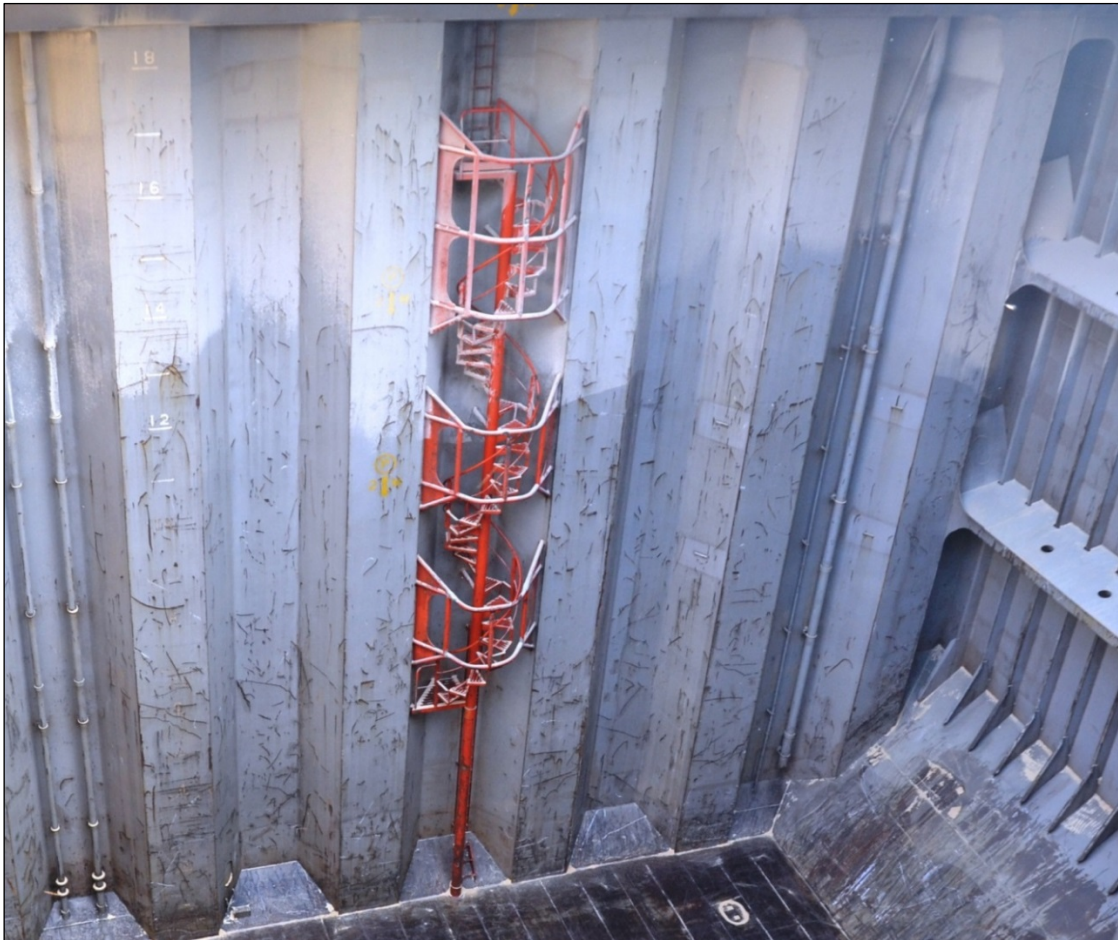
Figure 6: Spiral steps at the forward edge of CH3

The companionway at the forward edge of CH3 consists of spiral steps fitted with a railing and changes to a vertical ladder without protection six metres above the floor.

The spiral steps at the forward edge are also consistent with requirements. It is difficult to understand why the last six metres is continued with a vertical ladder, however. This is also considered a hazard, which could have been avoided by a continuation of the spiral steps to the cargo hold floor.
