**Bundesstelle für Seeunfalluntersuchung**  
**Federal Bureau of Maritime Casualty Investigation**  
Federal Higher Authority subordinated to the Ministry of Transport  
and Digital Infrastructure

Investigation Report 34/15

**Very Serious Marine Casualty**

**Fatal accident**  
**on board the MV HANJIN DALLAS**  
**on 1 February 2015 off the east coast of**  
**the United States**

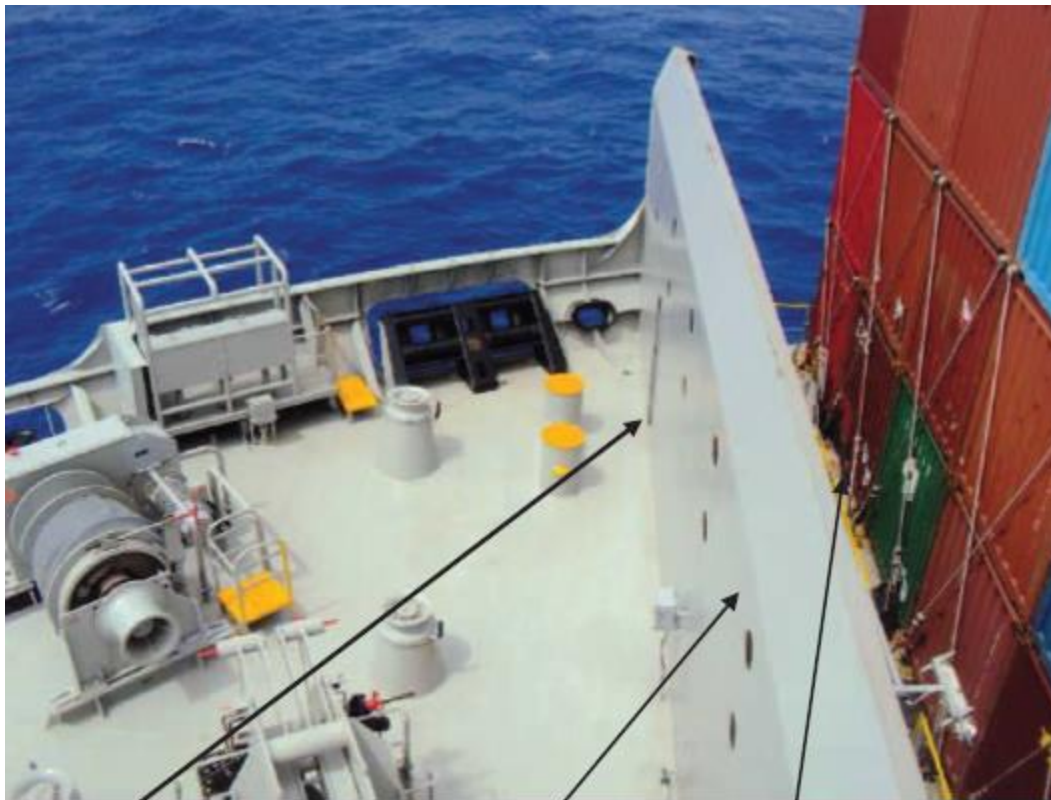
Figure 5: Scene of the accident (view from above)

The scene of the accident is on the starboard side of the forecastle. A breakwater is installed forward of the first container tier, which has a passageway to the forecastle on each side.

Passageway                      Breakwater                      Casualty found here

Due to wash, the bosun was probably struck very unfortunately by waves at the passageway of the breakwater and forced against the containers. The injuries he sustained in the process were so severe that he later succumbed to them.

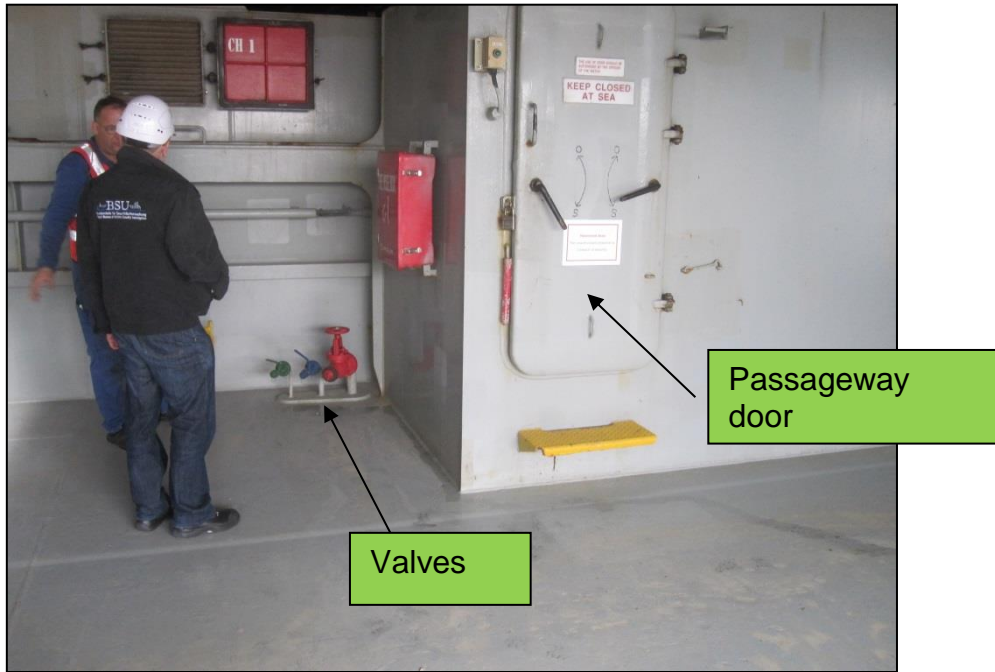
Figure 7: Valves and passageway door

The casualty's position was reconstructed when the scene of the accident was surveyed in the port of New York. The passageway door was closed when the SM went forward. Consequently, it is reasonable to assume that the bosun went forward on the port side of the main deck.

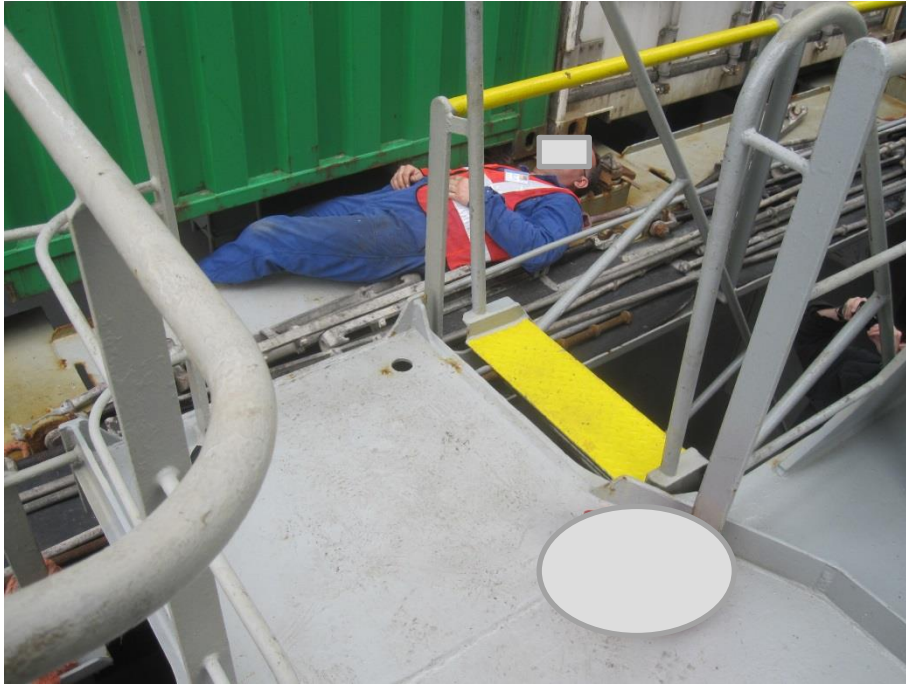
Figure 9: View from fore through the breakwater

The route on the port side of the main deck is initially protected from the wind and waves, leading into the sheltered area on the aft edge of the forecastle behind the breakwater. Steps lead upwards (the last one is painted yellow) and end behind the breakwater where the forecastle passageway is located.

The bosun was found behind the lashing bars (not yet fitted in the above image). The opening in the breakwater that leads to the forecastle is located exactly in the area where the casualty was found.
