Bundesstelle für Seeunfalluntersuchung
Federal Bureau of Maritime Casualty Investigation
Federal Higher Authority subordinated to the Ministry of Transport
and Digital Infrastructure

Investigation Report 34/16

Serious Marine Casualty

Grounding of the CSCL INDIAN OCEAN in the River Elbe on 3 February 2016

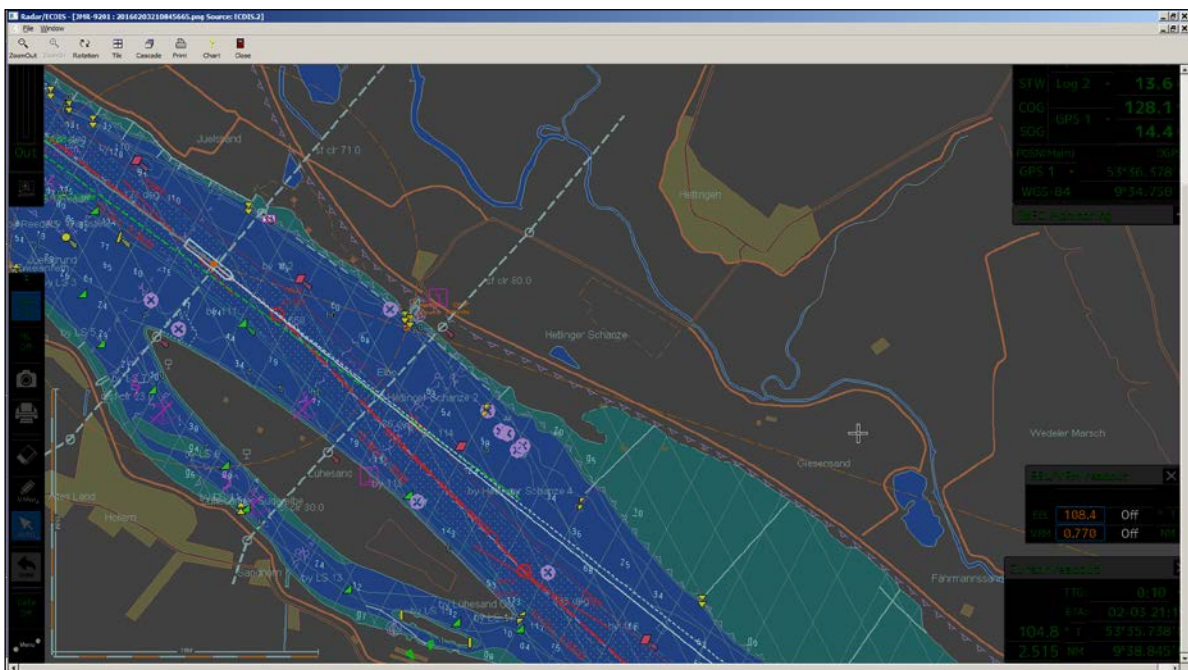
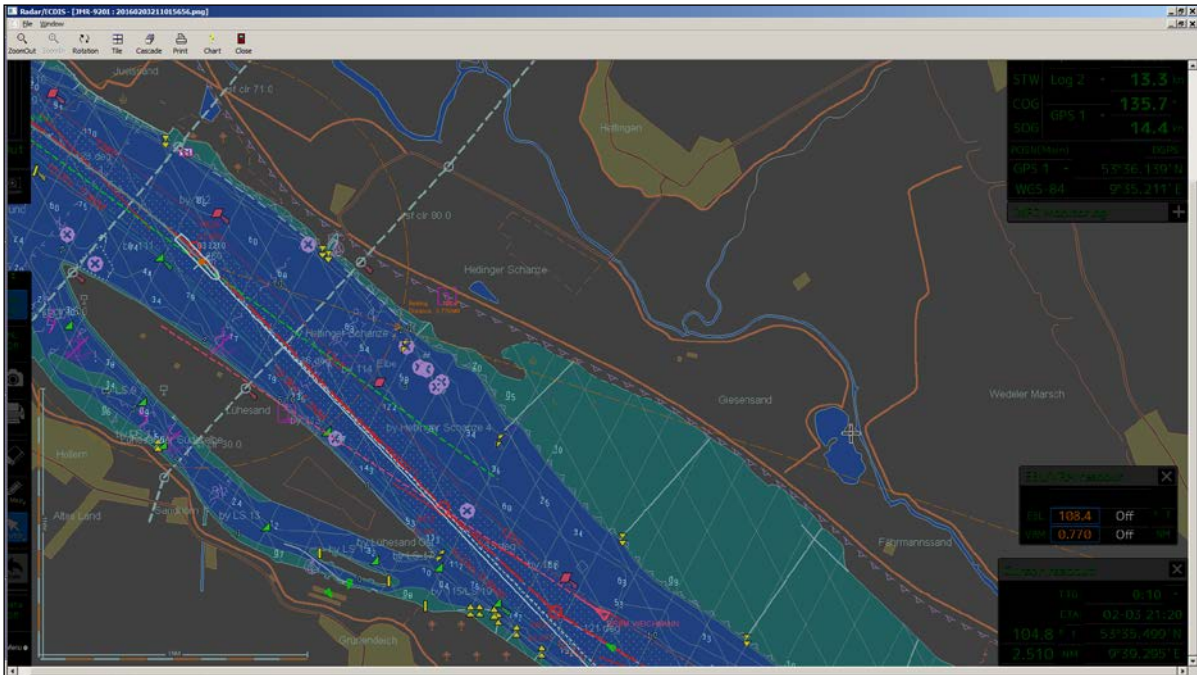
The recorded ECDIS data show clearly that the large container ship passed the first of two high-voltage power lines at Lühesand shortly before the first audible alarm on the bridge. The nautical chart shows that the clearance between water surface and high-voltage power line is 80 m at medium tide height. Since the height of the CSCL INDIAN OCEAN is approximately 69.0 m (including antenna system on the observation deck), a height of approximately 56.9 m remains above the waterline when the current draught of 12.1 m is subtracted. This means that the clearance to the high-voltage power line is approximately 23 m. In the opinion of experts consulted by the BSU, this clearance is wholly adequate, meaning that an electromagnetic effect on the ship's technical installations can be ruled out and that the present case was a random convergence of events (see Figure 6 and Figure 7).

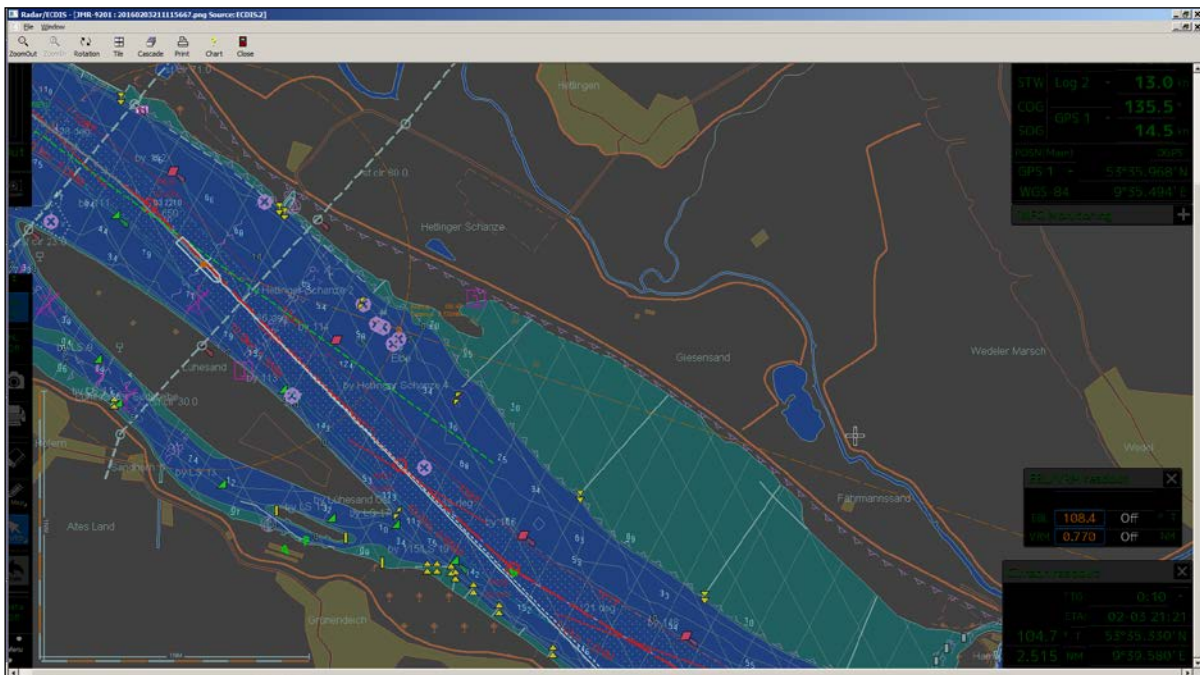
Figure 8: 221124 – helm failure noticed

Figure 8 shows the ship's position (at a speed of $v = 14.5$ kts) when the helm failure was noticed on the bridge. This is easy to follow from the audio recording of the bridge microphones. Unfortunately, the error log recordings of the VDR provide no information as to the cause of the helm failure. Only errors caused by the helm failure are recorded.

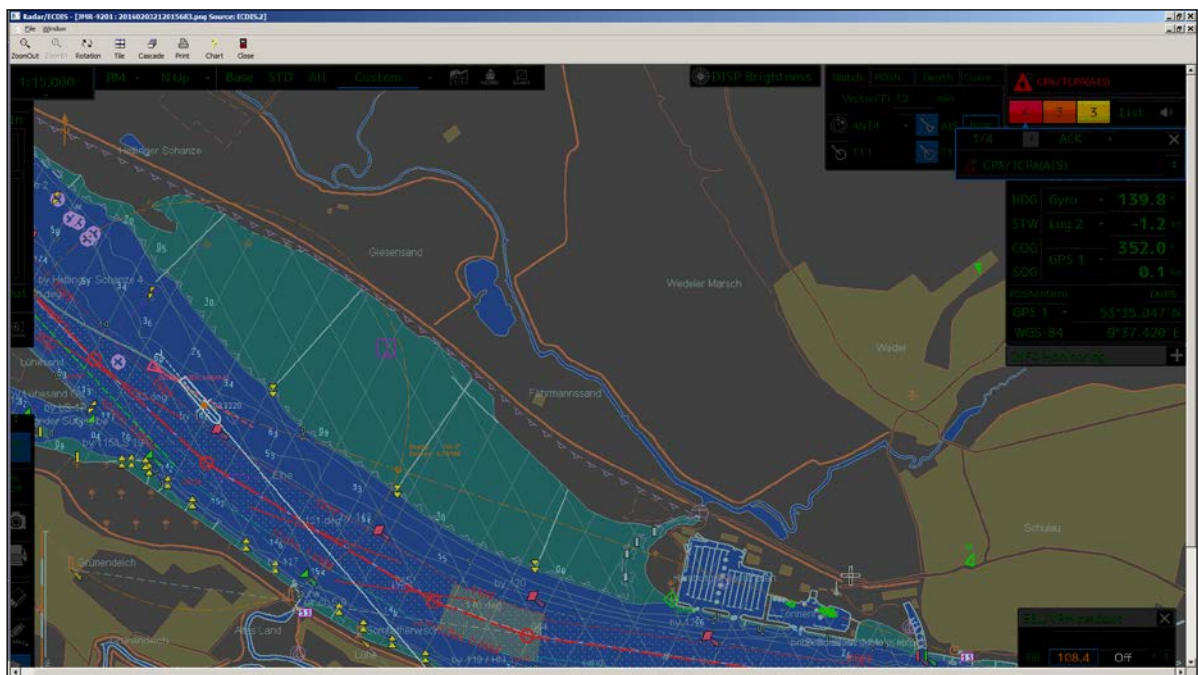
Figure 12: 222010 – grounded: SOG = 0.1 kt

The GPS devices indicate a speed over ground (SOG) of NULL at 222010. The CSCL INDIAN OCEAN's fore section has run aground on the port side.

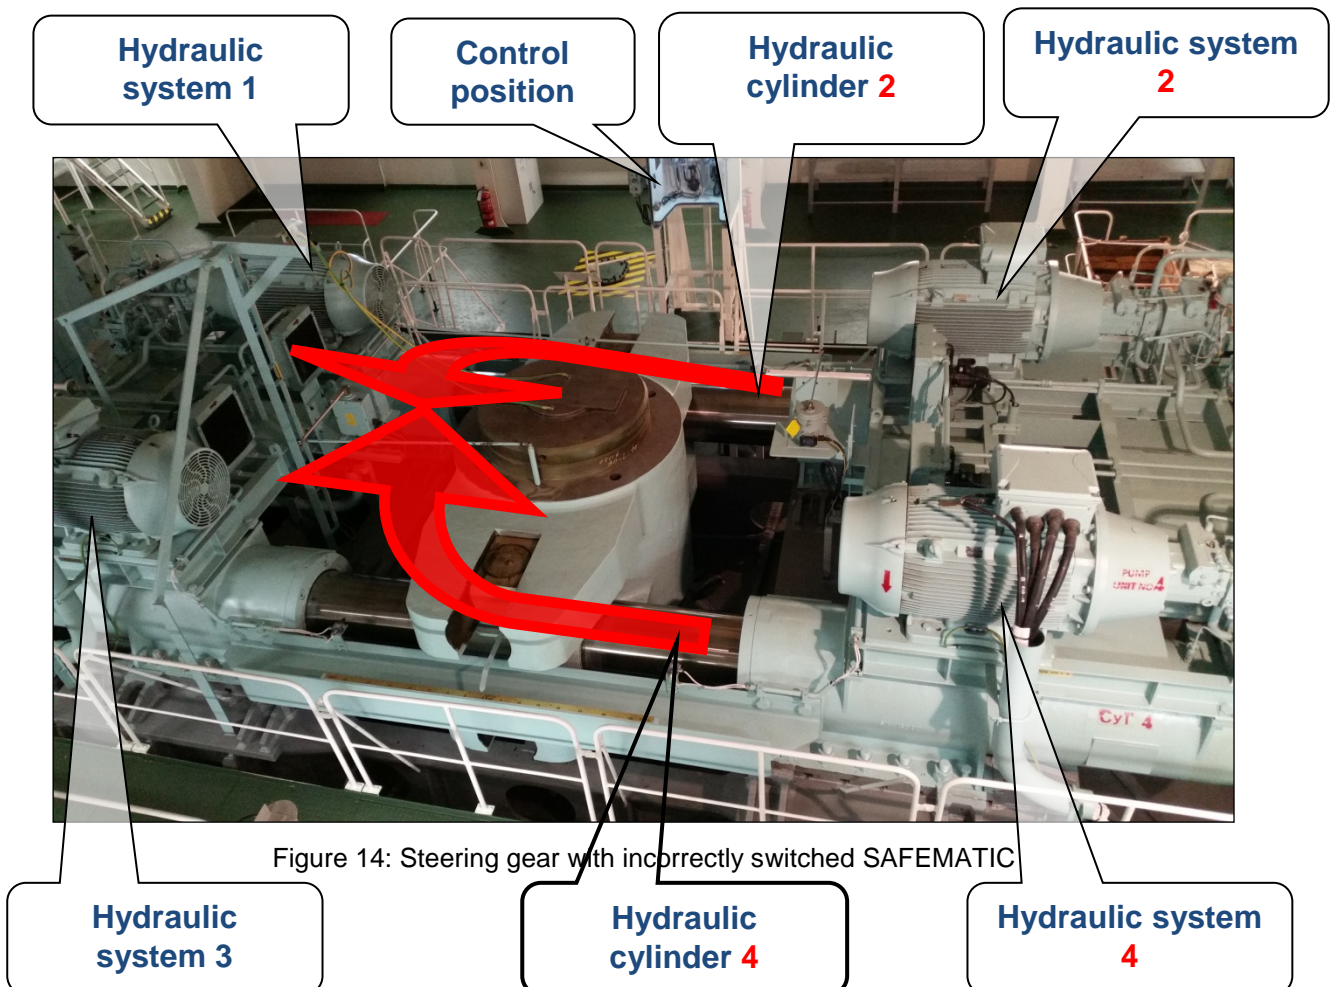
Figure 14: Steering gear with incorrectly switched SAFEMATIC

To check the SAFEMATIC, the test switch at the switch cabinet was pressed (see Figure 15). As expected, two of the four hydraulic units then switched off. The helm failed to respond to any command, however. Following that, each valve was then switched on and off systematically by hand until the helm finally responded. This revealed that the SAFEMATIC was switched incorrectly in that as well as hydraulic cylinder 2 being operated, as intended, hydraulic cylinder 4 was also operated. Regrettably, this was such that both cylinders pressed on the rudderstock simultaneously in the same direction, meaning the rudder was unable to turn. The load on the rudder's mounting was enormous (see Figure 14).

Figure 22 shows the same chart. This shows how the incorrectly connected cables found affect the hydraulic fluid's routing. Under these conditions, the SAFEMATIC valve 2 is inactive, while 1 opens. Accordingly, valve 2 allows the flow of oil up to valve block 1 on the port side, where a valve that builds a connection back to valve block 2 is thus opened. A hydraulic short circuit is created, which causes cylinders 2 and 4 to activate, meaning they block each other mutually. The rudder is now unable to move. Instead, extremely large forces now act on the rudder's mounting.

The Federal Bureau of Maritime Casualty Investigation recommends that the owner inspect sister ships to determine whether their SAFEMATIC is also wired incorrectly and whether the cables of the hydraulic locking system also terminate at a switch cabinet.

The BSU recommends that the classification society broaden the periodic inspections of the SAFEMATIC to include the implementation of a helm manoeuvre in SAFEMATIC mode.

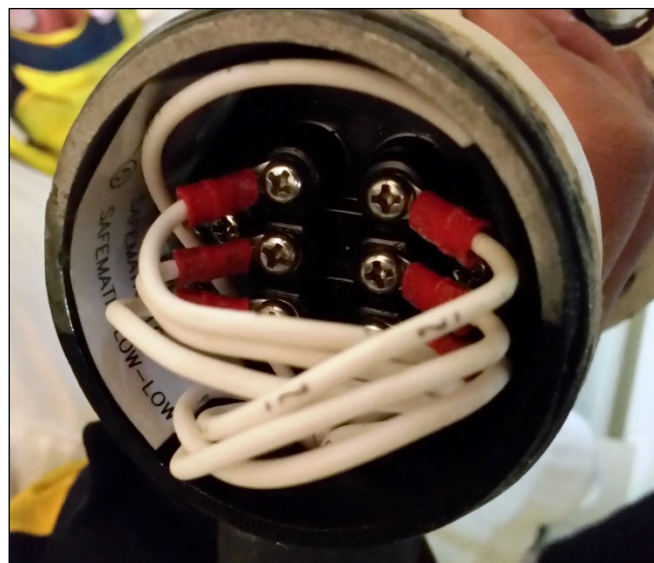
Figure 16: Float switch's contact panel

Since there was no evidence whatsoever of any leakage, it is reasonable to assume that there was no leakage in the hydraulic system. From this point, a float switch malfunction would be conceivable. The expert disassembled and tested this completely on behalf of the BSU on 11 February 2016. Figure 16 shows the clean contact panel of the float switch. No faults were found, however. The float switch operated as it should.

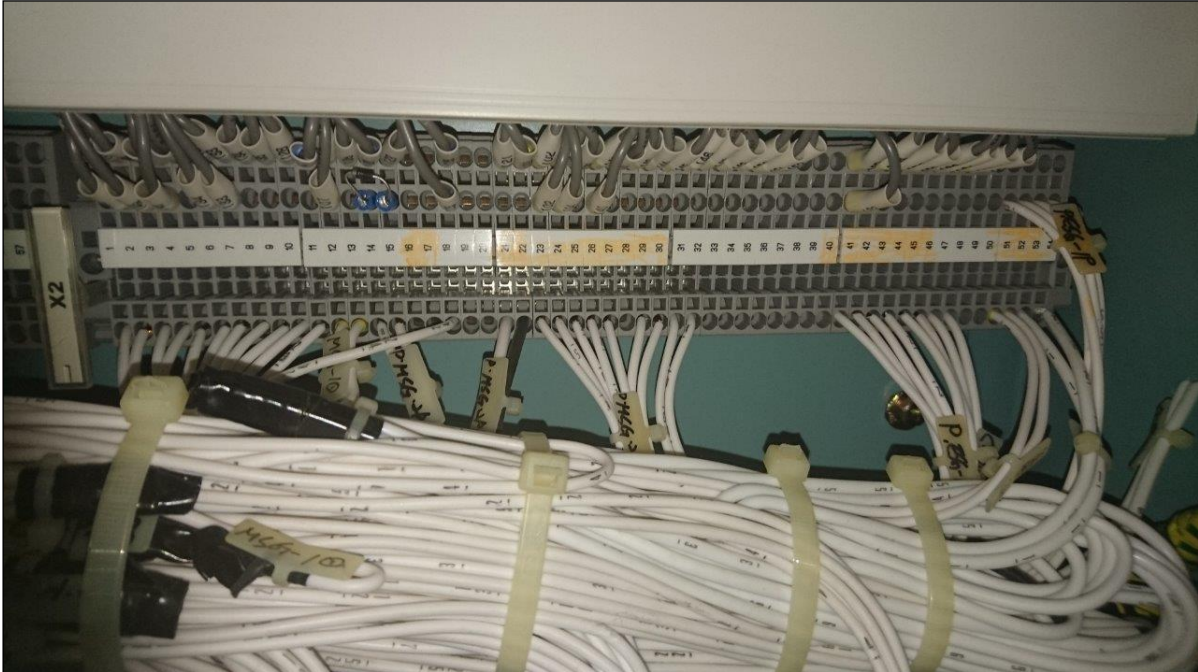
Figure 17: Terminal strip in the wiring cabinet

This valve's connections were inspected. In the associated switch cabinet, the fault, which resulted in the incorrect switching of two valves, was then detected in the terminal strip (see Figure 17).

The accident was caused by incorrect wiring in the SAFEMATIC. It was not possible to demonstrate why this system activated, however. The data stored in the VDR are not detailed enough for this. The engine room computer's error logs did not indicate any cause, either. It was also not recorded, if the ships command attempted to reactivate the steering gear after it had failed by means of the mandatory redundancies. With that in mind, it would be beneficial if modern steering gear stored a separate error log so that errors can be better analysed and avoided in the future.

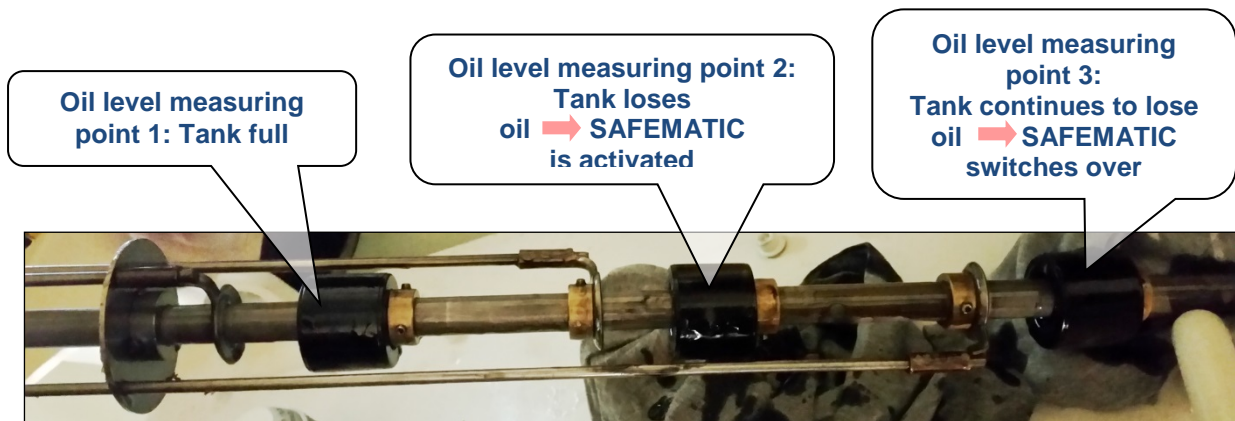
Figure 20: Removed float switch

Alternatives 2 and 3 can be ruled out because according to witness testimony, no one was situated in the steering gear compartment.
No other alternative was found than a random malfunction of the float switch.

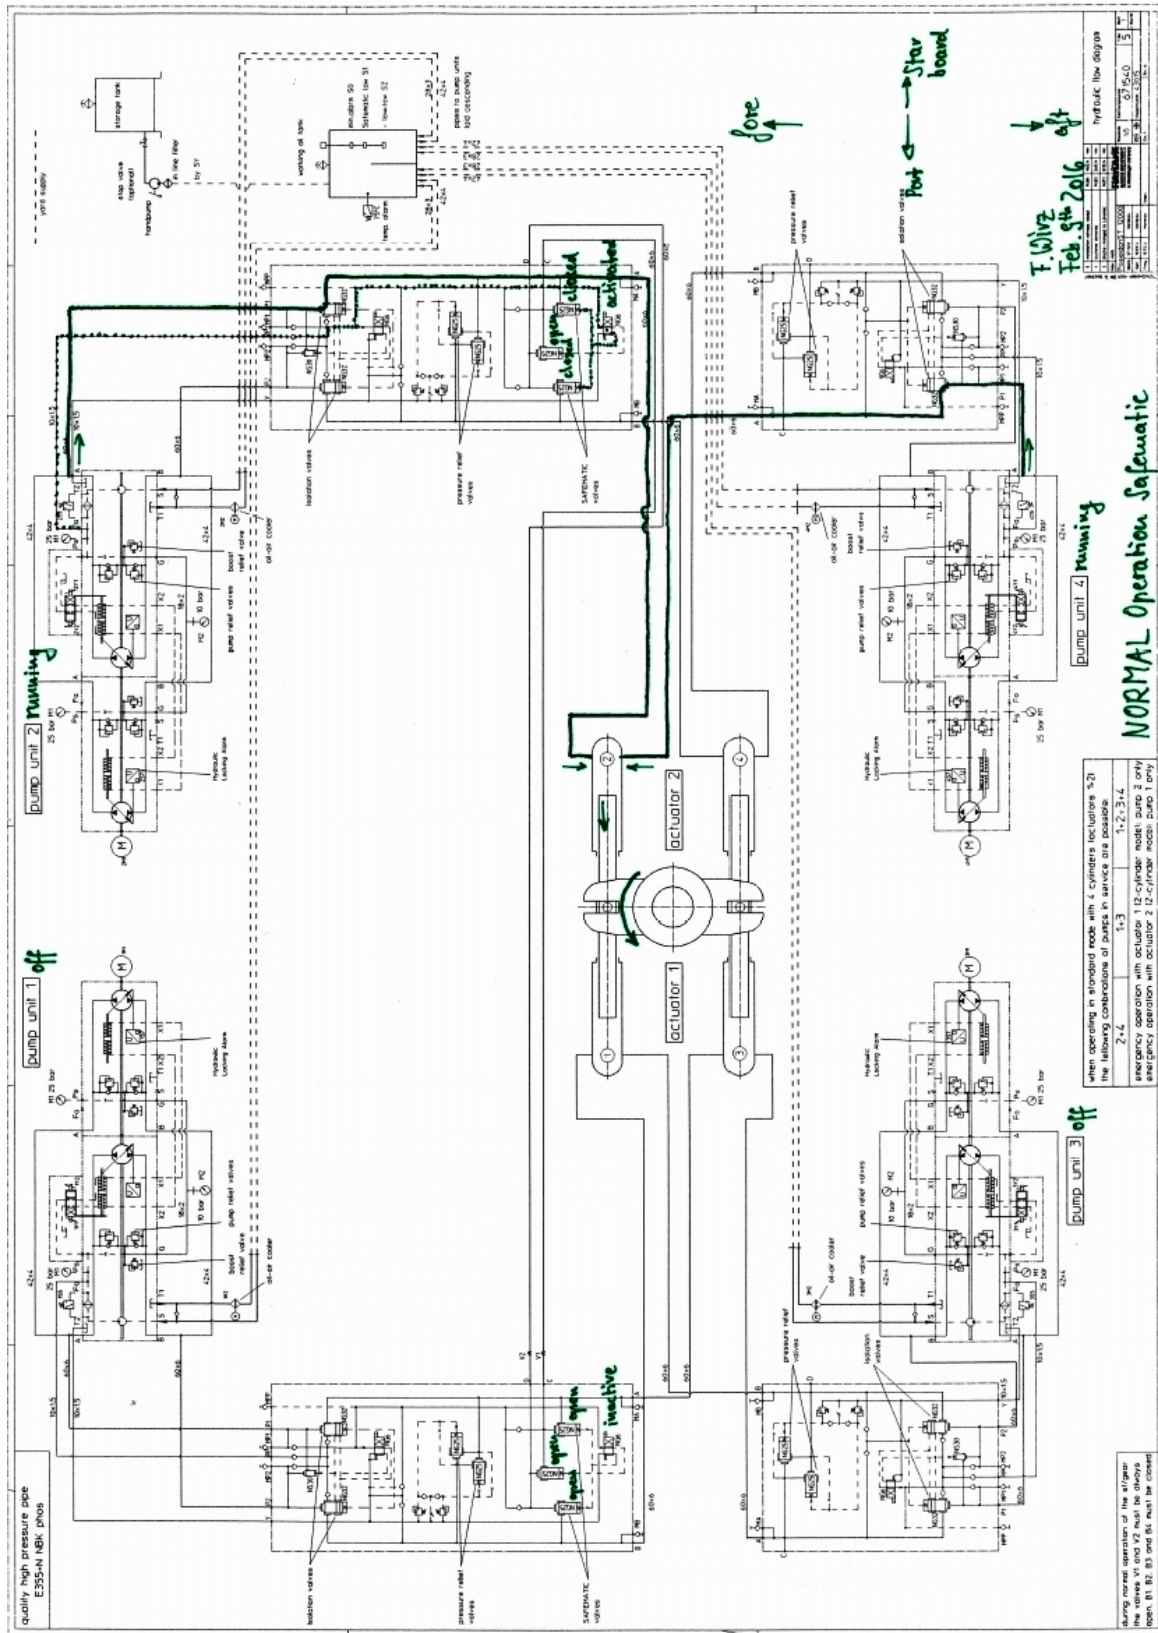
Figure 21: SAFEMATIC functioning as it should

Figure 21 shows the steering gear's hydraulic flow chart. The hydraulic fluid's routing in SAFEMATIC mode is shown in green. As an example, it is assumed here that the rudder should turn anti-clockwise, meaning hydraulic line 'A' is under pressure. This means that pump 2 operates after the float switch has indicated an initial drop in the tank's oil level. The activation of valve 2 by the SAFEMATIC separates the two hydraulic circuits from one another, meaning only cylinder 2 moves so as to move the rudder.
