Bundesstelle für Seeunfalluntersuchung
Federal Bureau of Maritime Casualty Investigation
Bundesoberbehörde im Geschäftsbereich des Bundesministeriums
für Verkehr und digitale Infrastruktur

Investigation Report 36/14

Serious Marine Casualty

**Collision between the WES JANINE and
STENBERG on the Northwest-Reede anchorage
off Brunsbüttel on 16 January 2014**

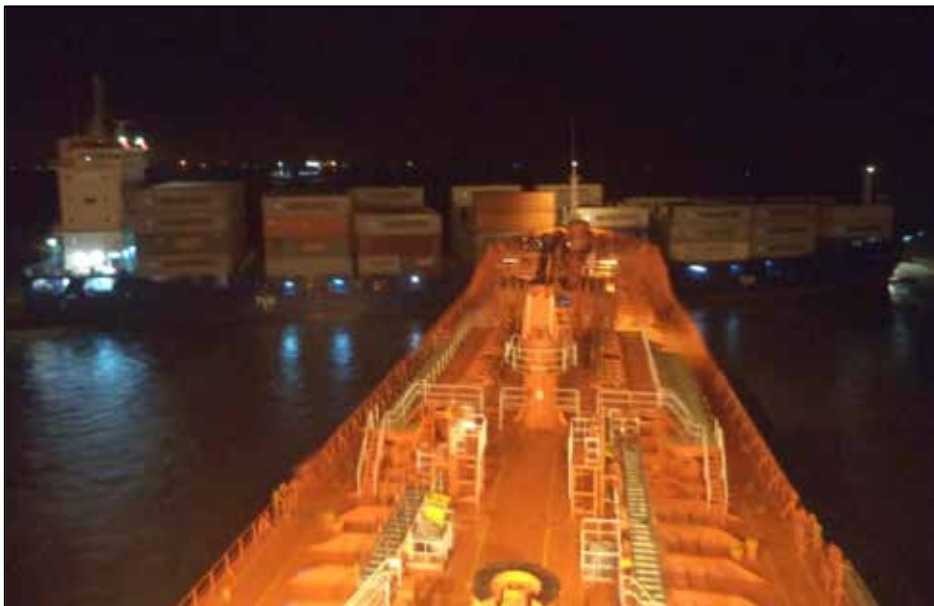
Figure 4: Collision between the WES JANINE and STENBERG at 0604

Since the STENBERG's anchor cable was more or less preventing the WES JANINE's stern from moving and the ebb current acted on the port side of the container ship, a strong shear effect was produced. The WES JANINE turned to starboard and across the current and the tug was thus no longer able to control her. The WES JANINE continued to drift towards the STENBERG, resulting in a minor collision with the STENBERG at 0604.

Since the STENBERG's anchor cable was preventing the WES JANINE's stern from moving, the tug was unable to hold the WES JANINE against the current. The two ships collided at 0604. As a result of the discussion between the ship's command and pilot, a further tug was ordered at 0606.

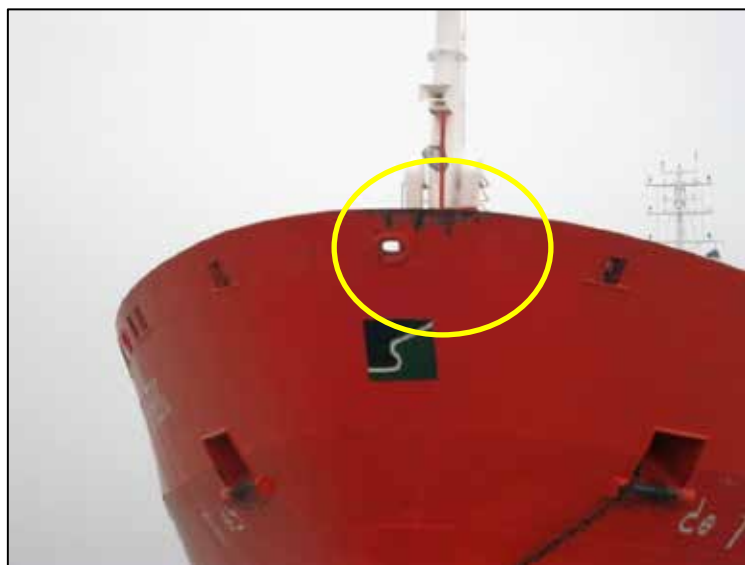
Figure 5: STENBERG with minor damage to her bow

The collision resulted in paint abrasion on the STENBERG's bow (Figure 5). Three containers on board the WES JANINE were dented (Figure 6). Moreover, her hull was dented by the STENBERG's bulbous bow.

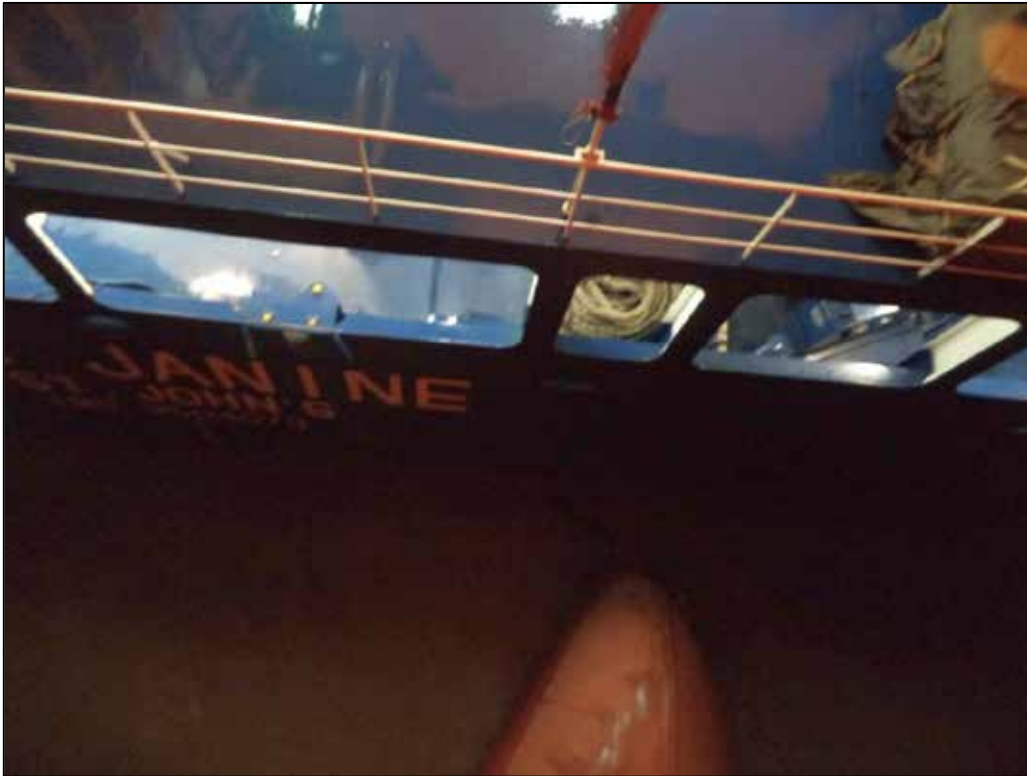
Figure 7: The WES JANINE converging with the STENBERG

At 0527, the officer in charge of the navigational watch on the STENBERG noticed the convergence of the WES JANINE. He immediately informed the pilot, who was resting on the bridge sofa, the master, and the watchkeeping engineer. At this point, the distance between the two ships was estimated at 50 m. Shortly after, the WES JANINE's stern converged to up to 2 m.

Another four chain lengths were paid out at 0532 to increase the distance to the WES JANINE.

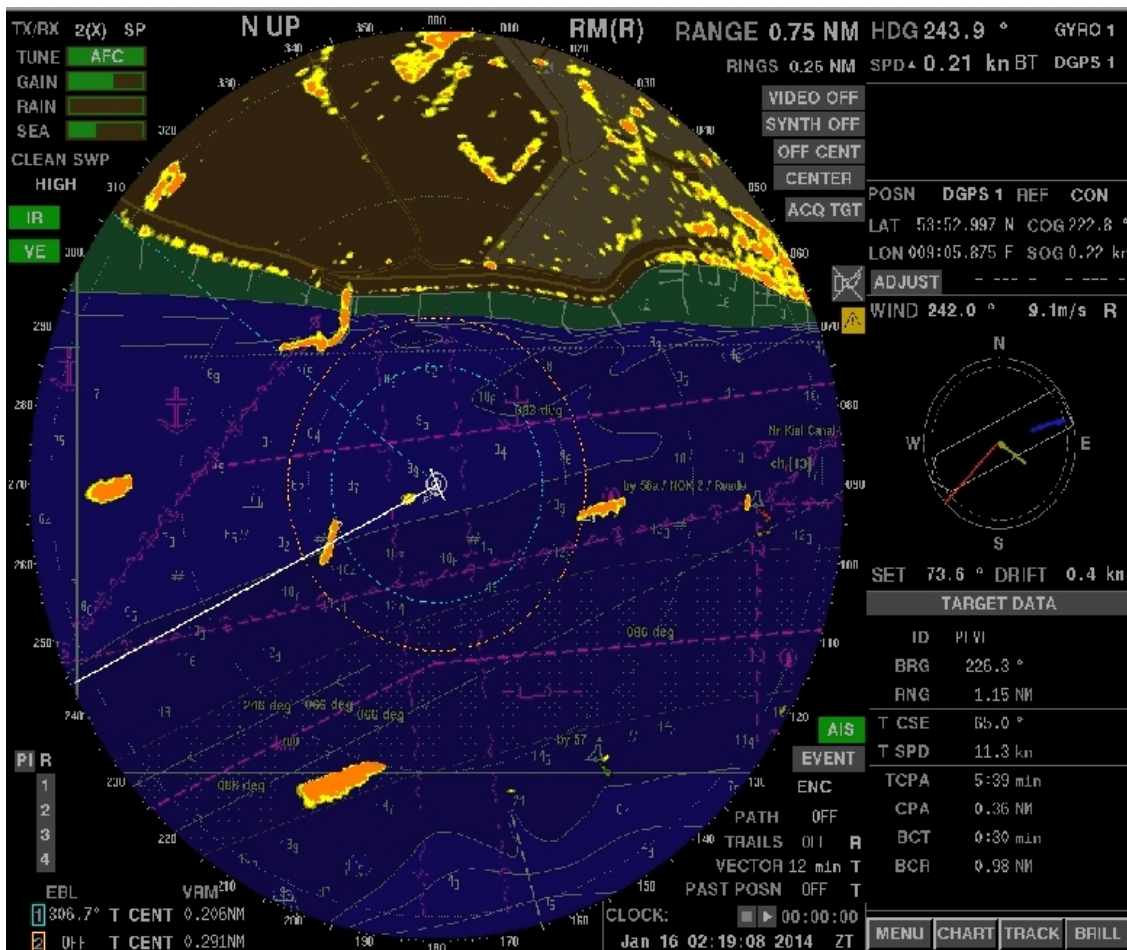
Figure 10: WES JANINE – image from radar 2 at 0219²

After the anchor manoeuvre was completed, the VRMs and EBL of radar unit 2 were set so that they could be used to monitor the position and the distances to the adjacent laid-up vessels (Figure 10). The distances to the STENBERG and RIJNBORG were 0.206 nm and 0.291 nm respectively. The EBL was pointing at the western corner of the ferry terminal (radar bearing: 306.7°). No corresponding settings were made on radar unit 1.

The subsequent change in the position of the ship due to the turn of the tide did not result in an adjustment of the range markers or EBL on board the ship.

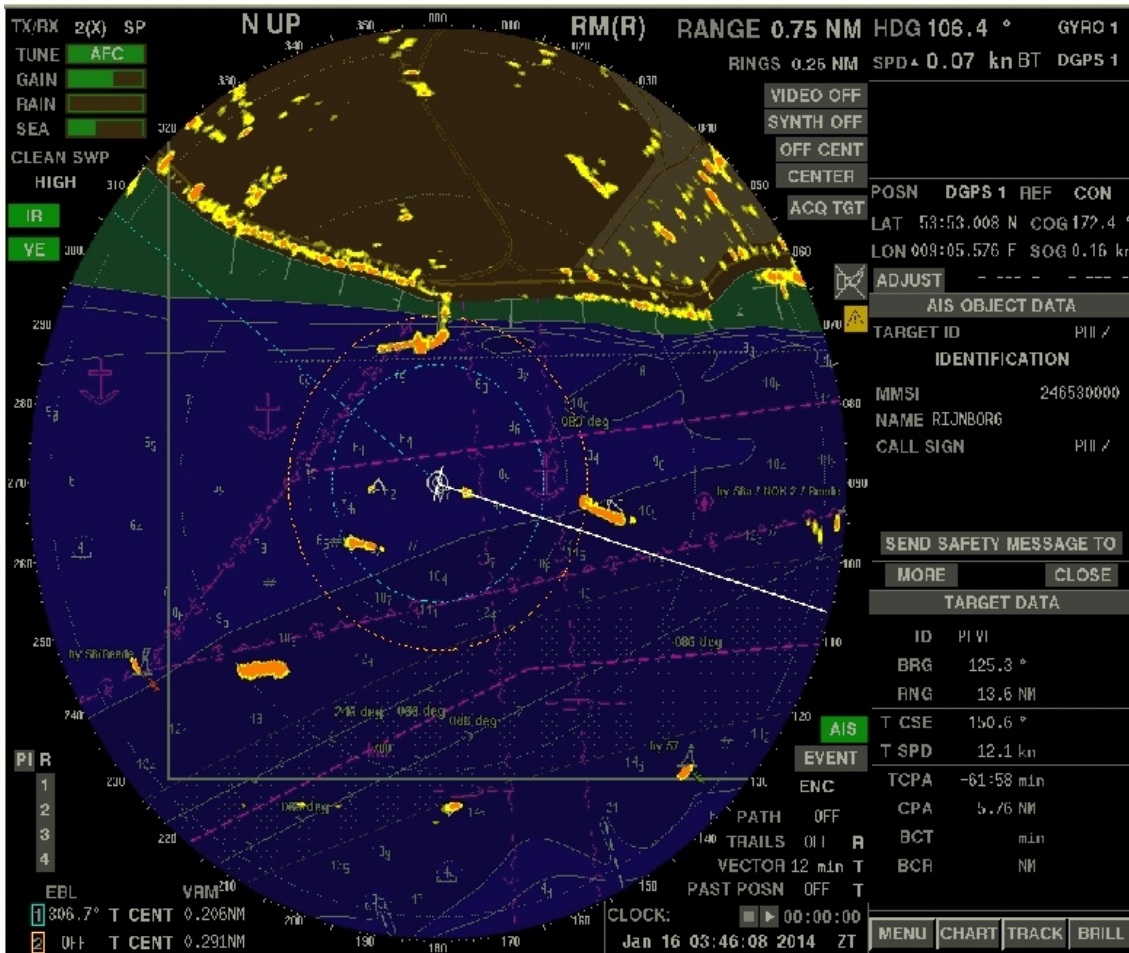
Figure 11: WES JANINE – image from radar 2 at 0346

However, it was still possible to use the VRMs to monitor and assess the situation because they were set approximately to a corner of the respective radar echo. Other technical aids like setting an anchor alarm in the GPS were not used.

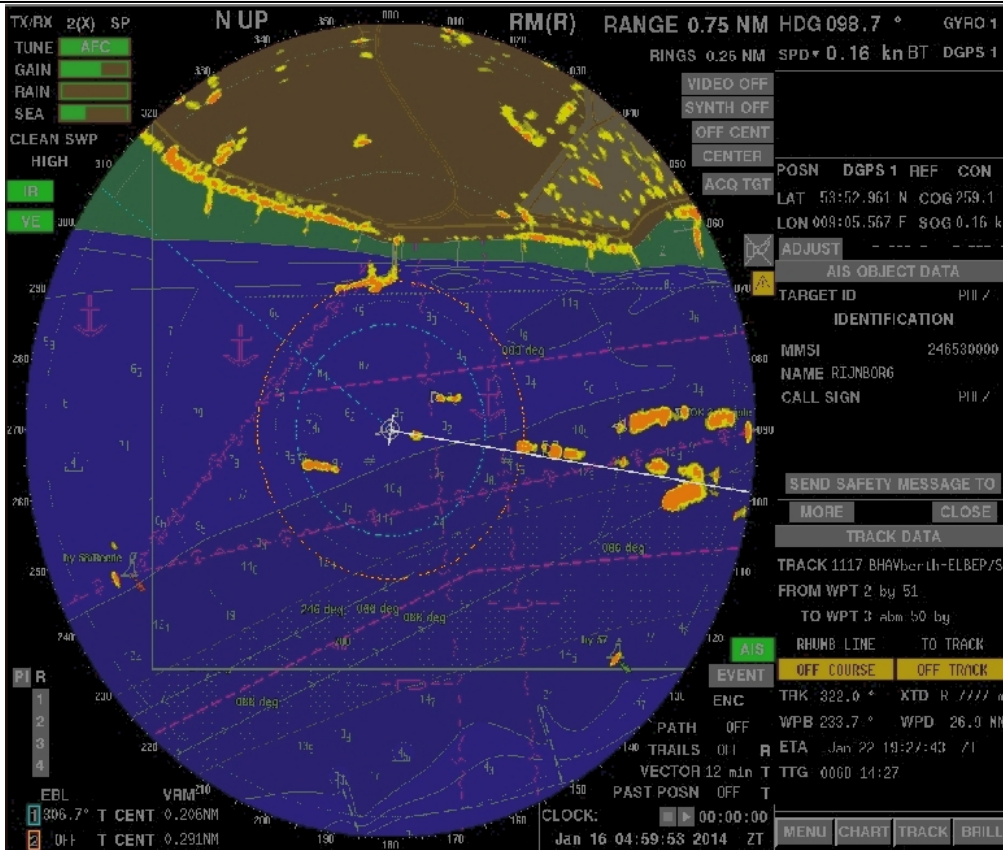
Figure 12: WES JANINE – image from radar 2 at 0500

The WES JANINE started to drift at about 0450. This was evident from both the change in the position of the range markers in relation to the reference objects and increase in speed on the radar screen. The displayed motion vector also continuously pointed towards the STENBERG. It appears that the officer in charge of the navigational watch noticed a change in the anchor position at 0502. As a result, he selected the STENBERG as a radar echo to track in radar unit 1 (Figure 13). Although the speed (drift velocity) of his own ship increased further and the distance to the STENBERG, shown as a digital value on radar unit 1, dropped, it appears that initially no other action was taken.

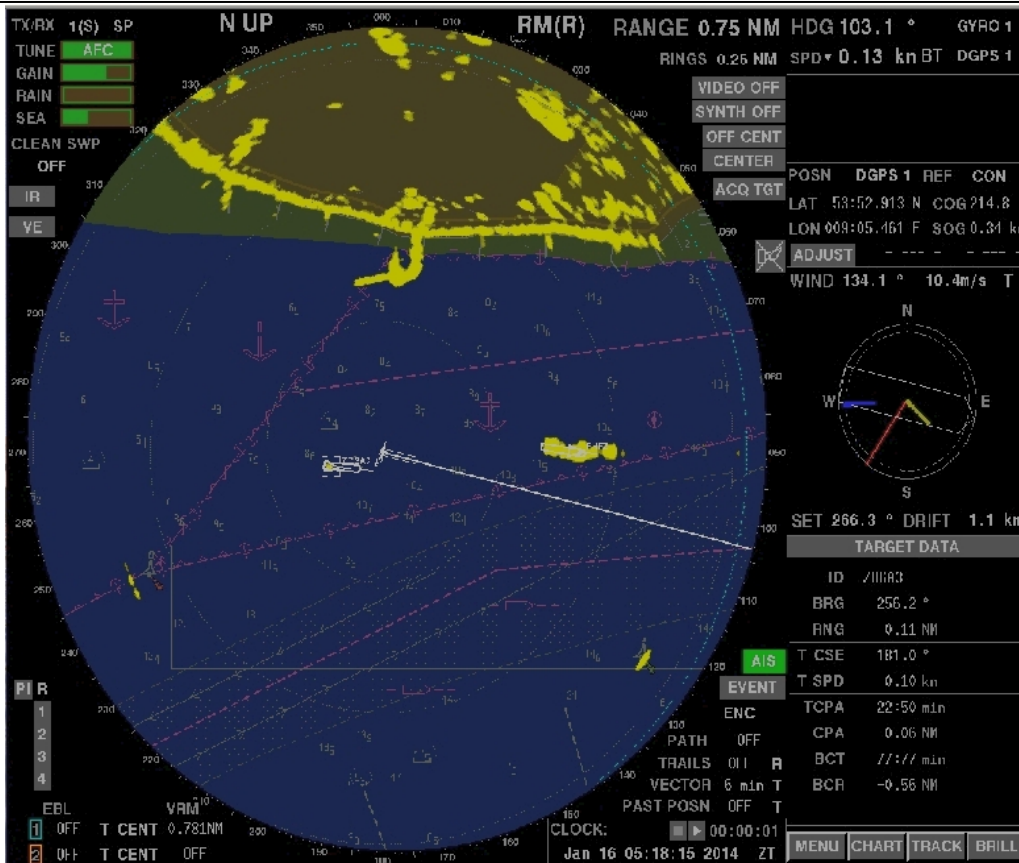
Figure 16: WES JANINE – image from radar 1 at 0518

At 0518, the officer in charge of the navigational watch on the WES JANINE called the pilot by phone and requested that he come to the bridge (Figure 16). The distance between the ships³ was about 80 m at this point. When the pilot arrived at 051930, the officer in charge of the navigational watch asked whether he should start the engine, to which the pilot said yes. The pilot then acquired information as to what ship they were currently approaching from the indicators. The master arrived on the bridge shortly afterwards. The pilot issued an instruction to weigh anchor at 0526 (Figure 17). He had been waiting for the engine to be started prior to that. At 052650, the STENBERG's pilot asked on VHF whether the close convergence had already been noticed on board the WES JANINE. The WES JANINE's pilot confirmed this. There had been no communication between the two ships prior to that.

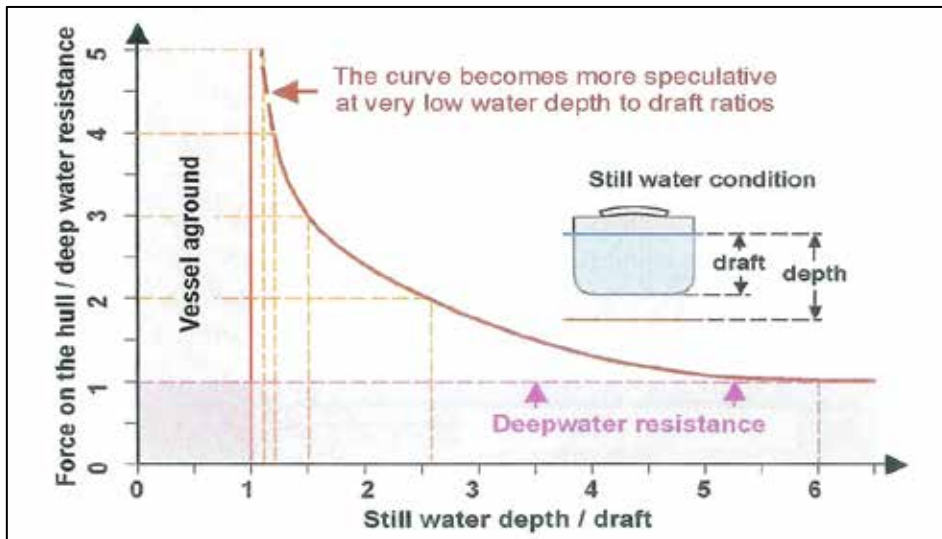
Graph 1: Forces on the ship based on draught and water depth

The anchorages in this area of the River Elbe are exposed to relatively strong currents. At the same time, the influence of the current on the ship, i.e. the force acting on the hull, rises concomitantly with the drop in underkeel clearance¹⁴, meaning the ratio of ship's draught to water depth changes. The increase in force acting on the hull at a constant current velocity can be taken from Graph 1.

The following values arise when the graph is applied to the present case. The water level stood at 12.3 m (section 3.2.4) when the ship was arriving at the anchorage. Her mean draught amounted to 7.75 m, which results in a water depth to draught ratio of approximately 1.6. The graph thus indicates that the force acting on the hull's value increases by a factor of 2.9 as compared to the deep water situation.
