Investigation Report 370/14

Very Serious Marine Casualty

**Foundering of the grab dredger ZANDER
and drowning of two seamen
on 24 November 2014
in the North Sea north of Norderney**

1 July 2016

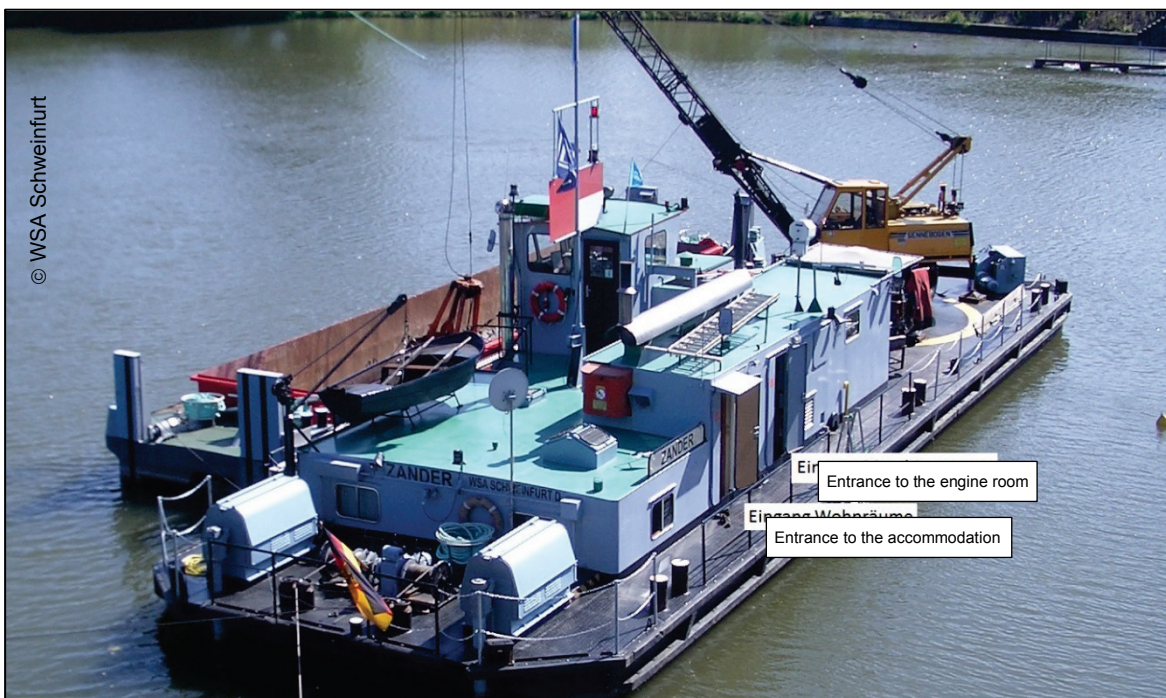
Figure 3: Access points to the accommodation and engine room

The superstructure stretched about three quarters of the breadth of the ship above the engine room, the accommodation, and part of the stowage compartment. Consequently, a side deck of 1 m in breadth remained at the port and starboard side of the main deck. In each case, the accommodation and the engine room were only accessible via a door and the adjoining companionway on the starboard side (see Fig. 3).

A so-called ship spotter photographed the ZANDER in the Kiel Canal during her transfer voyage. A comparison of Figs. 3 and 4 shows that the lifebuoy on the wheelhouse's aft wall was removed and had not been replaced. Accordingly, one lifebuoy had been mounted fore and one aft of the superstructure, both so that they could float free from their stowed position. The buyer stated that it had placed on board an inflatable liferaft, lifejackets, survival suits, hand flares, and a first aid kit specifically for the transfer voyage across the Baltic Sea and North Sea. According to the vendor, the additional life-saving appliances had been stowed in the forward superstructure at the beginning of the transfer voyage. The following life-saving appliances were recovered after the vessel foundered: one Merman 14 A foam lifejacket, one 150 N inflatable lifejacket (inflated), two ISS 590 survival suits, and

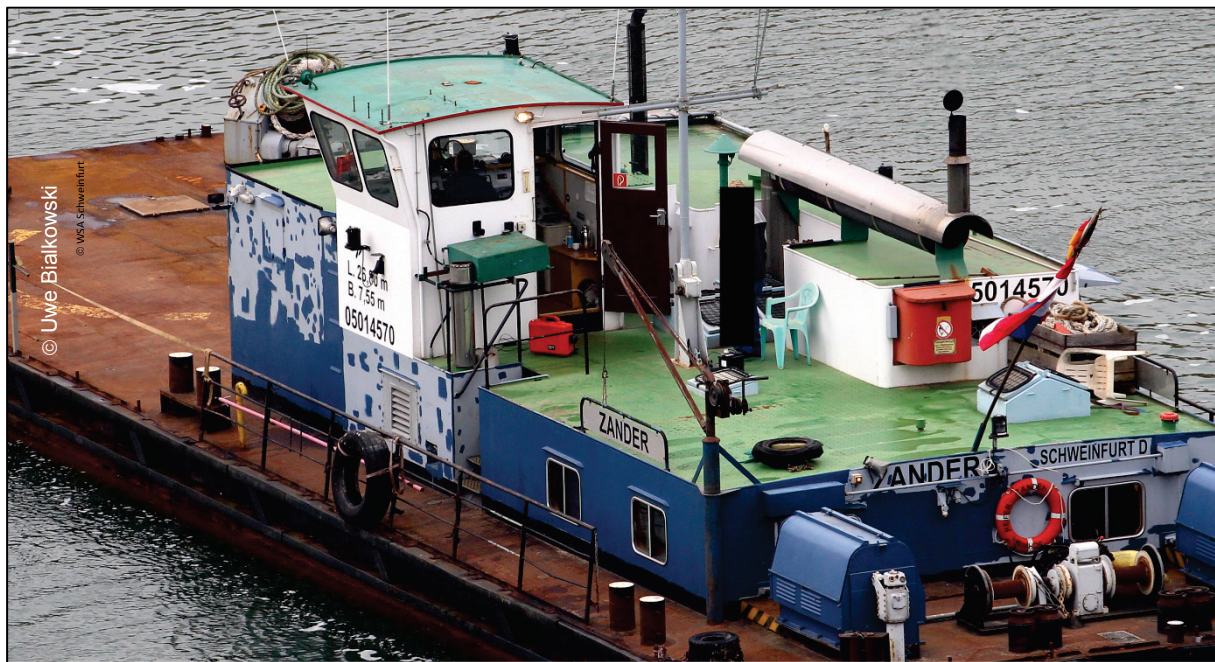
Figure 4: Access to the wheelhouse

The stowage compartment was accessible via a companionway located in the forward superstructure and four flush-mounted hatches that differed in size and were located on the main deck. The ballast tanks and void were accessible via manholes flush-mounted on the deck. The wheelhouse was located on the port side above the engine room. The wheelhouse was accessed via steps on the port side (see Fig. 4).

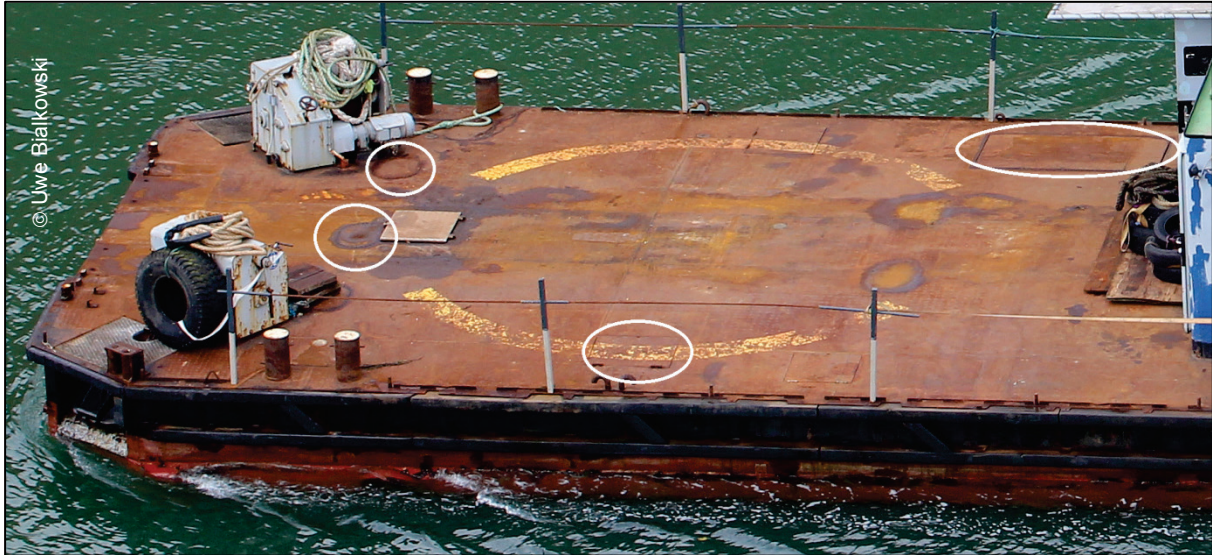
Figure 13: Deck openings on the fore section

All the window panes were cracked. All the doors were absent and in some instances laying right next to the wreck. Two manholes on the main deck, which belonged to the forward ballast tanks, were open. Their covers were not found. Two hatch covers over the stowage compartment were also absent. One hatch cover was found right next to the wreck. The open manholes and hatches identified are marked in Fig. 13.

Apart from the ventilation pipes, water could also have penetrated through the numerous deck openings. The absence of the manhole covers indicates that they were not screwed down properly. The doors in the forward superstructure (see Fig. 16) had a low coaming and could not be closed weathertight¹⁰, meaning it is also likely that water had penetrated into the stowage compartment through them. In contrast to all the other life-saving appliances, the lifebuoys mounted fore and aft were not seen after the ZANDER foundered. It is possible that they had already been caught by a wave and washed overboard.

The investigators assume that rather than being removed by the crew, the absent manhole and hatch covers were pushed out by excess pressure that had built up when the vessel foundered.

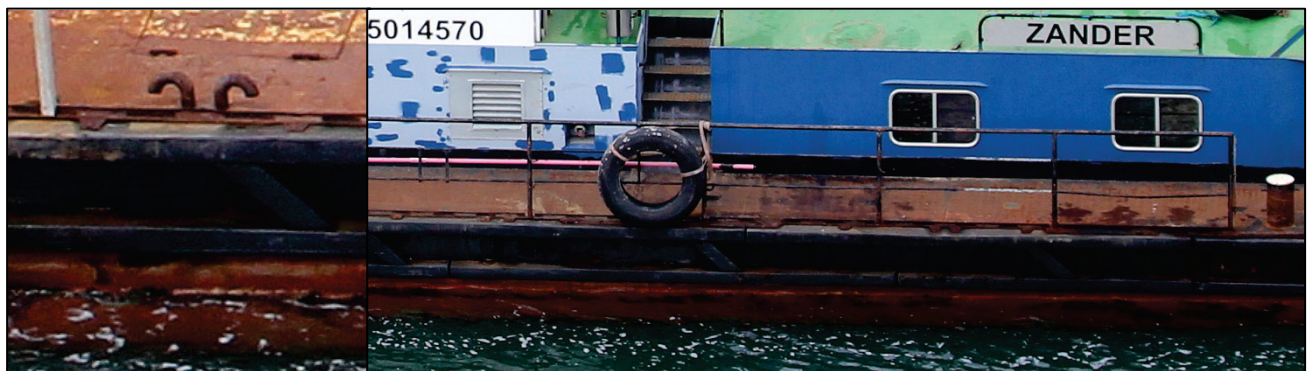
Figure 14: Ventilation intakes and windows

A permit for the ZANDER was not requested from the Ship Safety Division (BG Verkehr). It is also evident that the ZANDER was not eligible for a permit on account of her condition, however. The photographs of the ZANDER taken on 22 November 2014 when she was transiting the Kiel Canal show, inter alia, that engine room ventilation pipes and ventilation intakes were not closed. The accommodation's windows (simple design) were not fitted with deadlights.
