Investigation Report 94/15

Serious Marine Casualty

Collision between the SAINT GEORGE and a lock gate at Brunsbüttel on 20 March 2015

21 March 2016

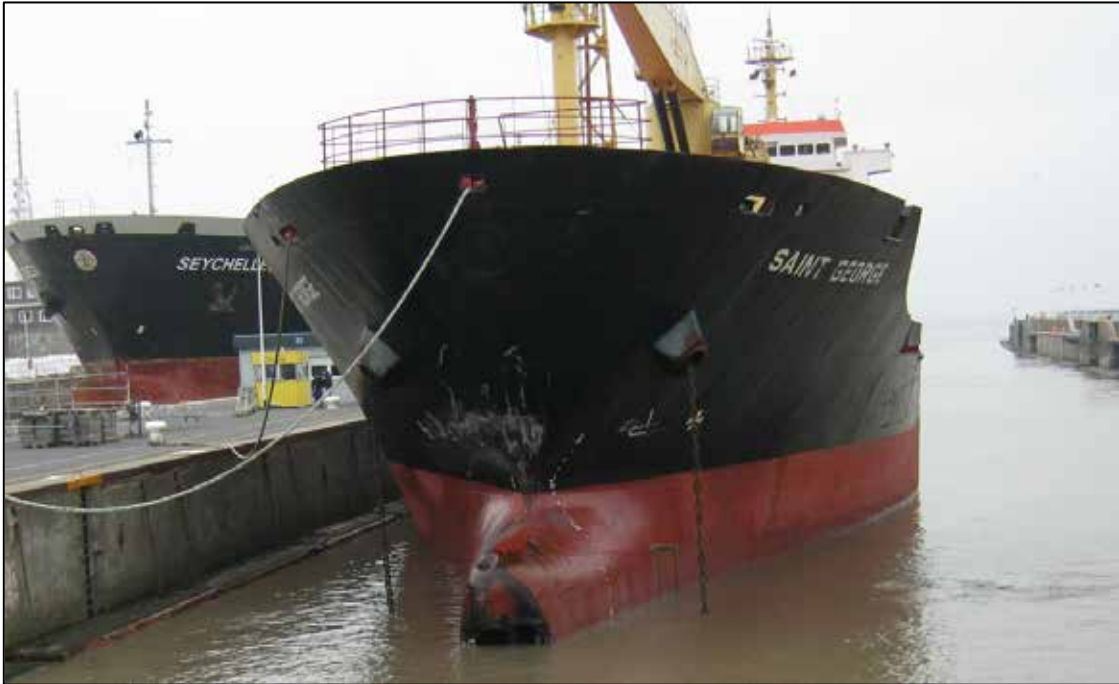
Both ship and lock gate were considerably damaged as a result of the collision. The SAINT GEORGE's bulbous bow was severely damaged and there was water ingress via a hole of some 0.8 m x 1.5 m. The fore section was also dented above the waterline. The SAINT GEORGE remained in the lock to begin with an initial investigation. After that, she received a specific approval to proceed under her own power to a shipyard in Rendsburg for repairs.

Figure 3: Damage to the fore section

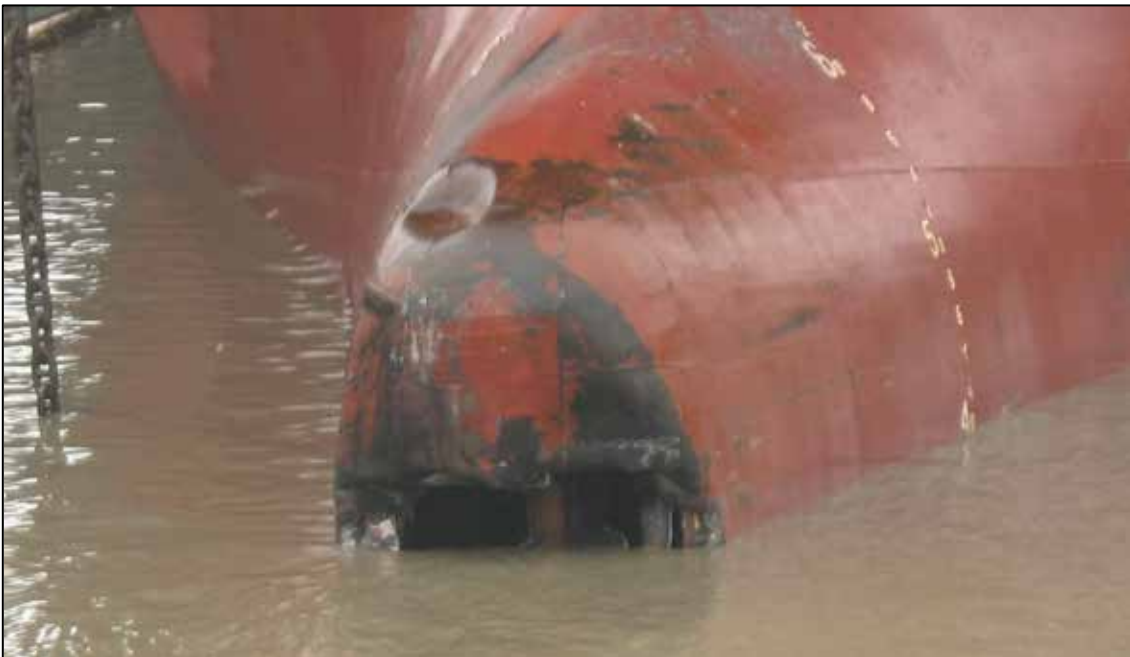
Figure 4: Hole in the bulbous bow

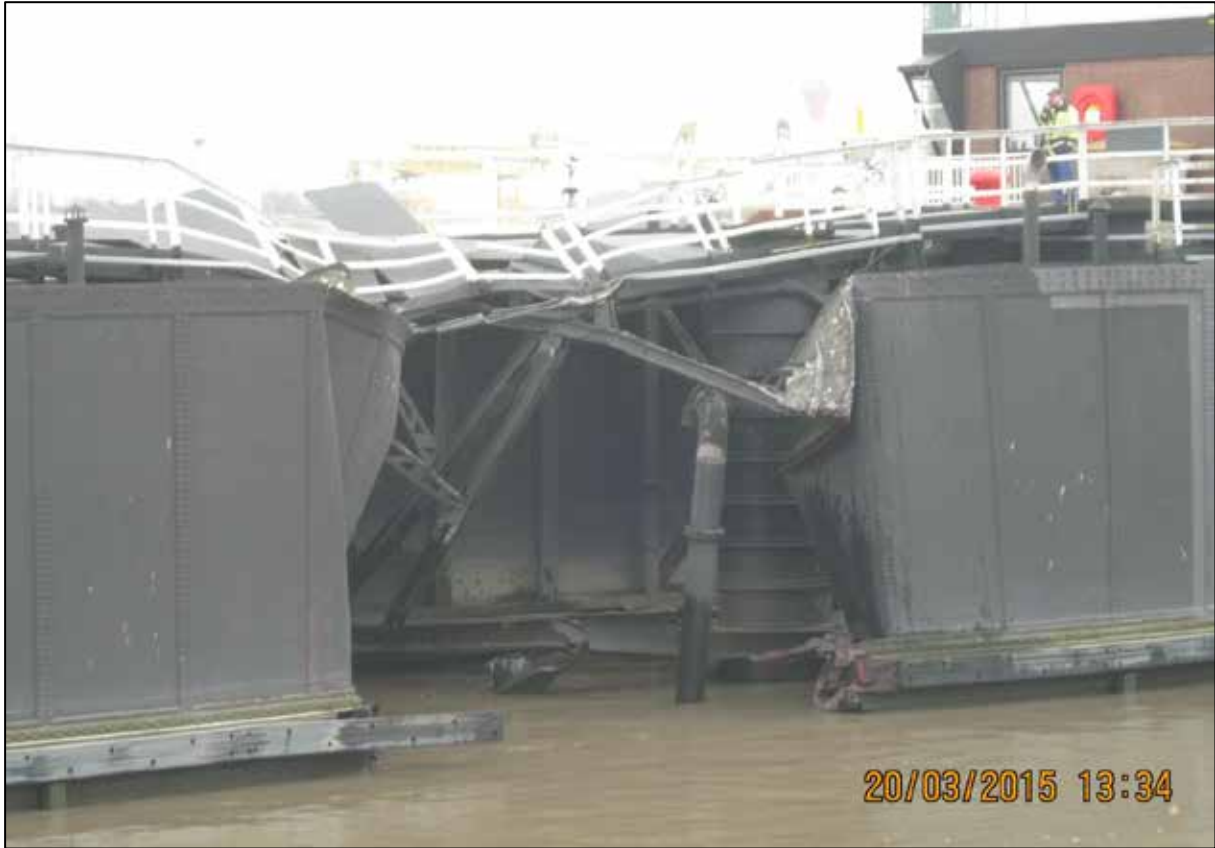
Due to the force of the collision, the lock gate was almost split in two. Moving it was no longer possible and it could not be repaired at the scene. Since a replacement gate was initially not available, there were major traffic delays on the Kiel Canal.

Figure 5: Damage to the lock gate

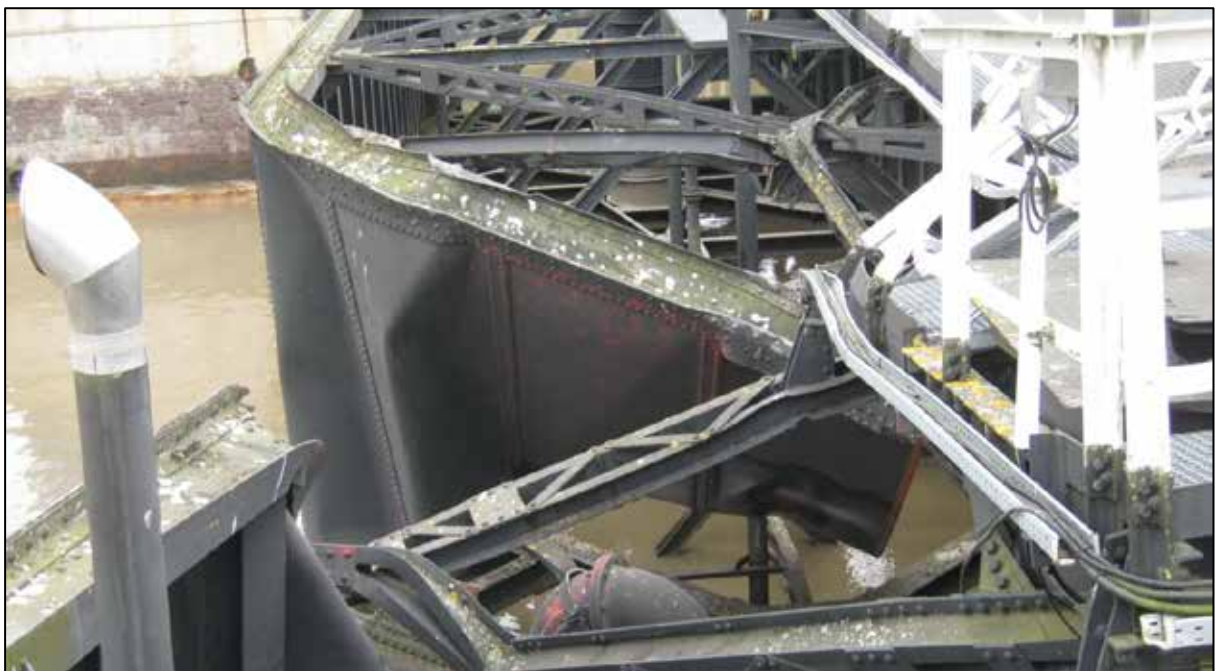
Figure 6: Damage to the lock gate

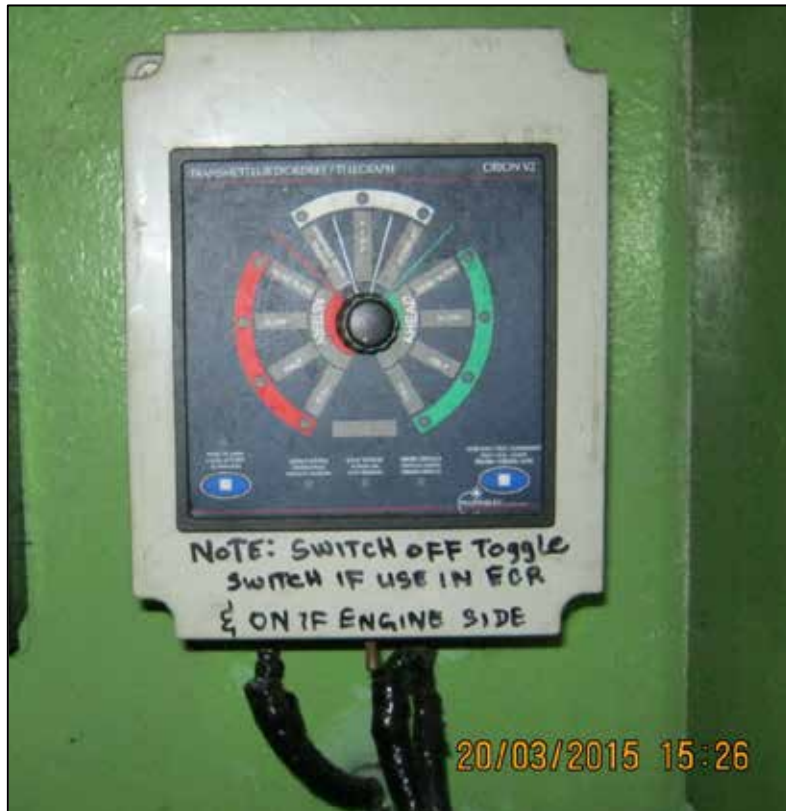
Figure 12: Engine order telegraph at the engine's control stand

The second (reserve) engine order telegraph connects the bridge with the control stand in the ECR, as well as with the control stand directly at the engine. This engine order telegraph is disc shaped and smaller than the (main) engine order telegraph discussed above.

In all probability, the accident was caused by an error in operating the engine order telegraph on the bridge. The BSU is of the opinion that this momentary lapse was facilitated by the use of the reserve engine order telegraph. Due to the technical design (lever ahead or astern), an error in operating the main engine order telegraph is less likely. The risk of confusion on the SAINT GEORGE was increased further by the opposing displays on the reserve engine order telegraph and indicator showing the direction of rotation.

The Federal Bureau of Maritime Casualty Investigation recommends that the ship's command of the SAINT GEORGE use the main engine order telegraph whenever possible. In the event of a fault, an inspection and repair should be carried out without undue delay.

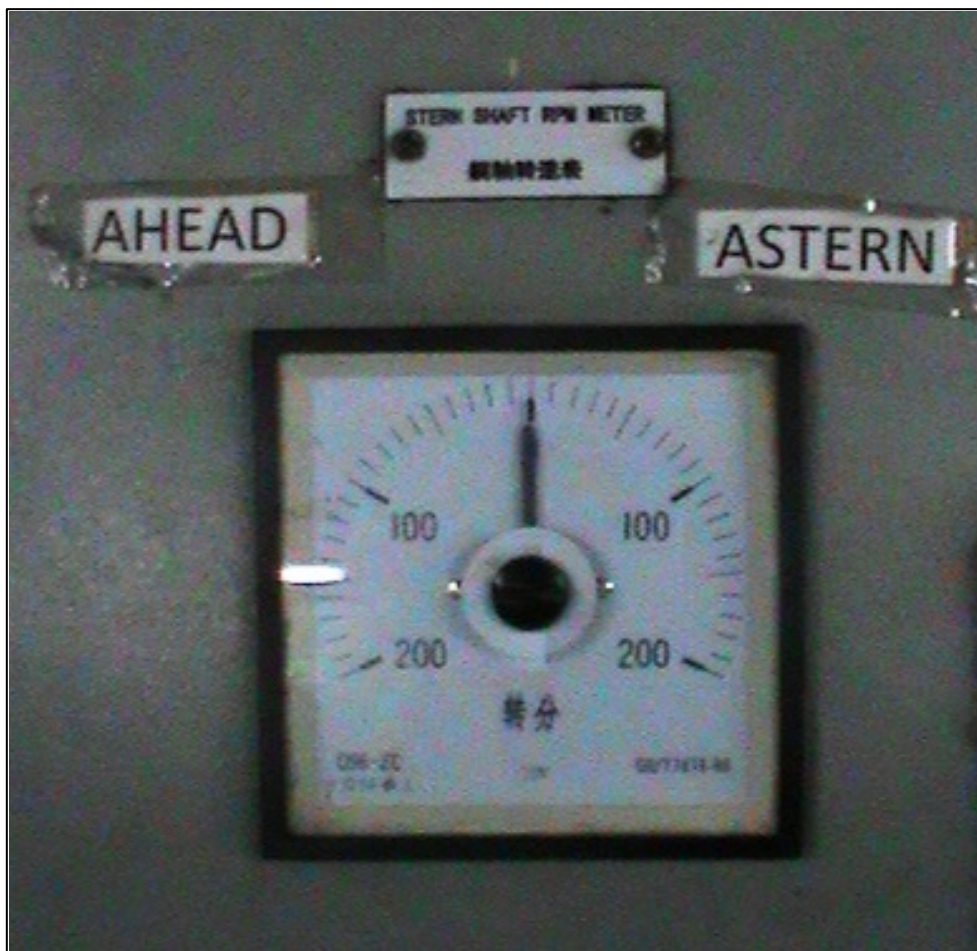
Figure 13: Indicator for rated speed and direction of rotation of the propeller in the ECR

Such indicators are implemented by means of analogue pointer instruments on the SAINT GEORGE. The indicator on the bridge is positioned in the console above the engine order telegraph (see Fig. 11). In the ECR, a identical indicator is also located in the immediate vicinity of the engine order telegraph.

The Federal Bureau of Maritime Casualty Investigation recommends that the ship's management of the SAINT GEORGE modify the indicators for the propeller's speed and direction of rotation, so that the display conforms to the norm.

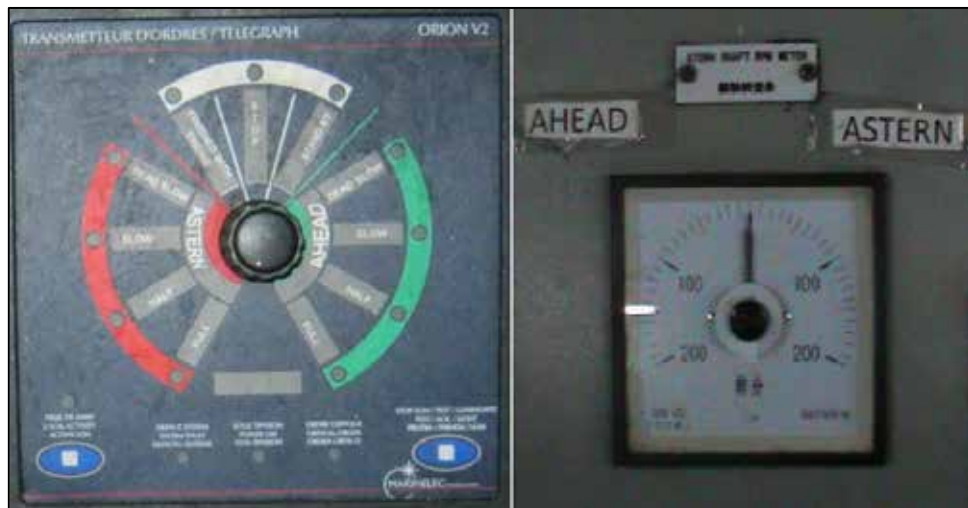
Figure 21: Comparison between the engine order telegraph and indicator showing the direction of rotation

Even though – as in the SAINT GEORGE's case – the direction of rotation is marked clearly on the indicator, a display contrary to the norm can lead to misinterpretations.
