Interim Investigation Report

pertaining to Investigation Report 168/16

Fatal person overboard accident involving a crew member of the fishing vessel PESORSA CUATRO on 17 May 2016 200 nm west of Ireland

11 May 2017

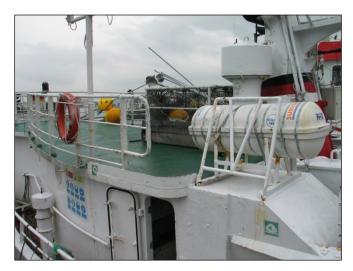
The BSU surveyed the PESORSA CUATRO on 20 May 2016, the day she sailed into A Coruña. It was found in the process that due to its design, the guard rail on the observation deck was not completely closed in the vicinity of the liferaft stored there. This may have been the root cause for the crew member falling overboard. The owner made appropriate modifications immediately.

Figure 3: Missing guard rail on the observation deck

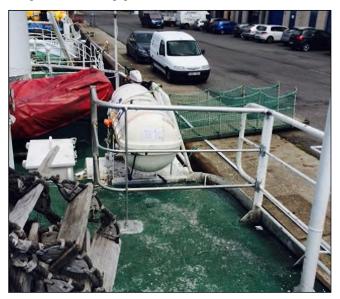
Figure 4: View of the guard rail after the modification
