Investigation Report 189/14

Serious Marine Casualty

**Collision between the sailing vessel NOBILE  
and worksite craft WERKER in the  
Flensburg Firth on 30 May 2014**

24 February 2017

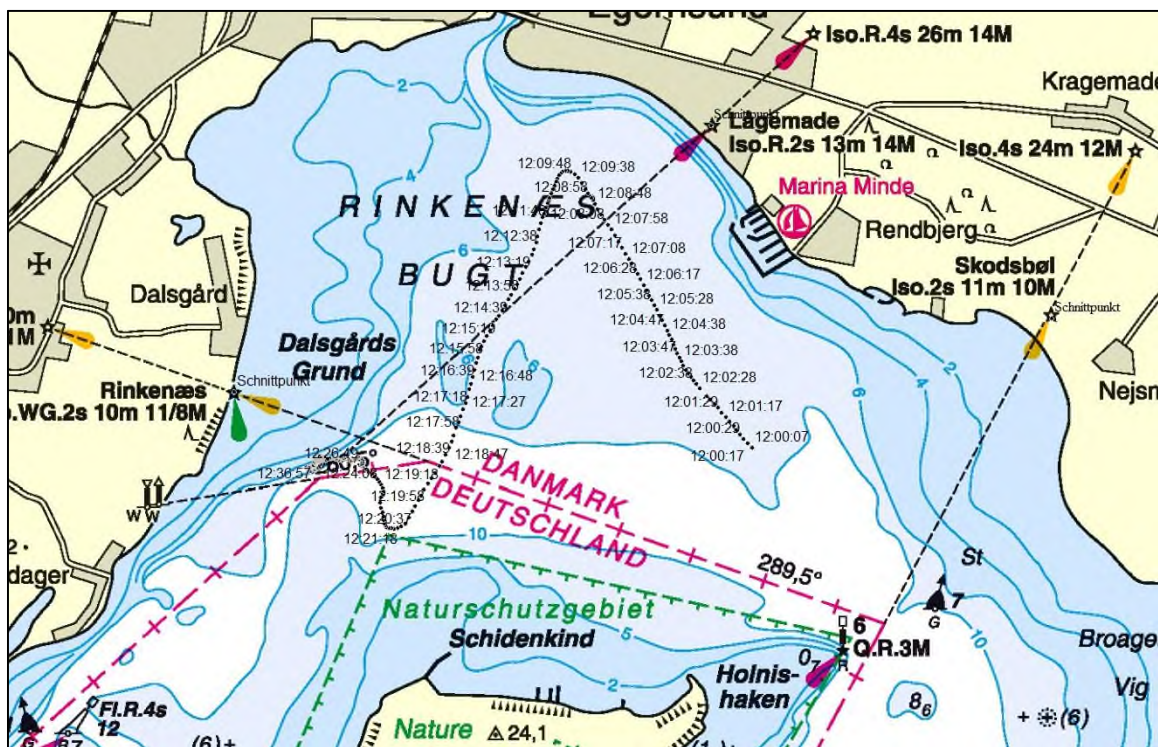
Figure 4: Course steered by the NOBILE (times in UTC)

After leaving Sønderborg at about 1000 on 30 May 2014, the mainsail, foresail and jib were set. Nothing was changed in this respect up until the collision. According to the skipper's testimony, the sails selected promised balanced sailing and easy handling. Weather conditions were good. It was sunny with only a few clouds. A westerly wind of 4 Bft (slightly more in gusts) prevailed.

From 1100 onwards, the ship took part in the Flensburg-Fjord-Regatta, which as a feeder regatta for the Rum-Regatta should have taken a group of sailing vessels from Sønderborg to Flensburg. The regatta was an informal event<sup>5</sup> and did not have a regatta committee in the traditional sense. The finish was a pair of buoys in the Flensburg Firth and the participants were responsible for timekeeping. The positions were acknowledged during an award ceremony, however.

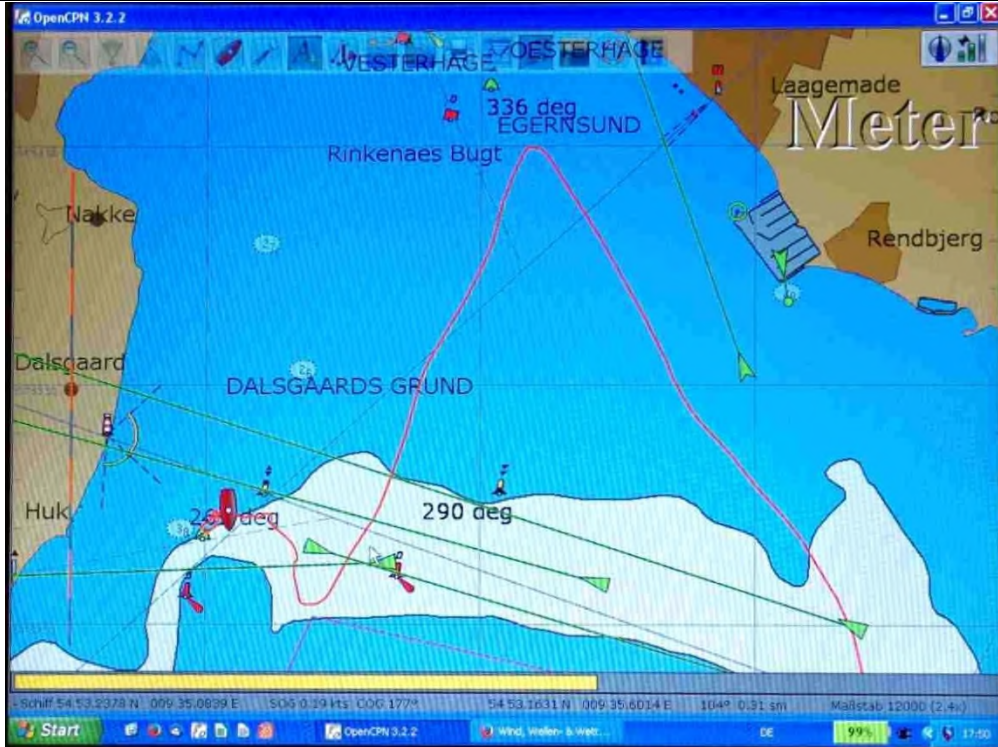
Figure 5: Photograph of the NOBILE's plotter showing her track<sup>7</sup>

It was possible to trace the skipper's account of the course of the voyage at least up until the tack north of the Holnis Peninsula (area of land outside the bottom edge of the image at Figure 5).

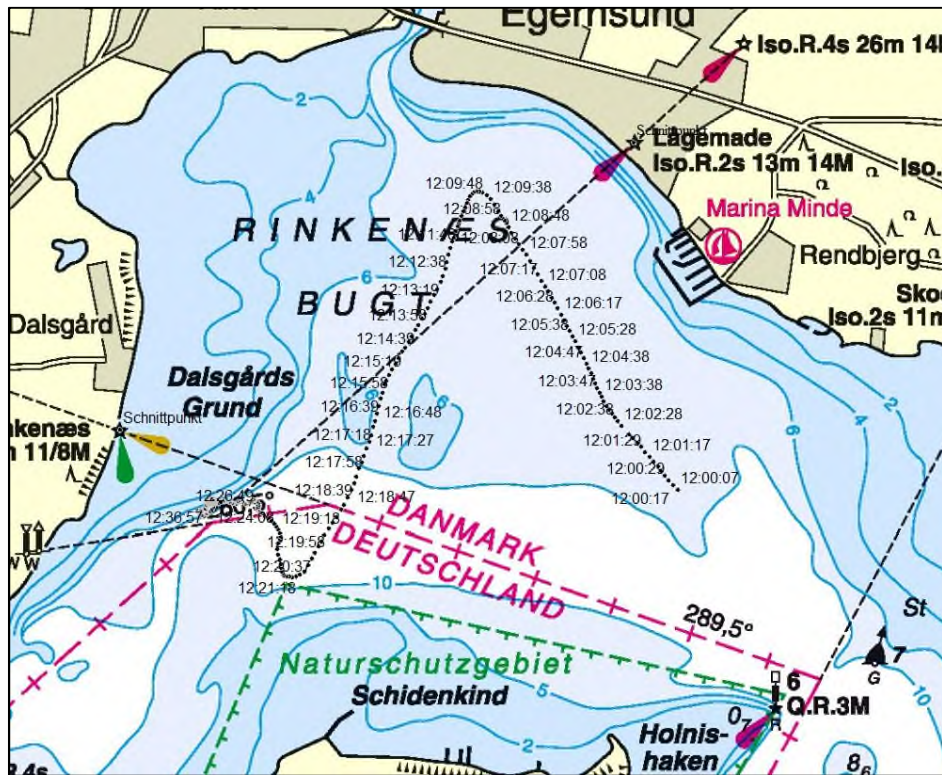
Figure 7: COG of the NOBILE (times in UTC)

Figure 7 shows the resulting course over ground (COG) north of the Holnis Peninsula from 1400 (analogously also Figures 4 and 5). The COG on this leg was about 330°.

The tack after passing the Lågemade leading light was made at 1409. Up until that point, the ship had sailed at between 4.5 and 6.5 kts over ground. The tack was executed quickly and the ship accelerated again. She then reached 5.5 to 6.9 kts over ground. The two shallower areas (less than 6 m charted depth) in the middle of the Rinkenæs Bugt were passed between 1416 and 1417, where the more westerly was slightly crossed. This tack was completed at about 205°.

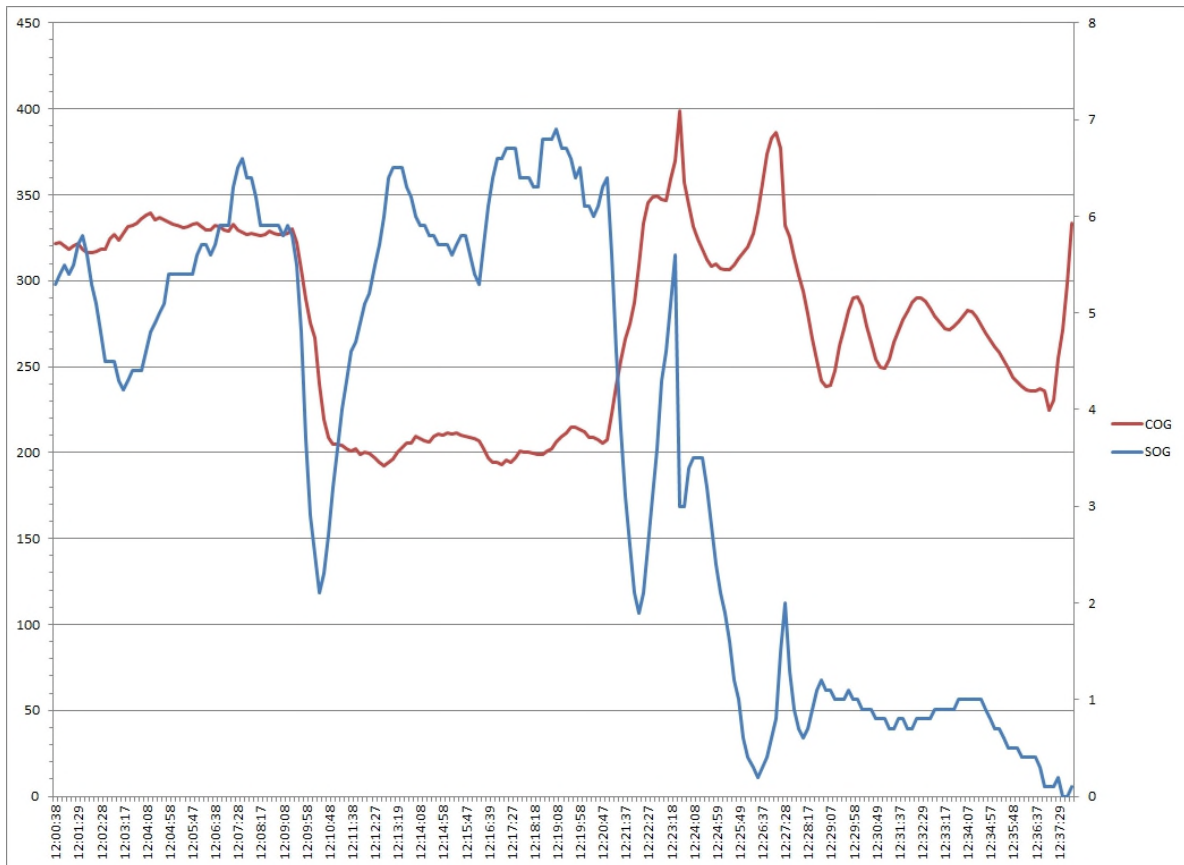
Graph 1: NOBILE: COG<sup>9</sup> [°] and SOG<sup>10</sup> [kts]<sup>11</sup>

A change in the COG to 23° is then evident from 142527, which coincided with a further drop in speed. The SOG dropped to almost zero at 142627.

Graph 1 shows the corresponding development of the COG and SOG. The annex (Spreadsheet 1 in section 8.1) contains an extract from the data set provided by the Shipping Administration, which is based on the AIS data for the period 141958 to 142807.

An analysis of Graph 1 shows that the NOBILE's course was far more consistent on the previous two tacks. The considerable unevenness after the last tack before the collision could have two causes. On the one hand, the ship could have been exposed to winds veering heavily at this point, e.g. because she was close to the shore, which made it difficult to steer a steady course. This should have prompted the NOBILE's skipper to keep clear of the WERKER in good time.

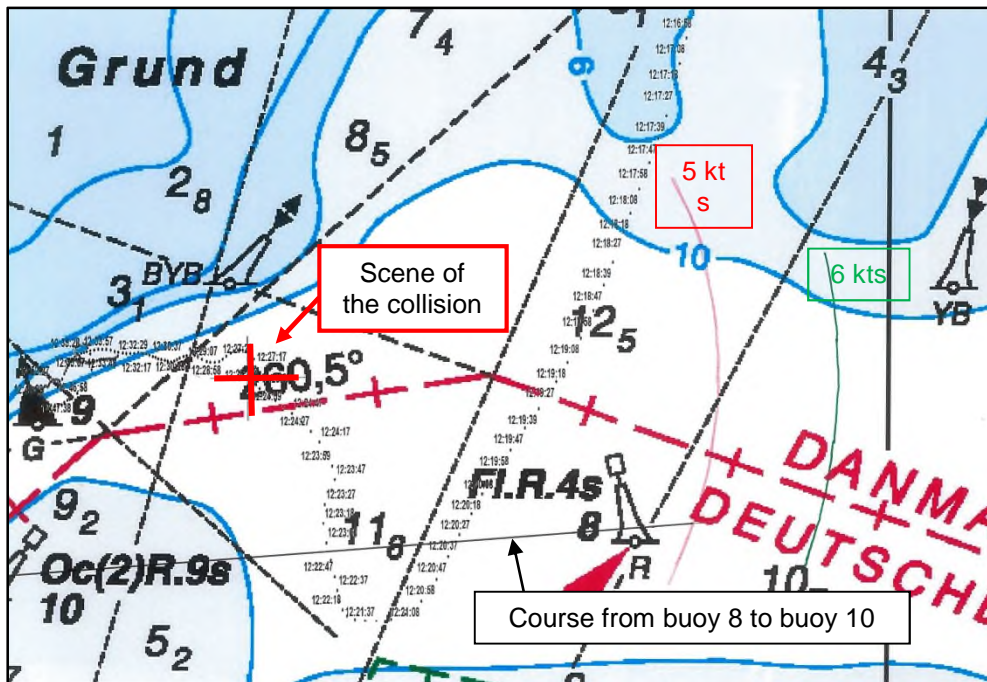
Figure 12: Possible positions of the WERKER four minutes before the accident

The analysis of the approach is complicated for lack of data on the course steered by the WERKER. This is demonstrated with an example (see Figure 12). At a speed of 5 kts, the WERKER was located in the vicinity of buoy 8 four minutes before the collision (142127). At a speed of 6 kts, she was 1.3 cbl away from the buoy.

It is apparent that the speed of 5 kts could coincide with the testimony of the NOBILE's skipper. The unclear course of the WERKER, i.e. passage close to buoy 8, or not, increases the number of variables and thus the uncertainty when analysing the development of the collision.

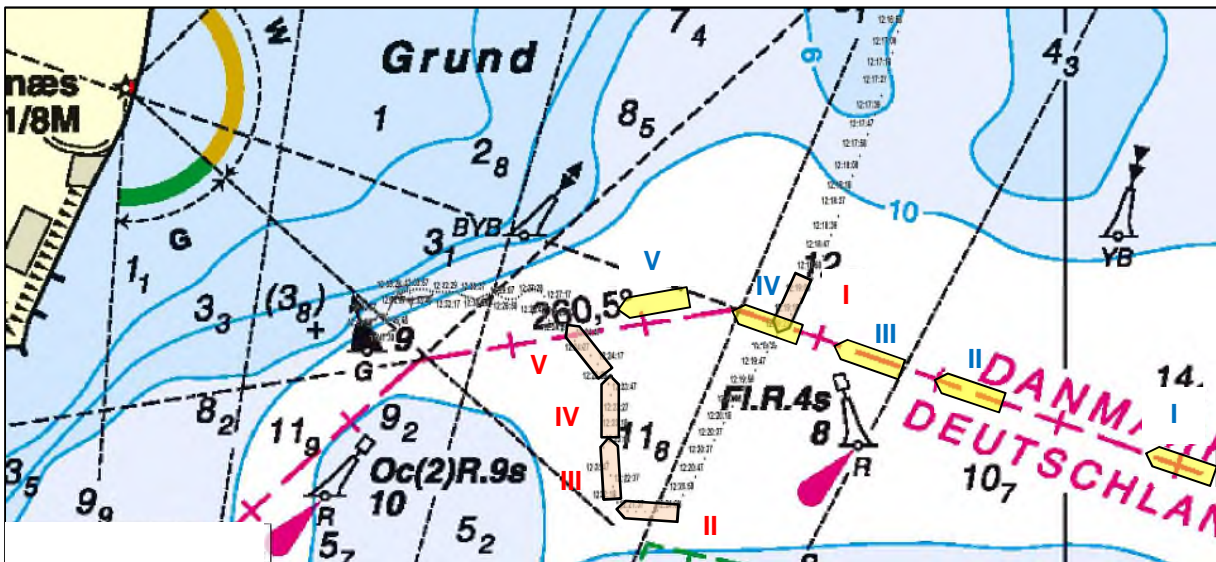
Figure 13: Assumed positions of the NOBILE and the WERKER<sup>15</sup>

For the following rough analysis of the approach of the two vessels, it is assumed by the investigators that the speed of the WERKER was about 5.5 kts, i.e. she made good a distance of 0.9 cbl per minute, keeping to the leading lights in the process. The below image emerges from this (see Figure 13):

- Position I: The NOBILE crossed the heading line of the WERKER at about 1419. The two vessels were about 3.5 cbl (650 m) apart at this point;
- Position II: The distance between the two ships was about 3 cbl (560 m) when the NOBILE tacked off the Holnis Peninsula (at 142127);
- Position III: At 142227, the distance between the two vessels was about 2.2 cbl (410 m). Buoy 8 was abeam of the WERKER;
- Position IV: Two minutes before the collision, at about 142327, the distance between the two vessels was about 1.4 cbl (260 m);
- Position V: Based on the assumptions made, the distance still amounted to about 130 m at 142427.
