Investigation Report 225/15

Serious Marine Casualty

**Collision between the ferry FRISIA V
and a quay facility in Norddeich
on 16 June 2015**

7 March 2017

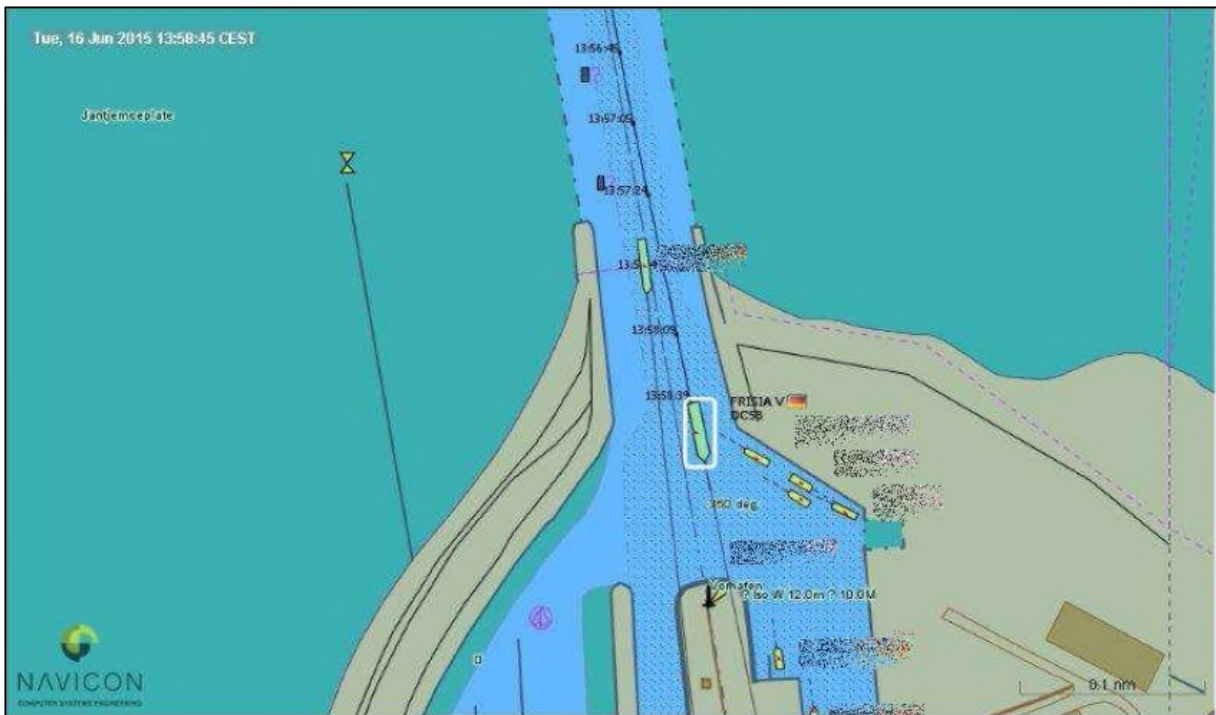
Figure 5: Position at 135845, 6.4 kts SOG

Shortly after leaving the narrow section between the breakwaters (Figure 5), the captain attempted to switch the steering gear to manual on the port control console, so as to then manoeuvre resp. turn the ship using the Schottel propellers. This was unsuccessful, meaning the autopilot continued to head for the quay. The force of the impact was reduced by the full astern manoeuvre with the help of the middle engine. The speed was about 5 kts on impact.

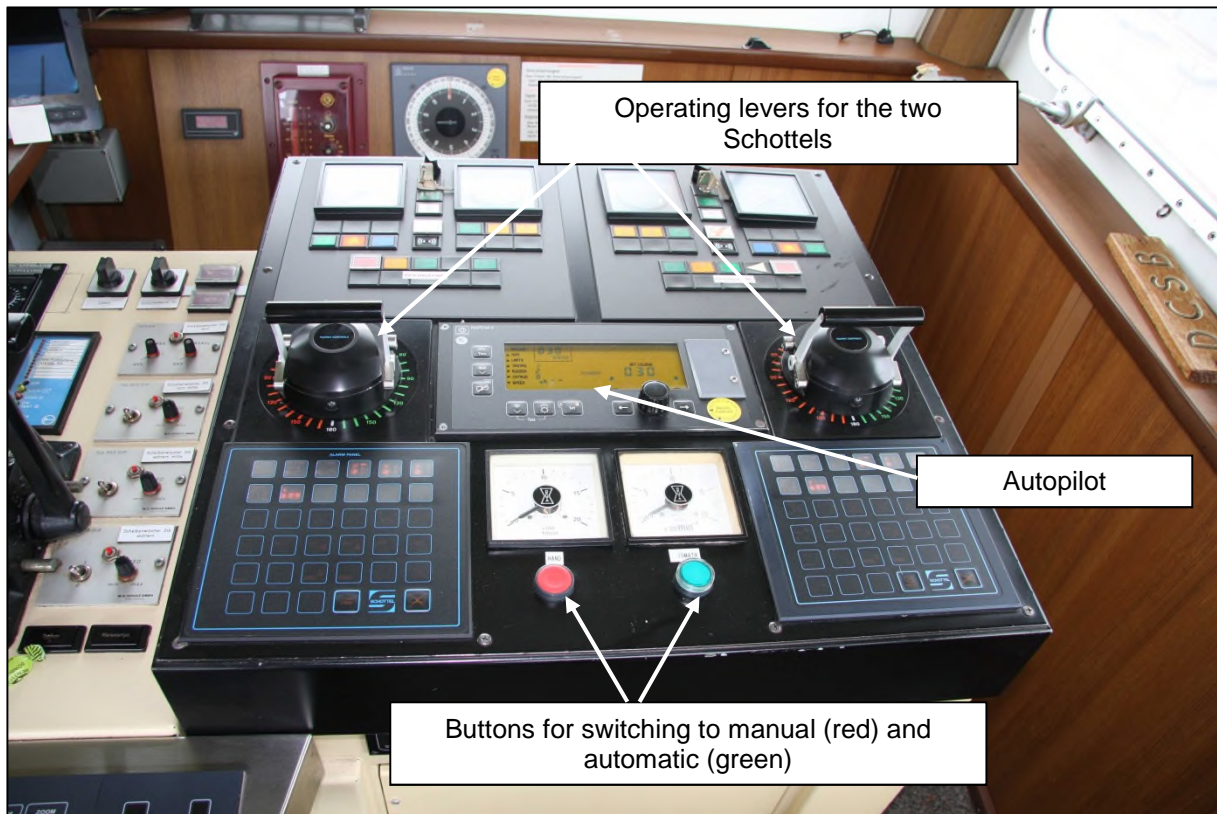
Figure 10: Operating console for the control system on the starboard side of the bridge

During the inspection of the control system for the engines and the Schottel propellers by a service engineer from the manufacturer, Kwant Controls, on 22 June 2015, it was found that the operating panels for controlling the Schottel and switching from one control console to the other worked without any problems. A potential malfunction was found in the push buttons for switching between autopilot and the manual control system, however. It was possible to reproduce the fault on both buttons on each control console if the push button was not pressed down to a sufficient depth. In the event of an 'operating error', the connection between autopilot and the control system for the Schottel propellers was not switched on or off completely, even though the indicator light signalled this, as it illuminated or extinguished if the push button was only half-pressed. Consequently, the autopilot only appeared to be switched off and only part of the control system for the propulsion units was active during the accident.

It was possible to guarantee the desired function by installing relays within the circuitry.

A company commissioned by the shipping company modified the electrical circuitry during the call at the shipyard. The alterations implemented in the circuitry's design prevented an incident of this nature from reoccurring up until the ship was taken out of service.

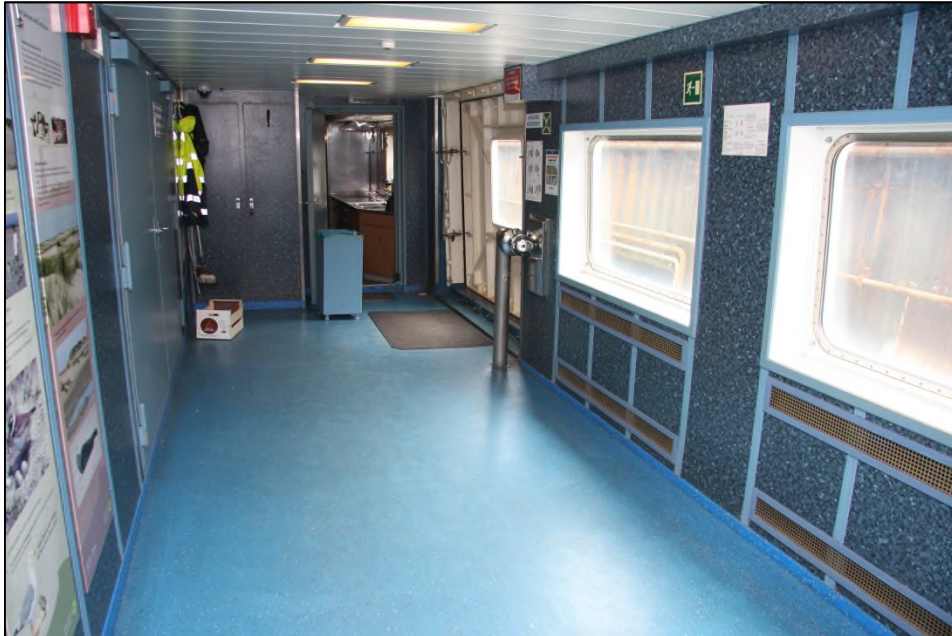
Figure 11: Area in front of the door

During the inspection of the ferry, it was found that prior to berthing larger groups of people usually gathered in the area in front of the door and in the area of the baggage compartment. In the event of unforeseen movements of the ship, a greater risk of injury prevailed there due to the limited number of handholds available.
