Bundesstelle für Seeunfalluntersuchung
Federal Bureau of Maritime Casualty Investigation
Federal Higher Authority subordinated to the Ministry of Transport
and Digital Infrastructure

Investigation Report 262/14

Very Serious Marine Casualty

**Foundering of the fishing vessel ANDREA
and death of a crew member
in the Baltic Sea off Lippe
on 16 August 2014**

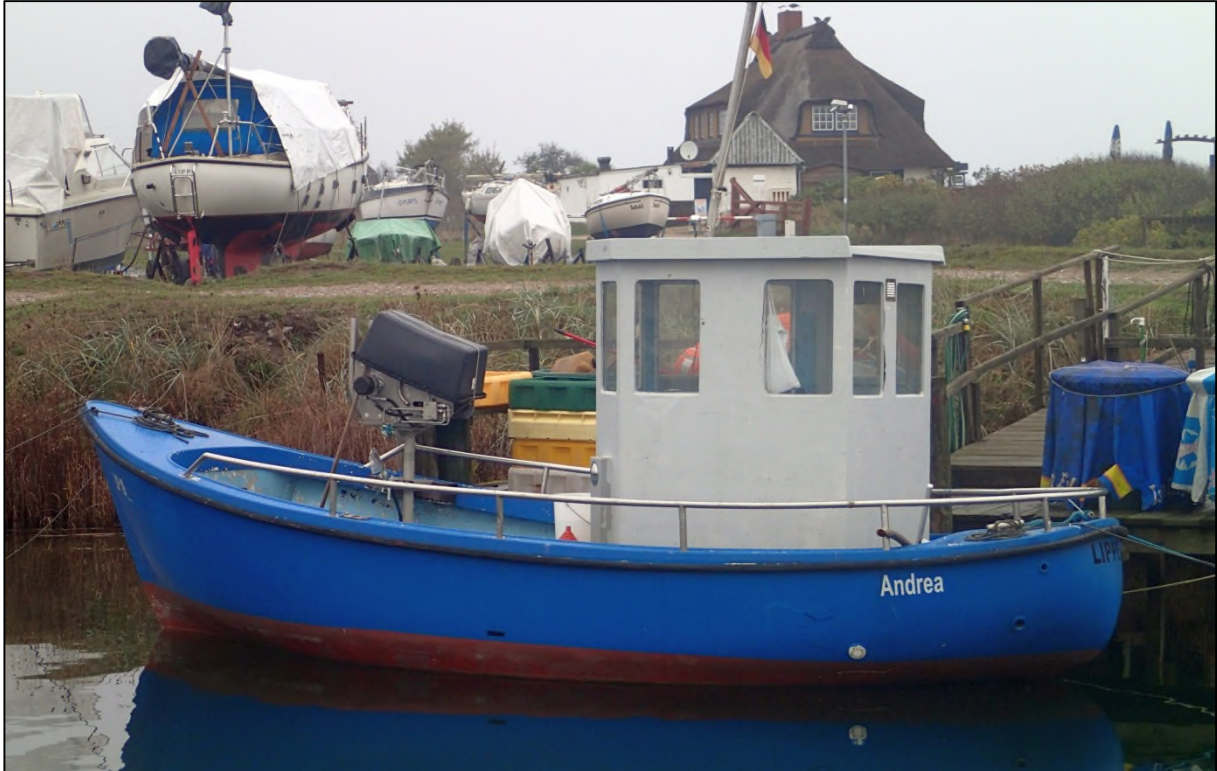
Figure 1: Photo of the ANDREA after she was salvaged

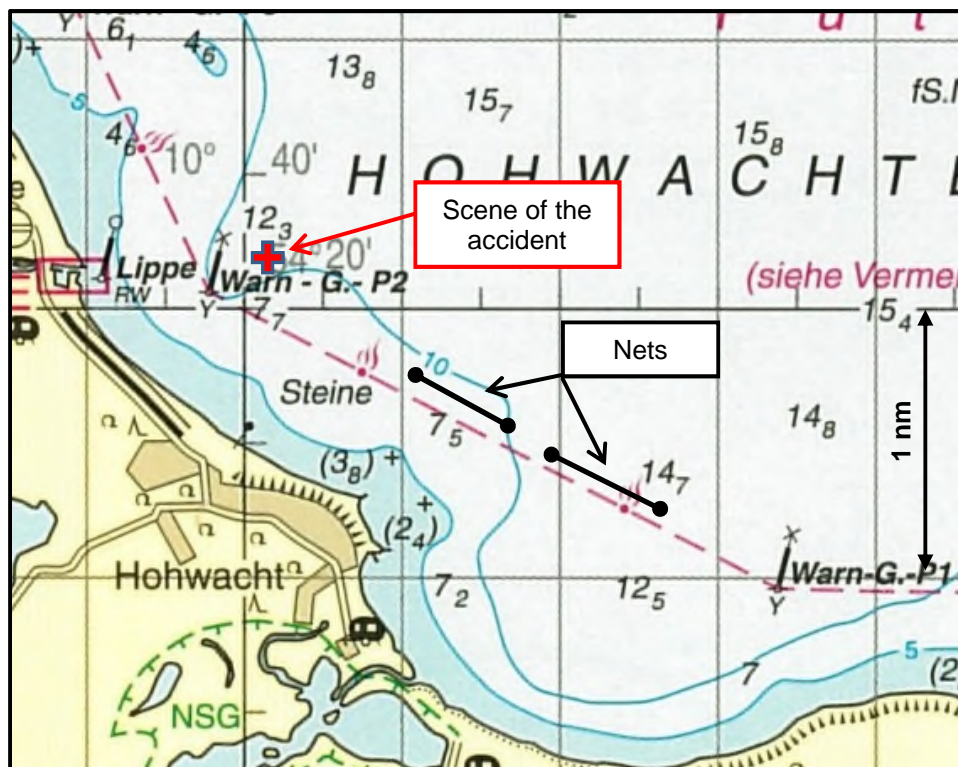
Figure 3: Approximate position of the nets

Sailing at a speed of about 6 kts, the position of the nets was reached at about 0530. Since the north-westerly wind and waves were increasing, the crew was in a hurry to haul in the nets. The second crew member hauled in the nets using a hydraulic net hauler and immediately stowed each of them in a rain barrel with a capacity of some 200 litres without emptying the catch. The skipper steered the fishing vessel while this was happening. The nets were hauled in between 0600 and 0615 and the return voyage started. At this point, the net barrels were unsecured on the port side of the fishing vessel's forward section.

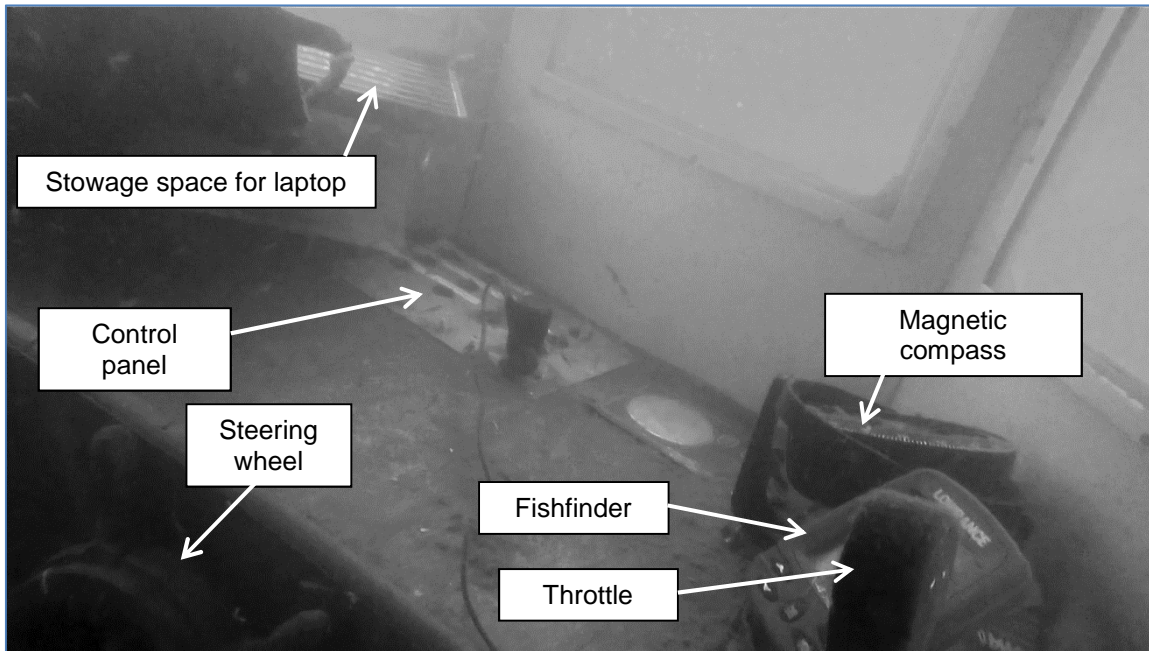
The divers found that the wheelhouse door was open. The throttle was almost set to neutral, i.e. in the middle position. The laptop was found outside the wheelhouse.

Figure 5: View inside the wheelhouse

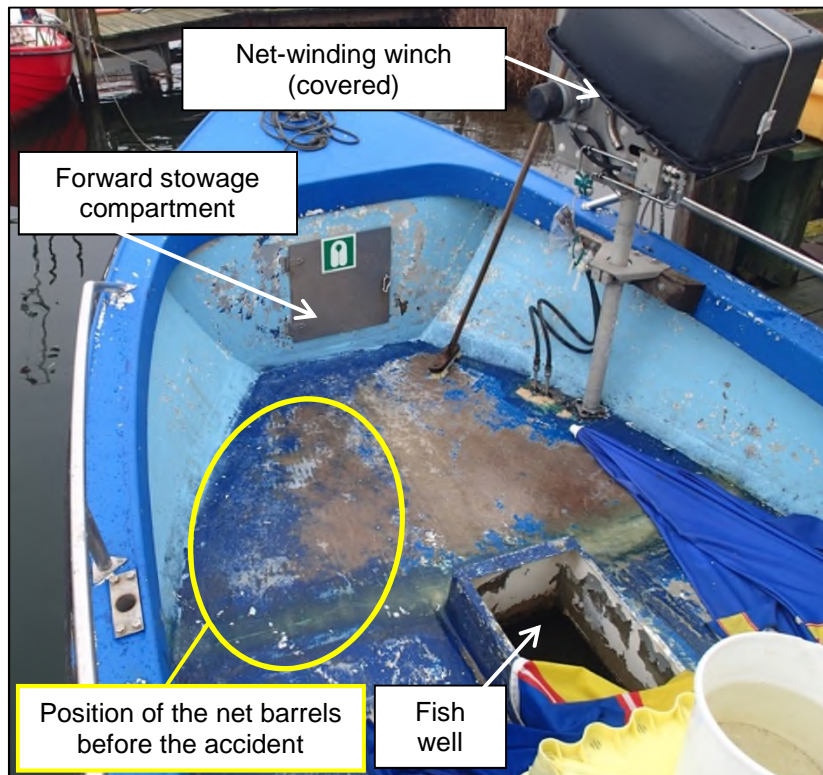
- no mount for a ring lifebuoy on the wheelhouse or anywhere else;
- extremely heavy wear in the forward area of the deck, meaning it had hardly any non-slip coating;

Figure 7: View of the fore section of the ANDREA

It was also found that the deck was worn during the survey by BG Verkehr. A condition that the deck be overhauled or a new GRP coating applied was then issued. This and several other minor defects had to be remedied prior to setting sail.

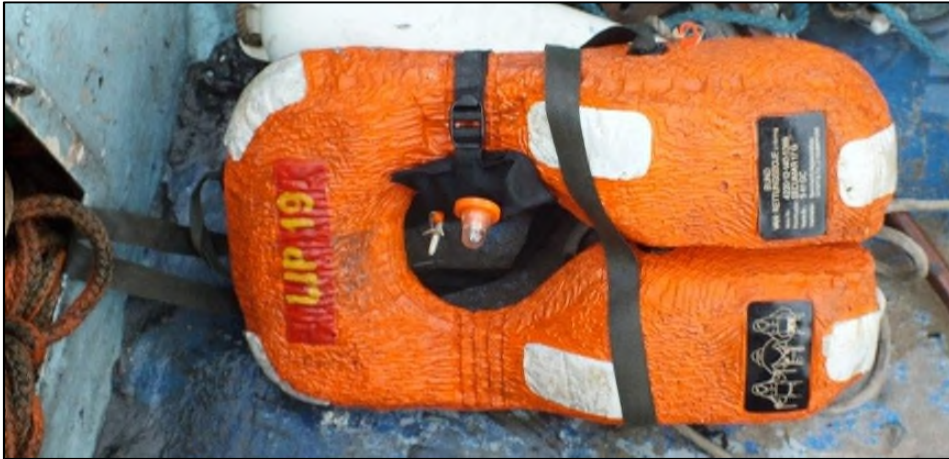
Figure 8: Lifejacket from the ANDREA

The BSU assumes that one lifejacket and one inflatable life jacket was on board during the voyage. However, neither fisherman was wearing one of these life-saving appliances at the time of the accident. Moreover, the lifejacket was stowed in a manner that rendered quick access impossible. The investigators found no evidence to suggest that additional life-saving appliances (lifejacket, inflatable life jacket) were carried on board for the second person. However, the life-saving appliances probably available on board would have been sufficient to provide the two crew members with adequate protection against drowning (if they had been worn).

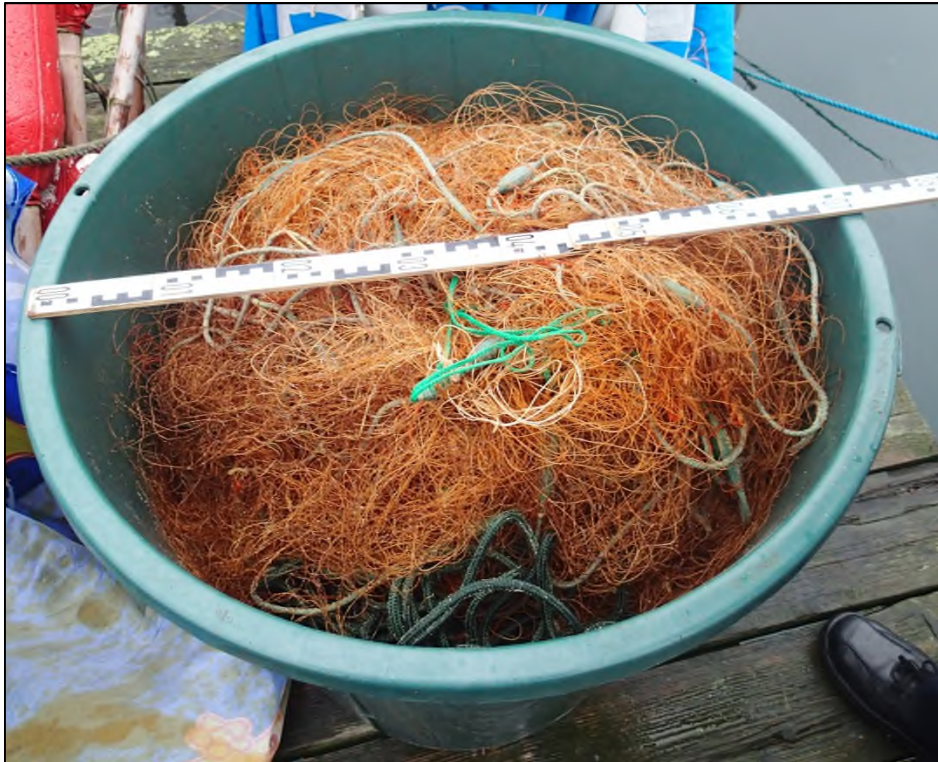
- the nets, which had already been collected by another fishing vessel before the ANDREA was salvaged, were back in their barrels. The height of the barrels was 0.73 m and their inside diameter at the top edge was about 0.70 m, meaning they had a volume of about 200 litres;

- according to a net manufacturer, the weight of a dry net of the length specified is about 60 kg. It was assumed that the net is made of a multimono-filament material. Accordingly, the net itself would not absorb any moisture. The water-absorbing capacity of the lead line is unknown.

Figure 9: Top view of one of the net barrels on the ANDREA
