**Bundesstelle für Seeunfalluntersuchung**  
**Federal Bureau of Maritime Casualty Investigation**  
Federal Higher Authority subordinated to the Ministry of Transport  
and Digital Infrastructure

## **Investigation Report 268/15**

**Very Serious Marine Casualty**

**Fatal accident on board  
the CMV DUBLIN EXPRESS  
on 14 July 2015 en route from  
Caucedo to Rotterdam**

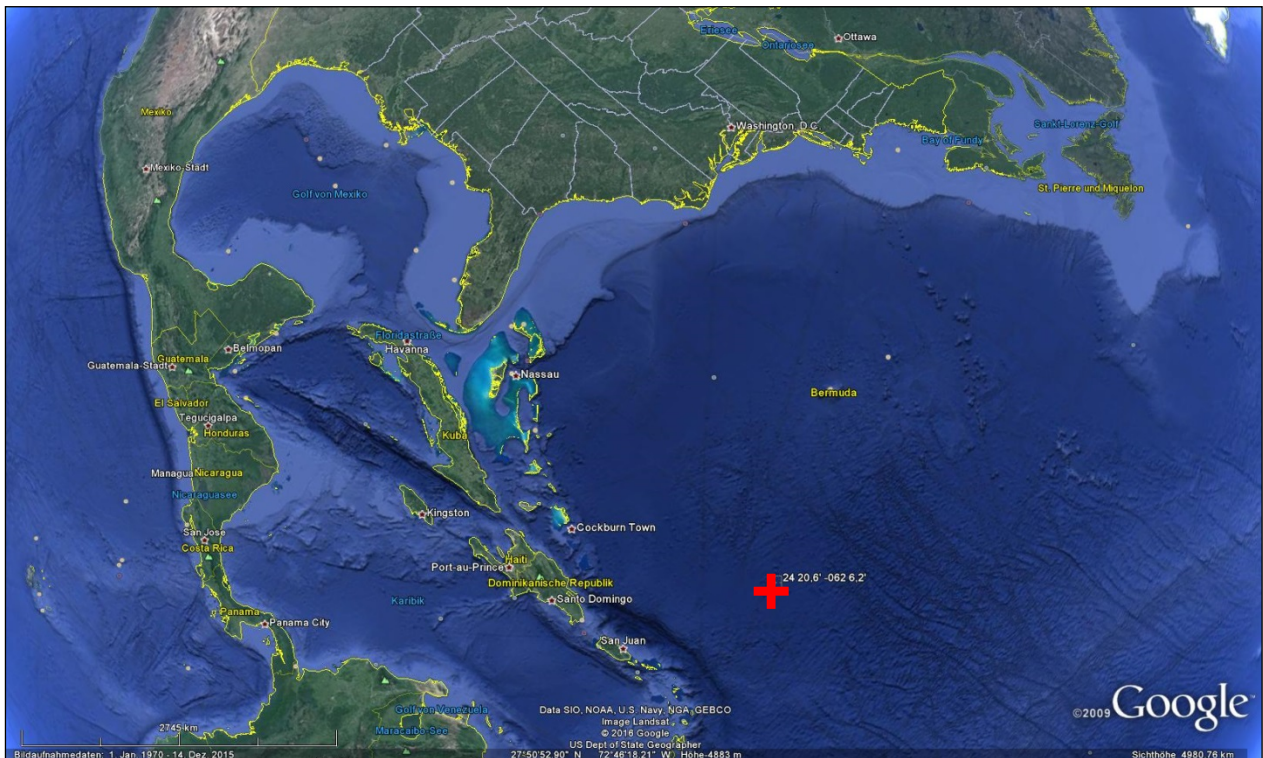
**Figure 2: Scene of the accident**

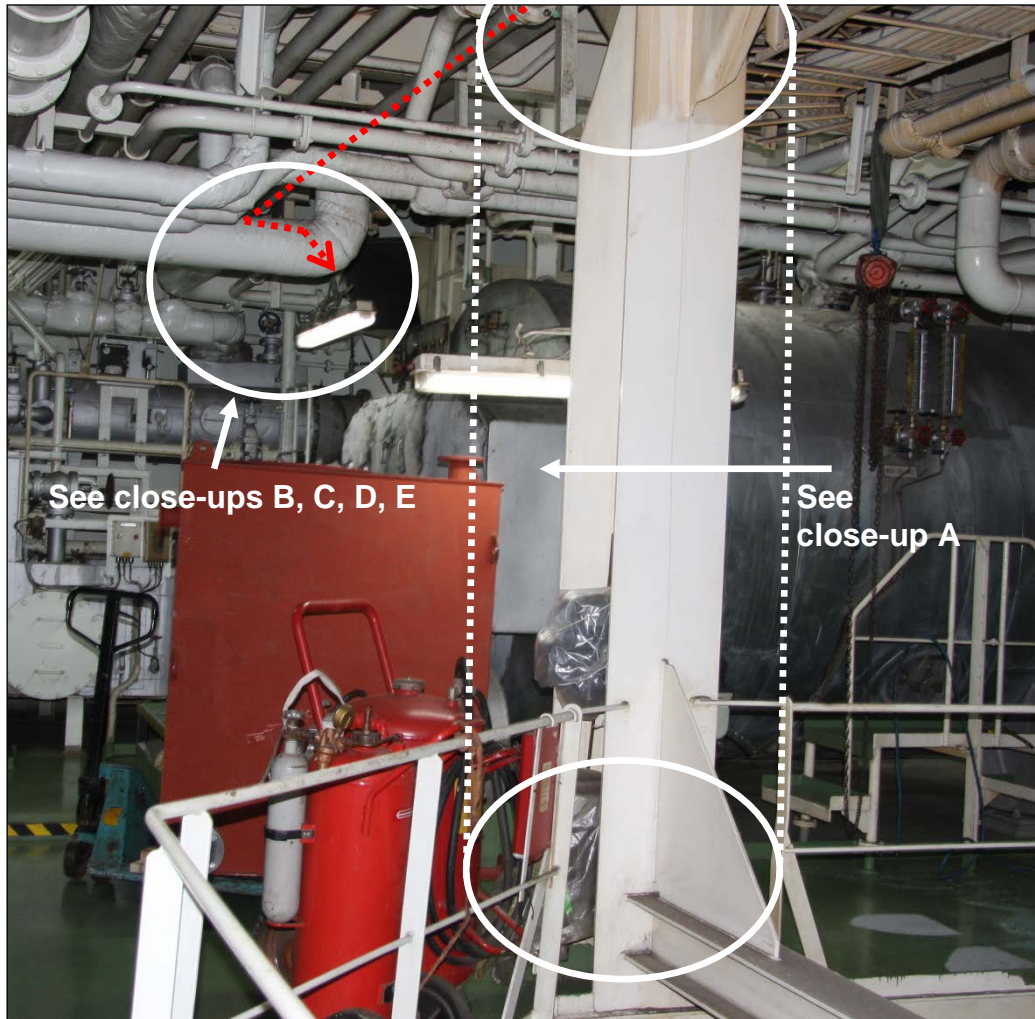
**Figure 6** shows an overall view of the immediate scene of the accident, which is visible only in the background of **Figure 5**. The ladder the casualty fell from stood in the vicinity of the vertical steel beam visible in the front of the figure (see also Figure 7 below: close-up A) at the time of the accident.

Figure 6: Scene of the accident (overall view)<sup>7</sup>

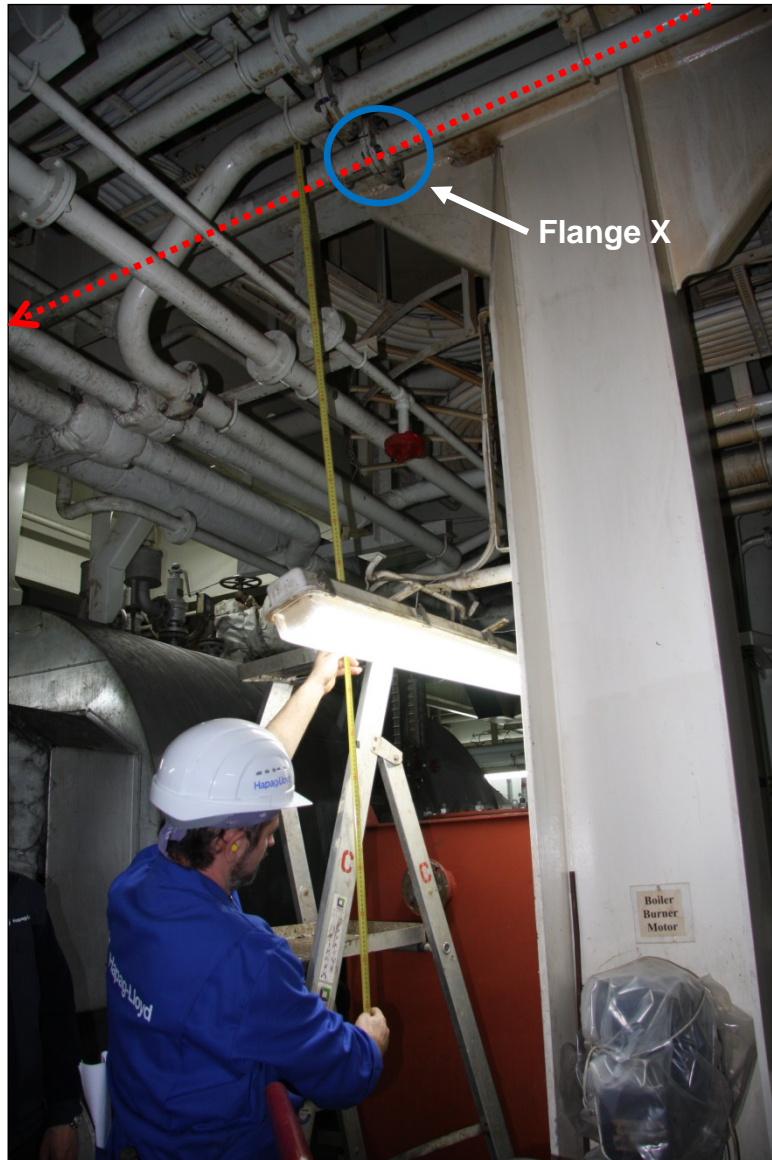
During the investigation in the port of Hamburg, the relevant stepladder was positioned for **Figure 7** where it stood at the time of the accident. The blue circle marks the flange connection<sup>8</sup> the casualty was probably working on overhead.

**Figure 7: Scene of the accident (close-up A)**

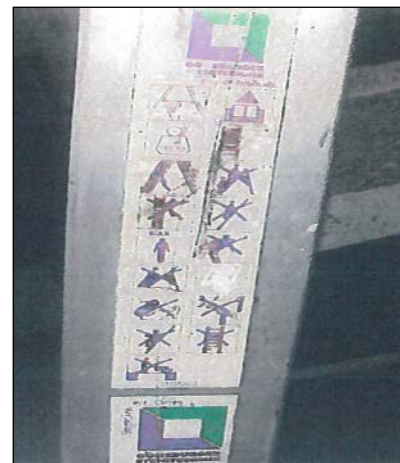
Usage of the ladder is explained by means of affixed pictograms (see **Figure 12**) in accordance with the requirements of industry standard DIN E 131-3. Inter alia, the following safety aspects to be observed when using the ladder are indicated by 17 simple and easily understandable illustrations:

**Figure 12: Safety instructions**

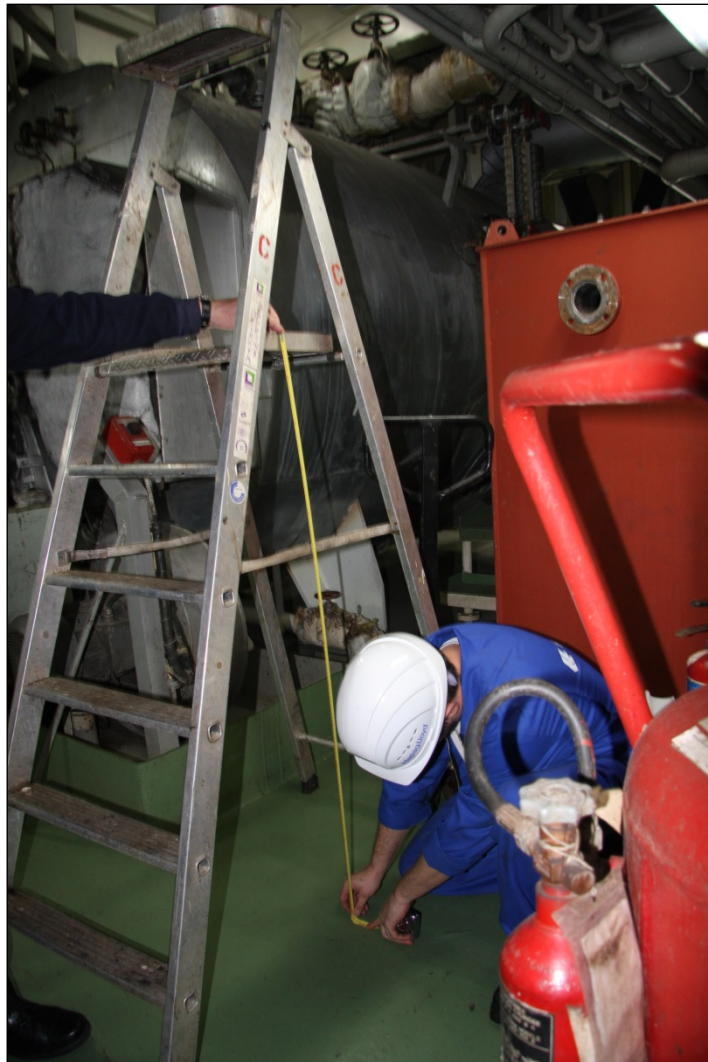
**Figure 13: Position of the ladder at the time of the accident (reconstruction)**

Although the ladder's condition was not new when the survey took place in Hamburg, it exhibited no damage and looked technically sound.

At the time of the accident, the ladder stood under flange X so that its steps were parallel to the direction of the discharge pipe's routing. Flange X was about 1.85 metres above the top step (the platform) of the ladder. Accordingly, the work height was 3.25 metres from the ground and thus within the limits specified by the manufacturer (3.50 metres).

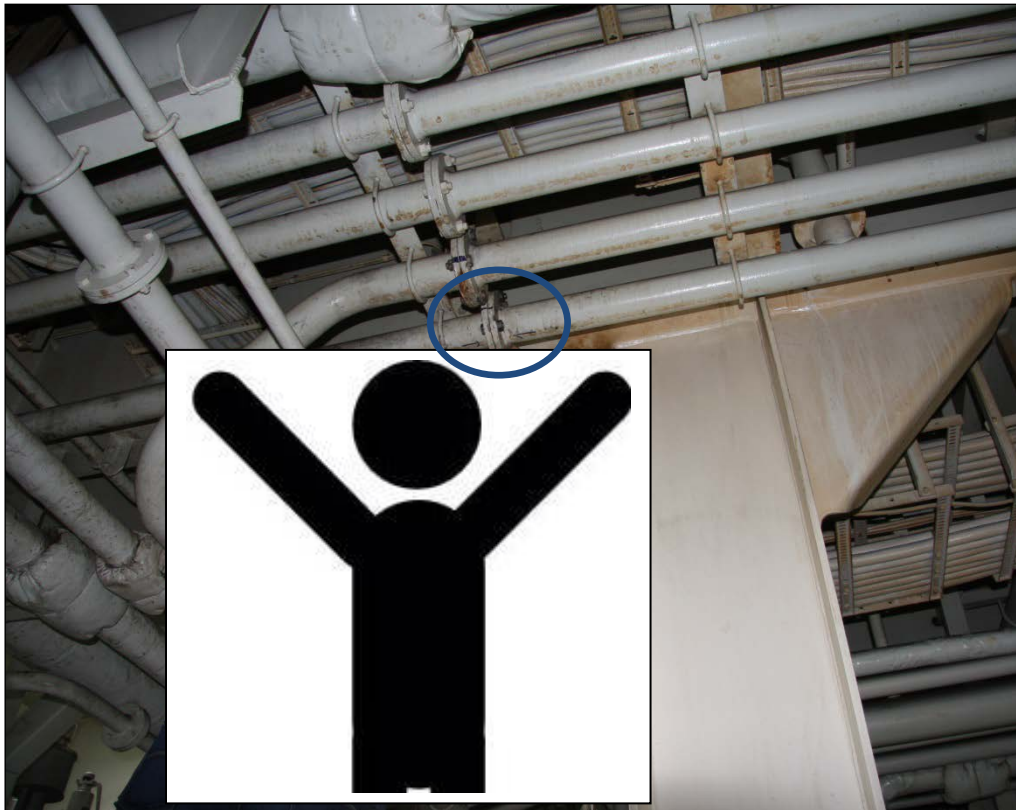
This means that while working on the flange connection, the 1.79-metre tall fitter had to raise his arms above his head to reach it (see **Figure 14**). The investigation delivered no evidence that would suggest use of the ladder did not comply with the technical specifications or that the usage instructions affixed to the ladder were disregarded.

**Figure 14: Casualty's working position on the ladder**

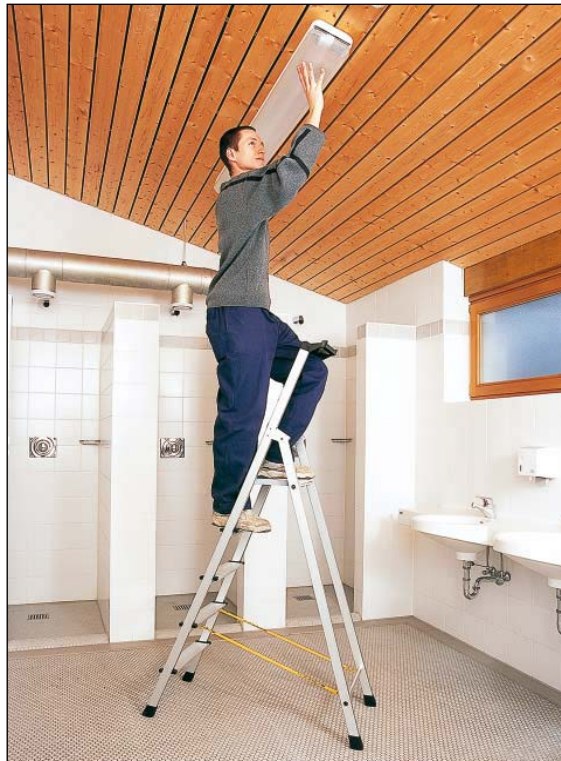
While the manufacturer's user information and its underlying DIN EN 131-3:2007 contain the explicit requirement that additional safety measures must be taken if it is not possible for the user to hold onto a ladder with one hand when working, Handbuch See and DGUV Information 208-016 contain no such advice. On the contrary, chapter 5.2 of DGUV Information 208-016 actually explicitly refers to and depicts working on a ladder without holding on as proper use with no additional safety precautions, regardless of design (see Figure 15).

**Figure 15: Safe position on a stepladder with platform according to DGUV 208-016<sup>23</sup>**

The Federal Bureau of Maritime Casualty Investigation recommends that as the umbrella organisation of the institutions for statutory accident insurance and prevention, the DGUV revise its publication DGUV Information 208-016 (directions for handling ladders and steps) and adapt it to account for the requirements of the European DIN EN 131-3:2007 standard (Ladders – User instructions) and the BetrSichV. As regards working on ladders without holding on, the ensuing obligation of preparing a risk assessment arising from the BetrSichV should be pointed to and – at least in certain cases – the need for additional safety measures should be included in the directions.
