Investigation Report 402/15

Very Serious Marine Casualty

**Fatal accident on board
the charter yacht DESDEMONA
on 21 September 2015 in the area of
the approach to Rostock-Warnemünde
between fairway buoys 9 and 11**

26 April 2017

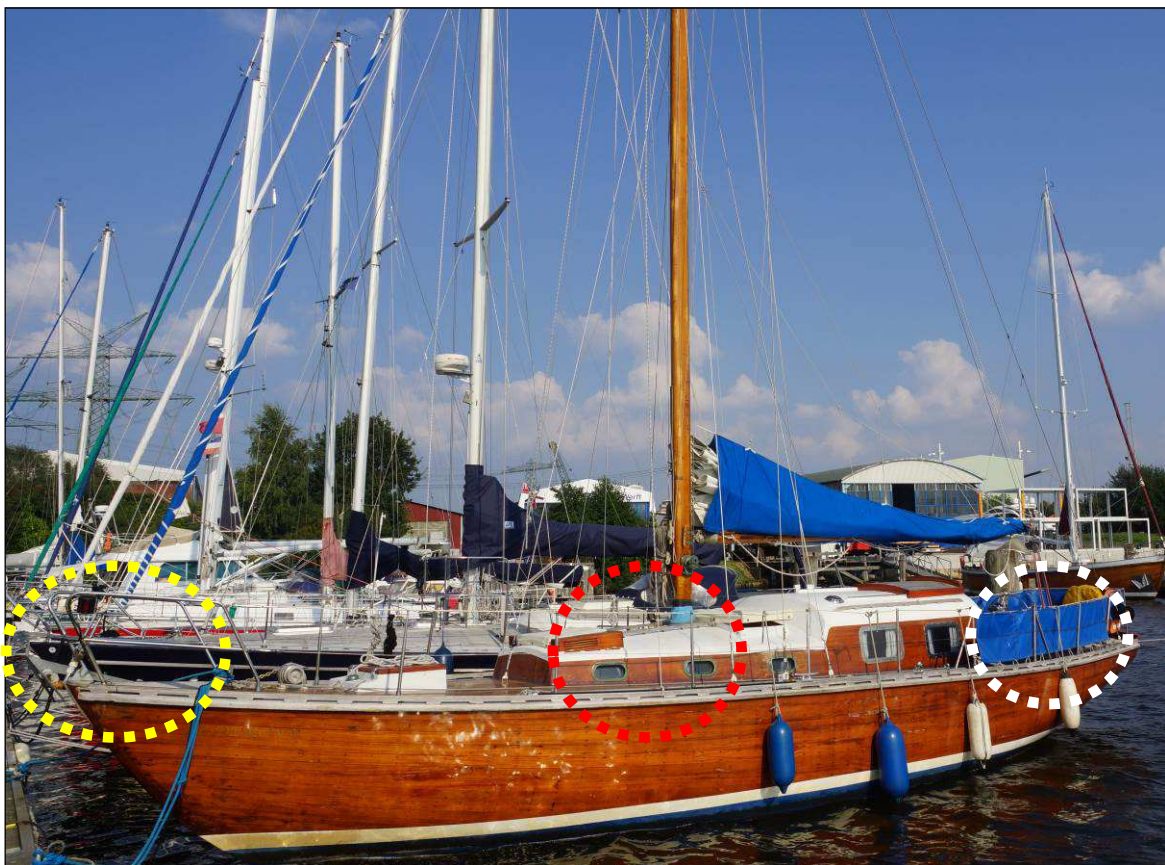
Figure 4: Position of the crew members at the time of the accident

The positions described above, in which the four crew members were located immediately before and during the accident are indicated by a colour in **Figure 4** below, which shows the DESDEMONA at her berth in Lübeck-Travemünde on a later date. The subsequent casualty was located within the red circle.

While the skipper was busy lashing down the struck foresail at the bow pulpit, the side of the yacht was suddenly caught by a wave, which caused her entire hull to rise and fall extremely violently. As a result of the centrifugal forces that inevitably occurred, the crew member crouching in the vicinity of the mast was thrown backwards over the guard rail on the port side. The casualty was initially able to hang onto the guard rail for a brief period outboard.

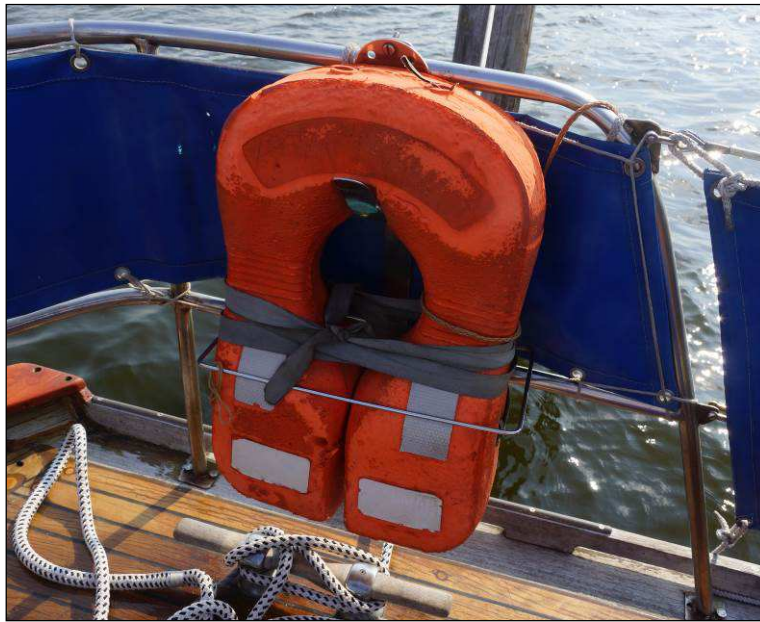
Figure 5: Horseshoe buoy in the yacht's aft section

A second rescue attempt, ultimately also unsuccessful, involved throwing the horseshoe buoy attached to the guard rail in the yacht's aft section to the casualty (see **Figures 5 f.**). These efforts also failed because the line belonging to the horseshoe buoy (see area marked red in **Figure 6**), which was on a drum and designed to form the connection between thrown horseshoe buoy and yacht, did not unwind properly when it was thrown. Accordingly, it was only possible to throw the horseshoe buoy about one to two metres in the direction of the drifting casualty, and thus not far enough.

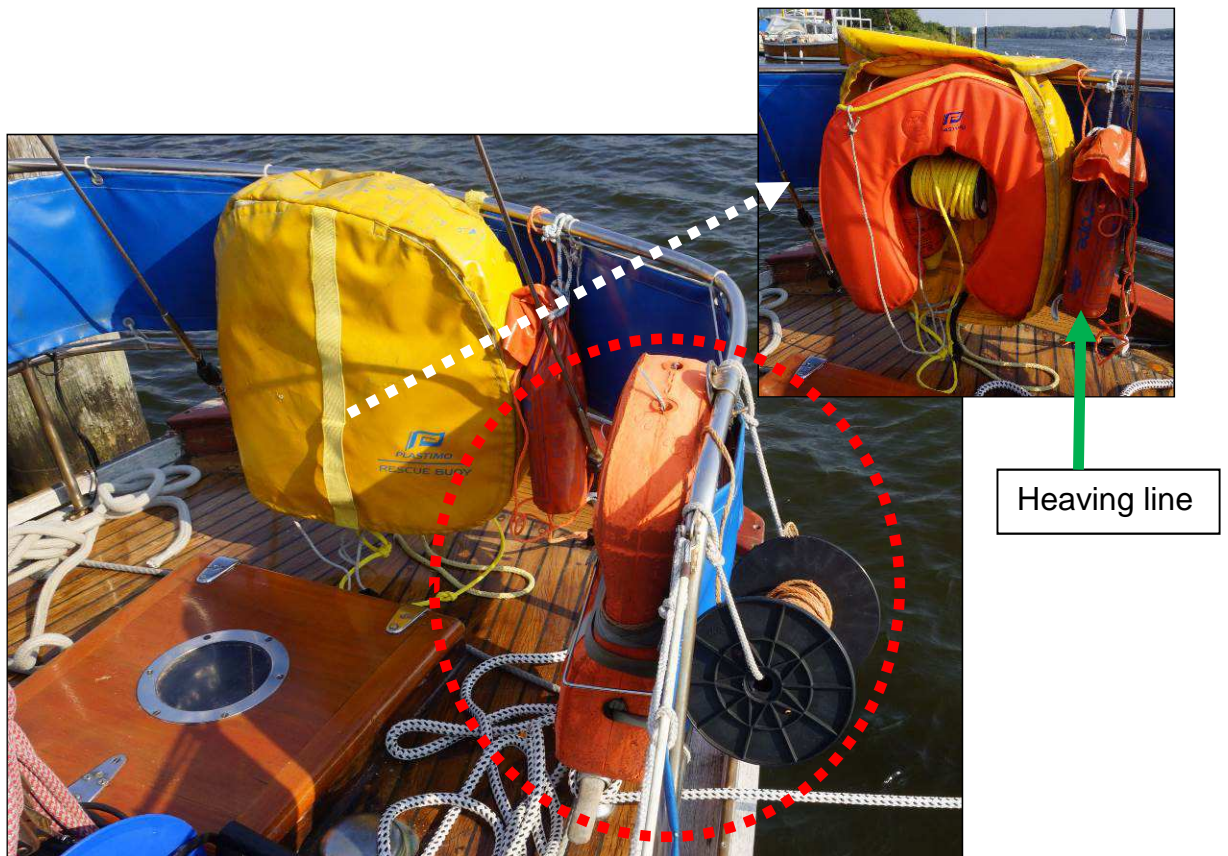
Figure 6: Horseshoe buoy and associated winding drum⁶

⁶ Note: The horseshoe buoy (also combined with a winding drum) under the yellow cover to the left of the horseshoe buoy circled red was not installed on board at the time of the accident. The charter company installed it on board additionally because of the accident. (This involved relocating the orange horseshoe buoy from the aft guard rail to its port side for reasons of space.)

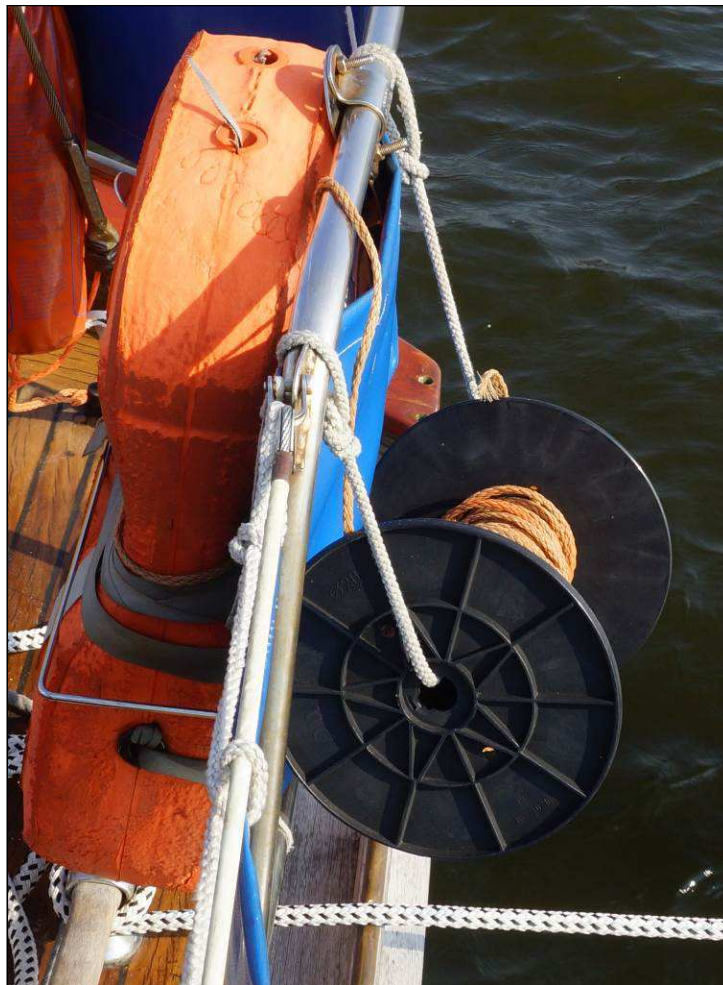
Figure 7: Improper installation of the winding drum belonging to the horseshoe buoy

During the investigation, it was no longer possible to ascertain with absolute certainty whether the unwinding issue was due to faulty installation of the winding drum or because the line had not been wound onto the drum properly. Potentially, there was even a culmination of the two sources of error.

Figure 7 below was taken during a survey of the yacht in autumn 2016. As regards the manner in which the winding drum was installed, it shows that insufficient attention was paid to ensure the drum would rotate freely, as required for the line to unwind, even after the accident.

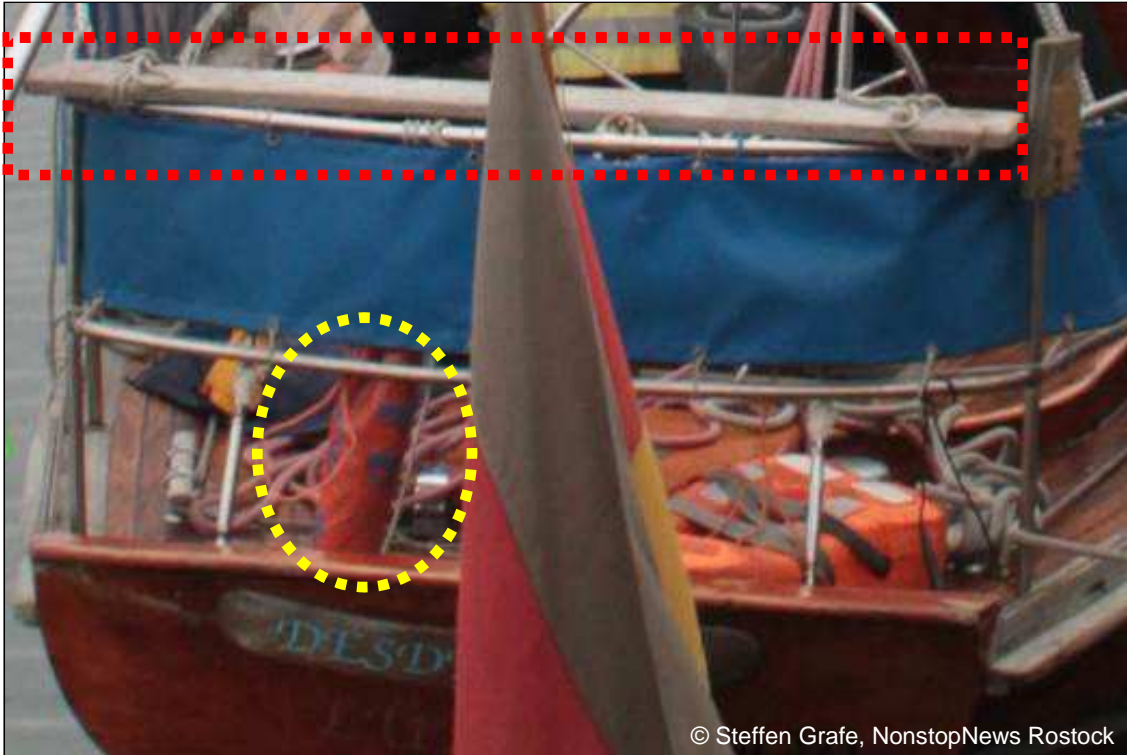
Figure 8: Stern of the DESDEMONA (on the day of the accident after sailing into Warnemünde)

Photographs in the daily press taken immediately after the DESDEMONA sailed into Warnemünde show that a fender board was mounted on the yacht's stern pulpit on the day of the accident (outlined in red in **Figure 8** below). According to the charter company, the crew must have mounted this board at the point in question after the handover of the yacht, presumably to use as a makeshift seat. That this board (additionally) prevented the lifeline from unwinding cannot be ruled out entirely. However, the above scenario is opposed by clear witness testimony indicating that the line did not unwind freely when the horseshoe buoy was thrown and then could not be pulled from the drum manually "due to a tangle" or "because it had not been wound on properly."

It is also evident from the press photographs that on the day of the accident a bag containing a heaving line was secured to the stern pulpit next to the horseshoe buoy (see yellow marking in **Figure 8**). It is likely that the crew member who was inexperienced in sailing and unsuccessfully attempted to throw the horseshoe buoy had no knowledge of the content or functioning of this bag. It was not possible to ascertain why the two experienced skippers failed to use the heaving line during their rescue effort.
