Bundesstelle für Seeunfalluntersuchung
Federal Bureau of Maritime Casualty Investigation
Federal Higher Authority subordinated to the Ministry of Transport
and Digital Infrastructure

Investigation Report 42/15

Very Serious Marine Casualty

**Fatal accident on board
the MV ASKOE
in the Baltic Sea
on 6 February 2015**

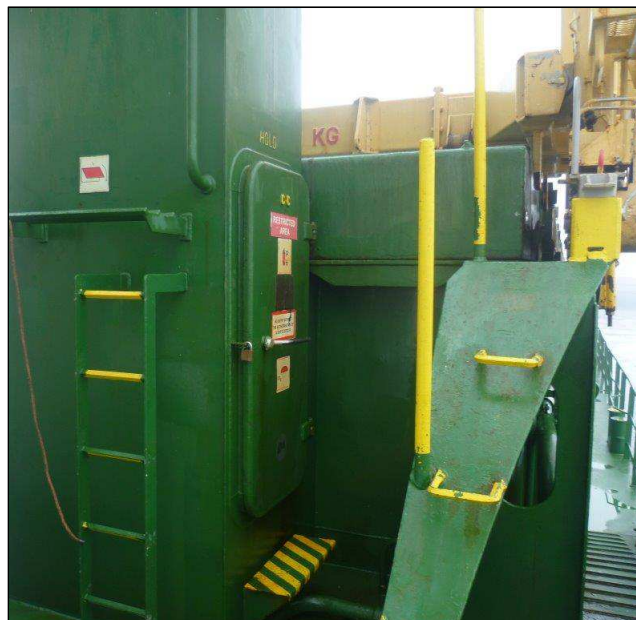
The master stated that formal information about the dangerous goods class MHB⁷ Group B was handed over together with this special timber cargo when the ship was loaded. Accordingly, any points of entry to the cargo hold were secured with padlocks after loading. All the crew members were aware of the combination of the locks in case of emergency, however. The chief officer briefed the crew at length on the dangers associated with this cargo. In addition, rules of conduct were displayed in all public spaces of the ship and warnings were attached to the cargo hold access cargo hold access hatches.

Figure 3: Cargo hold access cargo hold access hatch with warnings and padlock

An analysis of all the information available neither explains why the rating was in the cargo hold access cargo hold access hatch, nor how he lost his life there. He had not been instructed to enter the cargo hold access hatch and nothing was found that could explain his actions. The companionway was empty and nothing indicated precipitating circumstances (smuggled goods such as alcohol, cigarettes or the like). Moreover, no toxins were found in the body of the deceased. There were no switches that would need to be operated to make the ship ready for sea operation, either. Light switches for the deck crew, switches for the cargo hold fans or the like were not located in this companionway.

For whatever reason he descended, the CO content in this companionway was not so high that he would have lost consciousness within a few minutes.

The position in which he was found is also inexplicable. It is difficult to imagine that his unconscious body would have been able to rotate in the confined space to the extent that his head would finally hang downward. On the other hand, a headlong fall into the vertical passage is unlikely because the body would then have probably dropped through to the bottom (or the lateral deceleration would have caused injuries at the very least but no such injuries were found). Moreover, the ship sailed through an extremely calm weather zone with only two wind forces during the period of the accident. In all likelihood, the ship hardly moved at all. Consequently, there was nothing to cause him to lose his balance.

The ship's command was aware of what hazards the cargo involved. It had briefed the crew and secured the access points with locks. In the case at hand, it would have been better if not all crew members had known the combination for the padlocks. Having said that, it cannot be proven that toxic air was the cause of this accident, either. Hypothesising is encouraged due to the difficulty in demonstrating the course of events leading up to and during this marine casualty. The statutory task of the BSU is to determine deficiencies in safety without drawing attention to personal fault. Therefore, the BSU is dispensing with more theories and recommends that the ship's command provide fewer crew members with access to such dangerous cargo hold access hatches in the future.

The safety recommendations included in the draft of the investigation report addressed to the ship's command and owner of the AKSKOE, recommending that the ship's command of the ASKOE limit the number of crew members with access to locked holds to that absolutely necessary in the future, was already implemented by the ship's owner.
