Bundesstelle für Seeunfalluntersuchung
Federal Bureau of Maritime Casualty Investigation
Federal Higher Authority subordinated to the Ministry of Transport
and Digital Infrastructure

Investigation Report 439/16

Grounding

**of the CMV HANNI off Mühlenberger Loch
in Hamburg on 4 December 2016**

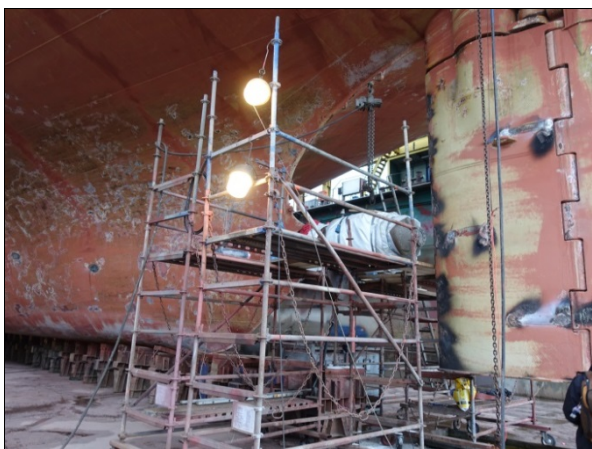
Figure 4: Damage to the propeller

The course of the accident and salvage were discussed initially. No pollutants escaped during the accident. The HANNI suffered damage to her underwater hull and propeller. The grounding was caused by the failure of the main engine and then drifting in the Elbe current. There were several alarms prior to the failure of the engine. The very powerful overspeed protection alarm caused the main engine and shaft generator to stop automatically. The two auxiliary diesel generators continued to run. The automated stop is comparable with a crash-stop, where the supply of fuel is ultimately discontinued. It took five to six minutes to restart the main engine (until control from the bridge was again possible). Recordings of the engine operation and any accumulated alarms were not available. During the accident, the alarm data recorder was out of service and the simplified voyage data recorder (S-VDR) did not record rudder and engine data. The speed governor was responsible for the error. The service engineer from MAN brought new replacement relays and pickups for this. A crack was found in a Hall generator. It was not possible to establish what caused this defect or how long it had existed. This crack caused incorrect rated speed synchronisation (see figure below). The speed measurement is set to a threshold of 15% at 514 r/min. The main engine shuts down automatically if this threshold is exceeded to avoid potential mechanical or thermal damage resulting from high centrifugal forces, which could lead directly to the total loss of the engine. Two independent pickups measure the rated speed. The cabling leads to two relays built into the alarm and monitoring system in the ECR. As soon as a pickup exceeds the pre-set threshold, either due to actual overspeed or a false value, the main engine is stopped automatically. The defective part must be replaced if a false value is transmitted (incorrect number of cycles).

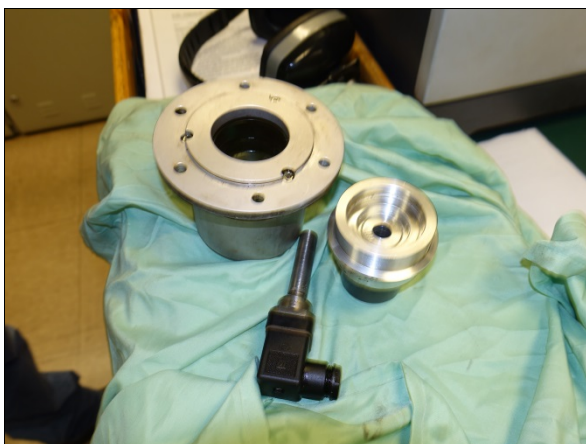
Figure 6: Pickup

The grounding incident was triggered by an overspeed protection alarm causing the main engine to stop automatically, similar to a crash-stop, so as to avoid potential mechanical or thermal damage resulting from excessive centrifugal forces, which could lead directly to the total loss of the engine. The alarm was due to a defective pickup. The rated speed is measured with two independent Hall generators. In the event of excessive deviations in the rated speed measured or overspeed, the main engine's rated speed is slowly reduced, the CPP's pitch is adjusted to zero, and the shaft generator is automatically disconnected from the on-board power supply network. In estuary trading, as was the case here, only the two diesel generators, which also drive the steering gear, are then running. Without a shaft generator, there is not enough power to operate the bow thruster.

The Federal Bureau of Maritime Casualty Investigation recommends that the owner include the pickups and associated speed sensors in a periodic maintenance plan and/or wherever appropriate take the precaution of exchanging them on its ships in accordance with empirical values specified by the manufacturer.

The Federal Bureau of Maritime Casualty Investigation recommends that MAN Diesel & Turbo SE configure the main engine's pickups for newly-built craft such that a plausibility check of the measurements is made between the sensors.

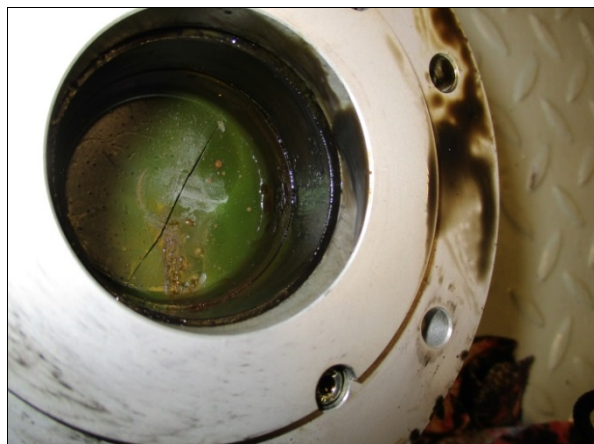
Figure 7: Crack in Hall generator

The pickups are maintenance-free according to the manufacturer. Replacement is only required when a sensor is defective. The defective Hall generator was tested on 1 August 1997, i.e. before the ship was put into service. According to the manufacturer's specifications, bypassing makes operation with one Hall generator possible. This procedure cannot be carried out during estuary trading, however. A greater degree of safety could be achieved if the existing Hall generators and their sensors were included in a periodic maintenance plan.

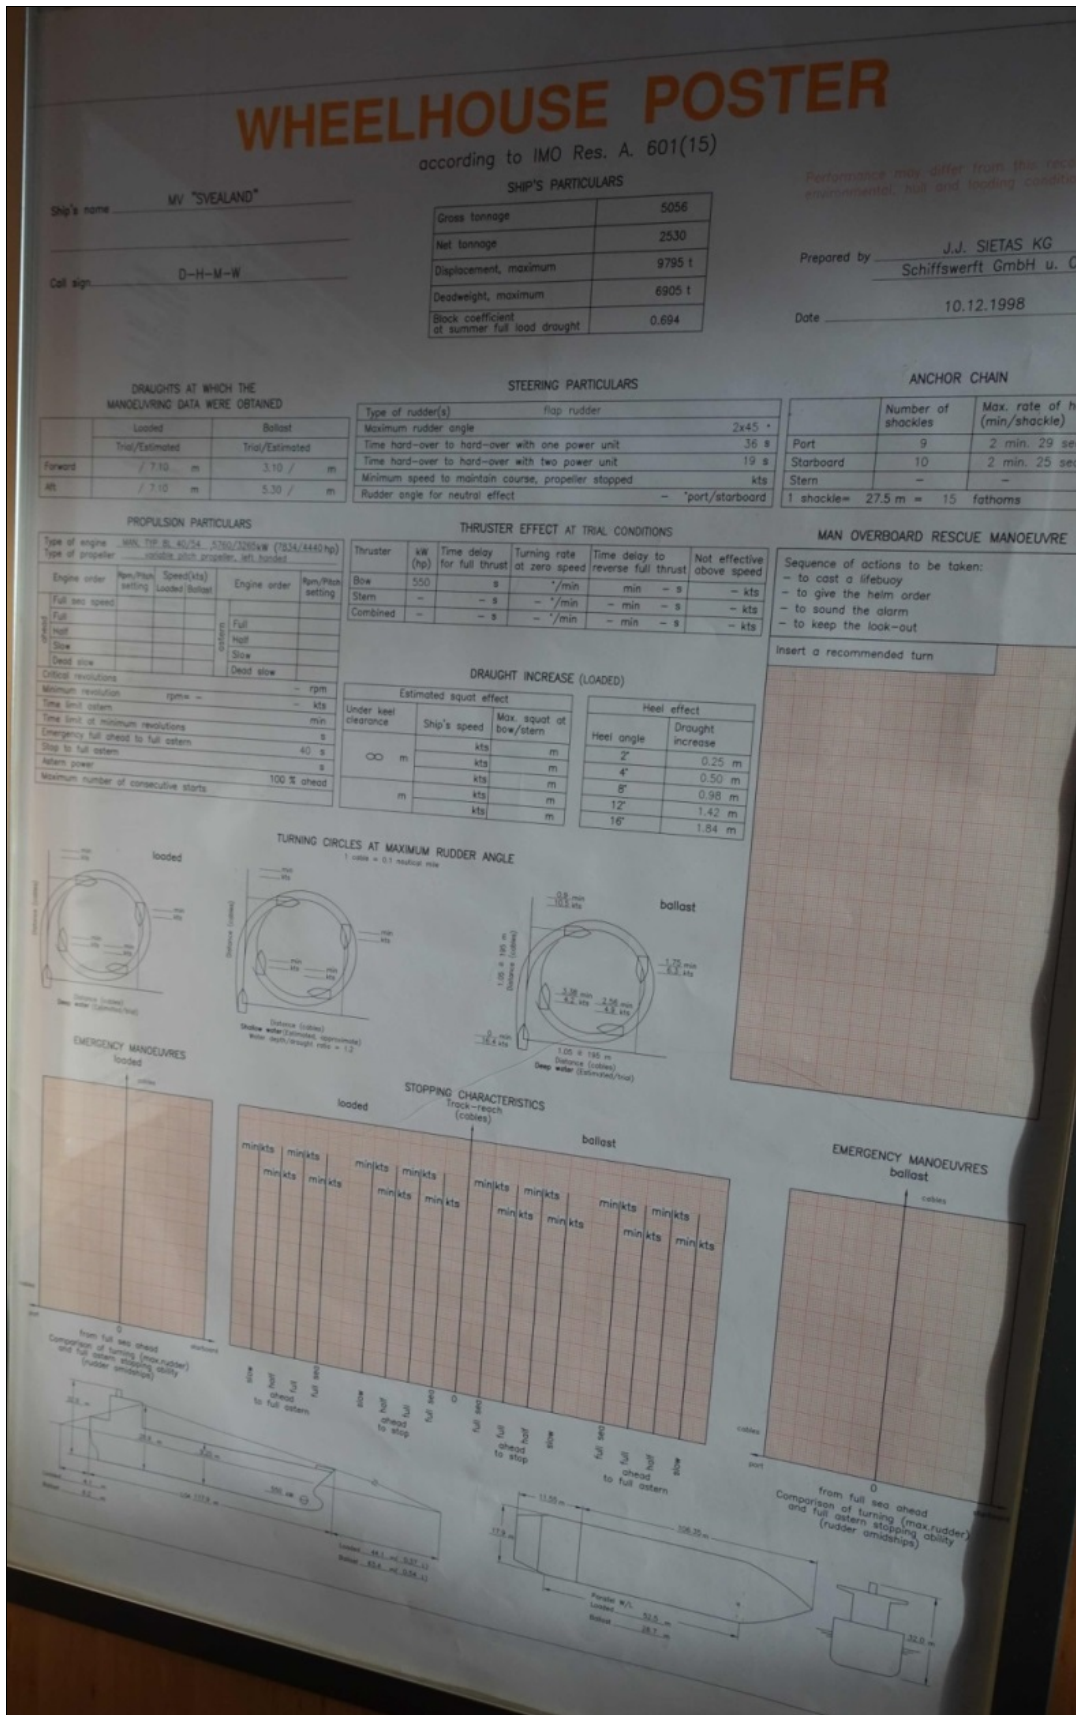
Figure 10: Wheelhouse poster

The wheelhouse poster (see Fig. 10) is only completed very sparsely. It was hanging in the companionway to the bridge during the BSU's survey. Key manoeuvring data, including turning circles when in laden state, as well as the emergency manoeuvre and advance distance characteristics were absent. The turning circle in ballast is specified at 195 m and takes 3.38 minutes when the momentum is 4.2 kts. A course alteration of 90° would have taken 0.9 minutes when the distance covered was also 195 m and the momentum 10.5 kts. After 100 m, the HANNI would turn after about 30 seconds. The wheelhouse poster gave no indication of the propeller's steering effect. A right-handed CPP was rather unusual for the year in which the vessel was built. This information was also absent.

The Federal Bureau of Maritime Casualty Investigation recommends that the owner revise the wheelhouse poster and the pilot card and supplement all queried data, as well as include the CPP's direction of rotation.

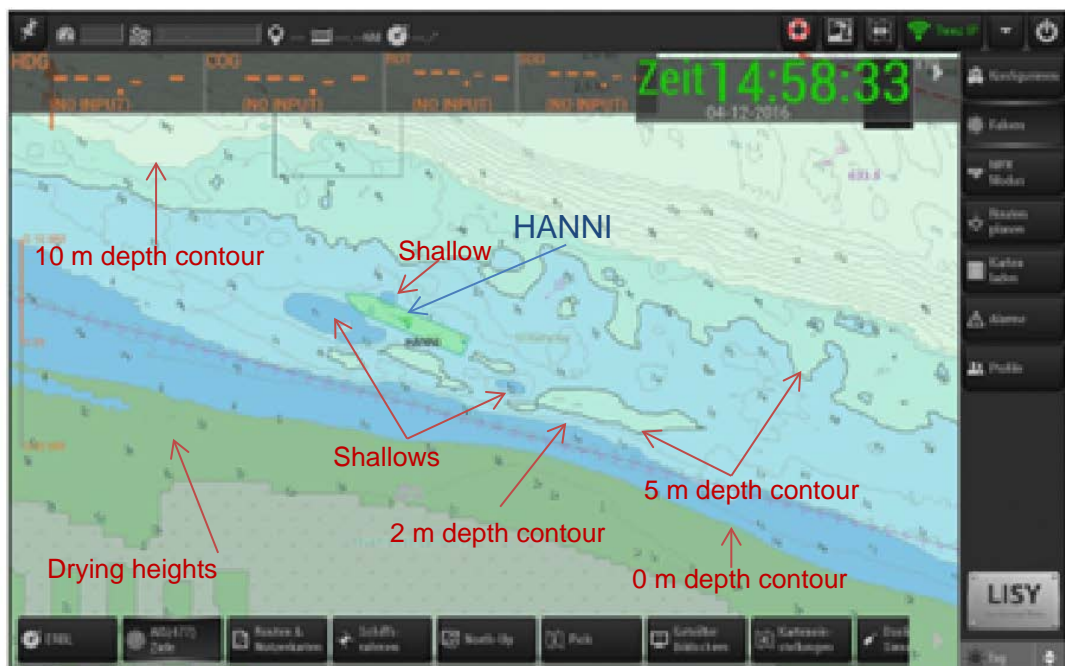
Figure 11: Portable Pilot Unit (PPU)

On 24 January 2017, the BSU visited the Harbour Pilots' Association and the VTS in Hamburg. On the day of the accident, the harbour pilot was already on board the HANNI at 0700, half an hour after she grounded, and the two tugs were made fast at 0706 and 0718. According to the PPU, which refers to CD, only the forward section of the HANNI was grounded between two shallows. It was unclear how the HANNI arrived at this position. Therefore, it was first planned to attempt to re-float her forward at an angle from the edge of the shallows on the ebb tide, which was now setting in. This attempt failed, as did ensuing attempts to move her with the support of the main engine and tugs operating at almost maximum bollard pull (taking into account the HANNI's maximum bollard load), and the water continued to recede. In the end, the salvage attempt had to be aborted after one hour.

New knowledge about the situation only came to light after the HPA had prepared a new sounding chart using the sounding boat DEEPENSCHRIEWER 1 between 1100 and 1230 on the day of the accident. The generalised depth contours and areas on the harbour pilot's PPU were no longer up to date, even though new sounding data from the HPA are used to adjust them on a monthly basis. According to the DEEPENSCHRIEWER 1's sounding chart, the HANNI's fore section was grounded completely and her port side up to the middle.

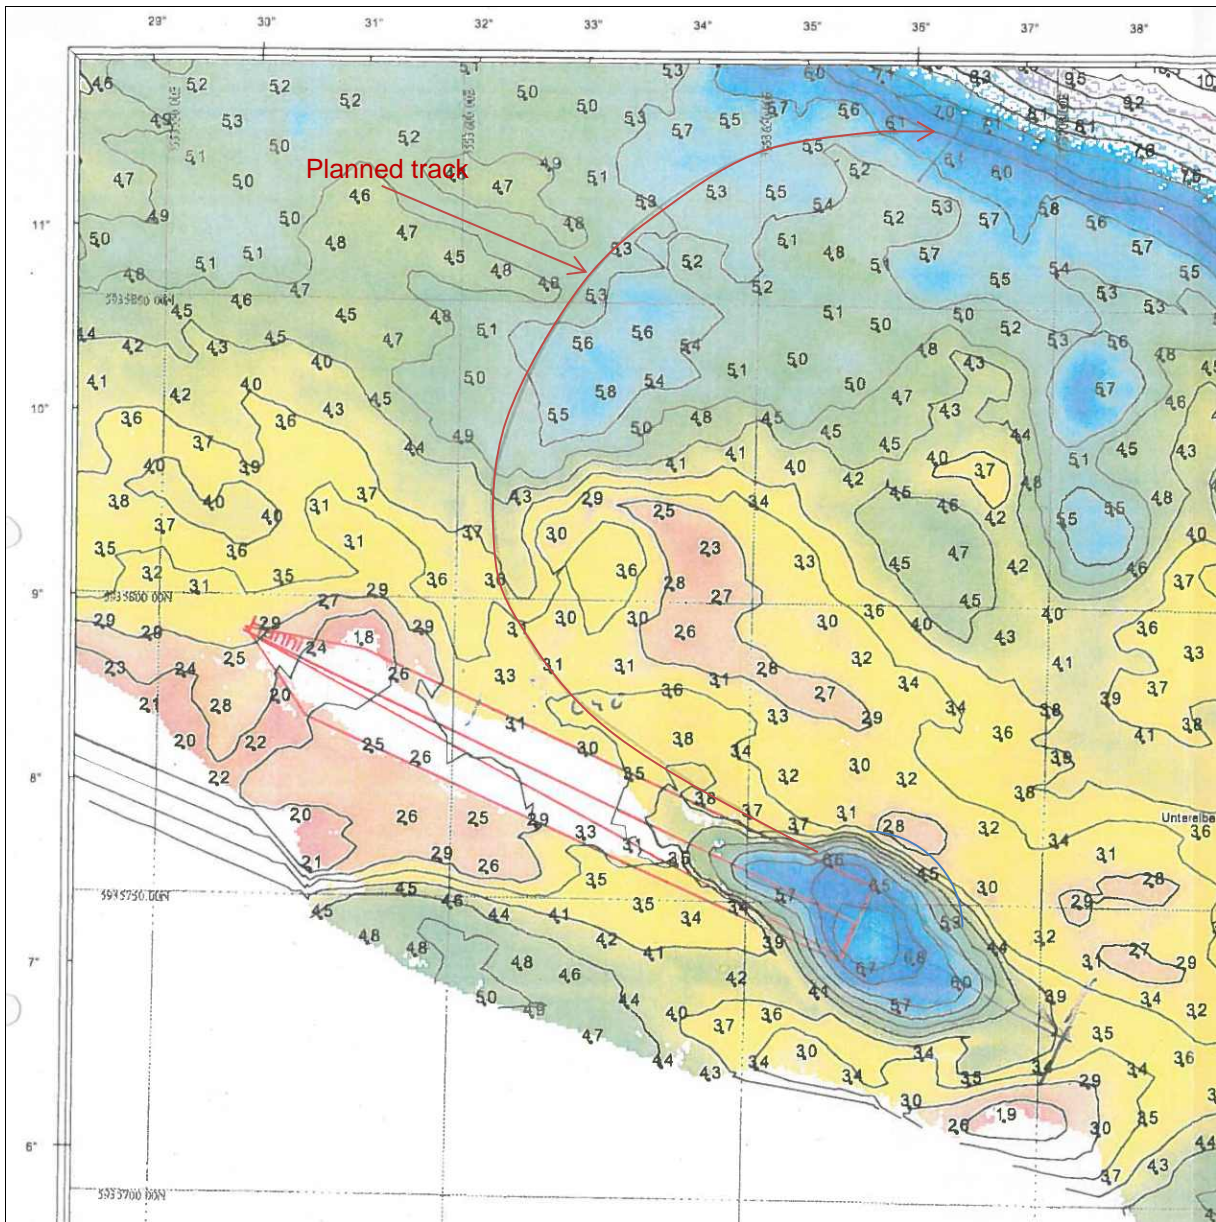
Figure 12: DIEPENSCHRIEWER 1's sounding chart³

³ The sounding chart refers to mean sea level – 1.6 m (mean low tide). The blue polygons behind the plotted outline of the HANNI are depth areas created by her propeller vortex prior to or during the first salvage attempt.
