Bundesstelle für Seeunfalluntersuchung
Federal Bureau of Maritime Casualty Investigation
Federal Higher Authority subordinated to the Ministry of Transport
and Digital Infrastructure

Investigation Report 43/16

Very Serious Marine Casualty

**Fatal line accident on board
the CMV MAERSK KURE
in the port of Bremerhaven
on 6 February 2016**

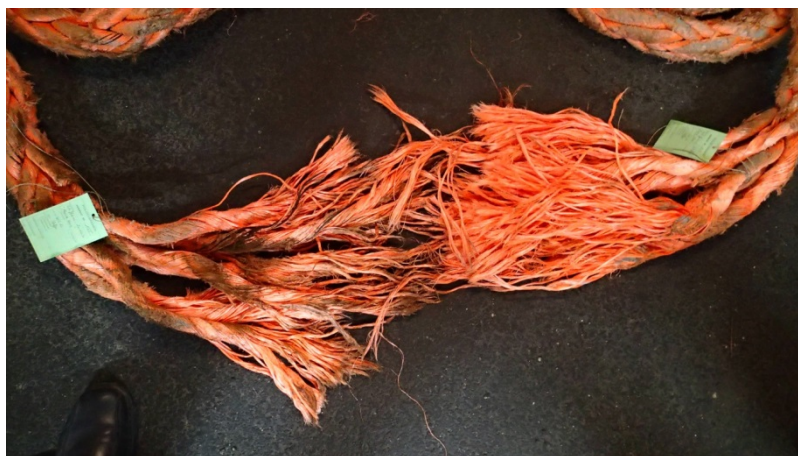
Figure 6: Line's point of failure
