**Bundesstelle für Seeunfalluntersuchung**  
**Federal Bureau of Maritime Casualty Investigation**  
Federal Higher Authority subordinated to the Ministry of Transport  
and Digital Infrastructure

## **Investigation Report 44/16**

**Very Serious Marine Casualty**

**Foundering of the fishing vessel CONDOR  
on 6 February 2016 about 3.5 nm east of the  
Baltic Sea Island of Fehmarn**

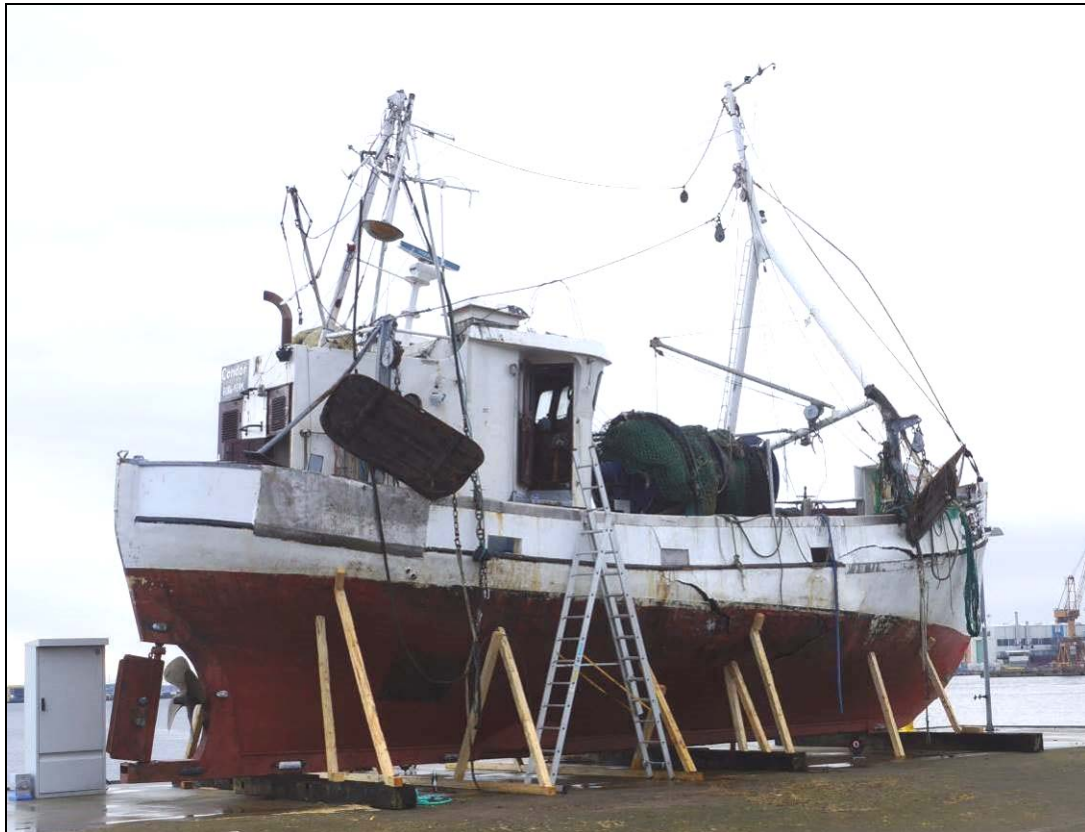
**Figure 9: FV CONDOR ready for the ensuing investigation**

<sup>10</sup> Note: The cracks in the shell plating visible in Fig. 9 are merely damage to the GRP coating applied to the fishing vessel's wooden hull for conservation purposes. (This damage was an inevitable consequence of the mechanical stress on the fishing vessel when she was lifted out of the water.)

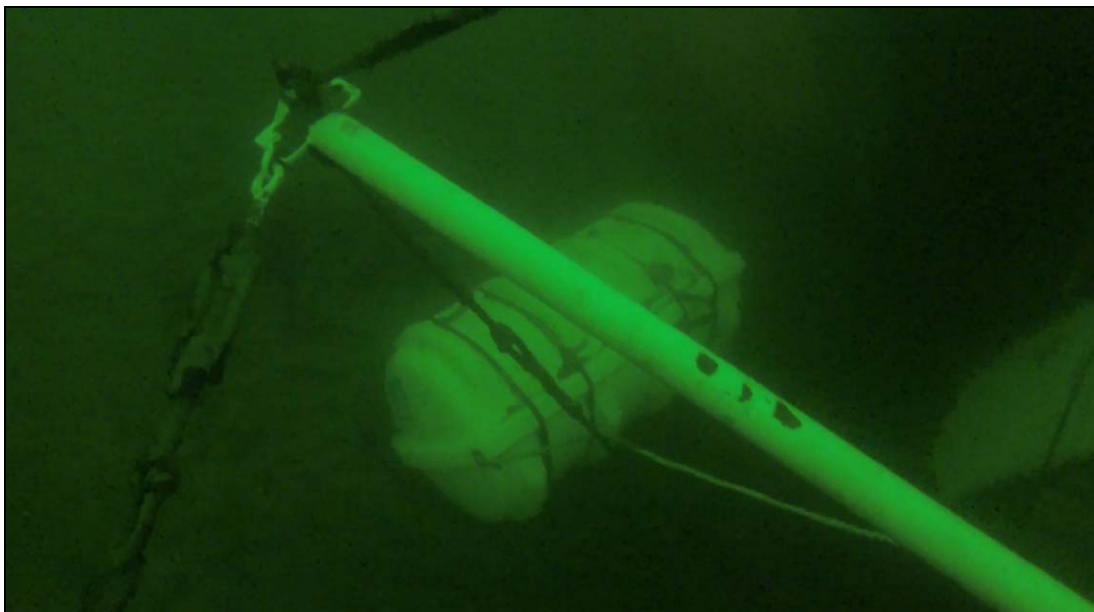
**Figure 13: Non-surfaced liferaft on the FV CONDOR<sup>11</sup>**

Other focal points of the BSU's investigation were aimed at clarifying why the liferaft on board the fishing vessel did not float up to the surface after the vessel foundered and why the emergency position-indicating radio beacon (EPIRB) installed on the fishing vessel, which was designed to transmit an automatic distress signal after the vessel foundered, also failed.

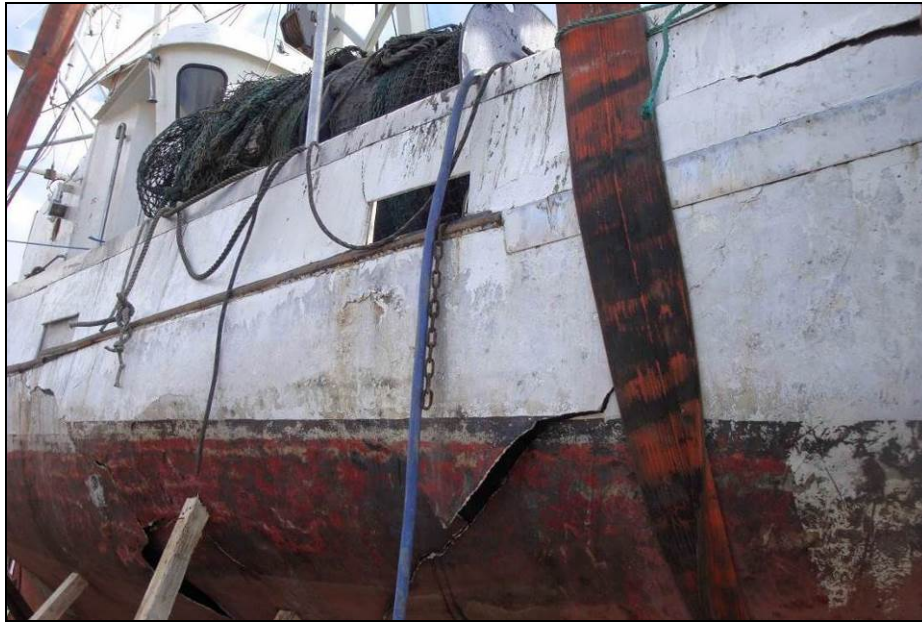
**Figure 15: Cracks in the GRP coating**

After the fishing vessel was salvaged, the hull exhibited large cracks at several points in the GRP coating (see **Fig. 15 f.**). Consultations with the salvage company revealed that these cracks were an inevitable consequence of the stresses on the hull during the lifting process. It was also found that the fishing vessel's wooden hull under the GRP coating did not exhibit any damage caused by decay. The initial suspicion that there may have been a connection between the CONDOR's GRP coating, rated inadmissible and/or problematic by the See-BG, and the foundering of the vessel was not confirmed.

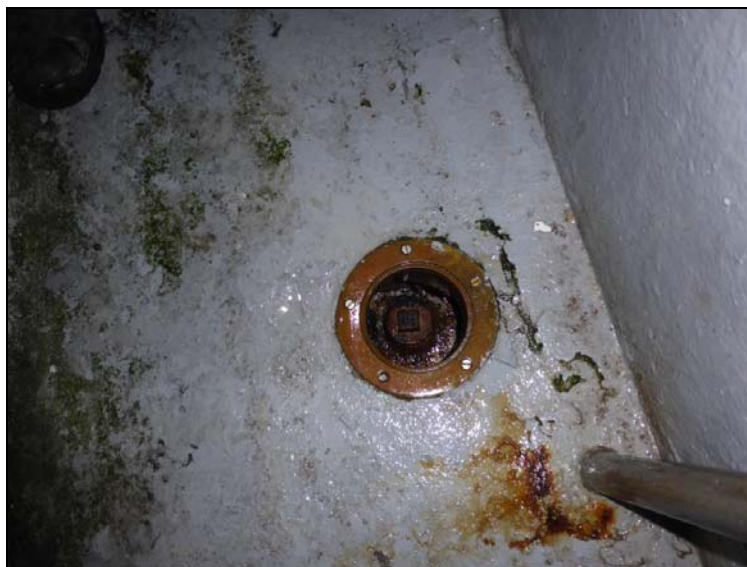
**Figure 18: Opening 1 in the main deck**

*The vessel's situation corresponded to the information provided in the DENEb's investigation report. The two openings main deck starboard side aft level with superstructure [sic] (diameter of each about 11 cm) were not closed. A cover was found not far from the bulwark and handed over to the client. The thread was so worn that it was not possible to establish a force-locked connection with the opening. The salvager provisionally sealed the two holes with bungs.*

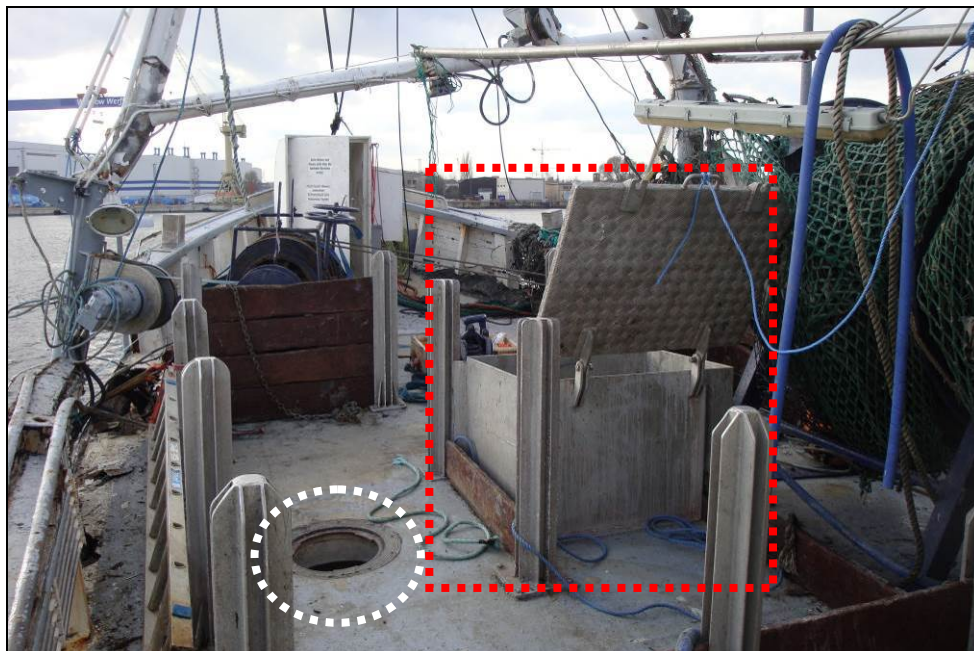
**Figure 20: Access openings to the hold<sup>16</sup>**

*Moreover, the hold for storing caught fish was found to be completely empty. The main hatch cover to the hold (see red marking in **Fig. 20**) was closed but not secured. The adjacent opening on the port side (diameter about 50 cm, see white markings in **Fig. 20**) was not closed, nor was a cover present.*

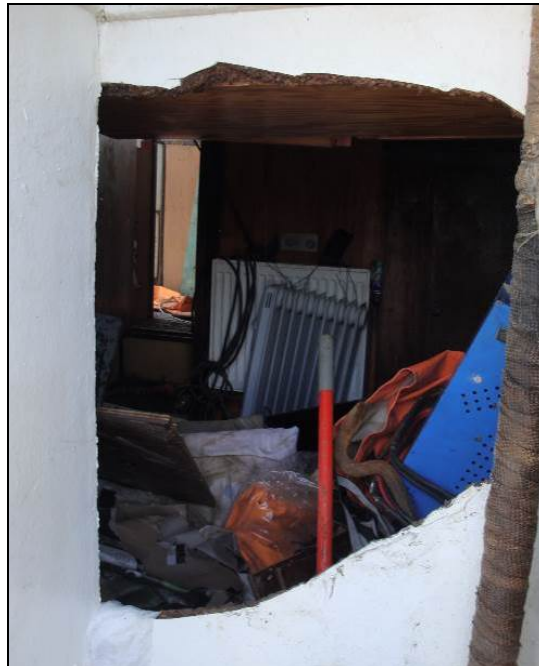
**Figure 21: Hole in the partition wall between the companionway and skipper's berth**

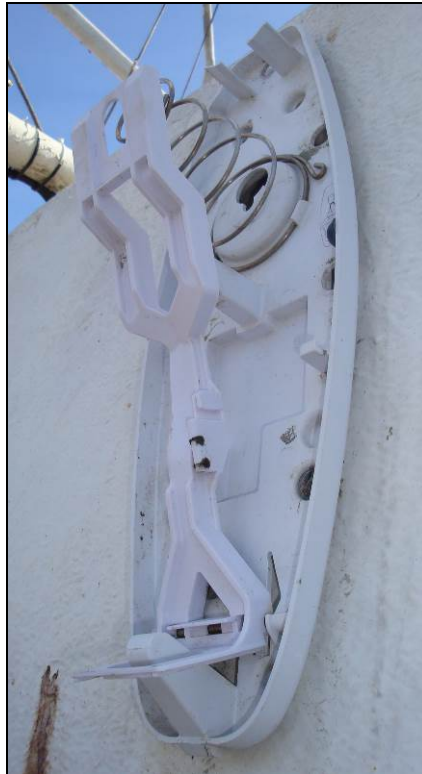
**Figure 28: Open EPIRB mount (starboard side of fishing vessel – wheelhouse)**

It was not possible to clarify why the EPIRB, which apparently only floated to the surface in direct connection with the fishing vessel's salvage operation, failed to reach the surface of the water on the day of the accident. That the hydrostatic release unit failed on the day of the accident and was only activated 'coincidentally' by mechanical forces acting on the fishing vessel during the salvage process cannot be ruled out. Since the actual hydrostatic release unit could not be found, investigating this hypothesis further was not possible.

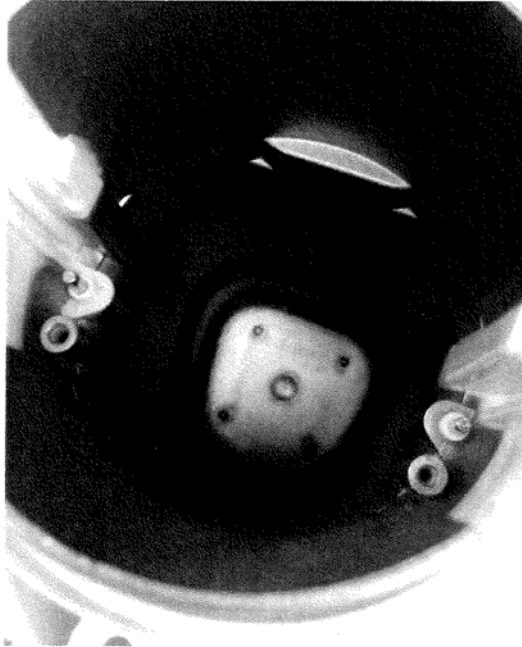
*Base of unit was dry.*

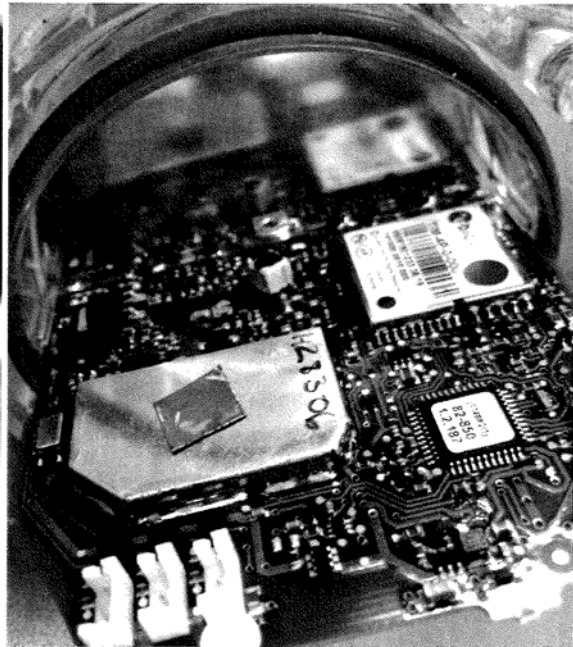
*No signs of corrosion on PCB*

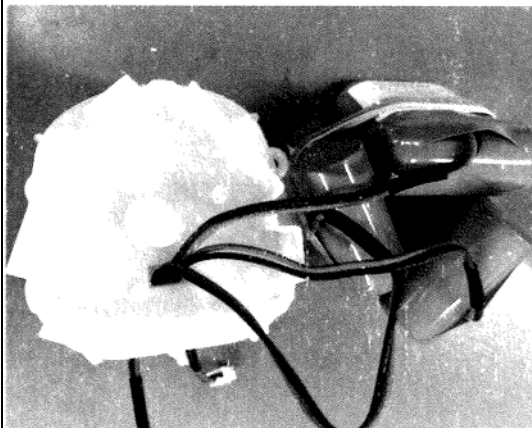
*Battery housing mould dry*

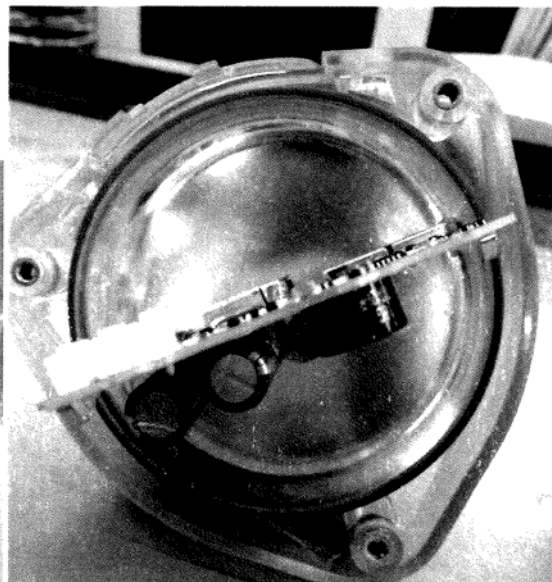
*O-ring seal intact and good condition – no evidence of damage*

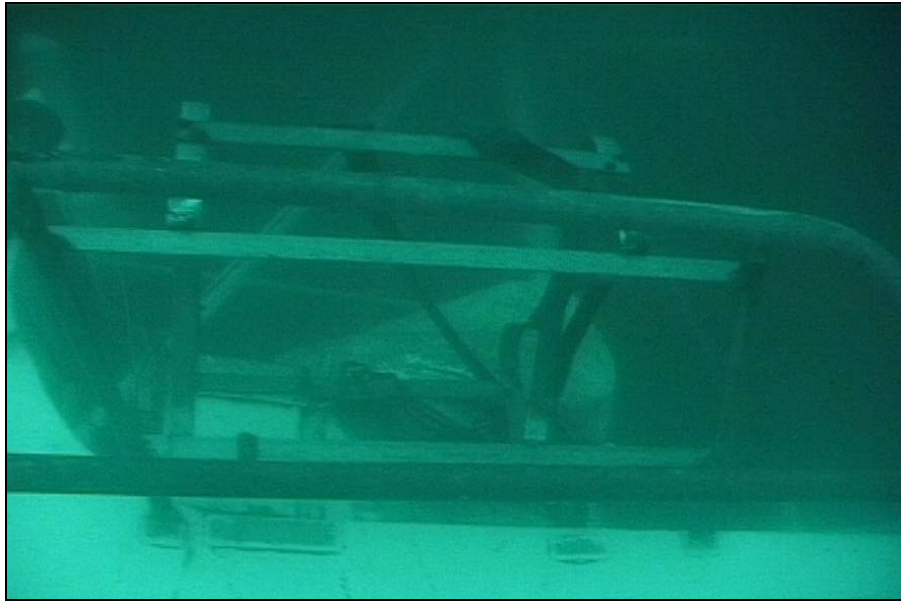
**Figure 37: Empty liferaft mount (extract from the DENEb's dive video – 12 February 2016)**

A liferaft could not be located on the surface of the water during the search and rescue activities after the fishing vessel foundered. Instead, it was found during the first dives on the wreck of the fishing vessel that the liferaft had detached from the mount and was floating in the water behind the aft edge of the deckhouse attached to the fishing vessel by the taut painter/release cord. (See **Fig. 37 f.** and especially the red marking in **Fig. 38**. The course of the line, which is barely visible in the murky water, is highlighted by a white dotted line in **Fig. 38** for better illustration.)

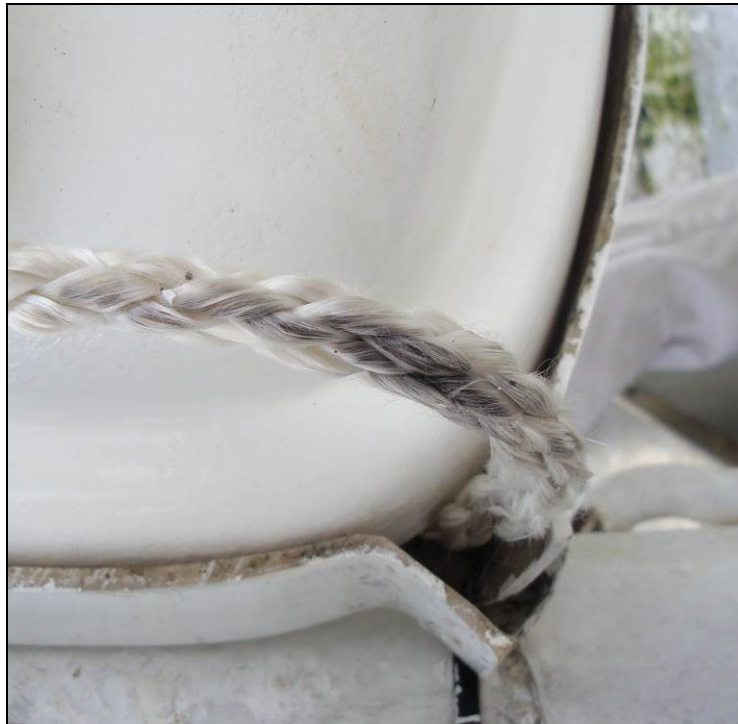
**Figure 41: Close-up of the liferaft's container (opening for the painter/release cord)**

The combined painter/release cord protruded about 3.5 m from the inside of the closed container at the intended opening (see **Fig. 41**) but contrary to the specifications (tractive force of only 150 Nm) could not be pulled out further even with moderate force.

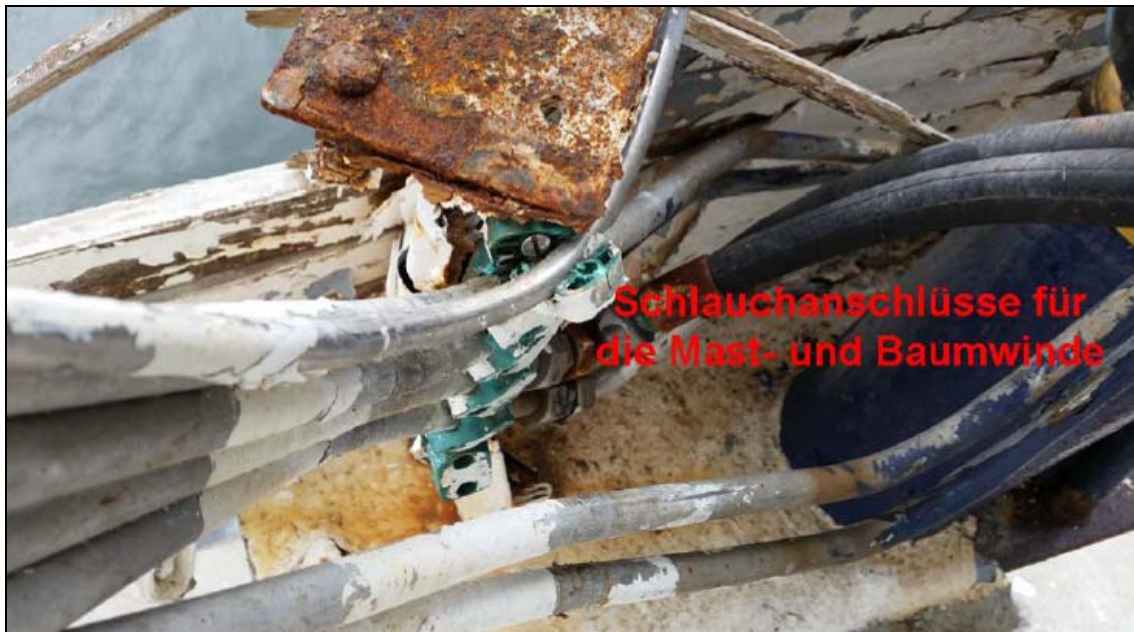
**Figure 103: Destroyed hoses and pipes on the port railing**
