Investigation Report 459/15

Serious Marine Casualty

**Collision on the Lower Elbe
between MV EENDRACHT and
MV TRANSCAPRICORN
on 26 November 2015**

14 July 2017

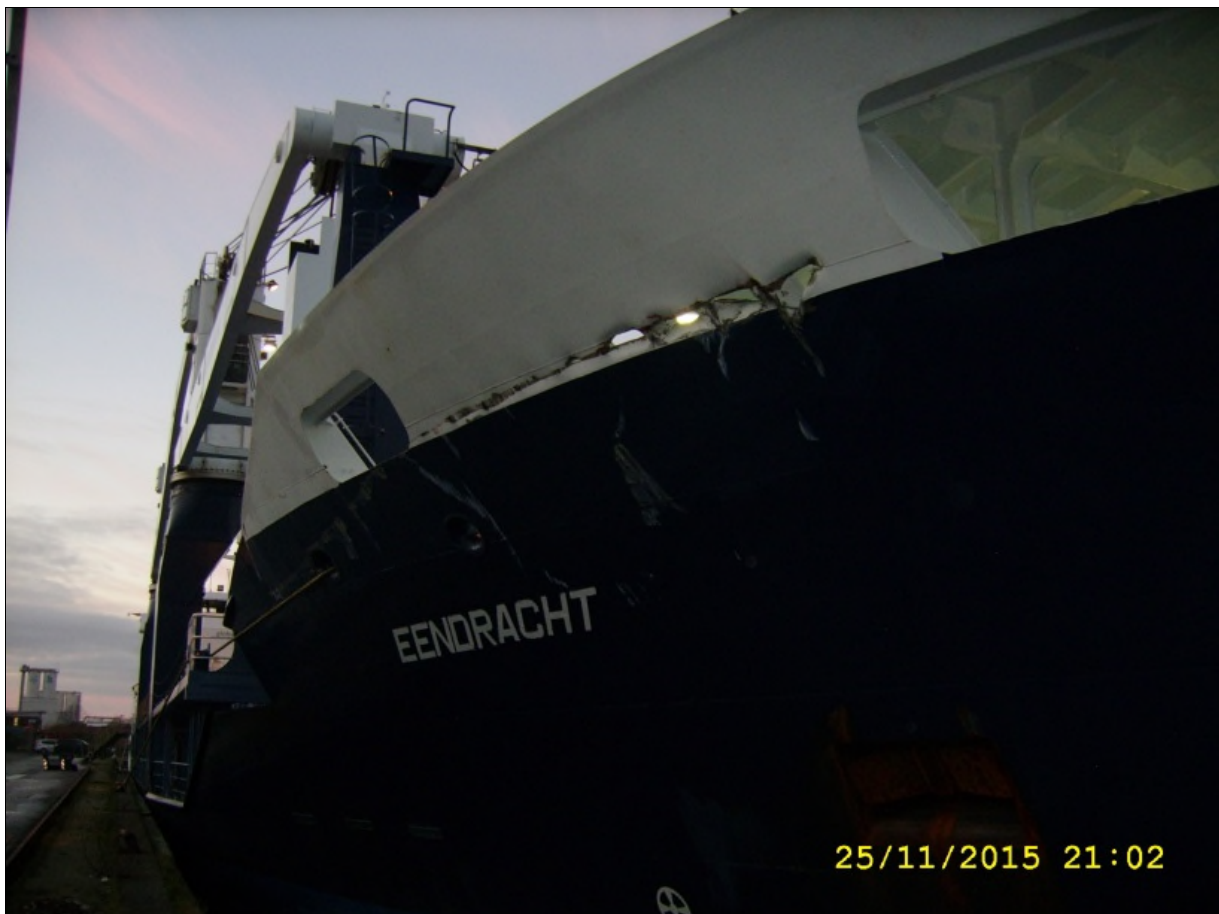
The EENDRACHT was permitted to sail on to Harlingen for repairs, with due regard to the weather conditions. No conditions were imposed on the TRANSCAPRICORN. Apart from the collision damage, no deficiencies were found on either vessel in terms of manning or equipment. The EENDRACHT sustained dents with cracks in the bow section on the starboard bulwark and on the starboard side of the transom.

Figure 4: Damage to the EENDRACHT's fore section, Ship Safety Division (BG Verkehr)

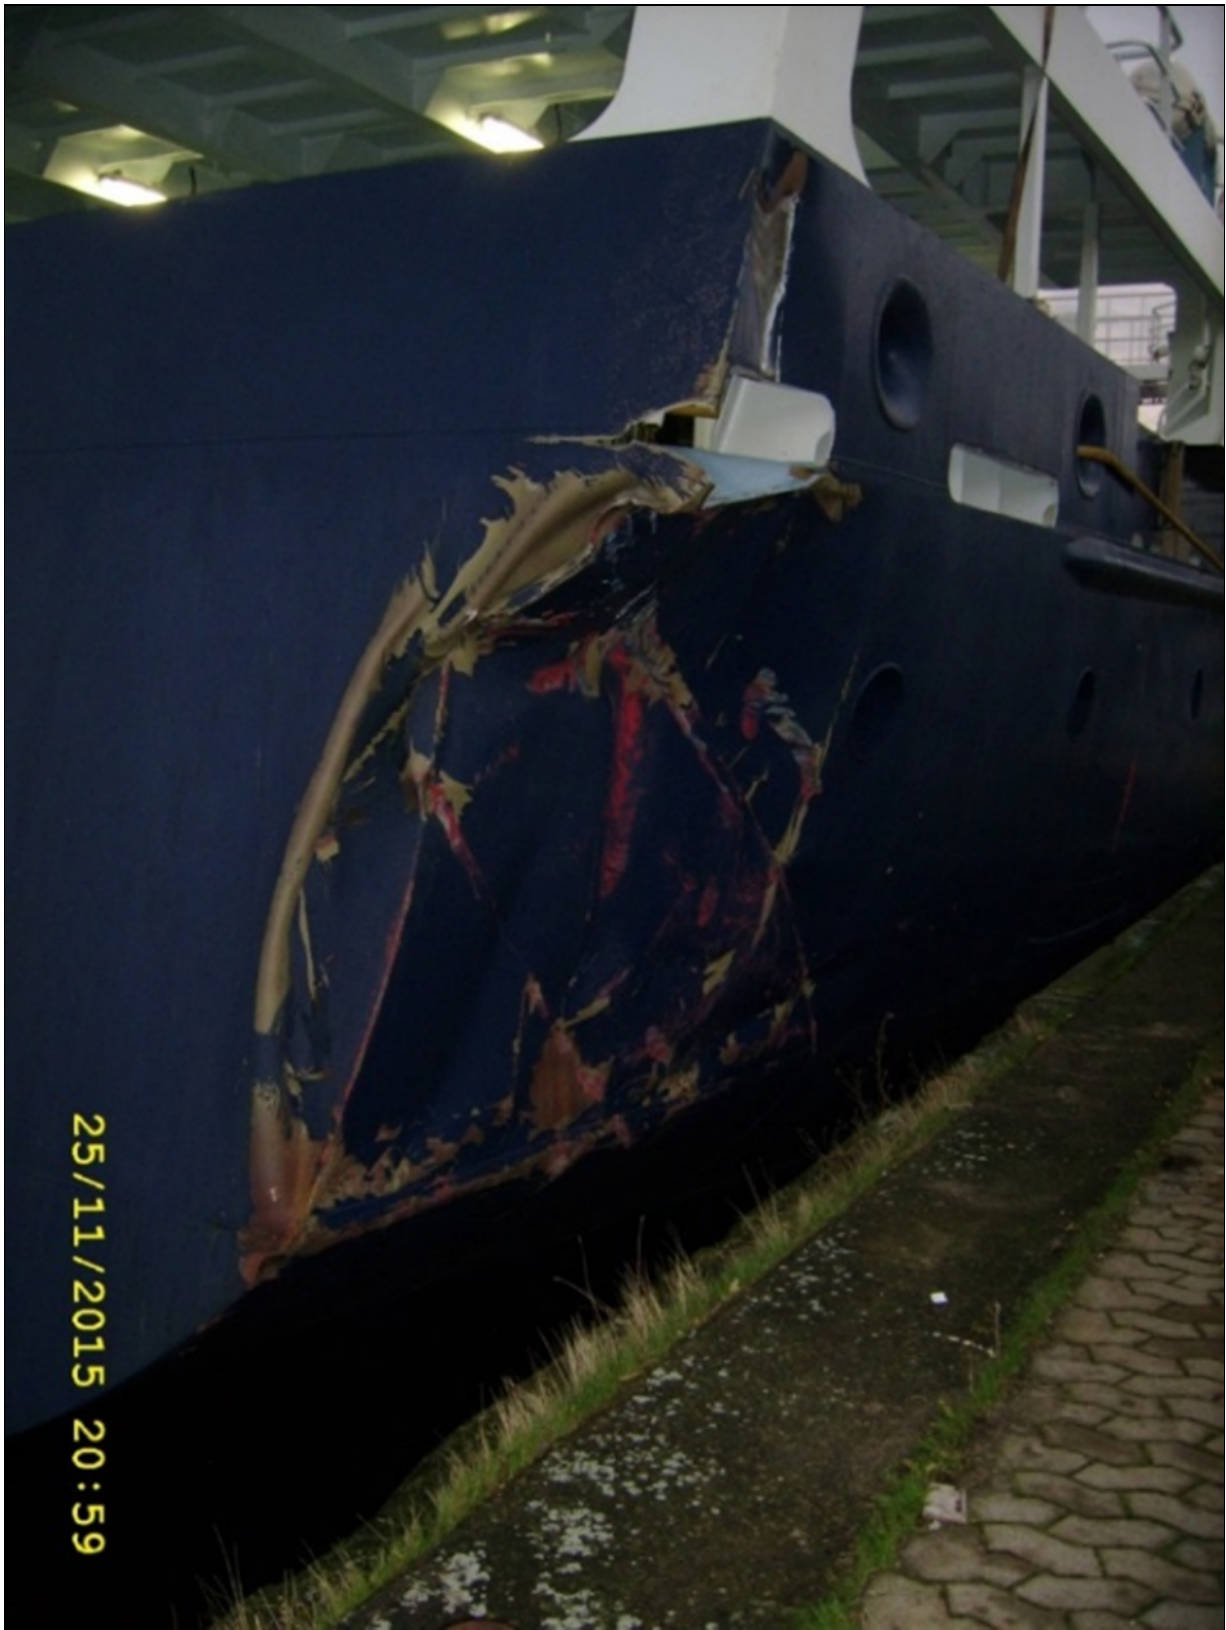
Figure 5: Damage to the EENDRACHT's aft section, Ship Safety Division (BG Verkehr)

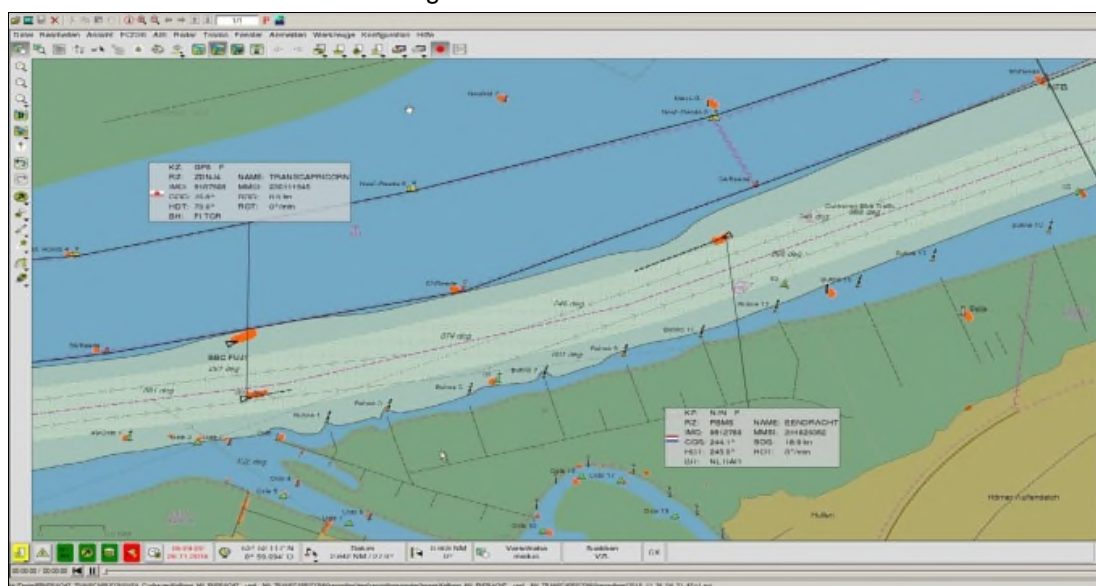
Figure 14: VTS at 052422

The TRANSCAPRICORN is located on the starboard side of the dredged channel and the EENDRACHT well outside the dredged channel at the edge of the fairway.

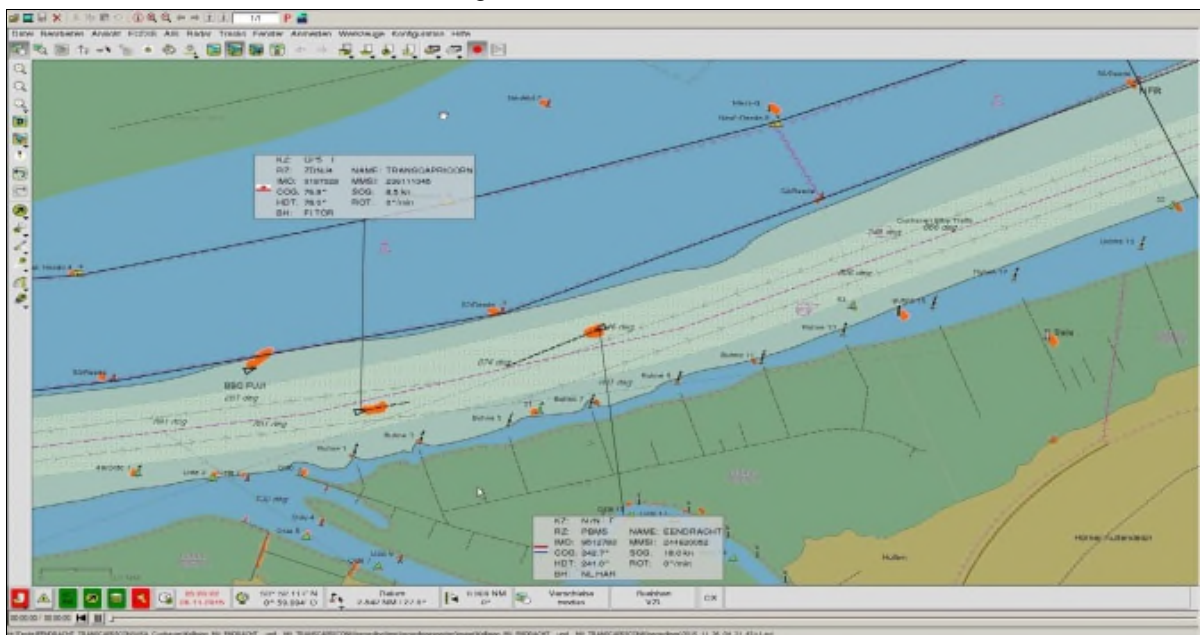
Figure 16: VTS at 052622

The TRANSCAPRICORN keeps her course on the starboard side of the dredged channel, while the EENDRACHT continues toward the dredged channel and the TRANSCAPRICORN. The vessels approach one another at a relative speed of 27 kts.

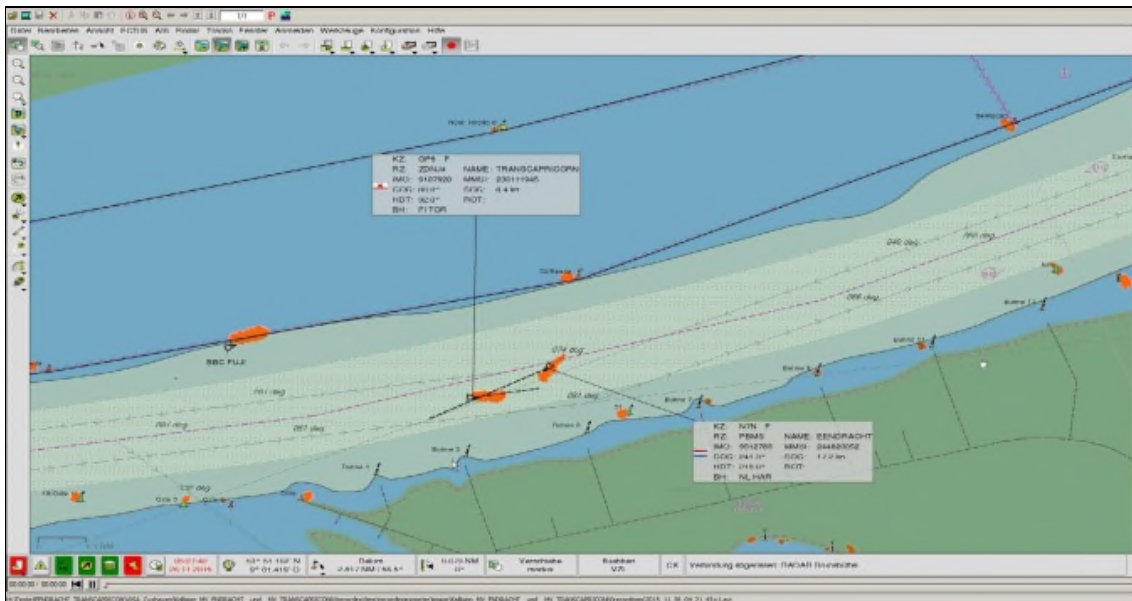
Figure 18: VTS at 052742

The EENDRACHT sails into the dredged channel and crosses the radar reference line. The collision is imminent.

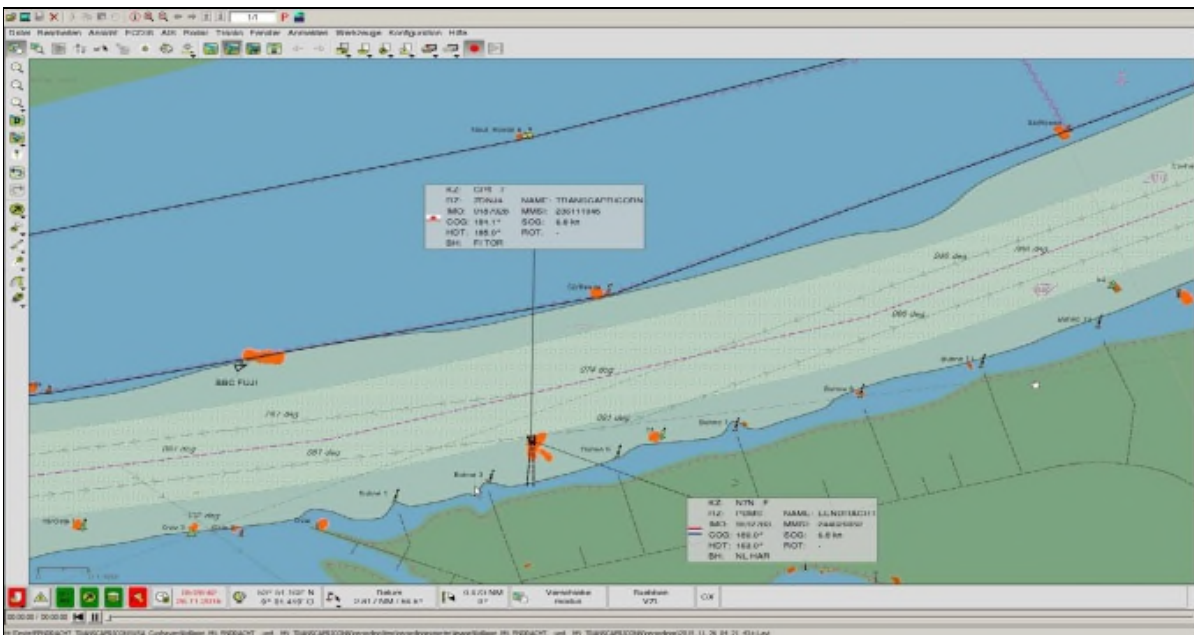
Figure 20: VTS at 052842

The TRANSCAPRICORN turns hard to starboard and the EENDRACHT hard to port. The vessels collide with their sides at an acute angle.

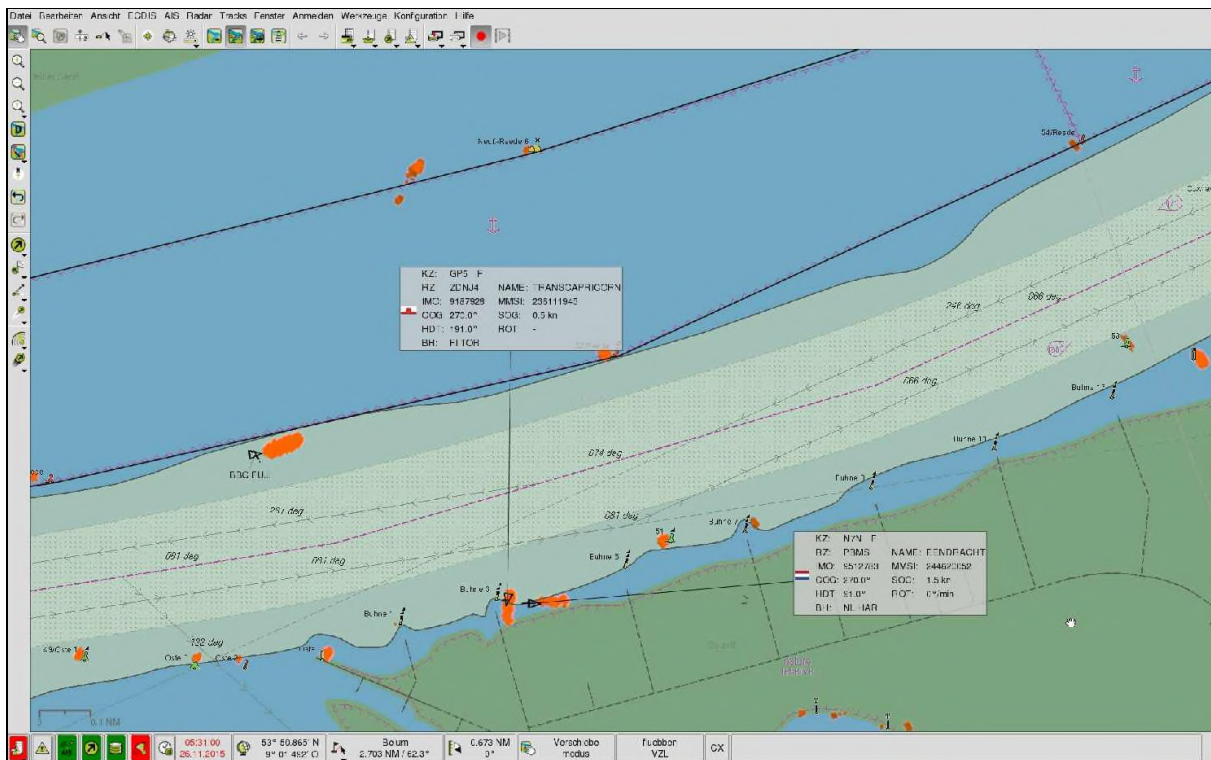
Figure 21: VTS at 053100

The TRANSCAPRICORN runs aground in mud, while the EENDRACHT is able to free herself and stay afloat.

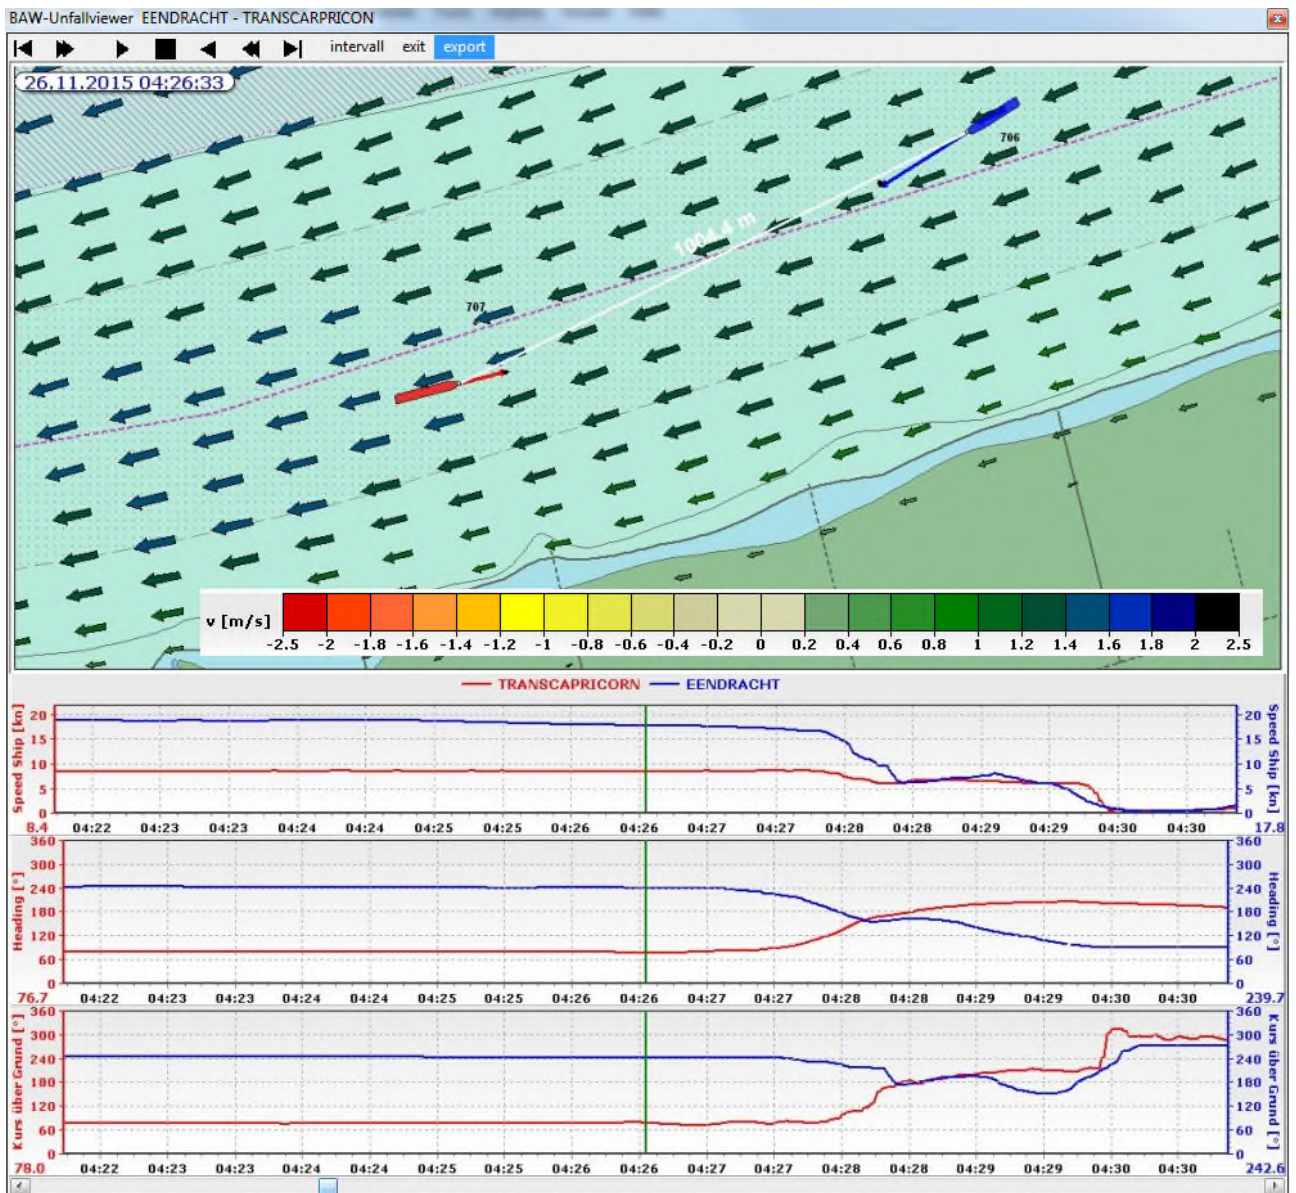
Figure 23: Situation at 052633

For the assessment of conditions at the time of the accident, four sailing situations are considered separately below (see Figures 23-26). Figure 23 shows the situation about 90 seconds before the collision. The prows of the oncoming BBC FUJI and

TRANSCAPRICORN were still about 1,000 m apart. Neither vessel had altered her course for about ten minutes. At 78° and a consistent 8.4 kts over ground against the ebb current, the TRANSCAPRICORN (shown in red, draught 6.2 m) kept an almost parallel course to the Balje leading lights plotted on the navigational chart at 81° and steered 3°. The EENDRACHT (shown in blue, draught 5.2 m) steered a course of 242° at a slightly decreasing speed of about 18 kts over ground. The Otterndorf/Belum leading lights are shown at 245.5° in the navigational chart. Accordingly, the EENDRACHT steadily approached the middle of the fairway. The ebb current's velocity in the fairway was about 1.3 m/s (BAW PROPTTEL).

At 052633 (see Figure 23), the distance between the two prows is calculated at 1,004.4 m on a constant bearing. It would have been necessary to respond immediately to prevent the collision. About 30 seconds later, the EENDRACHT's master switched to manual steering. Contrary to the intended course alteration to starboard, the EENDRACHT turned to port, however. This meant that a collision with the TRANSCAPRICORN, which according to the audio recordings on the VDR set her rudder to hard to starboard at 052724, was unavoidable. It was now a matter of preventing more severe damage and keeping the collision angle acute. The vessels collided at 052804. The EENDRACHT and TRANSCAPRICORN scraped past each other with the starboard and port side respectively. The impact caused material damage to the side of each vessel.

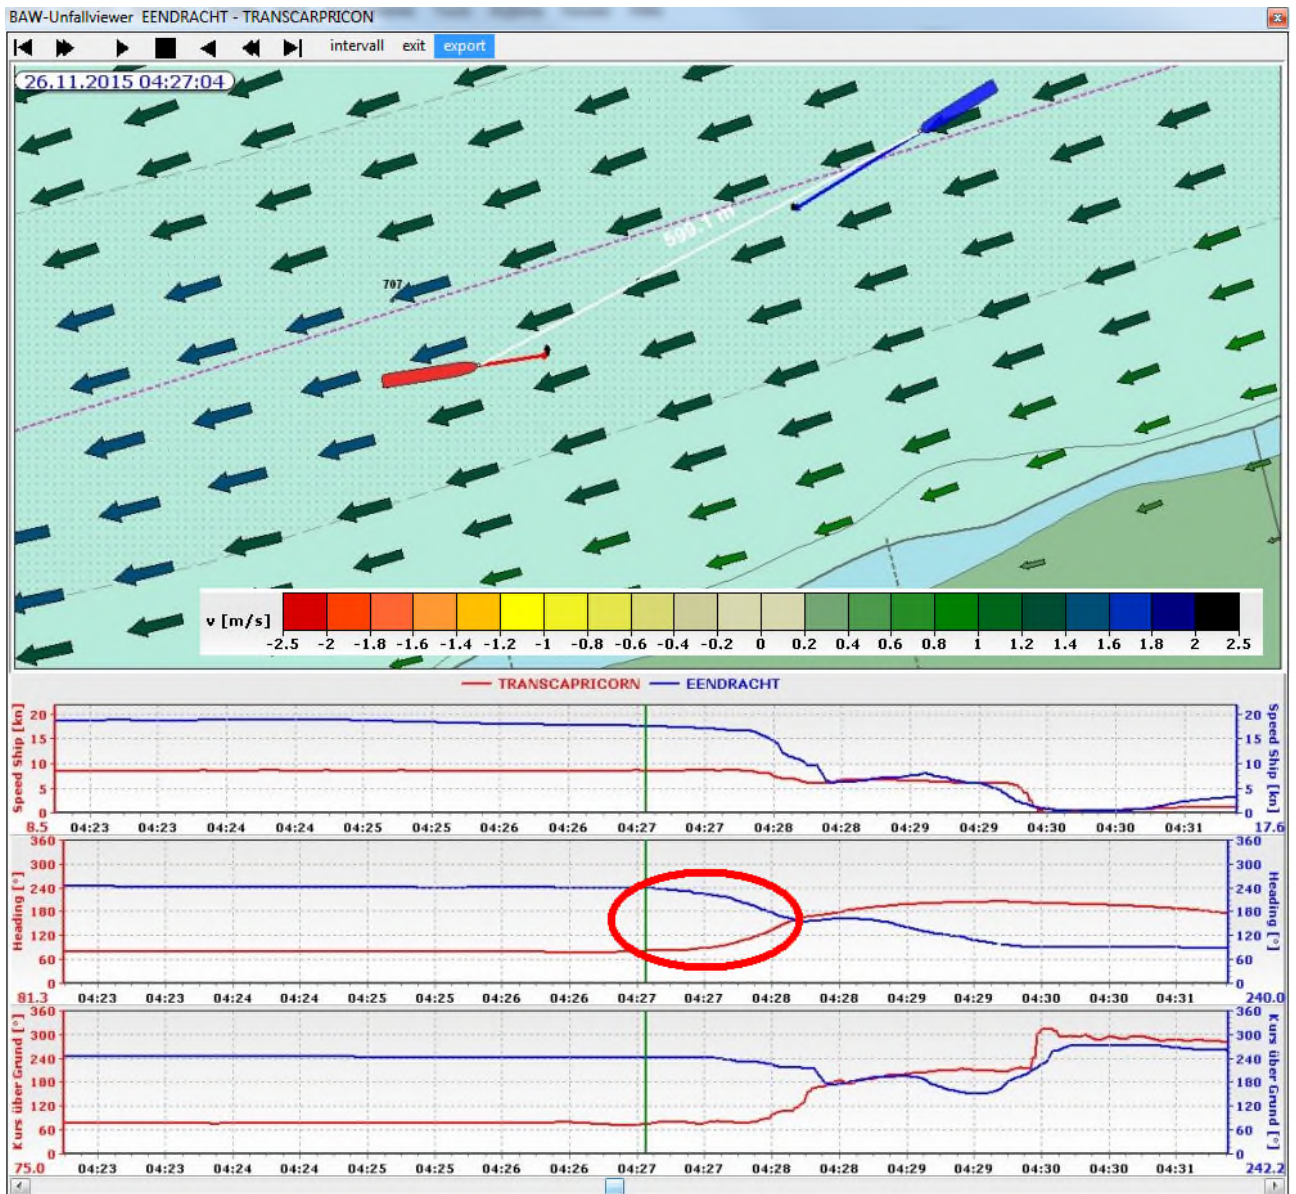
Figure 24: Situation at 052704, switched to manual steering

The EENDRACHT had almost reached the middle of the fairway about one minute (042704 UTC) before the collision. The distance between the prows was about 600 m. From this point, the bow of the EENDRACHT started to turn steadily to port and that of the TRANSCAPRICORN to starboard.

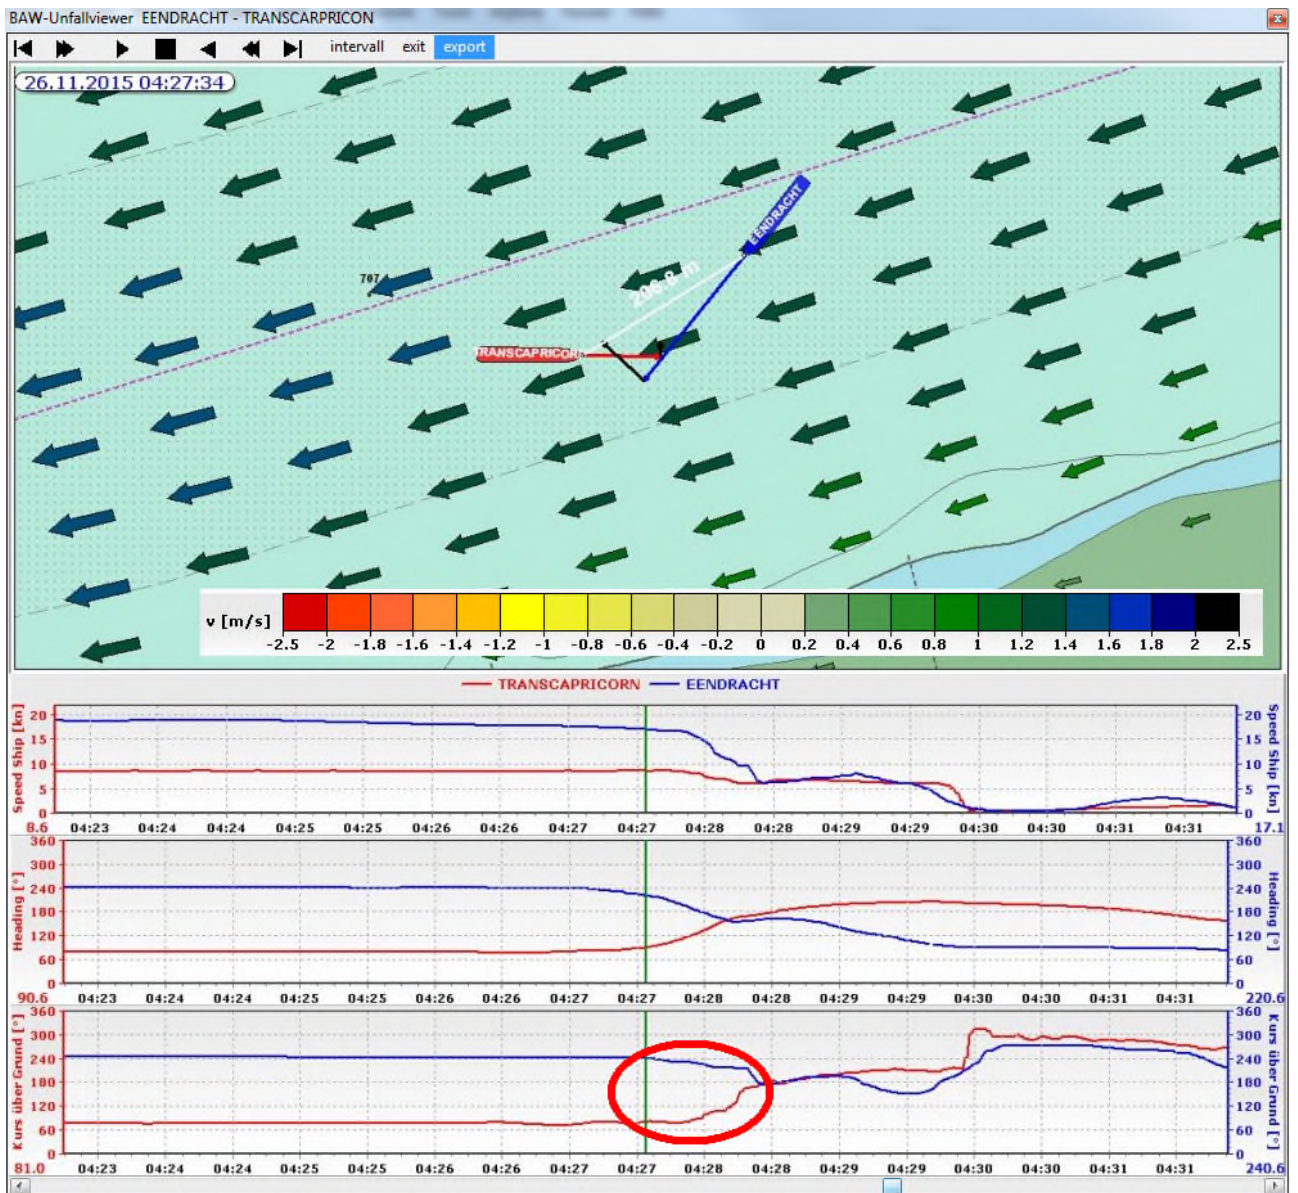
Figure 25: Situation at 052734

The whole of the EENDRACHT was on the opposite side of the fairway (Figure 25) approximately 30 seconds (042734 UTC) before the collision. The prows were now only about 200 m apart. Both vessels maintained their chosen directions of rotation. From this point, the course of each vessel altered significantly.

As shown in Figure 25, the EENDRACHT ran out of rudder at 052734 while crossing the radar reference line. The black SOG vector that has developed to starboard illustrates this in the animation. It was not possible to calculate the rate of turn reliably because only integers were available as heading data.

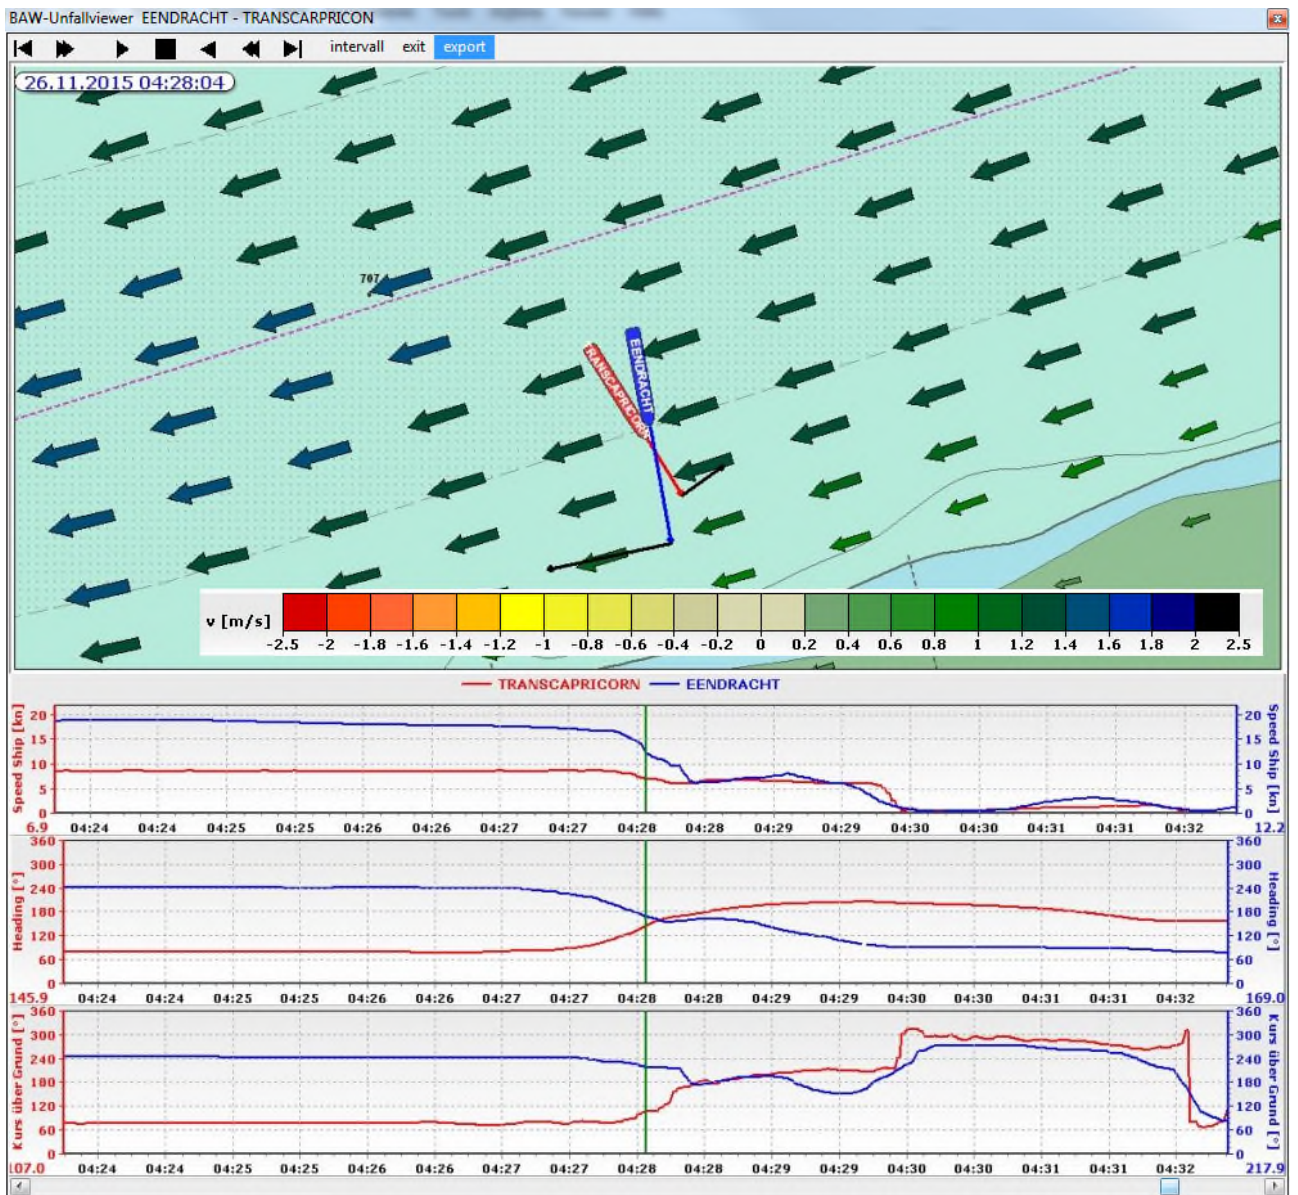
Figure 26: Situation at 052804, collision

At about 052804, the vessels collided level with their fore sections (see Figure 26). The TRANSCAPRICORN's speed and that of the EENDRACHT at this point still stood at 6.9 kts and 12.2 kts over ground respectively.

The EENDRACHT's course alteration to port about one minute before the collision contributed to the accident significantly. A more detailed assessment of the course of the accident is not possible due to the underlying data available.

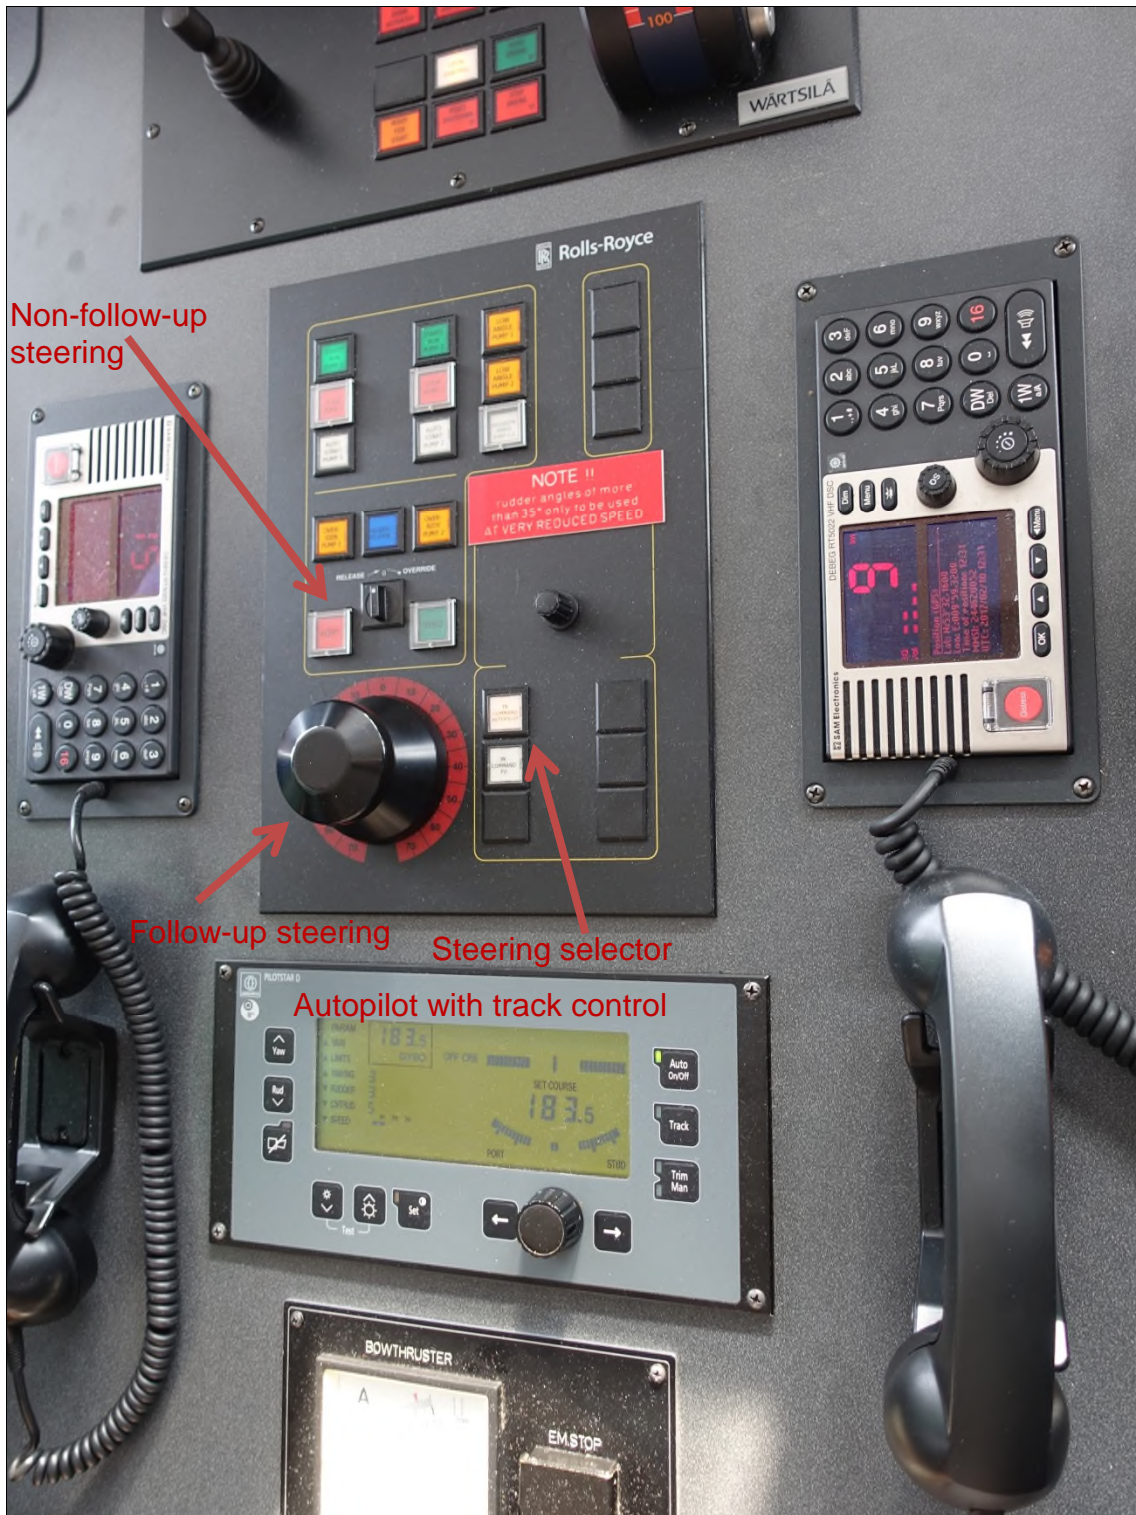
Figure 27: Control console

The non-follow-up steering on the EENDRACHT was equipped with an override function with buttons (push button) and additionally secured with transparent plastic flaps. The override function is a system that generally only has priority over the autopilot based on the guidelines of the classification society. On the EENDRACHT, the override buttons had priority over all other controllers, i.e. the steering selector is not required and the helm responds immediately when the button is operated.

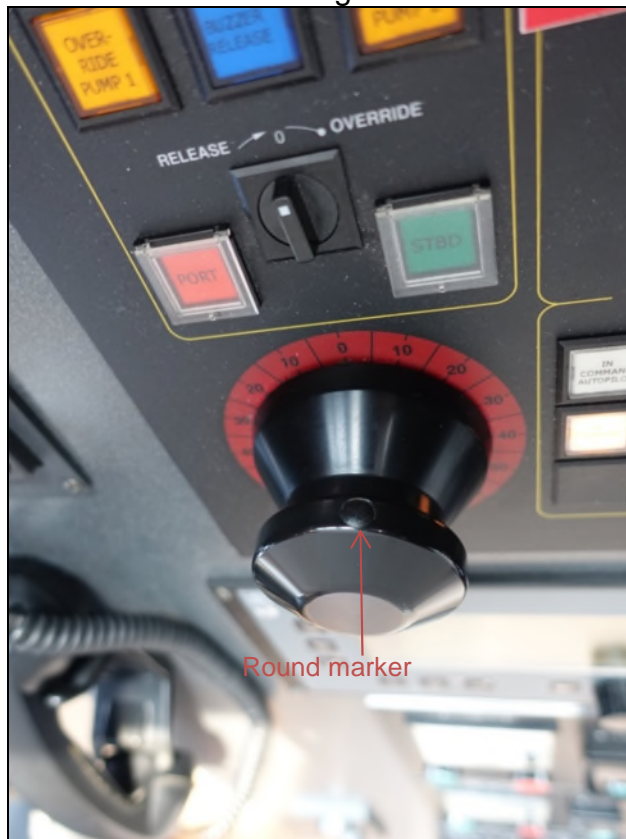
Figure 30: Manual helm with stepping amidships (0)

The rotary knob is furnished with stepping that can be felt when it is held and a round marker, which indicates the midship position of the rudder angle pre-selection. There is also a rudder angle indicator on the ceiling before the control console.
