**Bundesstelle für Seeunfalluntersuchung**  
**Federal Bureau of Maritime Casualty Investigation**  
Federal Higher Authority subordinated to the Ministry of Transport  
and Digital Infrastructure

Investigation Report 46/16

**Very Serious Marine Casualty**

**Fatal accident**  
**on board the FV PESORSA DOS**  
**on 8 February 2016 in the**  
**North Atlantic**  
**west of Ireland**

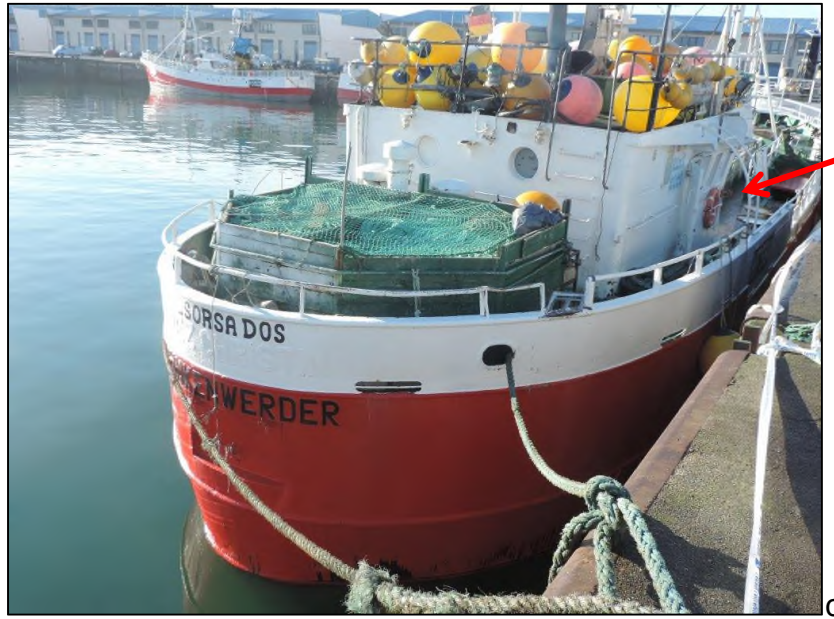
Figure 4: Stern with nets

The above Figure 4 shows the PESORSA DOS with the loaded nets and marker buoys used for fishing. During the accident, only a few of the buoys were stowed on the upper deck, as almost all the nets were deployed.

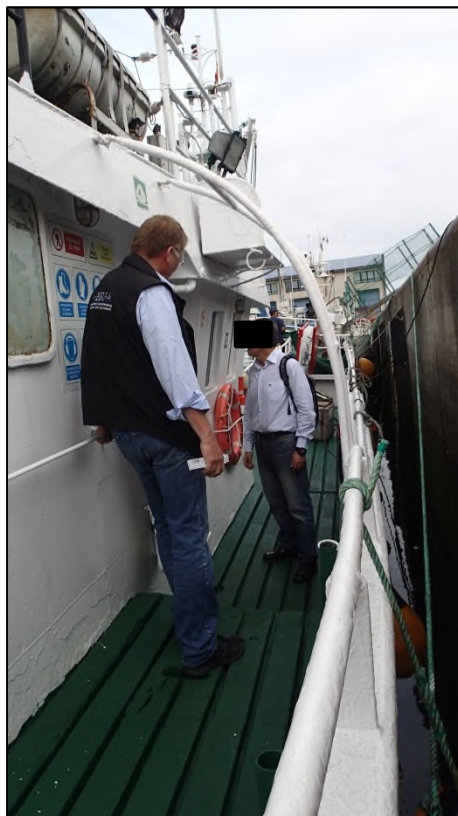
Figure 5: Position of the seamen before the accident

Figure 5 shows the approximate position of the two seamen washed overboard. The height of the guard rail from the upper edge of the wood cover is 92-94 cm; from the steel deck, it is about 100 cm.

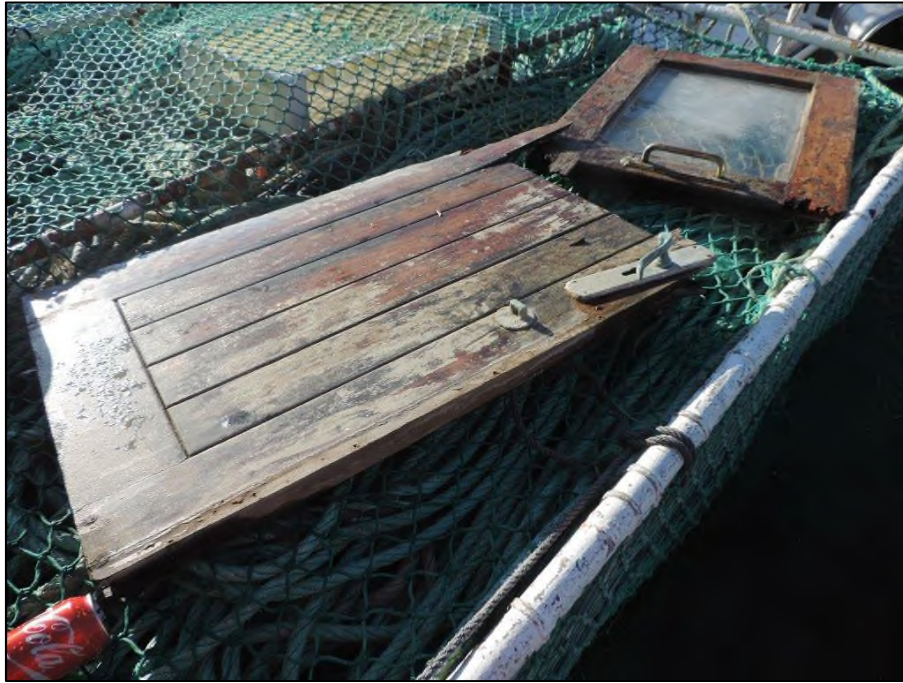
Figure 6: Destroyed wheelhouse door

The guard rail on the bridge deck was damaged by the wave, the bridge's wooden access door, including frame, was destroyed, and the EPIRB was washed overboard. Since the water at the steering wheel was about 60 cm deep, several electronic devices failed. The skipper immediately sounded the general alarm. The mayday emergency call was sent to Valentia MRCC in Ireland on border wave and to all ships on VHF channel 16.

During the accident, the wheelhouse door broke in two at the middle and its frame broke away from the steel surround and washed into the bridge structure.
