Investigation Report 470/15

Less Serious Marine Casualty

**Collision between the EMSMOON
and Friesenbrücke
railway bridge
at Weener, Ems,
on 3 December 2015**

23 February 2017

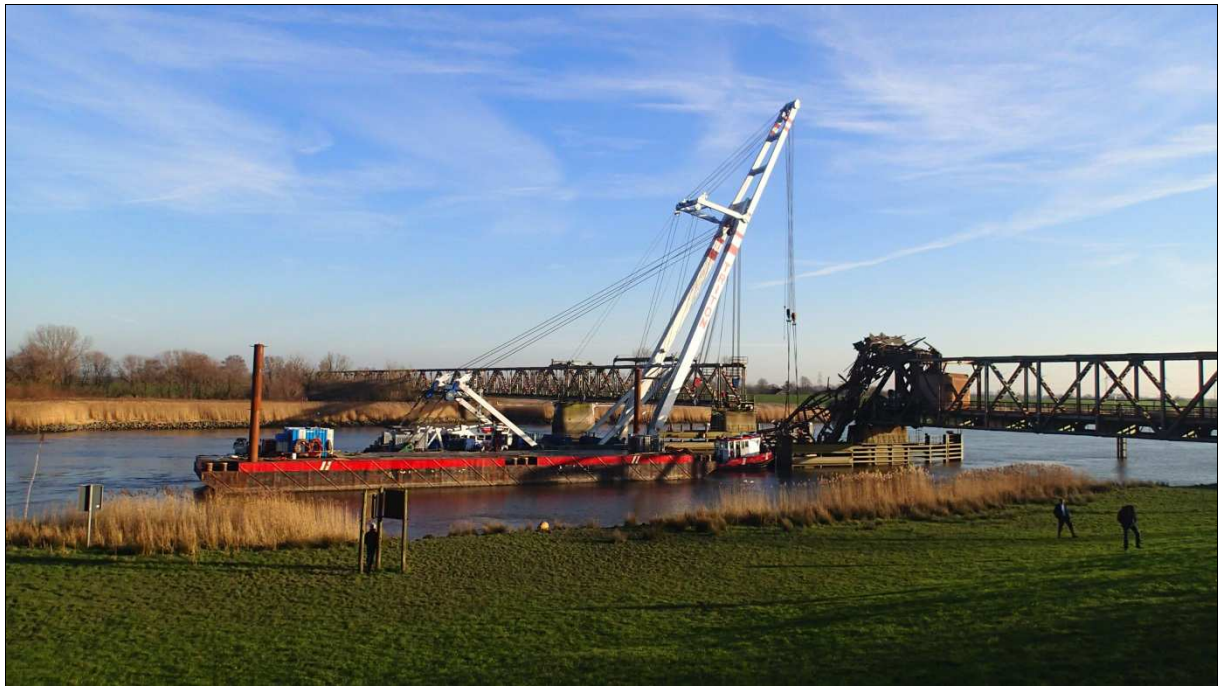
Figure 3: Recovery of the bascule

The BSU visited the scene of the accident on 8 December 2015 to inspect the damage and recovery of the bascule. The bascule was completely destroyed and could only be lifted out by means of a floating crane. This made it possible to clear the passage for use by larger ships again.

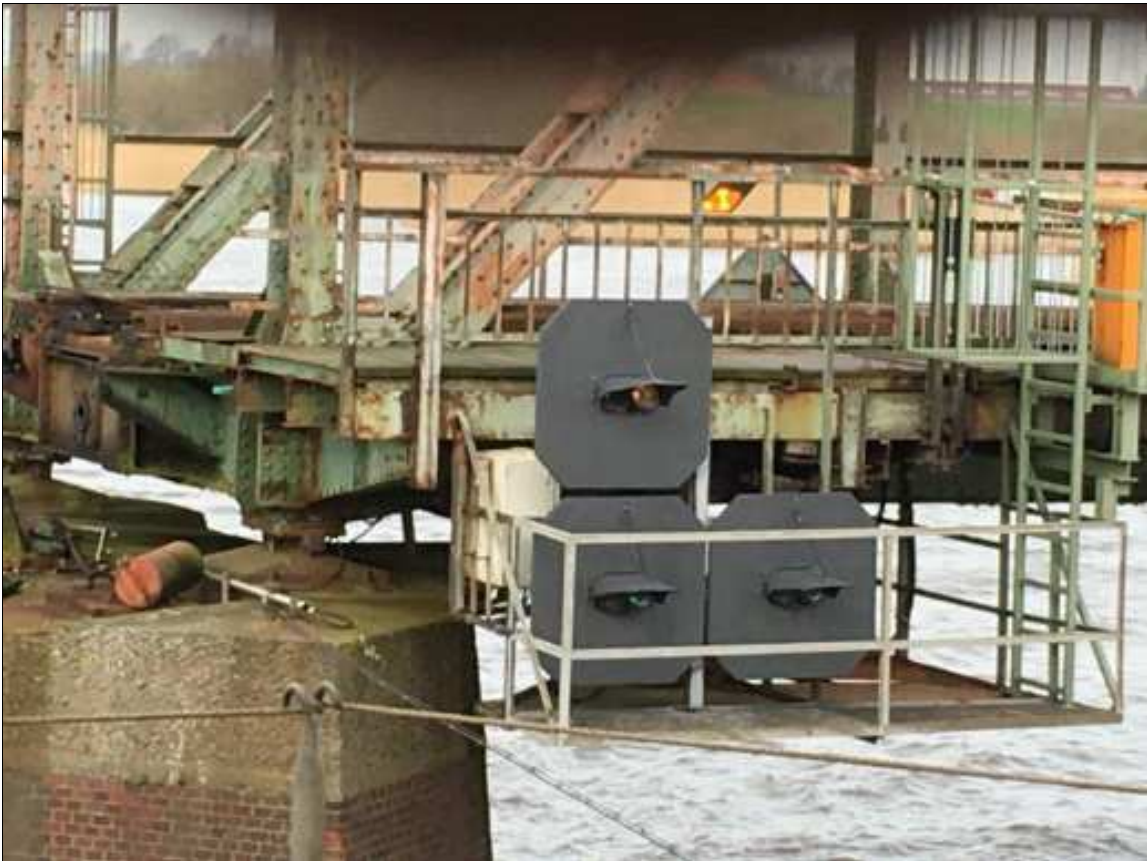
Figure 15: Signal board on (photograph unknown)

no shore-based linesmen. The ship's position cannot be maintained in an aft current at less than 4 kts using a controllable pitch propeller and bow thruster alone. At best, it was possible to traverse toward one side. An additional stern thruster would be necessary otherwise. The bridge signals are virtually never paid attention to on the Papenburg-Emden section. Depending on visibility, they were reportedly inconspicuous or at Weener became evident too late.

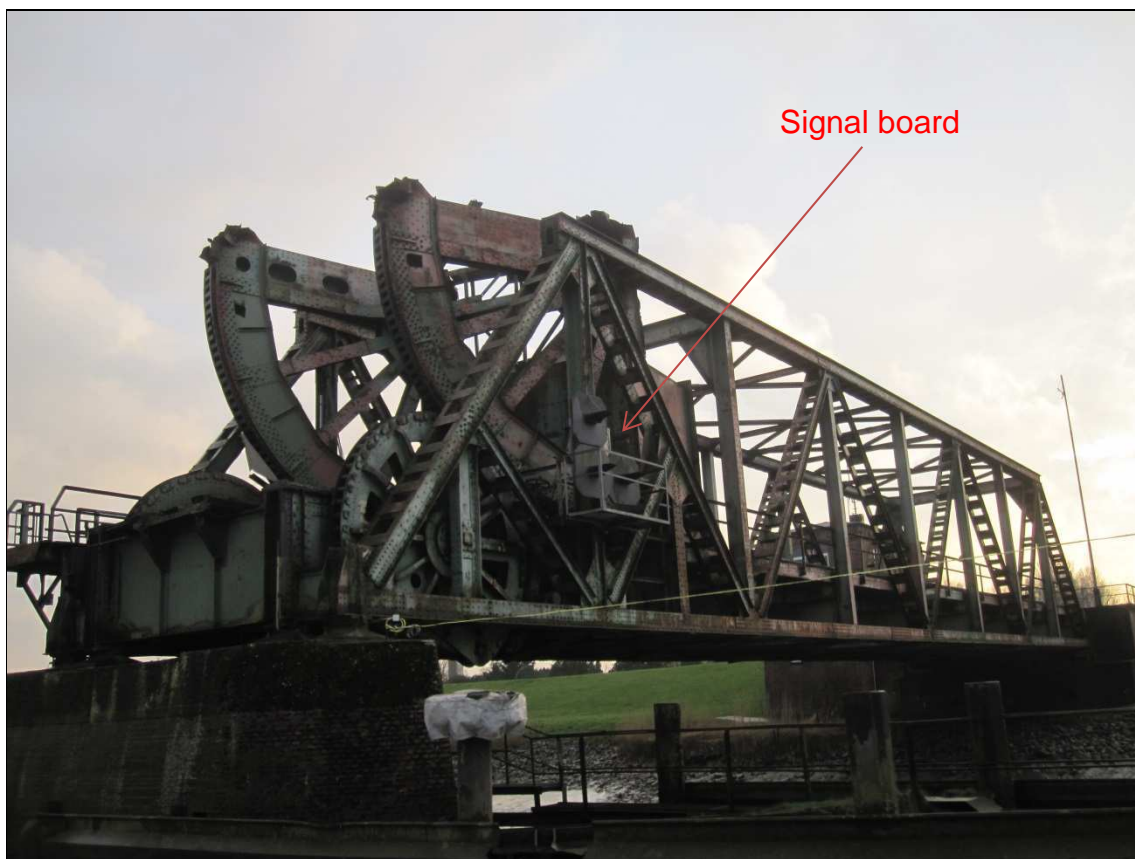
Figure 18: Northerly passage with destroyed bascule and signal board

Despite the fact that the signals on the bridge belong to Deutsche Bahn AG (DB), they comply with the standard of the Federal Waterways and Shipping Administration (WSV). A range is not specified.

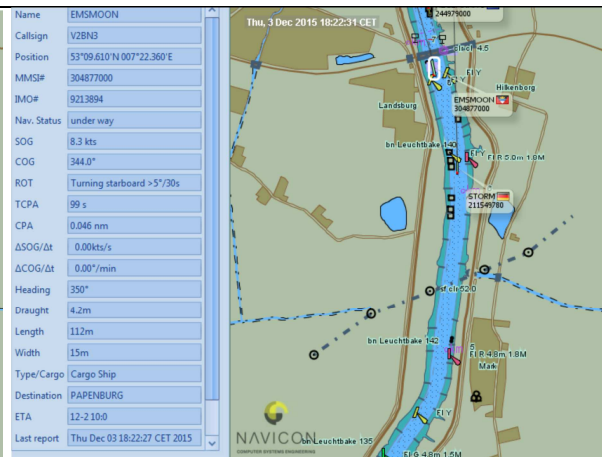
Figure 46: AIS at 182231 (8.3 kts)

The speed was barely reduced up until the impact with the Friesenbrücke Bridge. It drops rapidly due to the absorption of the lattice structure.

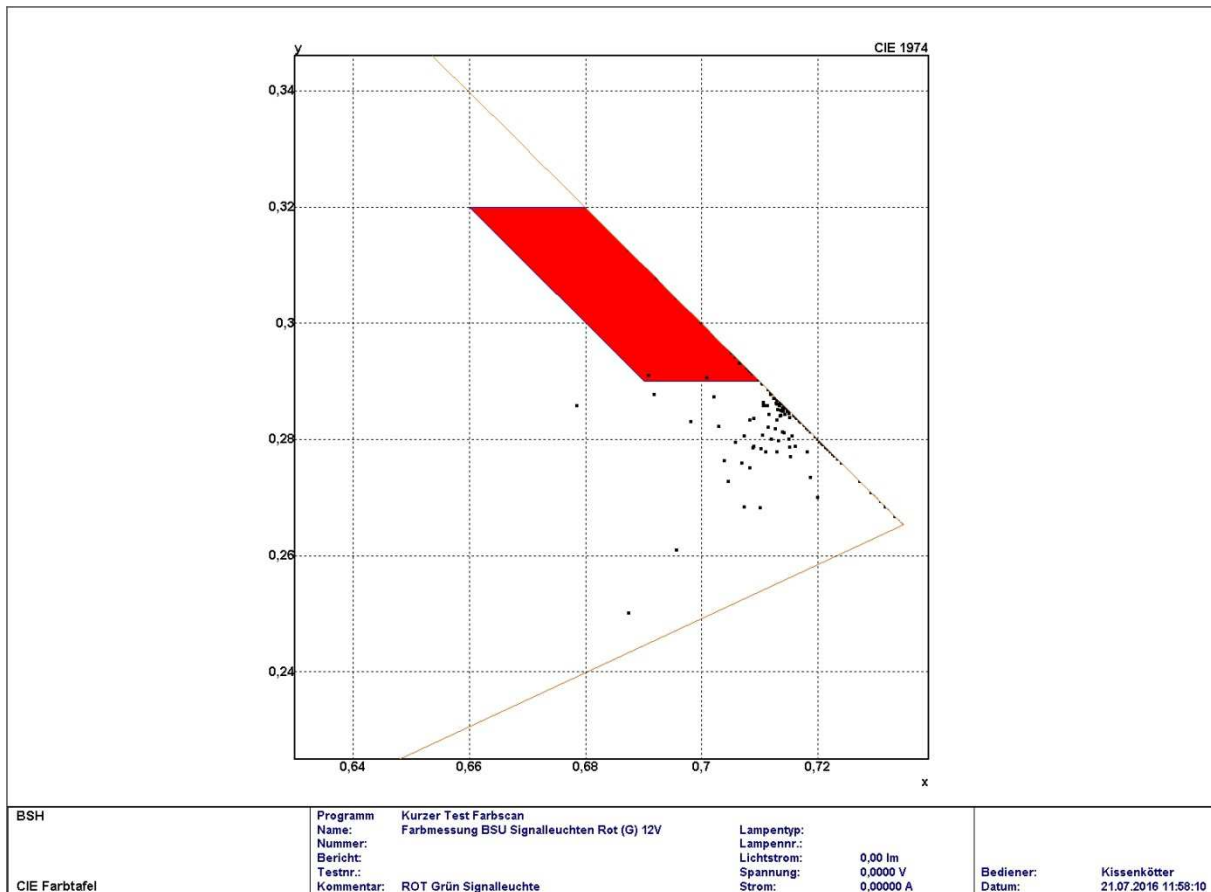
Figure 63: Colour measurement, 12 V RED, extract from CIE chromaticity diagram

The measured chromatic points of the red signal lights exhibit a clear tendency toward long wavelength from the red colour range.

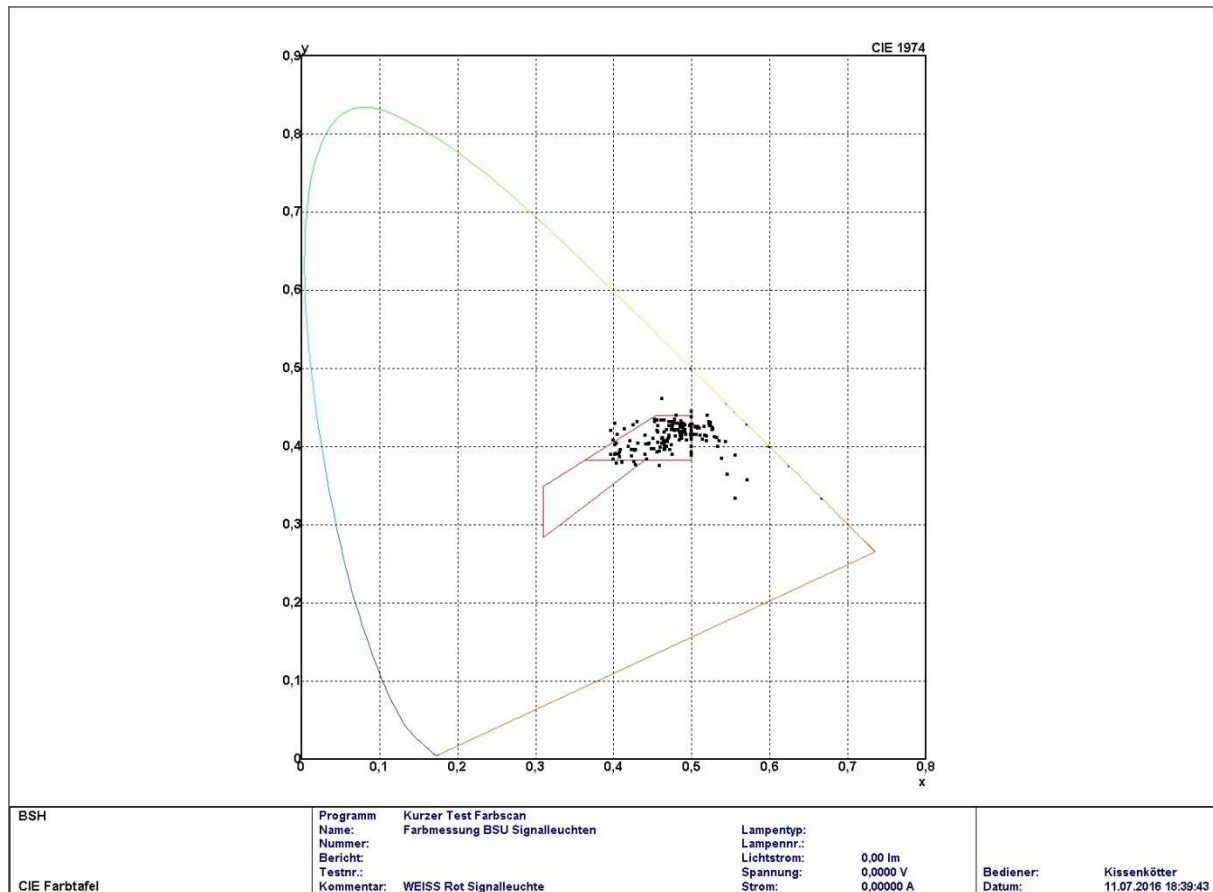
Figure 65: Colour measurement, 7.4 V WHITE, CIE chromaticity diagram

The measured chromatic points of the white signal lights are largely within the white colour range. A shift toward yellow is clearly visible.

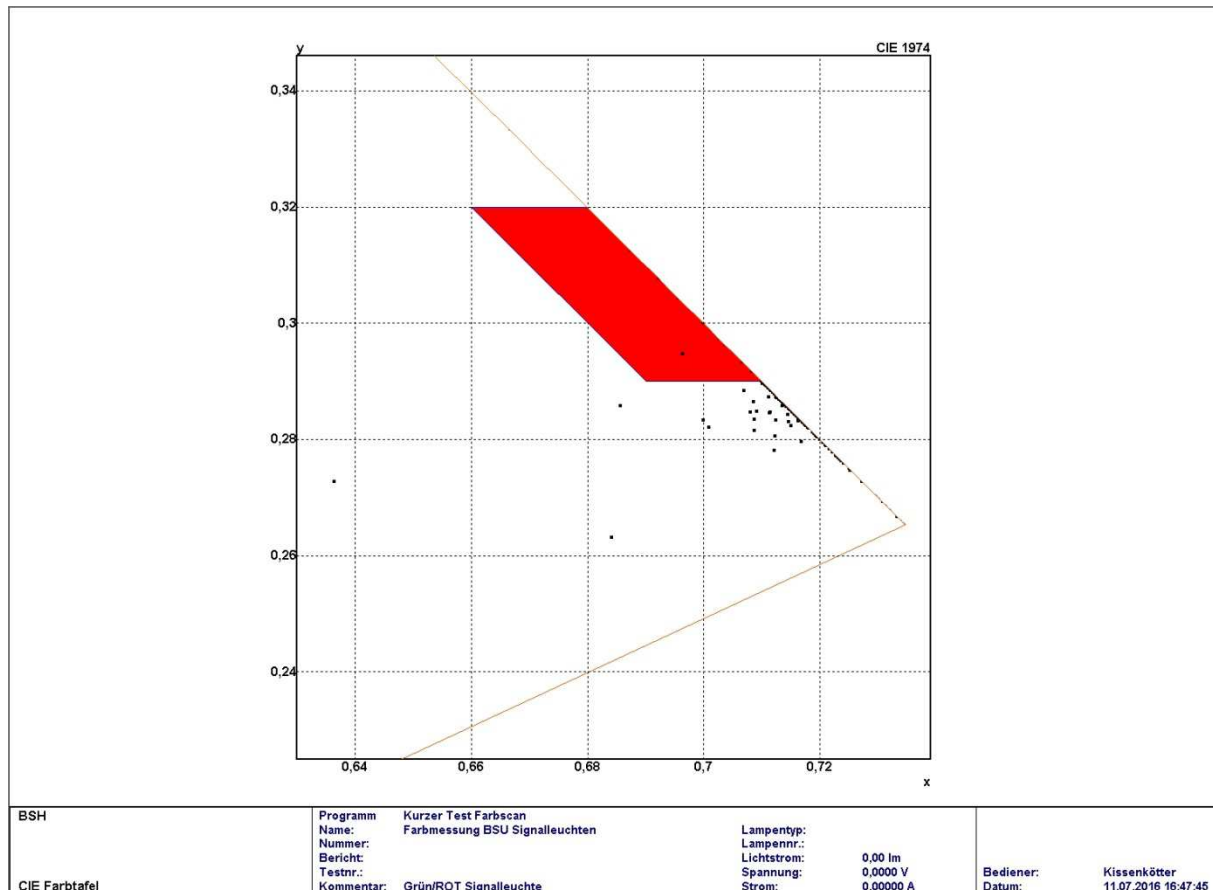
Figure 66: Colour measurement, 7.4 V RED, extract from CIE chromaticity diagram

The measured chromatic points of the red signal lights exhibit a clear tendency toward long wavelength from the red colour range.

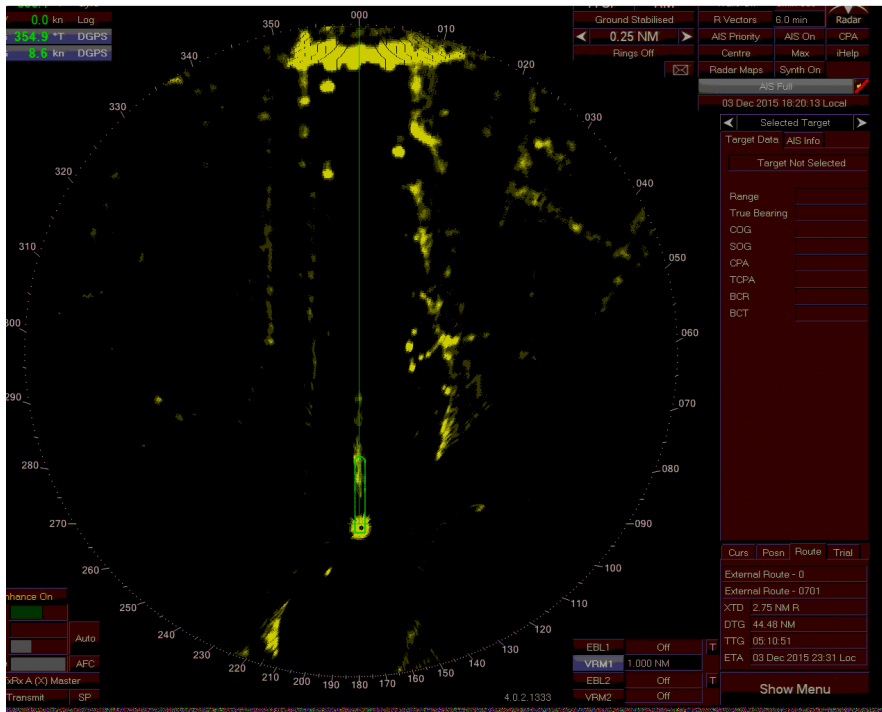
Figure 3: First recording of the radar image showing the bridge

1. On 3 December 2015, the VisionMaster detected and displayed the bridge for the first time according to the recording of the VDR at 182013 (VDR image 151203,172028,R1,9213894). The distance from the bow of the ship to the bridge at this point in time was 548 m \approx 0.296 nm (range was 0.25 nm) but off-centre (maximum view option) or 652 m \approx 0.352 nm from the radar antenna. This means that at a constant speed of 8.6 kts, the collision with the bridge would occur in 123 s if no action was initiated.

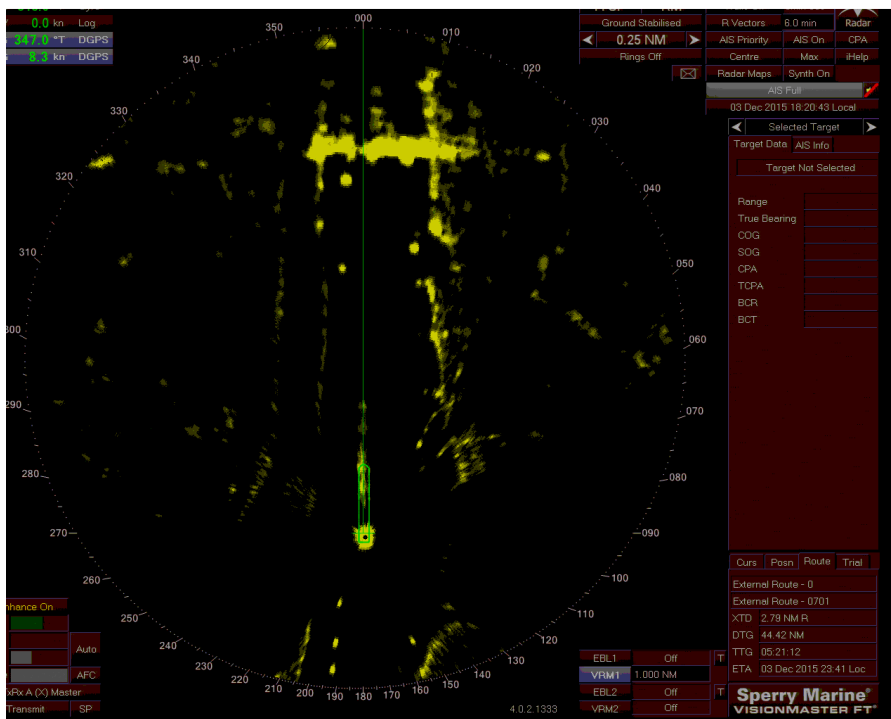
Figure 5: Second recording of the radar image showing the bridge

2. VDR image 151203,172058,R1,9213894 was recorded 30 seconds later. The distance from the ship's bow and radar antenna now stood at 431 m \approx 0.233 nm and 535 m \approx 0.289 nm respectively. The ship continued at about 8.4 kts, meaning the closed bridge was not noticed. The folding part of the bridge now shows a much weaker echo. The remainder of the bridge has changed only marginally and the objects (1-3) in the water are displayed just as clearly as 30 seconds earlier.

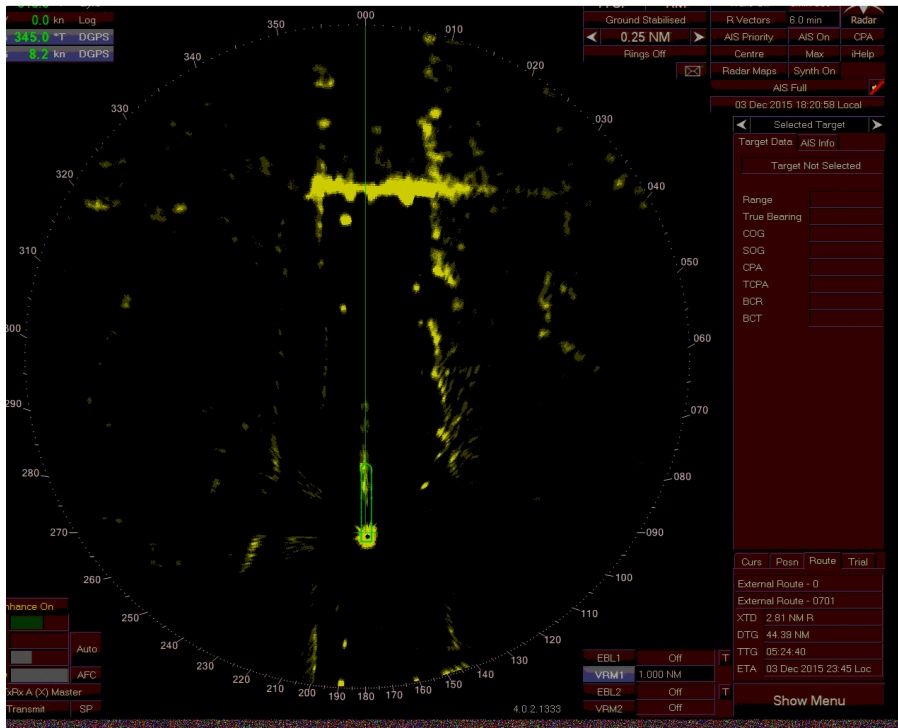
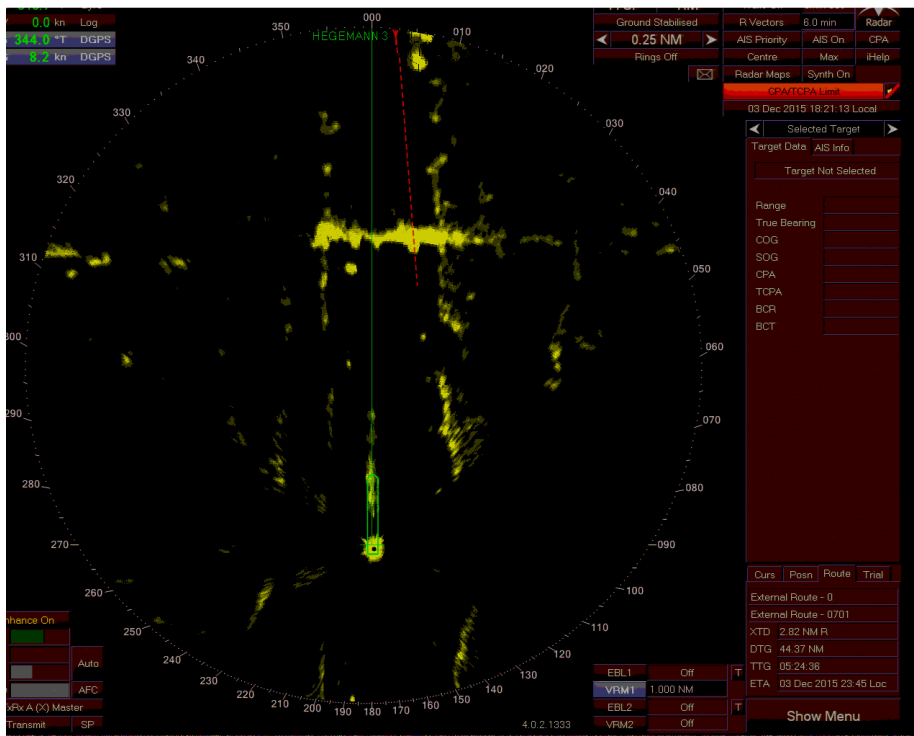
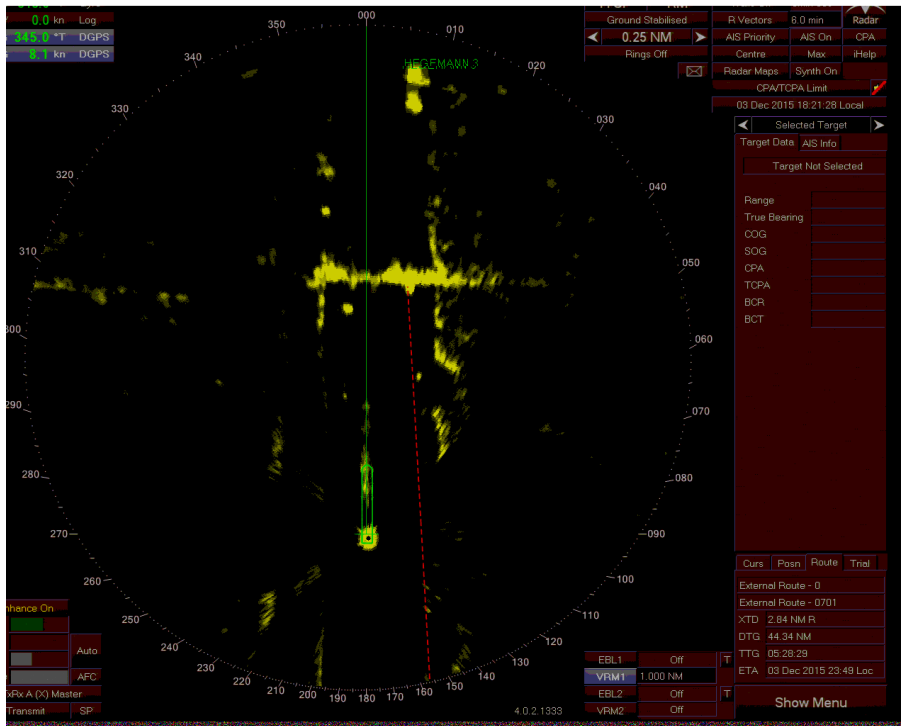
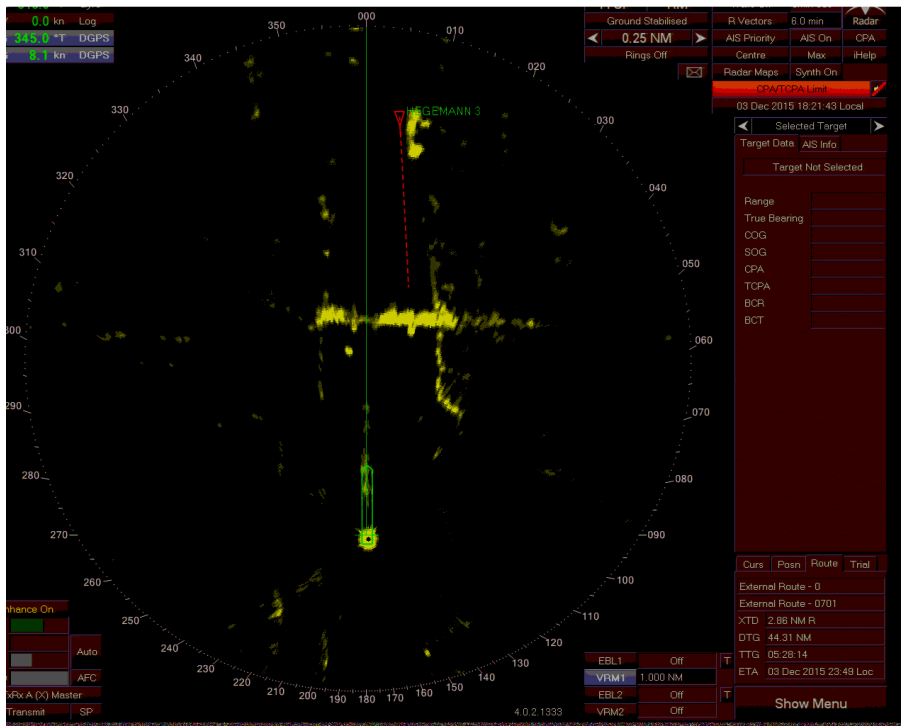
3. The following four VDR images, recorded up until immediately before the collision, show bridge echoes that are becoming increasingly diffused, and not only in the area of the bascule bridge. This could certainly lead to misinterpretations. This effect is not explained by the antenna's vertical radiation pattern. The angle to the foot of the bridge only reached 8° up until shortly before the collision, meaning it is within the guaranteed $\pm 10^\circ$ for vertical radiation patterns. Therefore, it can only be the structure of the lattice truss and elements that leads to reflections in all directions, as well as to extinction. That it is precisely the folding part which produces the poorest echoes in the VisionMaster, even though its structural design is no weaker than the rest of the bridge, is interesting. Extensive rust on the lattice elements leads to scatter and damping, which also worsens detection.
