Investigation Report 499/15

**Serious Marine Casualty**

**Grounding of the  
multipurpose ship  
BBC MAPLE LEA  
on 17 December 2015  
in Lake Saint-Louis, Canada**

14 March 2017

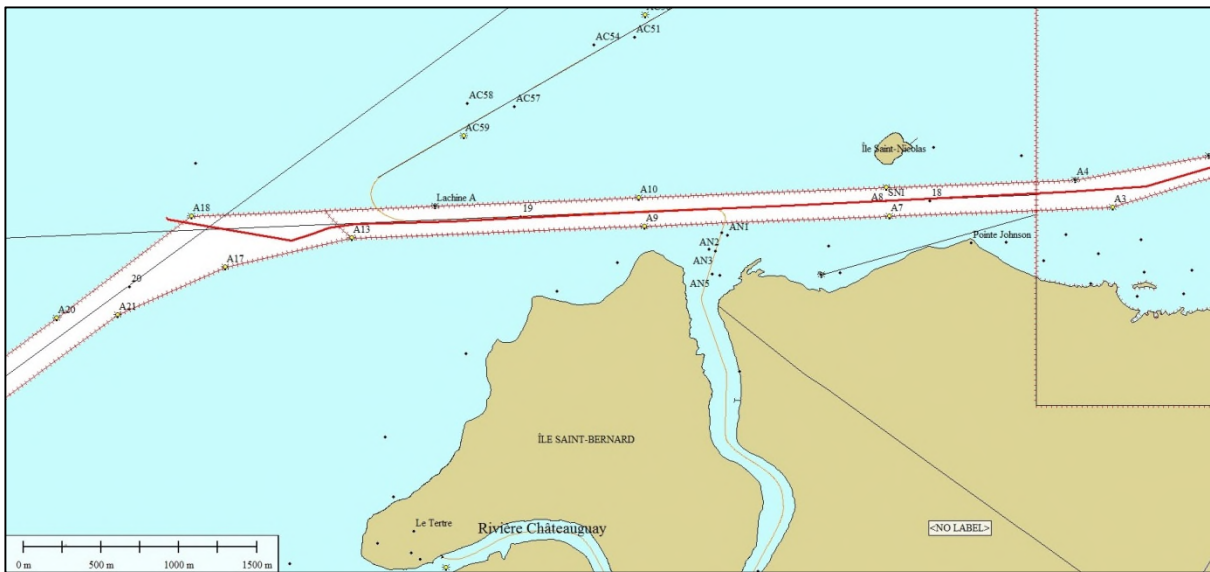
Figure 6: BBC MAPLE LEA's accident track

After passing buoy A13, the pilot had the engine stopped, as well as the helm set to hard-a-port and the bow thruster to full to port briefly. The ship turned slightly to port (course over ground: 248°) still at a speed of 6.4 kts. When the ship reached roughly the middle of the turning area, the pilot had the bow thruster stopped and the engine set to full astern. Her momentum was carrying her at a speed of 5.3 kts. He also ordered the bow thruster full to starboard. The ship continued toward the western buoy line for almost a whole minute, however. Her rate of turn was almost zero (course over ground: 270°). The ship started to turn slowly to starboard only when her speed dropped to less than 4 kts at 0753. The BBC MAPLE LEA's bow crossed the western buoy line at 0755 and grounded there.

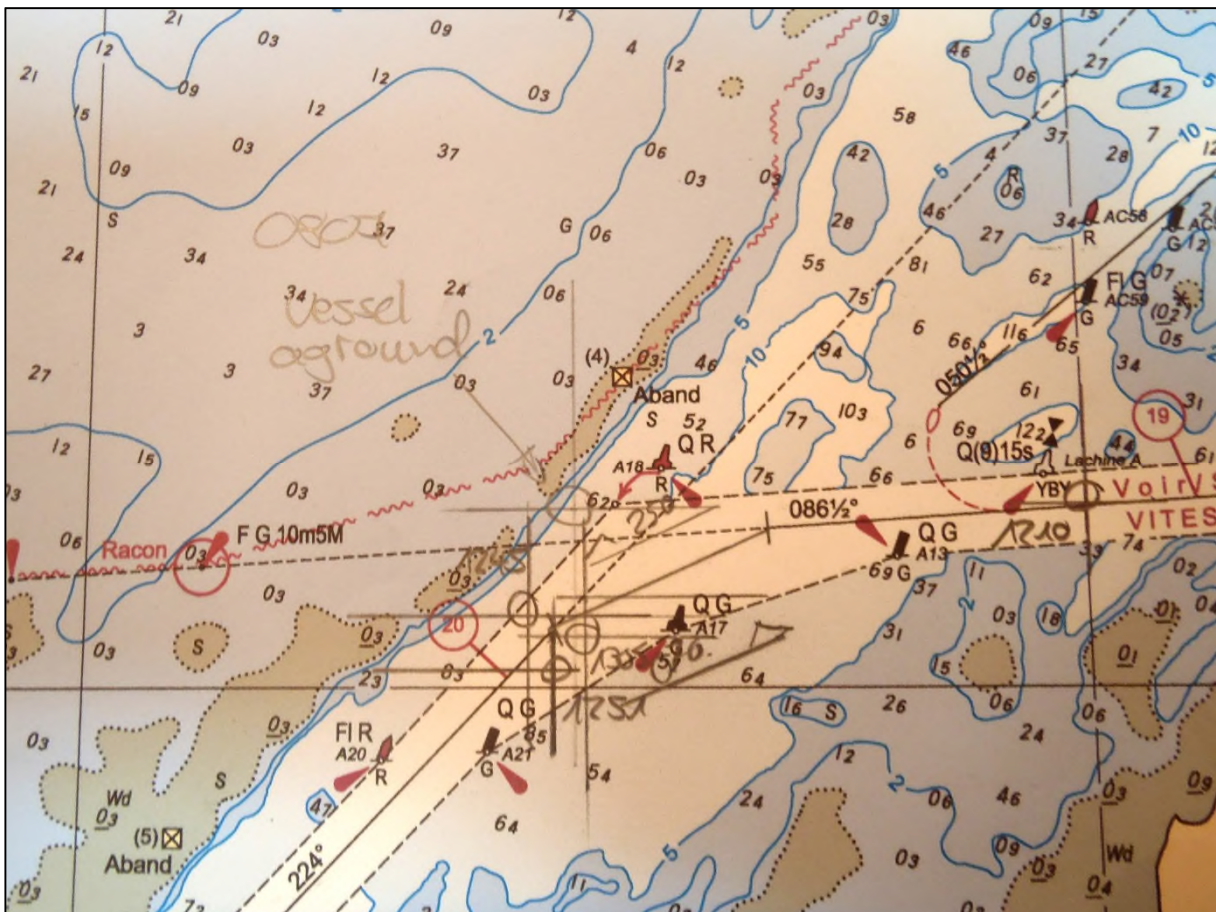
Figure 7: Extract from Paper Chart CA1429 from on board with the scene of the accident plotted

The depth of water in this area drops rapidly outside the fairway. The depth west of buoy A18 plotted in the official paper chart is 6.2 m (see Figure 7). The electronic nautical chart used by VTS Beauharnois Traffic shows 7.3 m in this area (see Figure 13). The BBC MAPLE LEA's forward and aft draughts stood at 7.8 m and 8 m respectively, whereas the water depth in the turning area originally earmarked stood at between 9.5 m and 10.5 m.

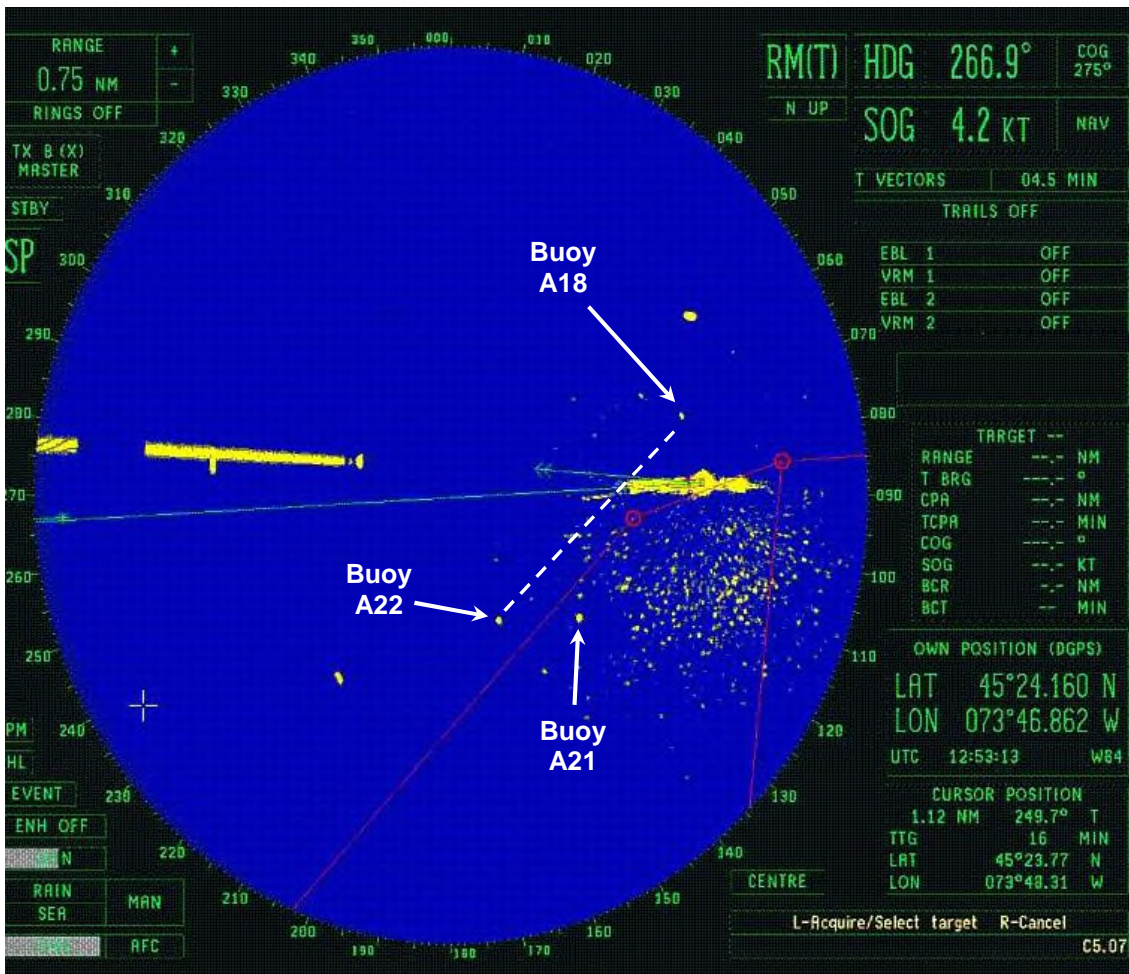
Figure 11: Radar plot at 075325

The radar data also recorded by the VDR indicate that the BBC MAPLE LEA's bow was on the buoy line (A18 and A22) at 075325 (see Figure 11).

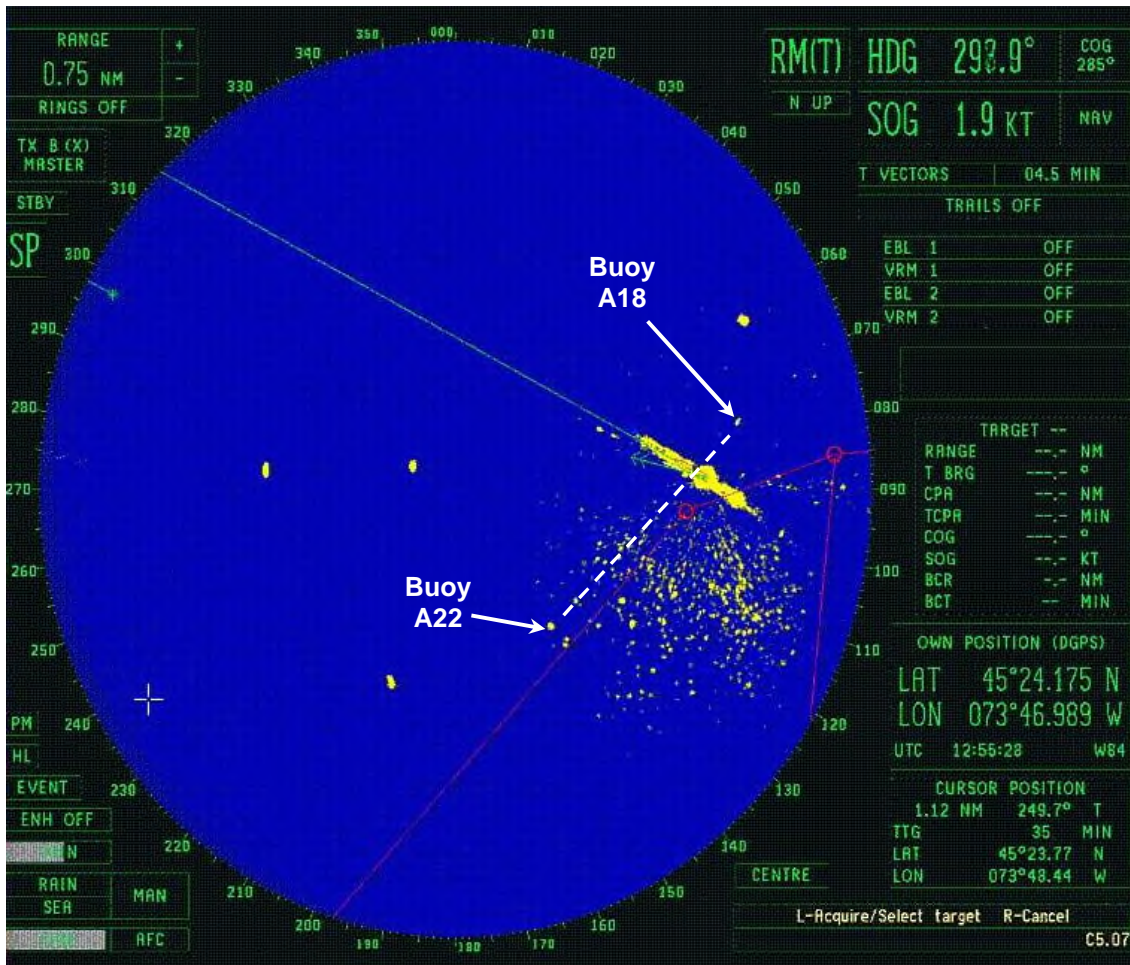
Figure 12: Radar plot at 075535 – time of accident

At the time of the accident, the BBC MAPLE LEA was about half a ship's length outside the fairway (see Figure 12).

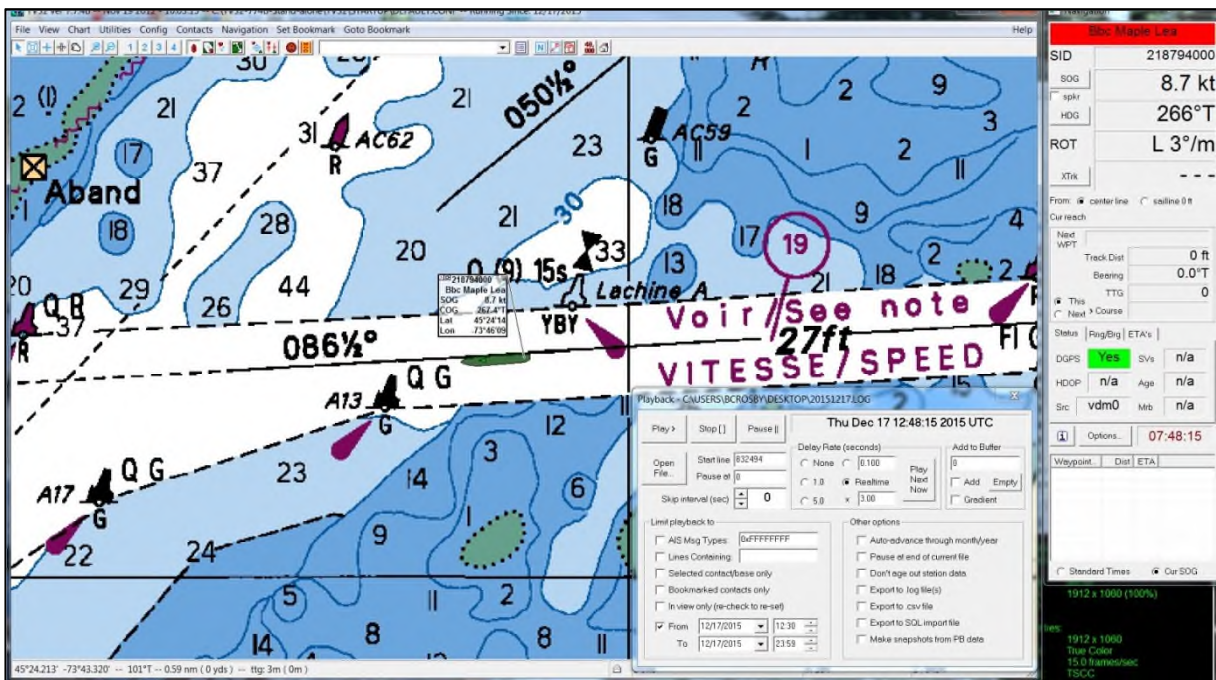
Figure 15: AIS plot at 074815 – approaching buoy 13

The BBC MAPLE LEA approached buoy A13 at a speed of 8.7 kts (see Figure 15). She was sailing in the middle of the fairway when the pilot initiated a port turn at 074816 ("Port ten" – see Spreadsheet 2).

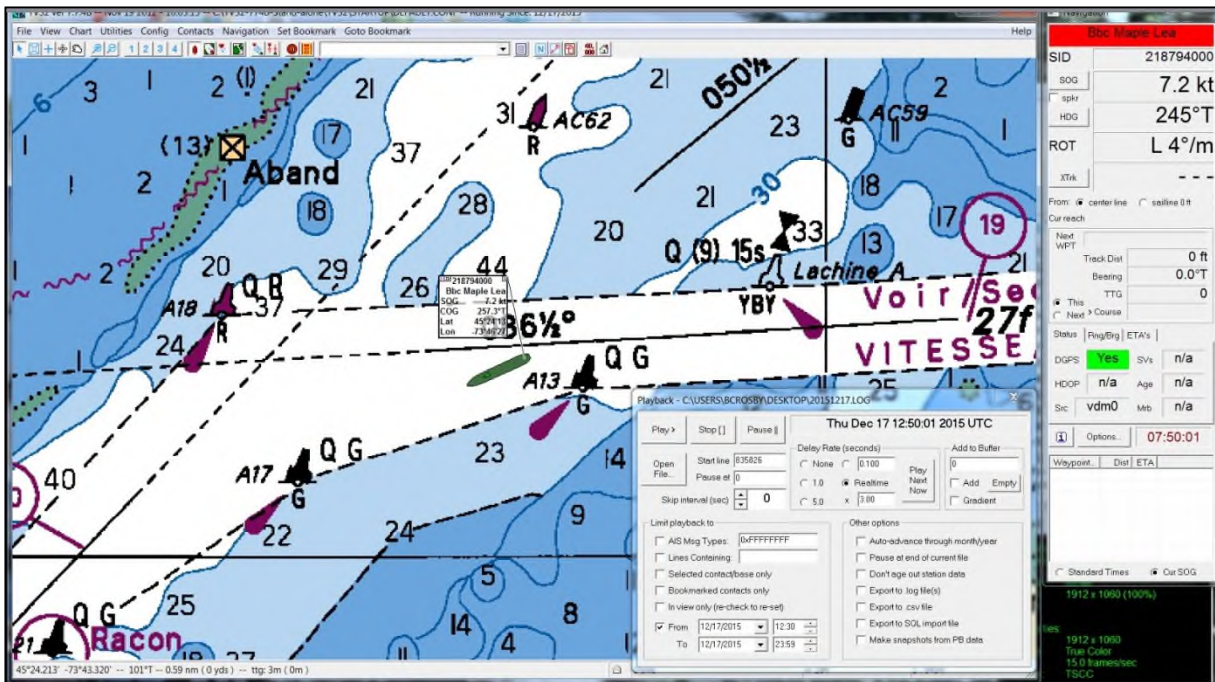
Figure 16: AIS plot at 075001 – "Stop engine"

After passing buoy A13, the pilot had the rudder set in the opposite direction briefly ("Midship... Starboard twenty... Hard starboard... Midship"). The BBC MAPLE LEA had developed a rate of turn of  $-21.4^\circ$  to port, which changed to  $4.3^\circ$  to starboard within 47 seconds as a result of the rudder being set in the opposite direction. The pilot had the engine stopped. The master confirmed the engine stop and executed it. The speed stood at 7.2 kts (see Figure 16).

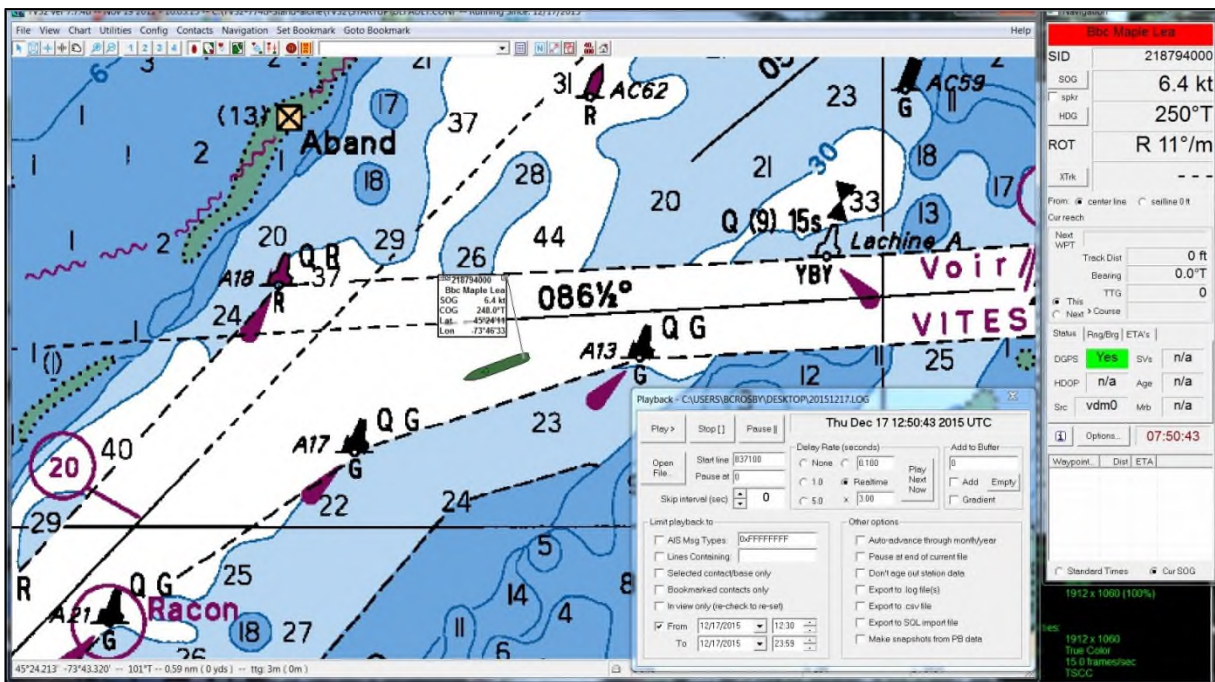
Figure 17: AIS plot at 075028 – "Hard-a-port"

The pilot then tried to make a port turn ("Port ten... Port twenty... Hard-a-port"). The starboard turn initiated by setting the rudder in the opposite direction continued for 30 seconds (at a rate of turn of 14.4°), however. At 075043, the pilot issued an order for the bow thruster to be set to "Full to port." Due to the speed of the ship, which still stood at 6.4 kts (see Figure 17), the bow thruster had hardly any effect, however.

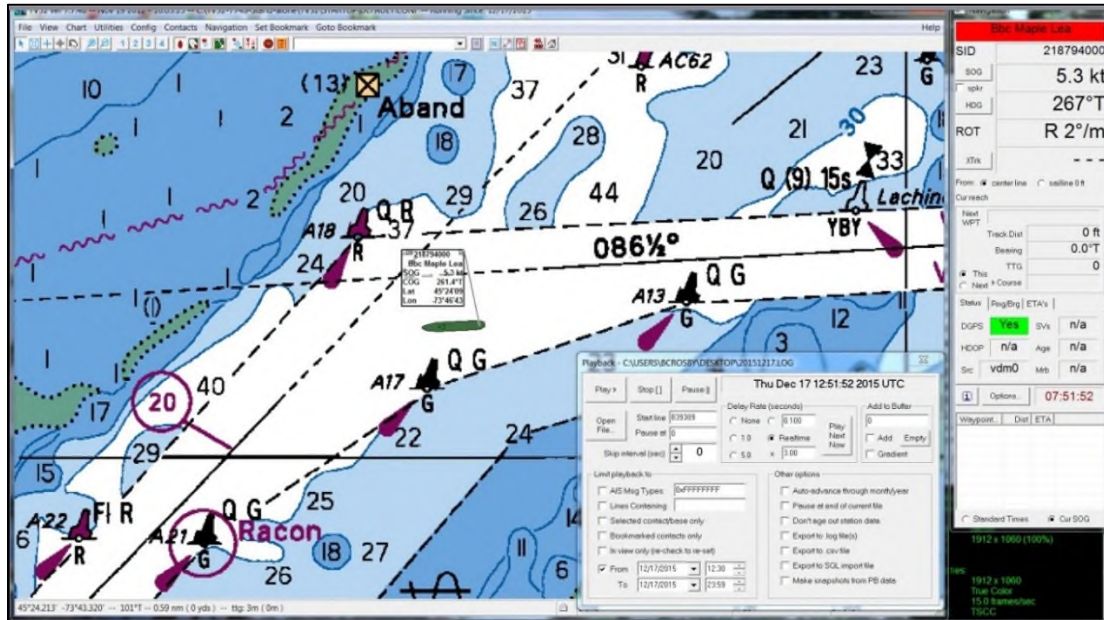
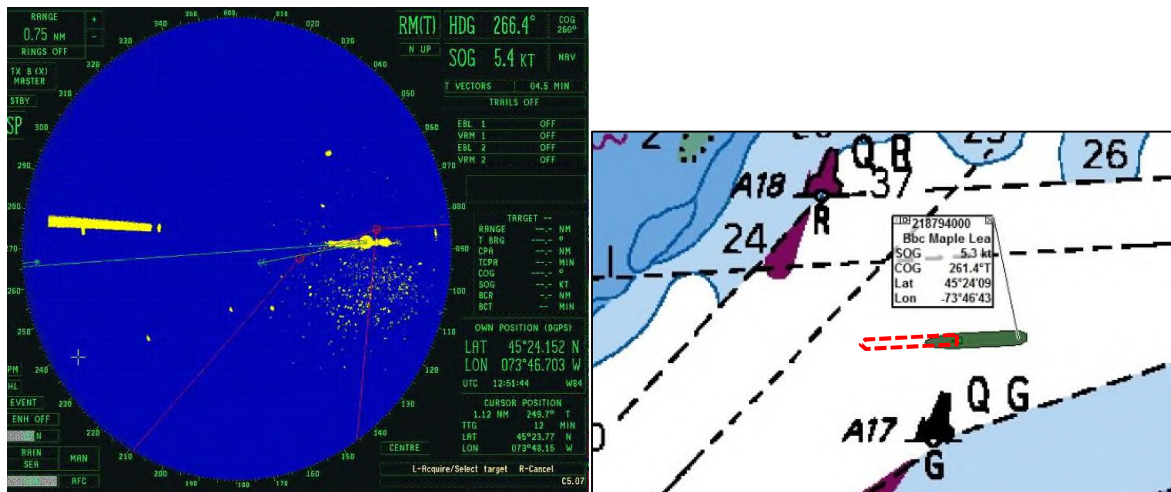
Due to the previously ordered port rudder angle, the rate of turn dropped again. The pilot had the bow thruster and engine stopped and the helm set to midships. The BBC MAPLE LEA had reached the middle of the turning area and with hardly any rate of turn (2.1° to 0.3°). She still proceeded at a speed of 5.3 or 5.4 kts (see Figures 18 and 19).

A comparison of the AIS and radar images reveals a deviation with regard to the ship's position. The position of the AIS antenna in Figure 18 (green triangle on the fore section of the ship's contour) is shown incorrectly. It is actually located above the bridge about 126 m away from the bow. The entry was made correctly on board. The ship's positions, which were verified by the BSU's investigators using the radar plots, are therefore much further ahead, as can be seen in the recordings of the VTS (see Figure 19 as compared to Figure 18). All the same, the turning manoeuvre is shown here using the AIS plots, as they are superimposed over a nautical chart with depths charted.

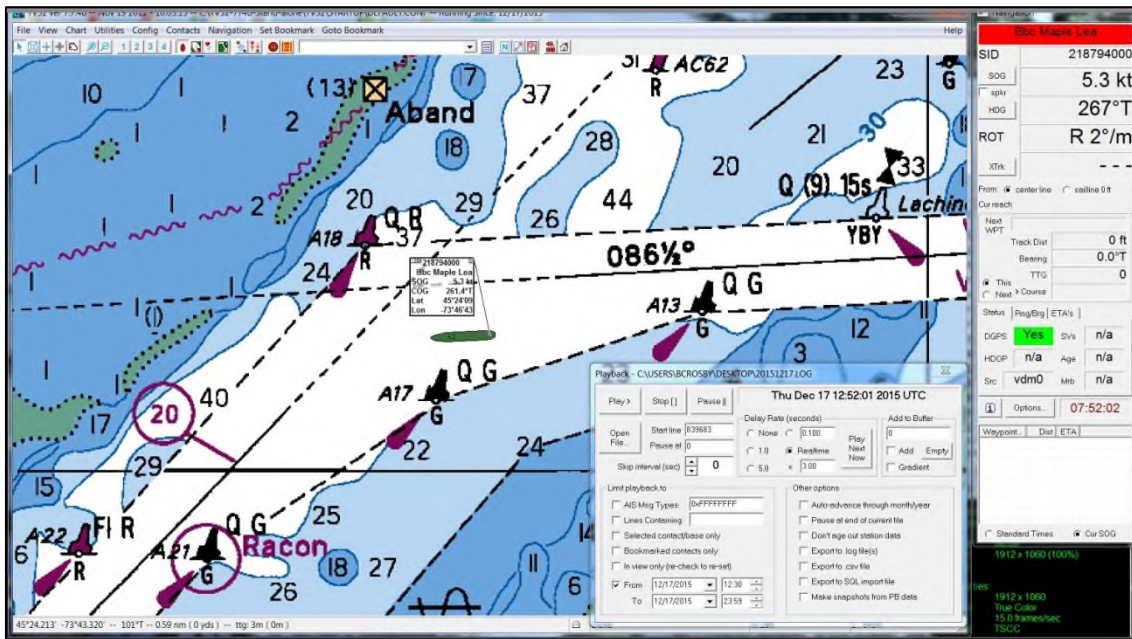
Figure 20: AIS plot at 075202 – "Full astern"

The pilot ordered the engine to "Full astern" at 075202 while the rate of turn was neutral. This order was drowned out by the simultaneously incoming VHF radio traffic of uninvolved vessels and therefore not executed by the BBC MAPLE LEA's master, however. The ship continued on a 264° course at a speed of 5.3 kts over ground toward the buoy line between fairway buoys A18 and A22 (see Figure 20).

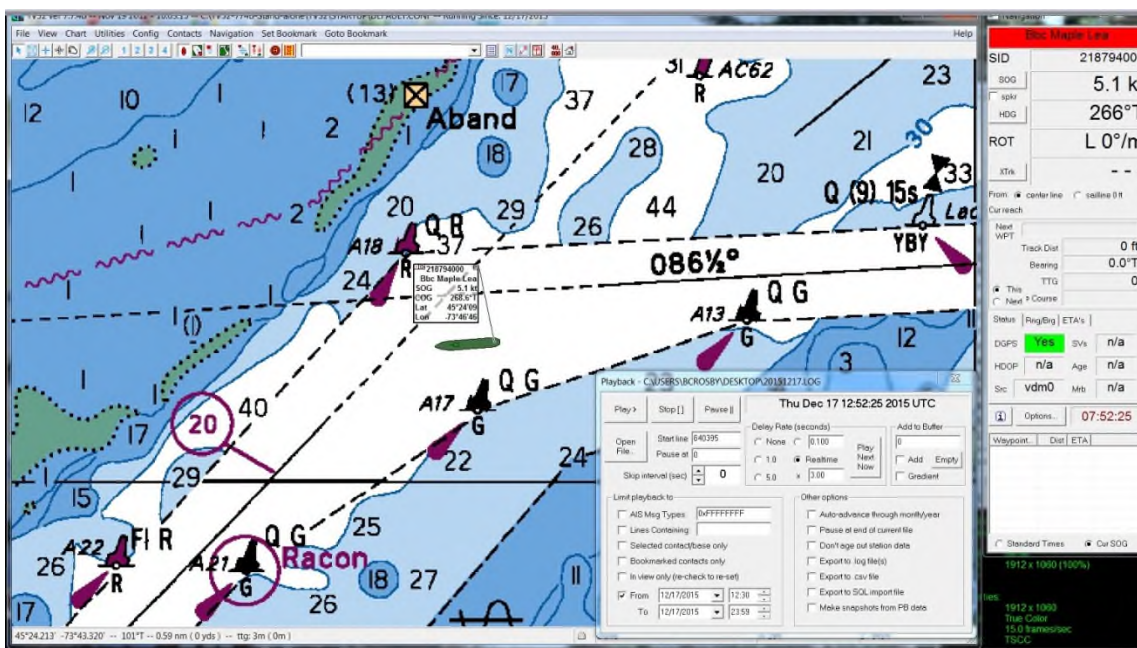
Figure 21: AIS plot at 075225 – "Full astern, Captain"

The pilot repeated the order quietly at 075211 and then with more urgency at 075226. The master only confirmed and executed the last repetition. Accordingly, the BBC MAPLE LEA had sailed on a westerly course at a speed of more than 5 kts for 24 seconds during this important phase of the turning manoeuvre (see Figure 21).

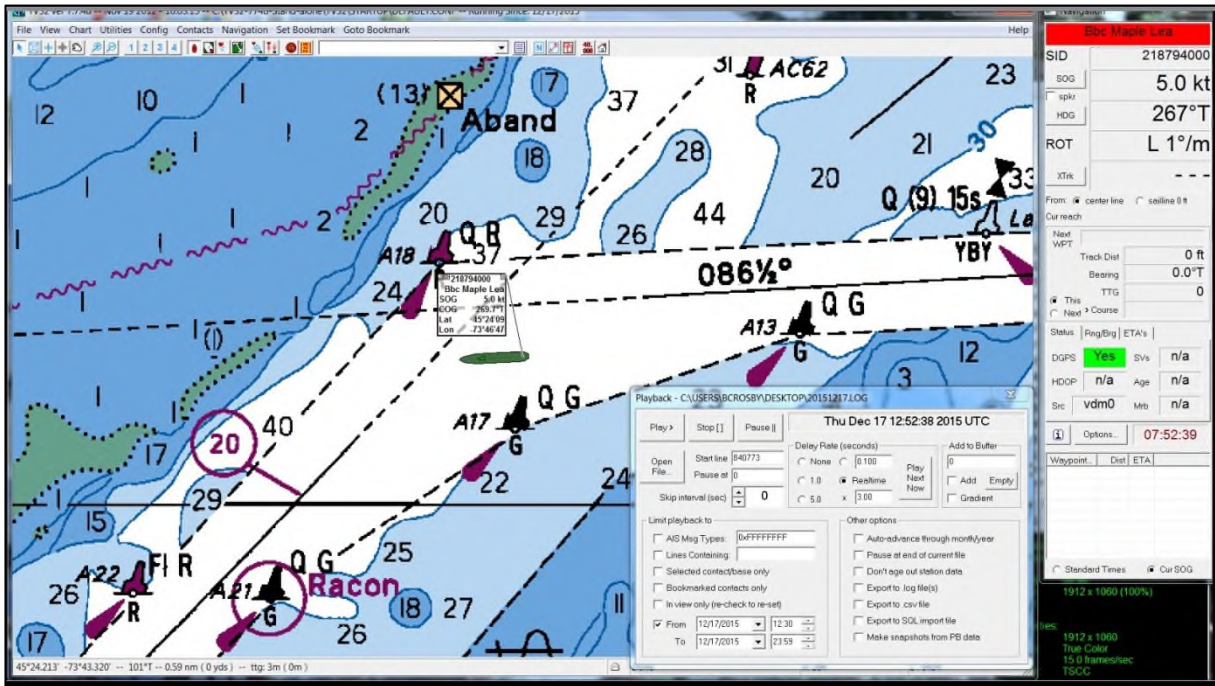
Figure 22: AIS plot at 075239 – "Full thruster to starboard"

The pilot ordered the bow thruster "Full to starboard" at 075239. However, this had little effect due to the speed of still 5 kts (see Figure 22).

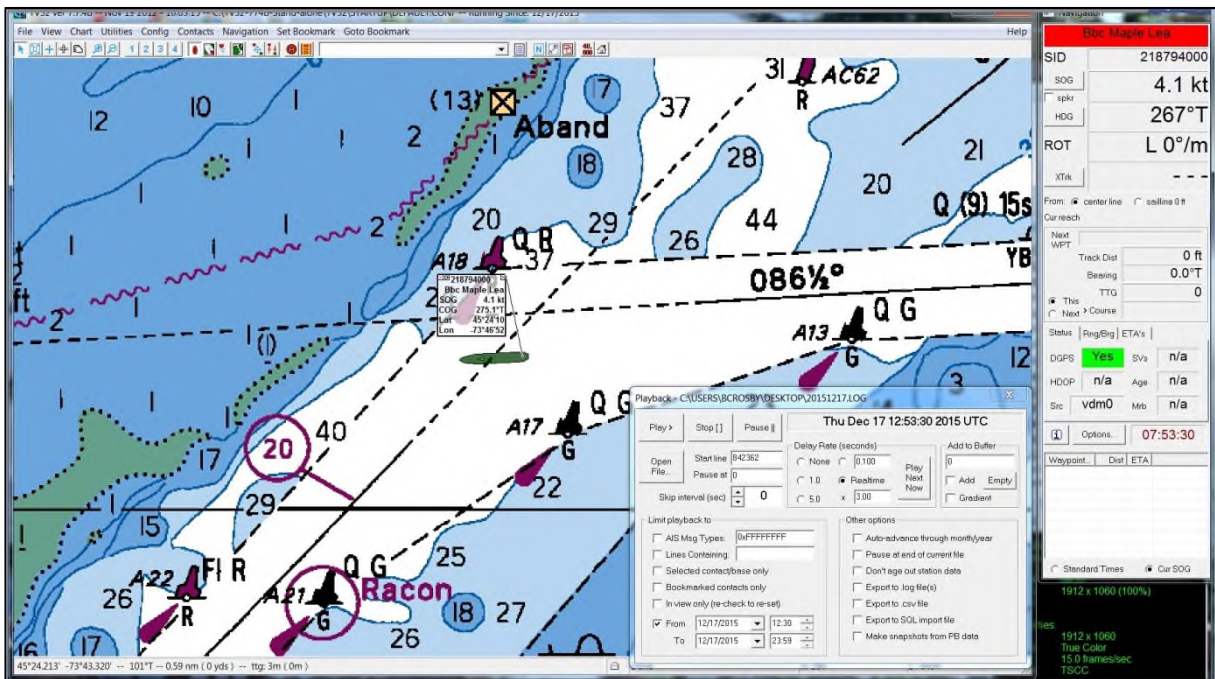
Figure 23: AIS plot at 075330

The BBC MAPLE LEA continued toward the western buoy line for almost a whole minute (see Figure 23).

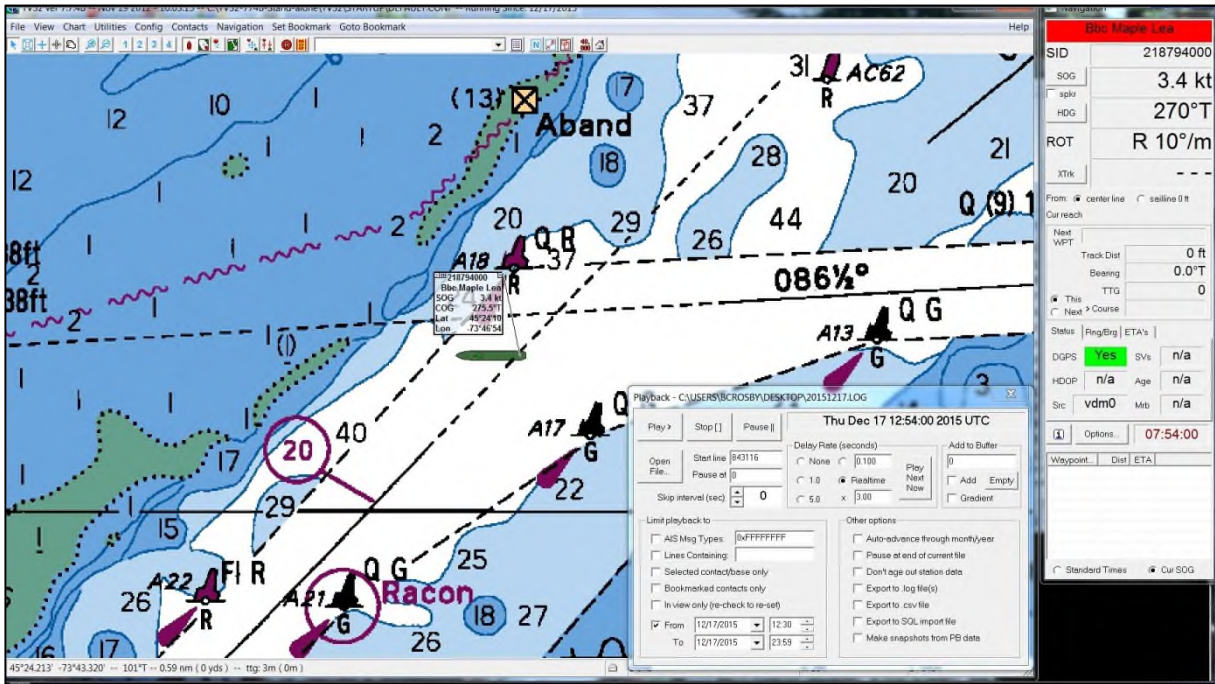
Figure 24: AIS plot at 075400

The bow thruster only started to have an effect in that a turn to starboard developed when the ship's speed fell below 4 kts (see Figure 24).

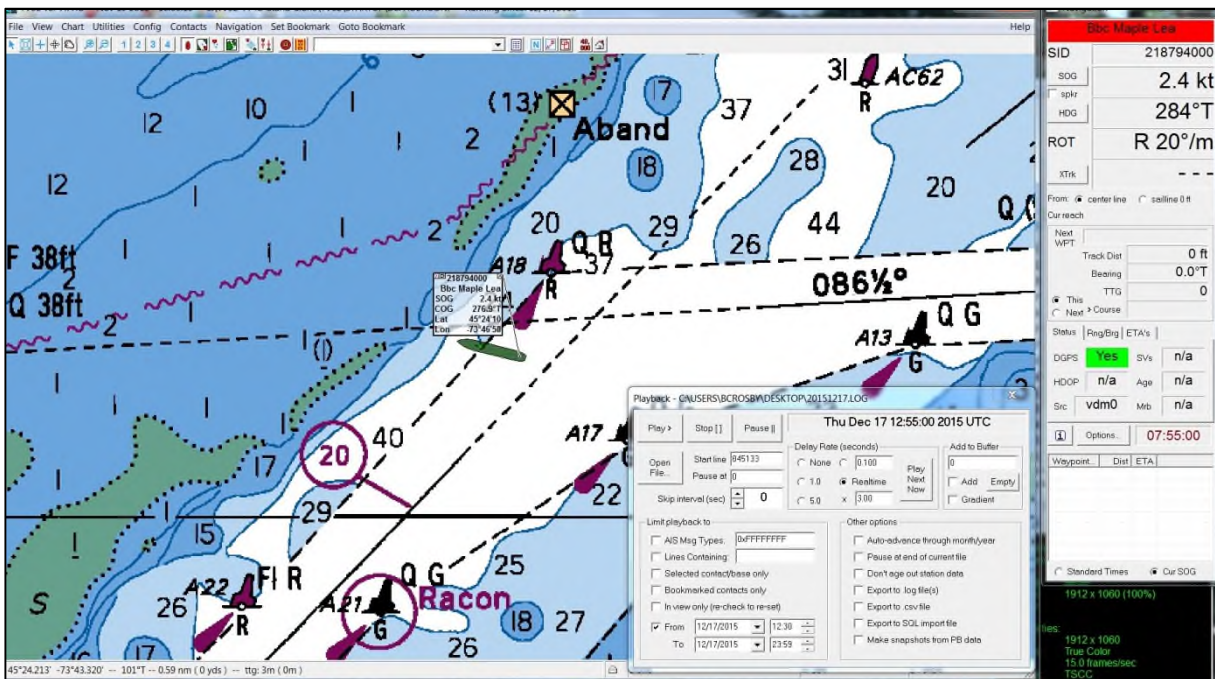
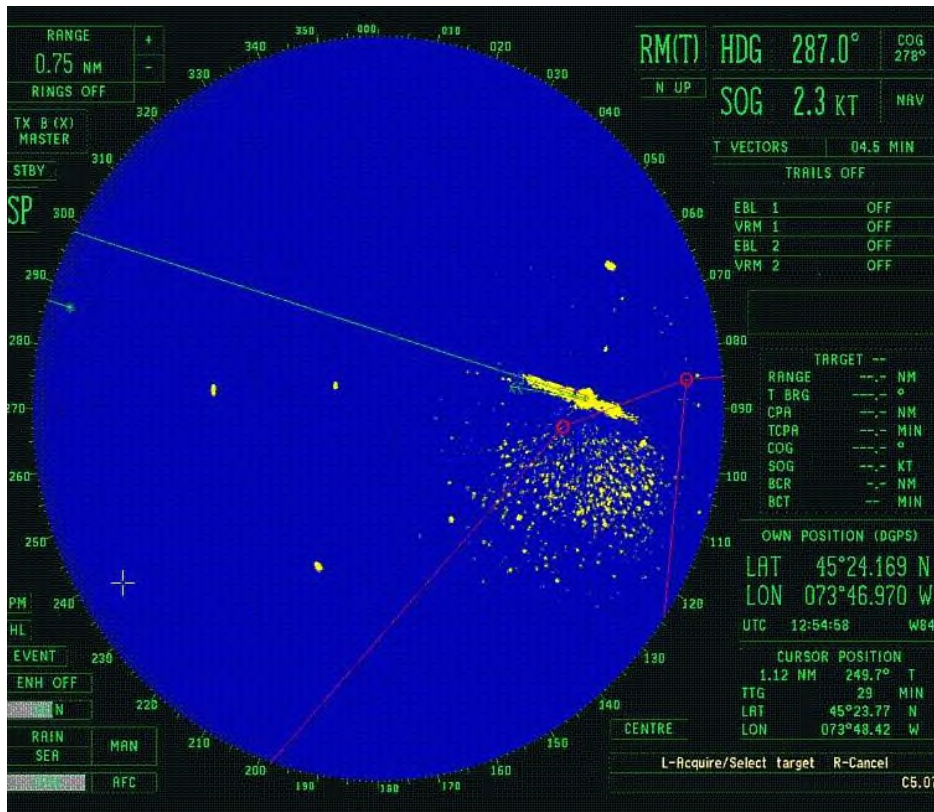
The starboard turn increased concomitantly with the falling speed of the BBC MAPLE LEA. However, the ship had already crossed the western buoy line at 075325 (see Figures 11, 25 and 26).

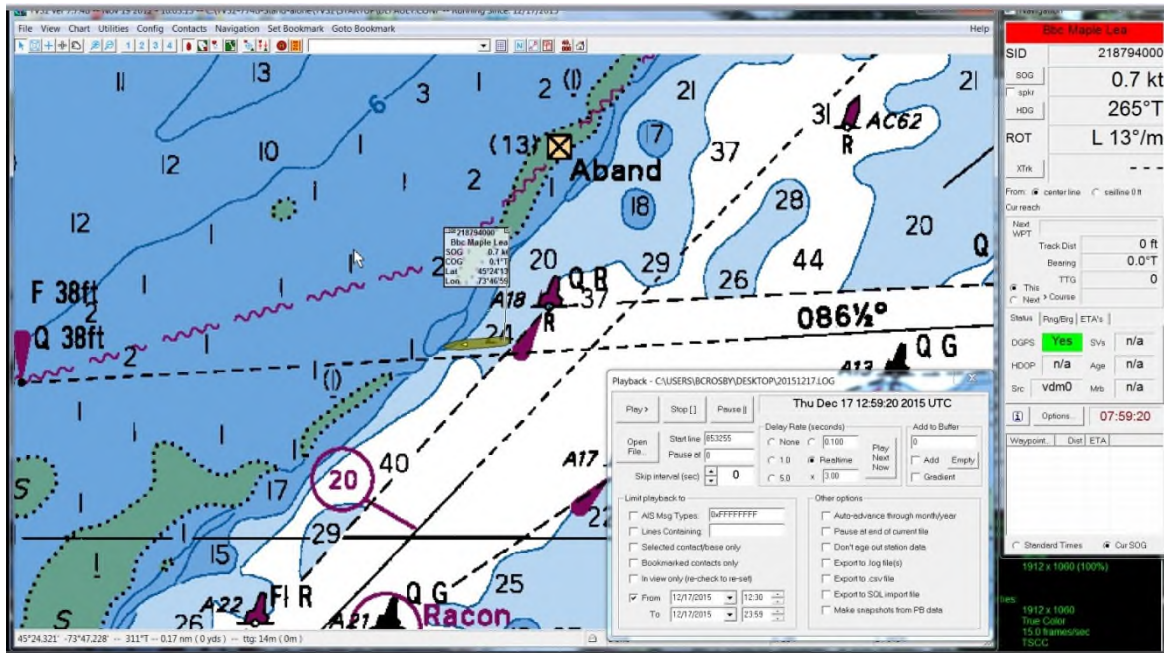
Figure 27: AIS plot at 075920 – position after the grounding

In water depths of some 7.3 m west of buoy A18, the BBC MAPLE LEA was unable to complete the starboard turn despite a rate of turn of 23°. Her bow ran aground at 075535, she then turned to port and after the unsuccessful attempts to refloat her again was situated outside the fairway (see Figure 27).
