**Bundesstelle für Seeunfalluntersuchung**  
**Federal Bureau of Maritime Casualty Investigation**  
Federal Higher Authority subordinated to the Ministry of Transport  
and Digital Infrastructure

Investigation Report 55/15

**Very Serious Marine Casualty**

**Foundering of the fishing vessel KRISTINA  
in the North Sea  
on 18 February 2015**

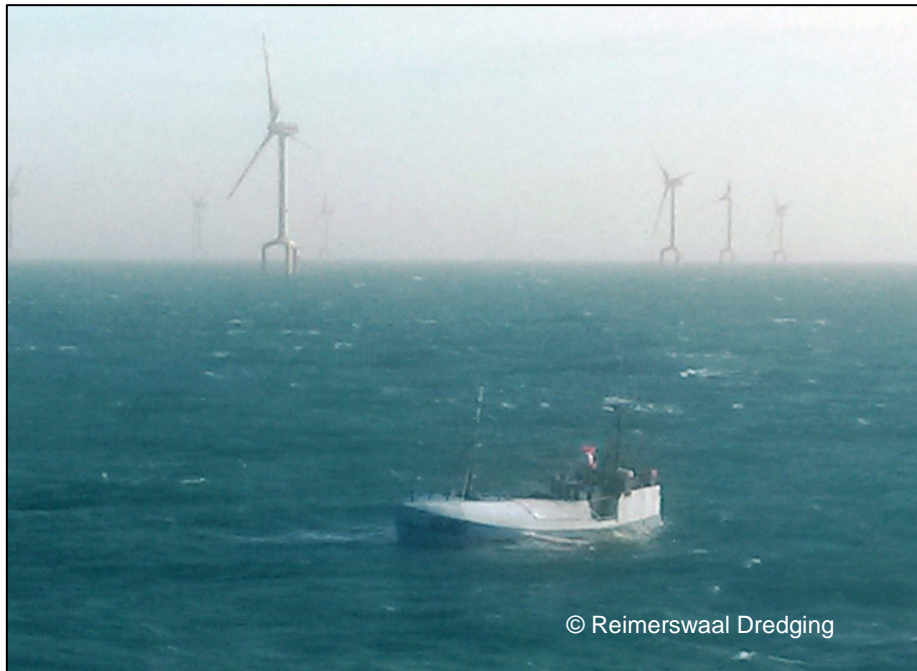
Figure 3: The KRISTINA upon arrival of the REIMERSWAAL

The REIMERSWAAL was the first vessel to reach the KRISTINA at 1023. Although the fishing vessel was still floating in a normal position at this point, she was already submerged to her main deck (see Figure 3). The REIMERSWAAL's crew started to prepare for the deployment of her fast rescue boat and were in radio contact with the crew of the KRISTINA. At 1045, the crew of the KRISTINA reported they were abandoning the bridge and moving to the main deck. When the KRISTINA began to list to starboard at 1047, her crew jumped overboard in their immersion suits. They were also carrying a portable VHF radio. The REIMERSWAAL's crew immediately deployed their fast rescue boat. She was operated by two people and sailed for the KRISTINA, whose crew was picked up shortly afterwards. The KRISTINA was already foundering at the stern while her crew was being picked up. When the fast rescue boat returned, only the bow of the fishing vessel was visible. Everyone was safely on board the REIMERSWAAL at 1100 (the point at which the KRISTINA foundered). The GLOMAR COMMANDER arrived at the scene of the accident shortly after.

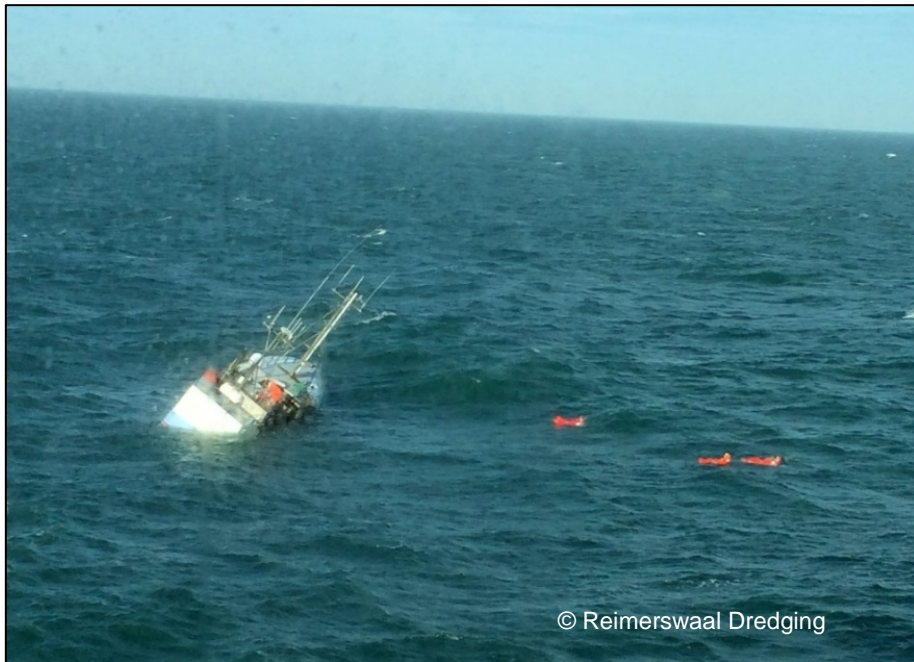
Figure 4: The KRISTINA's crew has abandoned the fishing vessel

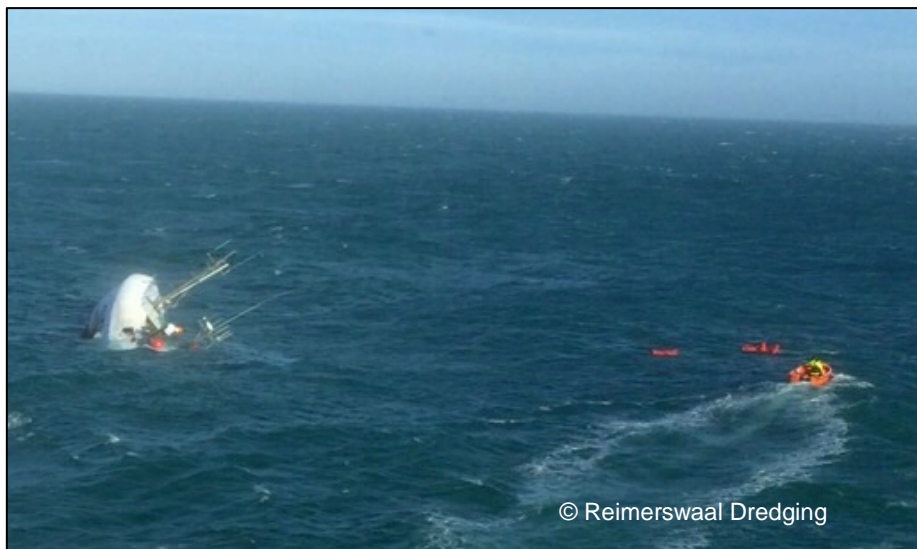
Figure 5: Situation shortly before the rescue

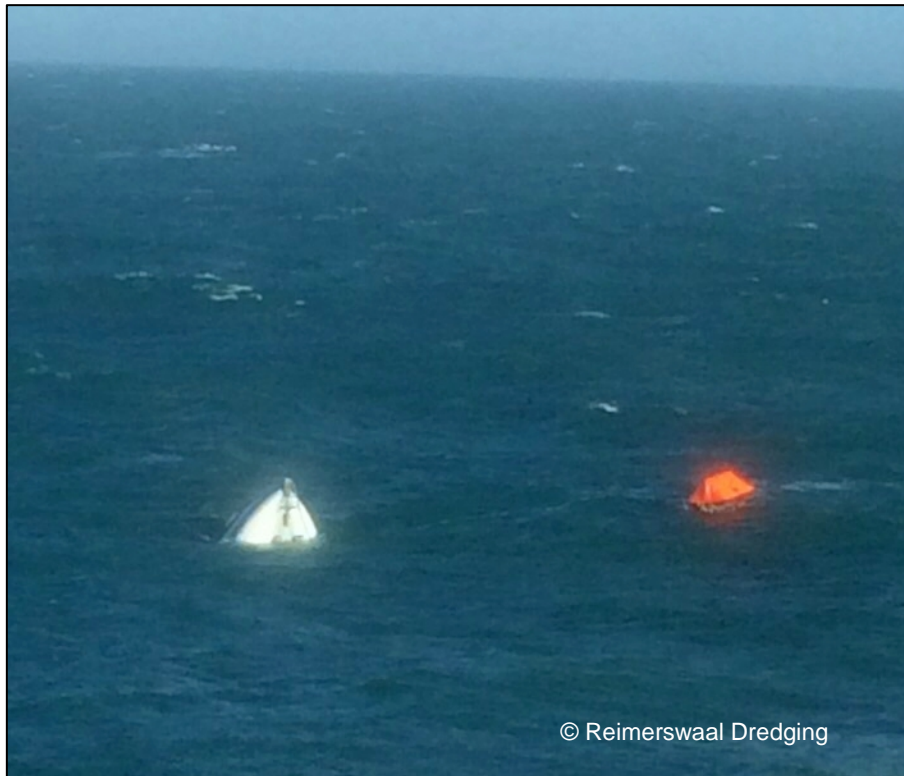
The EPIRB<sup>8</sup> and a liferaft deployed automatically as the fishing vessel was foundering. The alarm of the EPIRB was picked up by the control centre at 1055, forwarded to RCC<sup>9</sup> Münster and transmitted from there to the DGzRS. The liferaft was picked up by the GLOMAR COMMANDER.

Figure 6: KRISTINA and automatically deployed liferaft
