Interim Investigation Report

pertaining to Investigation Report 408/17

**Grounding of the bulk carrier
MV GLORY AMSTERDAM on
29 October 2017 about 1.6 nm
North of the North Sea Island of Langeoog**

29 October 2018

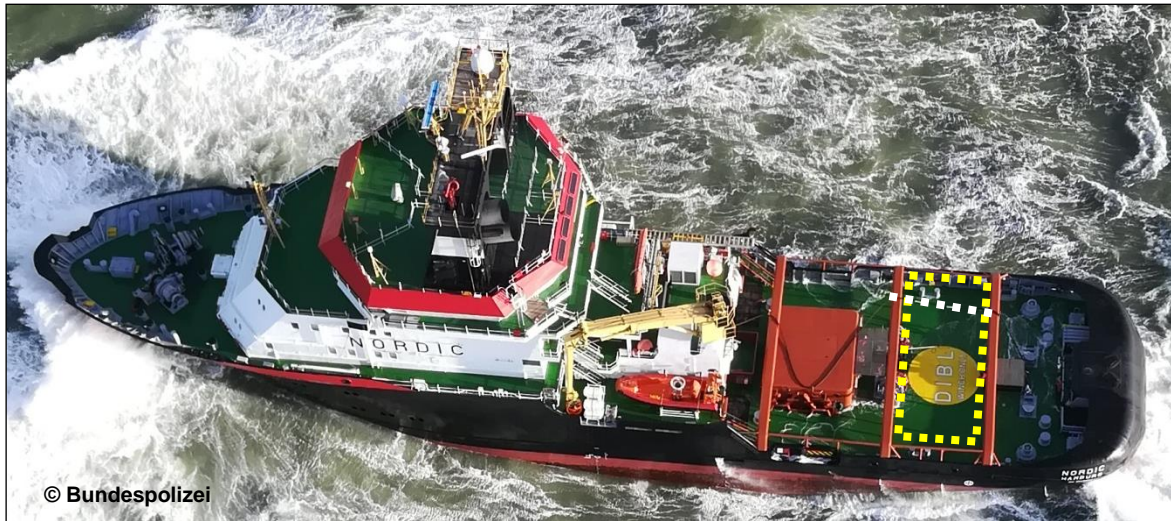
The BSU believes that the failure of the efforts taken by the helicopter of the Federal Police deployed to the NORDIC is unequivocally and exclusively can be attributed to the heavy sea in combination with the special structural features of the tug NORDIC. NORDIC's heavy movements in the heavy sea and the resulting difficulties in lowering the winch hook above the access area of the deck crew very much limited (cf. below the yellow marking in the **figures 3 ff.**), the special risk of throwing a person suspended at the winch hook against structural components of the NORDIC heavily pitching and rolling when winching up, before it reached a height uncritical above the vessel.

Figure 3: Emergency tug NORDIC at the day of the accident (winch area marked yellow)

An effective conversion of the structural conditions on board the NORDIC, if possible at all from a shipbuilding perspective, might not be possible at short notice. And even if possible, it would not be guaranteed, that winching the Boarding Team in heavy weather would be successful in any event. However, the accident event revealed explicitly the great importance of the fastest availability of a Boarding Team on board a distressed vessel. As a consequence, a Boarding Team for the North Sea should be stationed on shore, best in the area of the Federal Police helicopter base for the maritime emergency precaution in Fuhlendorf. From there the Boarding Team could be transferred to the distressed vessel without delay.

Permanently deploys a Boarding Team on shore for the area of the North Sea, best in the area of the Federal Police flying squadron in Fuhlendorf, at short notice.

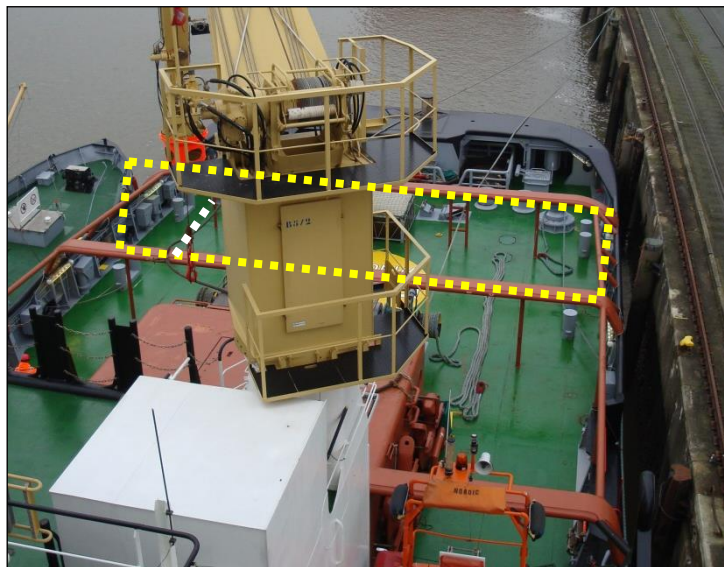
Figure 4: Lateral view on the winch area (restricted by steel cross braces)

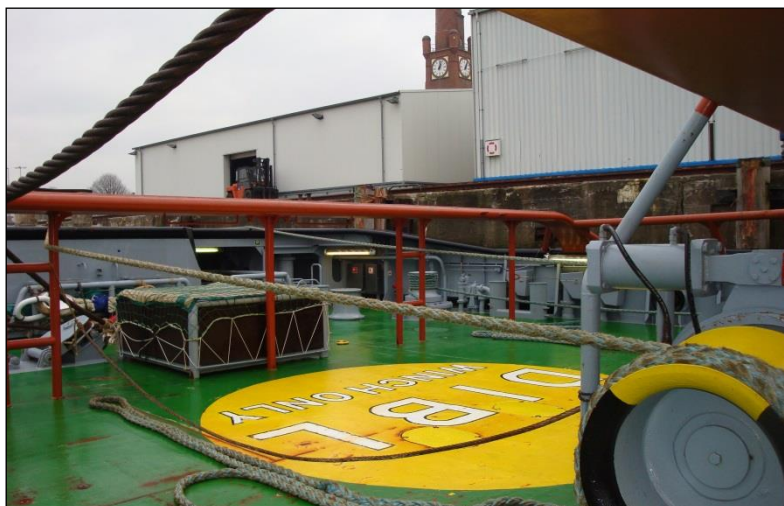
Figure 5: Restriction of the winch area by steel cross braces (partial view)
