Bundesstelle für Seeunfalluntersuchung
Federal Bureau of Maritime Casualty Investigation
Federal Higher Authority subordinated to the Ministry of Transport
and Digital Infrastructure

Investigation Report 160/17

**Line accident with minor physical injury
on board the traditional ship WISSEMARA
at 1400 on 24 May 2017
in the port of Wismar**

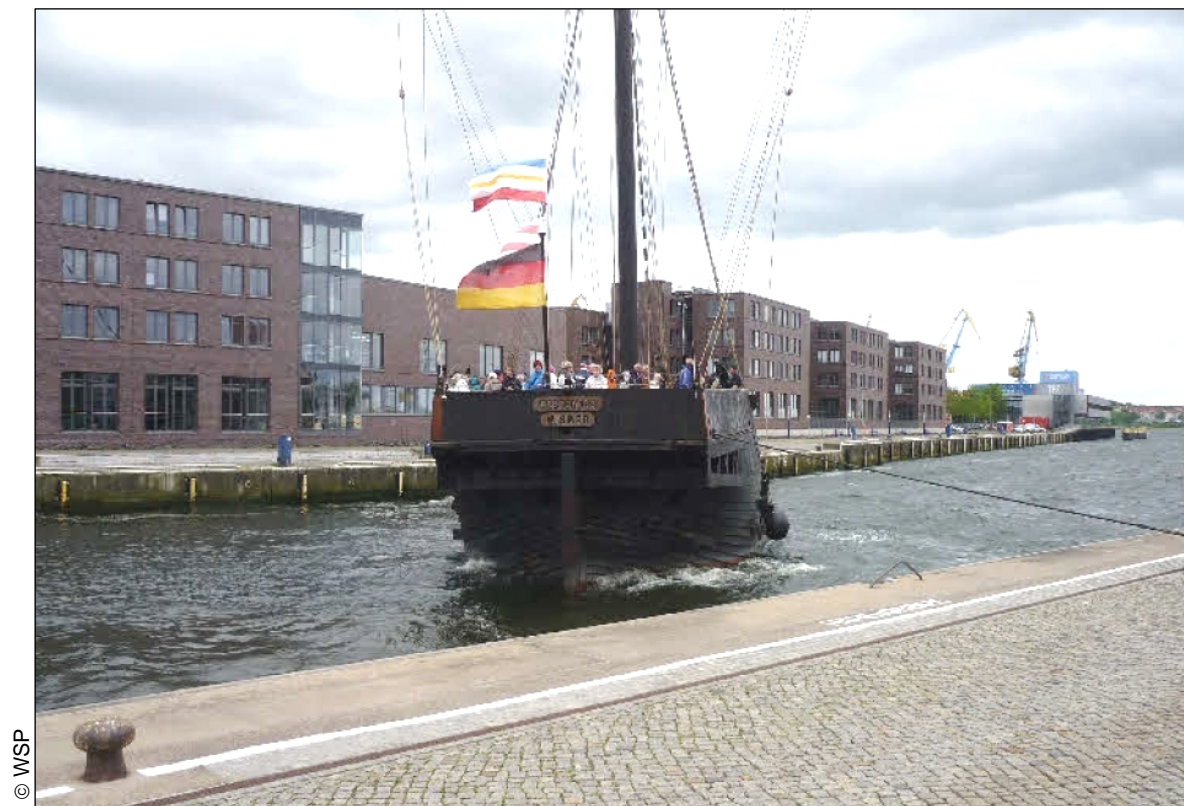
Figure 4: Berthing manoeuvre seen aft the stern

A 4-5 Bft north-west wind prevailed. The WISSEMARA moved slowly astern to the pier. The stern line was passed ashore with the help of a heaving line. The passengers were once more requested to move away from the mooring area on the starboard side for safety reasons. After the stern line was made fast ashore, the rudder was set to hard to starboard, the main engine to dead slow ahead, and the bow thruster operated at 100% to starboard. A strong gust of wind occurred at that precise moment, which turned the bow of the WISSEMARA to port. The main engine was once more briefly set to astern, so as to then spring on the stern line again while moving slowly ahead. When the stern line was then loaded, the cleat holding it broke. The flying wooden splinters that ensued struck a female passenger, who was still sitting in the danger area of the aft manoeuvring station despite all requests. She sustained minor injuries on her forehead.

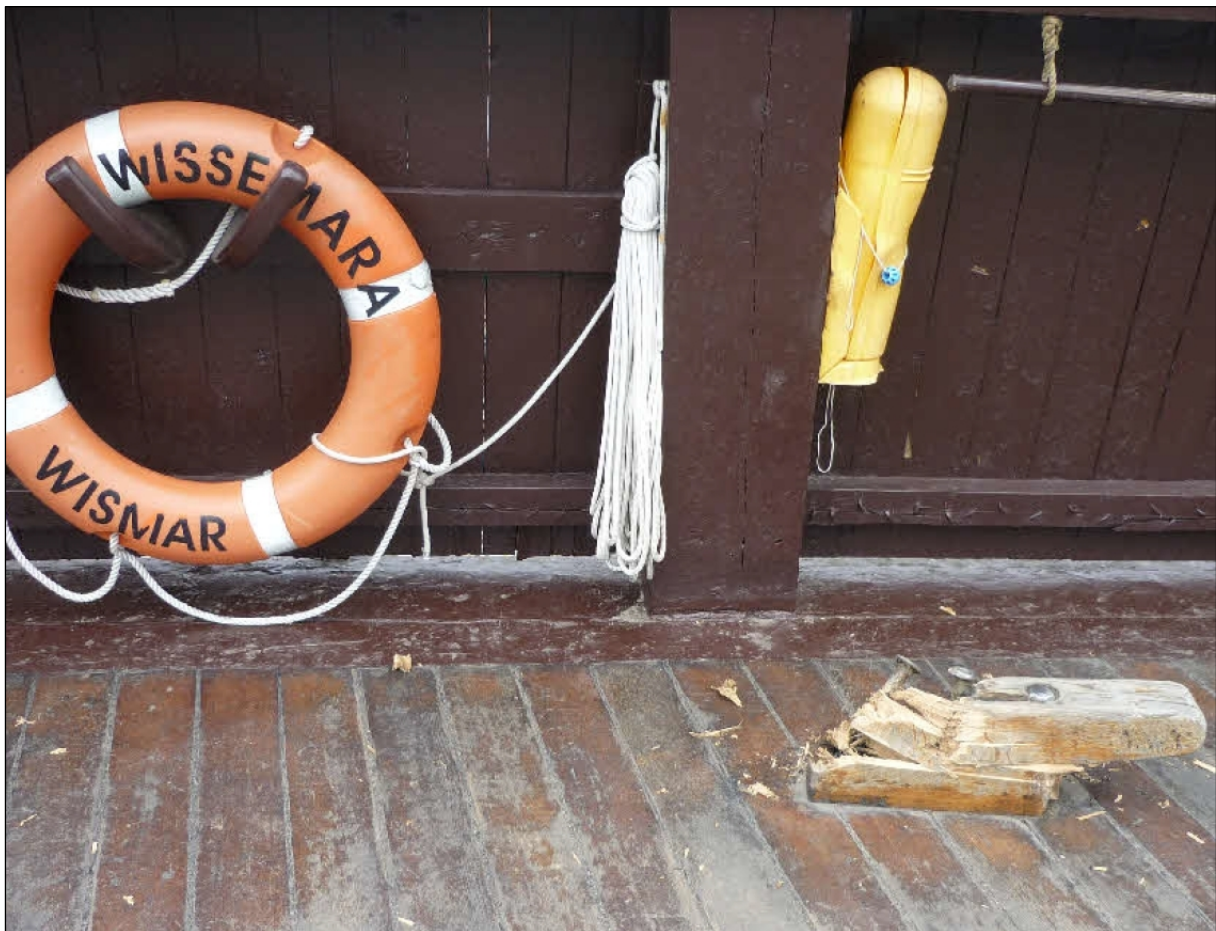
Figure 6: Destroyed wooden cleat (side view)

On the WISSEMARA, a wooden belaying cleat was destroyed (see Figures 6 and 7).

During a standard berthing manoeuvre, the mooring line was subjected to such a heavy load that it destroyed the cleat to which it was fastened. This resulted in injuries to one crew member and one female passenger. It must be noted that a cleat should withstand greater loads than a mooring line. This principle of shipbuilding has apparently not been adhered to here. The operating association attaches great importance to the authenticity of the cog and thus predominantly to her equipment with wooden components. The BSU fully understands this intention but also notes that hidden compromises between the original design of the cog from the Middle Ages and modern technology of today have already been identified and installed, making it even harder to understand why modern cleats made of metal were not fitted.

The destroyed wooden cleat shows that one side of it was so heavily loaded that a horn tore off. Therefore, it is also quite possible that the line was fastened to the cleat improperly.

The Federal Bureau of Maritime Casualty Investigation recommends that the Förderverein Poeler Kogge e.V. promptly replace all wooden cleats used when making fast with metal cleats with a higher holding force.

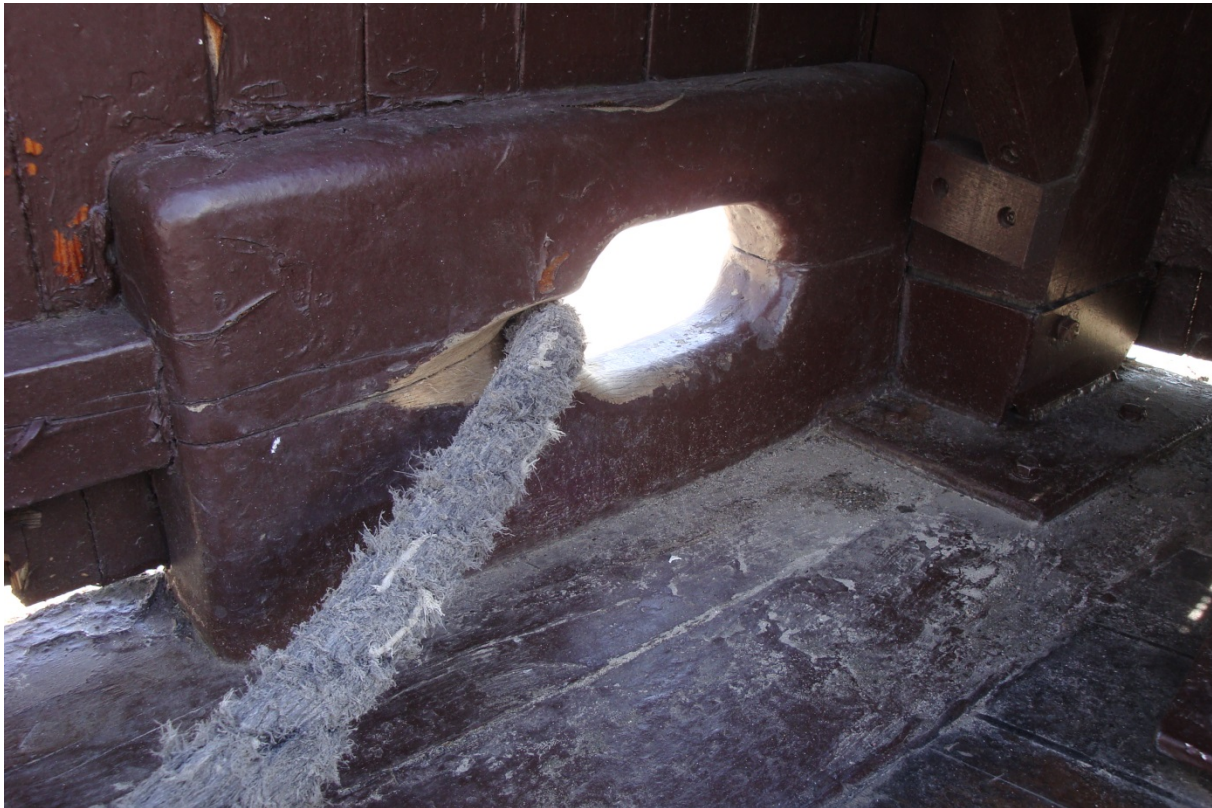
Figure 11: Wooden hawsehole with incision

It was found during the BSU's survey that the WISSEMARA's hawseholes were made of wood and therefore already damaged. It was clearly visible that the movement of the mooring lines had caused incisions in the hawseholes. Since modern technology was concealed throughout the ship by the 'charm' of the original cog, it is difficult to understand why the hawseholes and cleats were not installed according to current standards. It is unlikely that any passengers would be bothered if the internal parts of a hawsehole or cleat were made of metal. By contrast, this would increase the safety of everyone on board considerably.

The BSU noted during the local survey that hawseholes made of wood had been used up until that point. The movement of the mooring lines had already caused clear incisions in them. The operating association arranged for the hawseholes to be fitted with a metal edge in accordance with the advice of the investigators.

In August 2018, the association stated that all hawseholes now had metal edges.
