Bundesstelle für Seeunfalluntersuchung
Federal Bureau of Maritime Casualty Investigation
Federal Higher Authority subordinated to the Ministry of Transport
and Digital Infrastructure

Investigation Report 198/15

Serious Marine Casualty

**Chemical reaction within the fertilizer load on
board the PURPLE BEACH in the
deep water roadstead on the German Bight
on 25 May 2015**

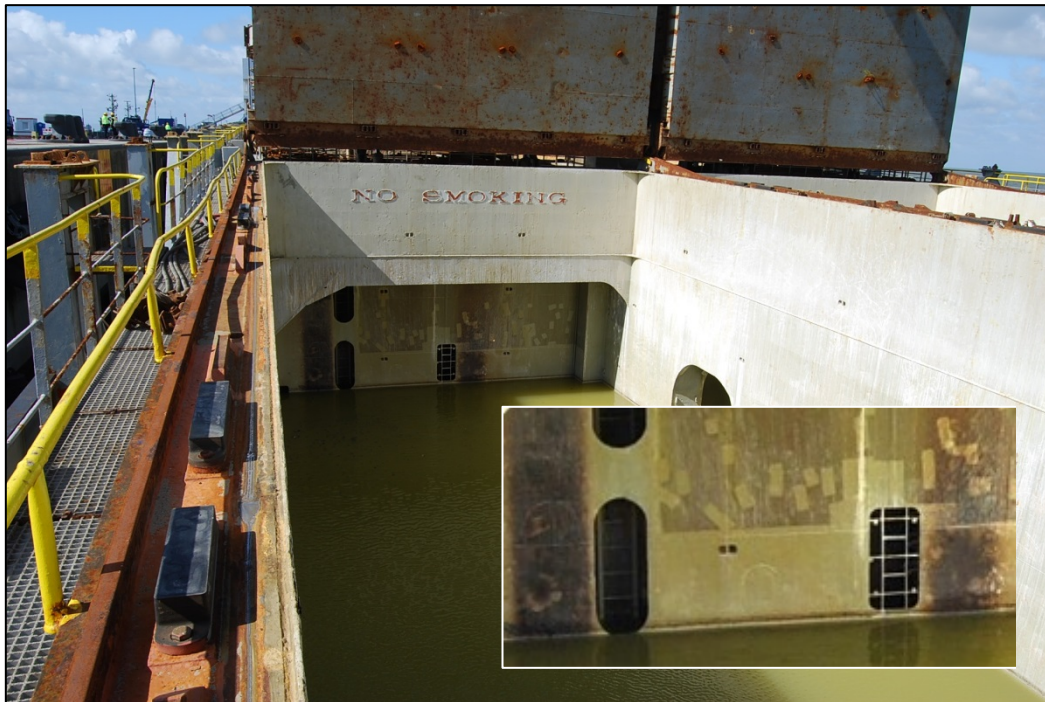
Figure 19: Cargo hold 2, tween deck, starboard side aft, 5 June 2015

Detail to the water level in the cargo hold.

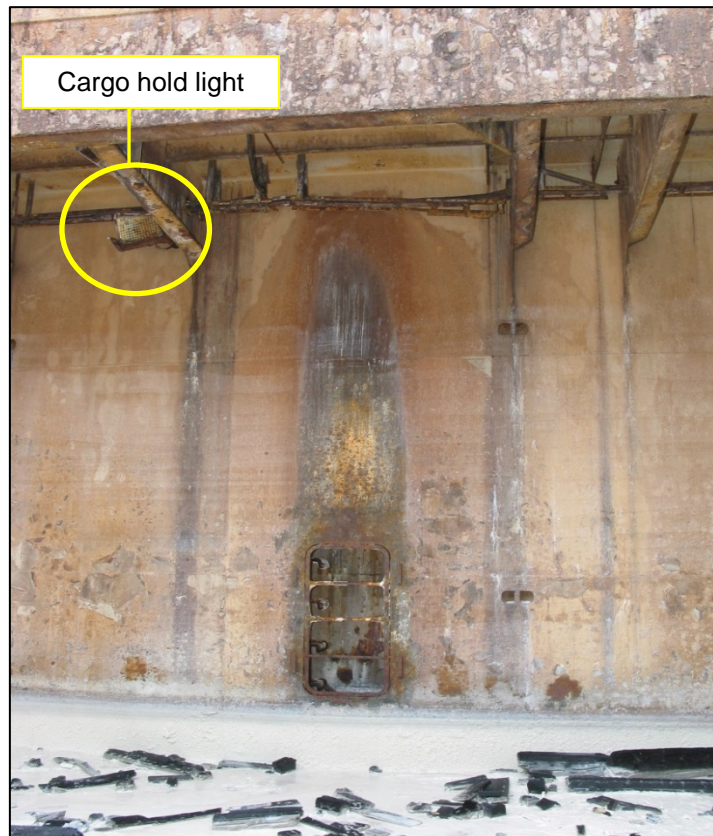
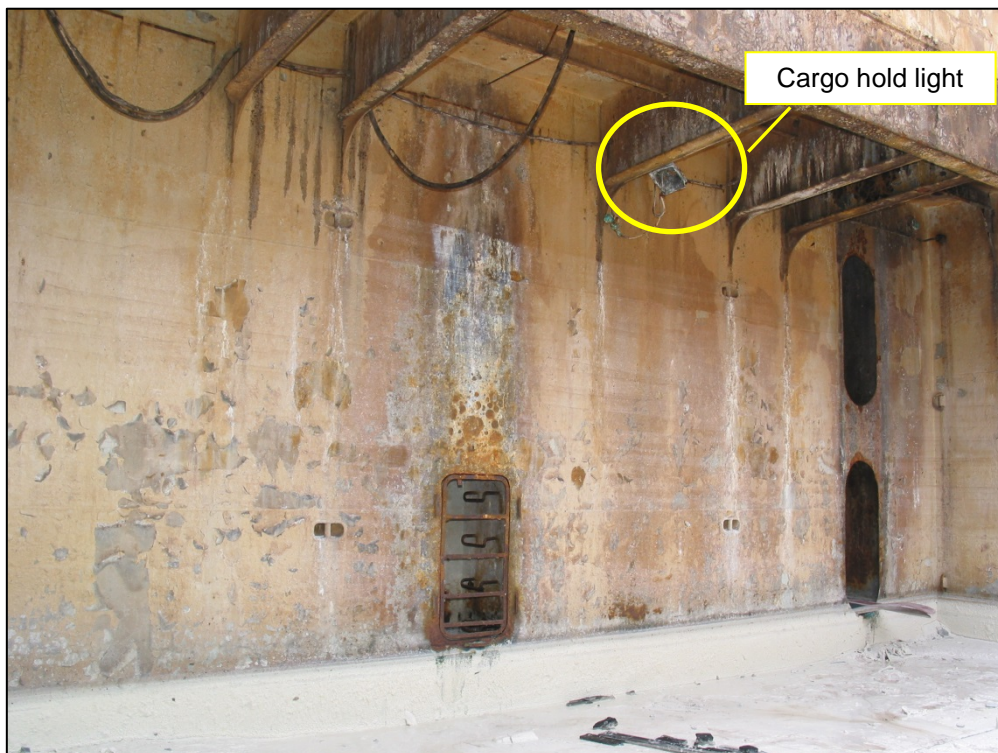
Figure 22: Cargo hold 3, tween deck, port side, ventilation trunk in the bulkhead to cargo hold 2

Figure 23: Cargo hold 3, tween deck, starboard side

During the survey, it was found that four cargo hold lights were installed in the tween deck (see Figures 22 and 23).

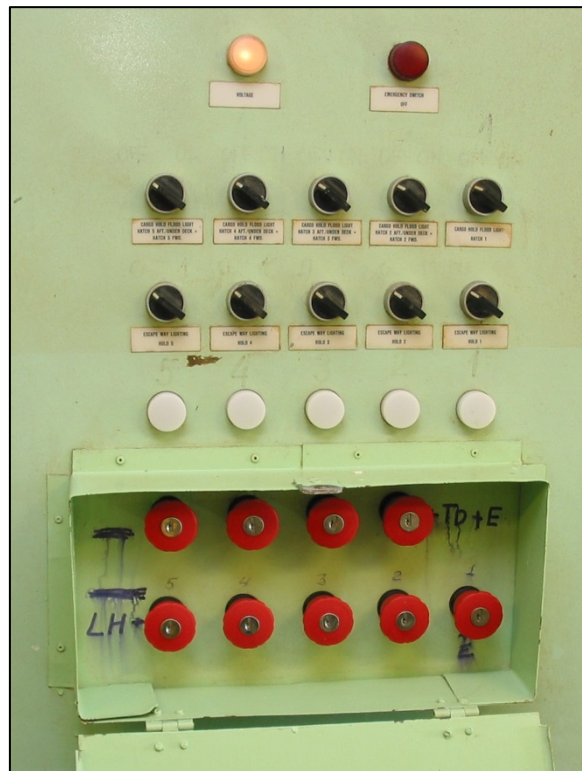
The control panel for the cargo hold lighting was also inspected again. Key switches were found under the on the 5 June 2015 locked cover, which the holder of the key could use to define the option of switching on the lighting for the tween decks and the access trunks together and/or the lower holds (Figure 24). The switches above the cover then only permitted a previously defined switching. It was no longer possible to determine the basic settings on the control panel and the key switch on the bridge from the time of loading until the accident or whether the cover was locked during this period. Similarly, it was not possible to determine whether the fuses for the area of the cargo holds were removed, which would have represented an even deeper intervention. There were no corresponding entries in the deck log book.

Figure 24: Control panel for the cargo hold lighting with cover open

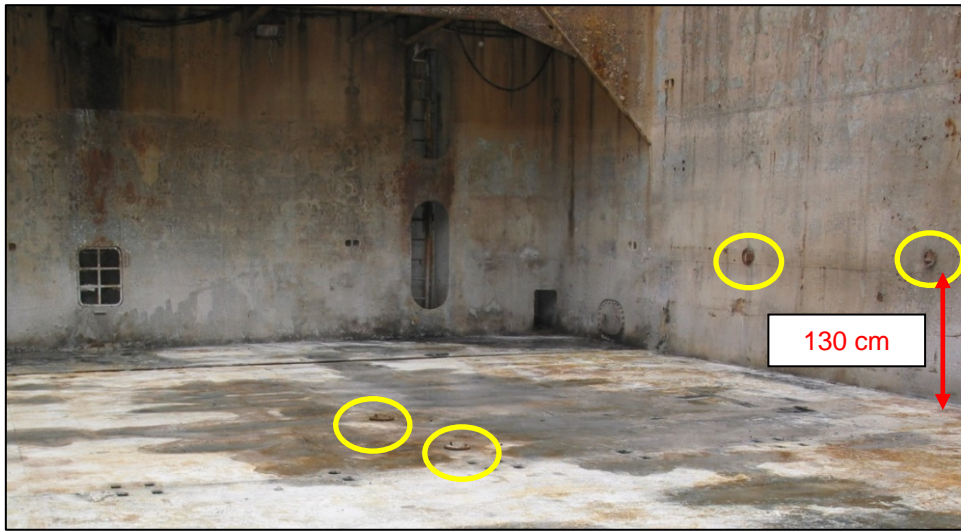
The D-rings installed in cargo hold 3's tween deck were surveyed and it was found that the size of the ring was smaller on some of them. In this case, the ring's length was 10 cm instead of the 12 cm found otherwise. Two of these D-rings were mounted on the aft pontoon hatch cover. Two others were on the outer side wall in this area. The four D-rings were additionally welded on in Antwerp for securing the load in the tween deck.

Figure 27: Additionally mounted D-rings

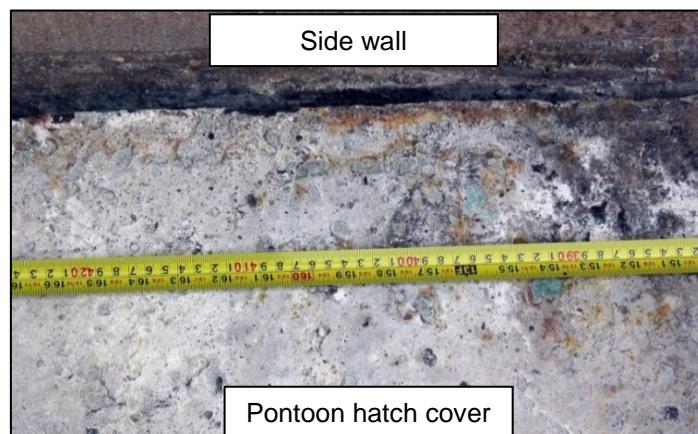
Figure 29: Gap between side wall and pontoon hatch cover

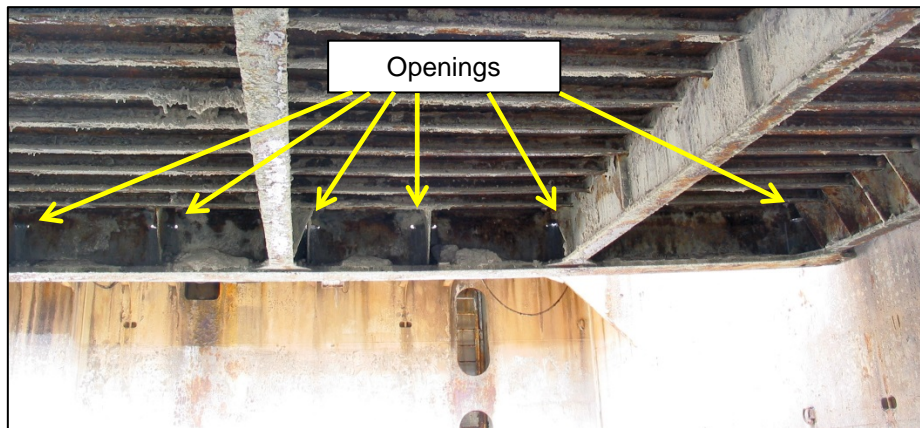
Figure 30: Inward openings in pontoon hatch cover

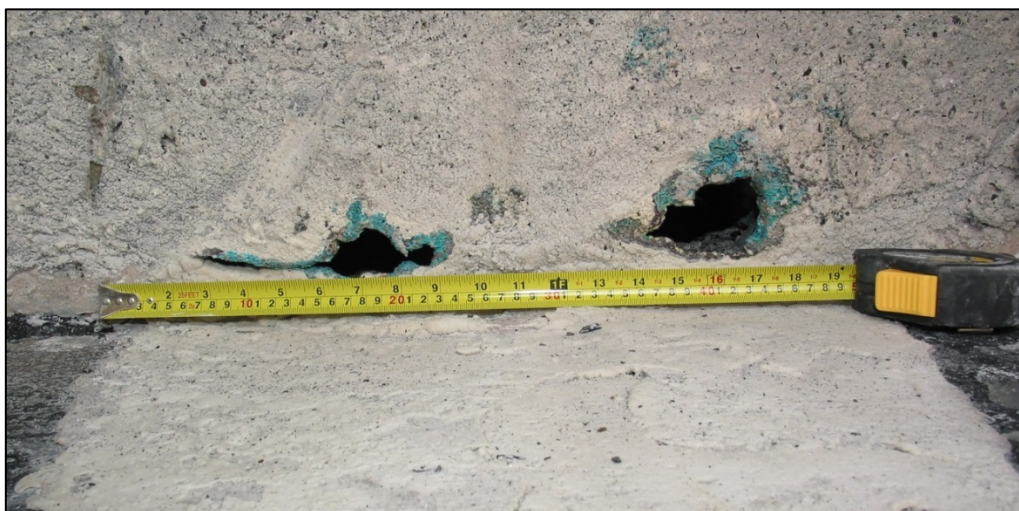
During the survey, it was also found that watertight integrity between cargo holds 3 and 2 was no longer given in the tween deck due to rust penetration in the transverse bulkhead. Large holes were found in the areas of the hold ladder's trunk on the port side (Figures 33 and 34) and of partition B (see Figure 31). These were located at a distance of about 70 cm and 90 cm from the outer wall in the area of the floor. The exact dimensions were difficult to establish due to the adhered incrustations (Figure 32).

Figure 31: Rust penetration at the bottom of the cargo hold 3 to cargo hold 2 bulkhead

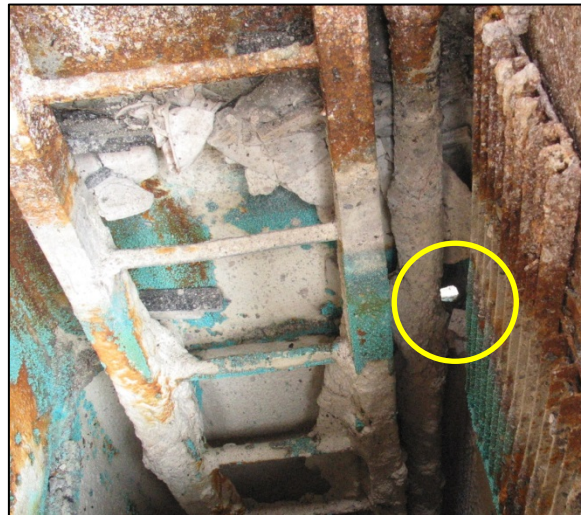
Figure 33: Rust penetration in the hold ladder's trunk on the port side (here the cargo hold 3 to cargo hold 2 bulkhead)

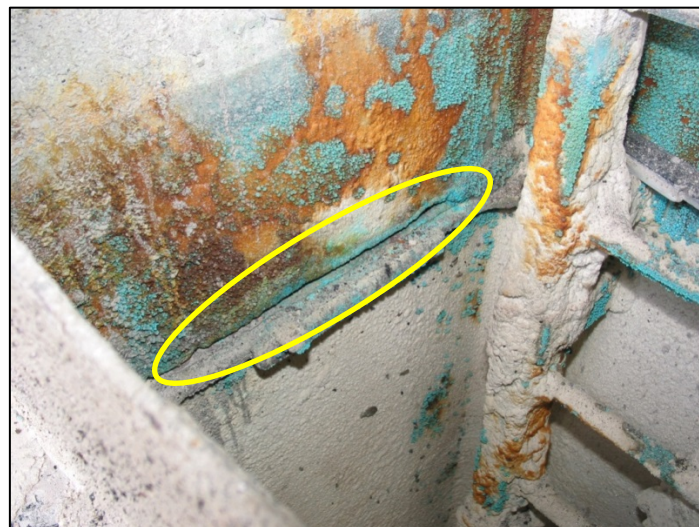
Figure 34: More rust penetration in the hold ladder's trunk
Cargo hold 3, forward edge of the tween deck, port side. View to the left from the entrance toward void space B (see Figure 35)

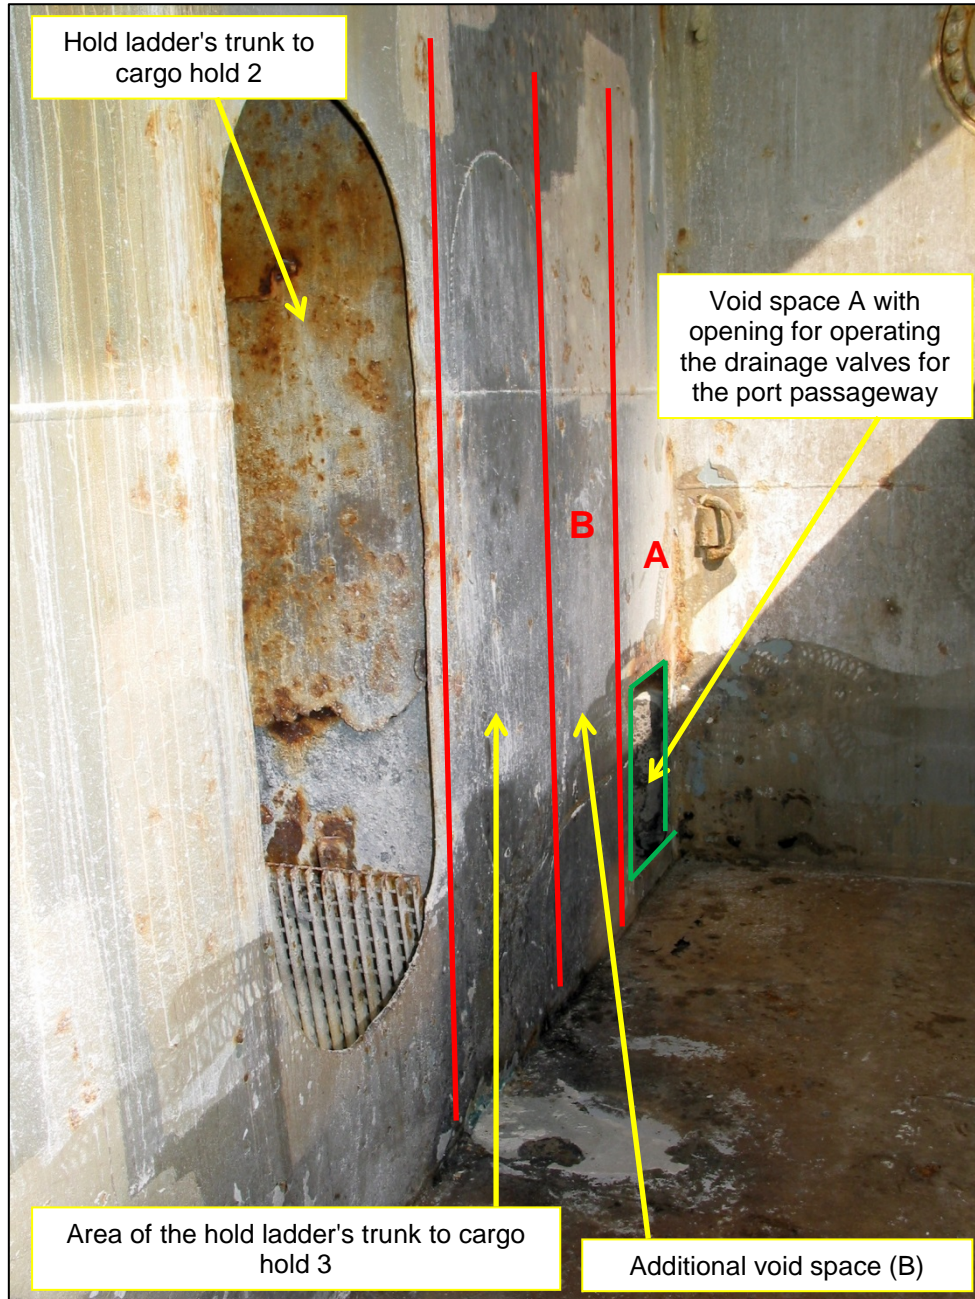
Rust penetration was also detected from cargo hold 2 in the transverse bulkhead to 3. This was in the areas of the hold ladder's trunk to cargo hold 2 and of void space B. Since there was a regular opening between A and B, the water could also enter cargo hold 2 there.

Figure 35: View from cargo hold 2 to the aft transverse bulkhead

Annotation: The BSU assumes, that the opening on the bottom of section A (green marked in figure 35) is the one which the firefighters saw the smoke emitting at their inspection on 26 May 2015.

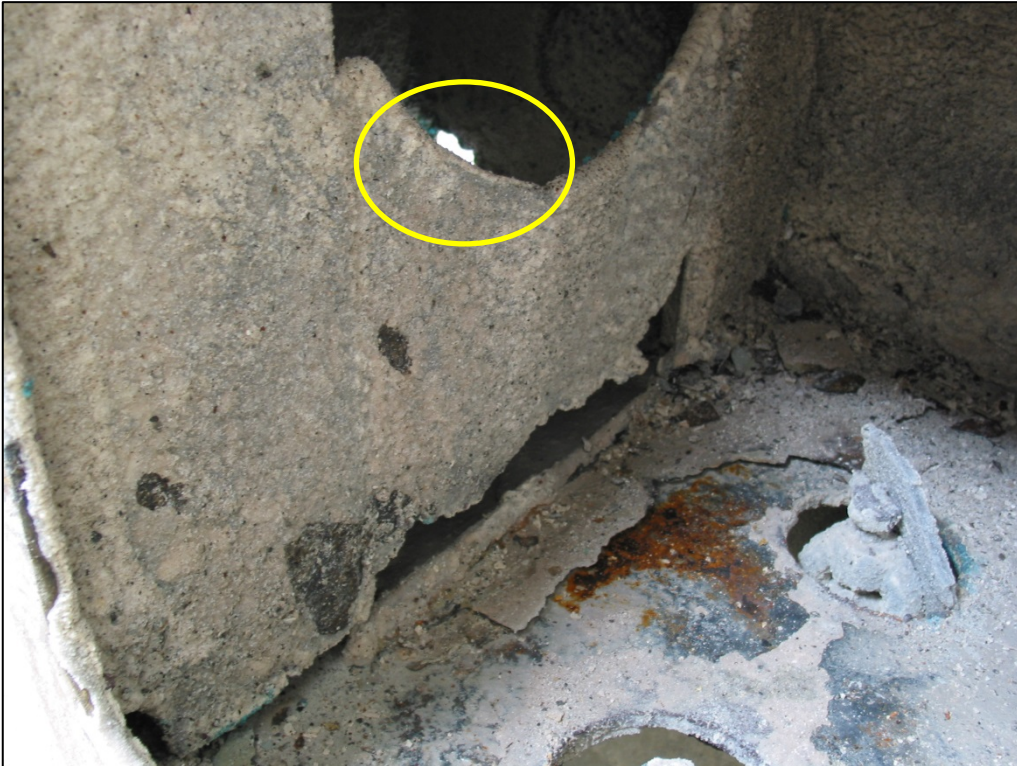
Figure 36: View in the opening to void space A and B

Highlighted yellow: Rust penetration in the bulkhead to cargo hold 3 (see Figure 31)

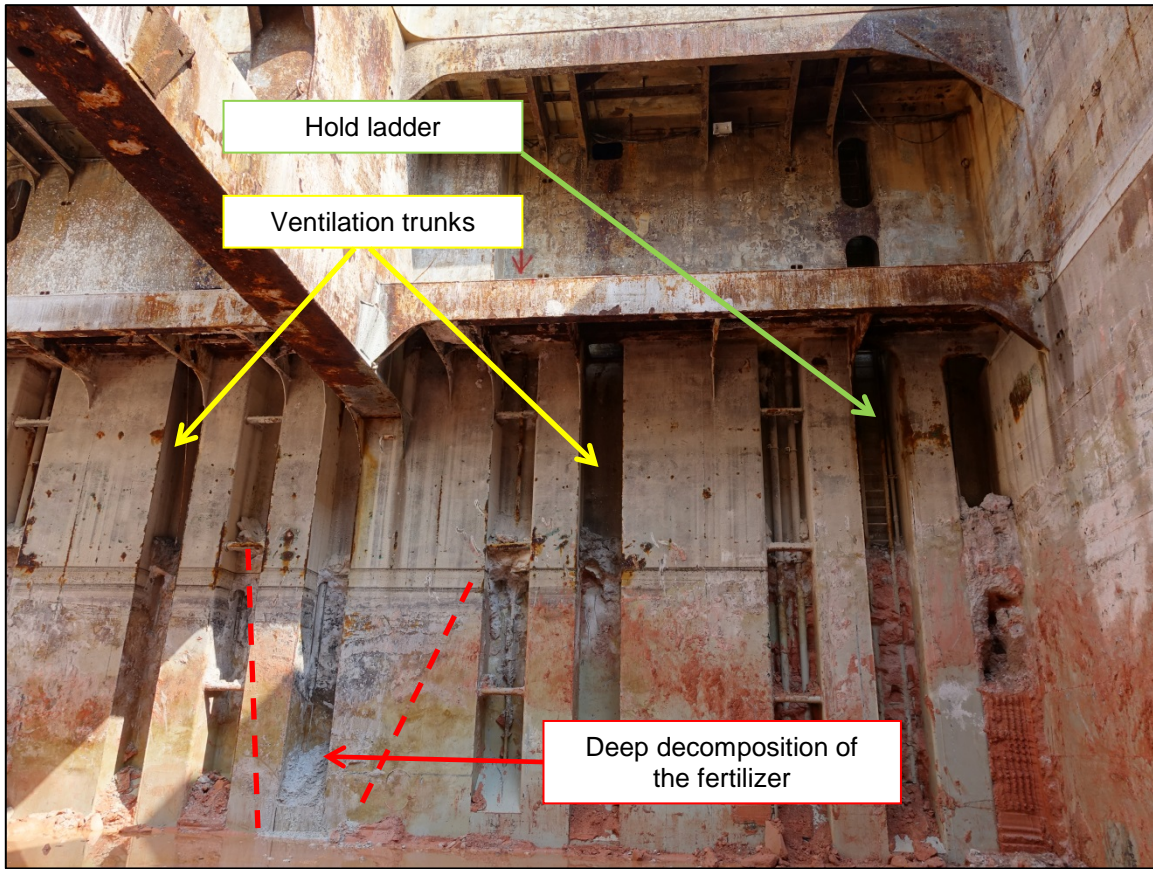
In addition to the BSU, surveyors from the other parties and WSP officers took part in the inspection of the cargo holds. The investigators entered cargo hold 3's lower hold for the first time during this survey. There were still remnants of the cargo in the lower hold at the time of the survey and the walls were only cleaned superficially. In terms of damage configuration, it appeared that the chemical reaction in the cargo had affected the cargo hold's aft area on the starboard side more than the port side. More white (converted) residues of the fertilizer were to be found there, while the fertilizer's reddish original colour was still generally visible in the remainder of the cargo hold. Moreover, it was found that decomposition was especially deep in the area of the aft edge almost in the middle (Figure 40).

Figure 40: Aft edge of cargo hold 3, port side

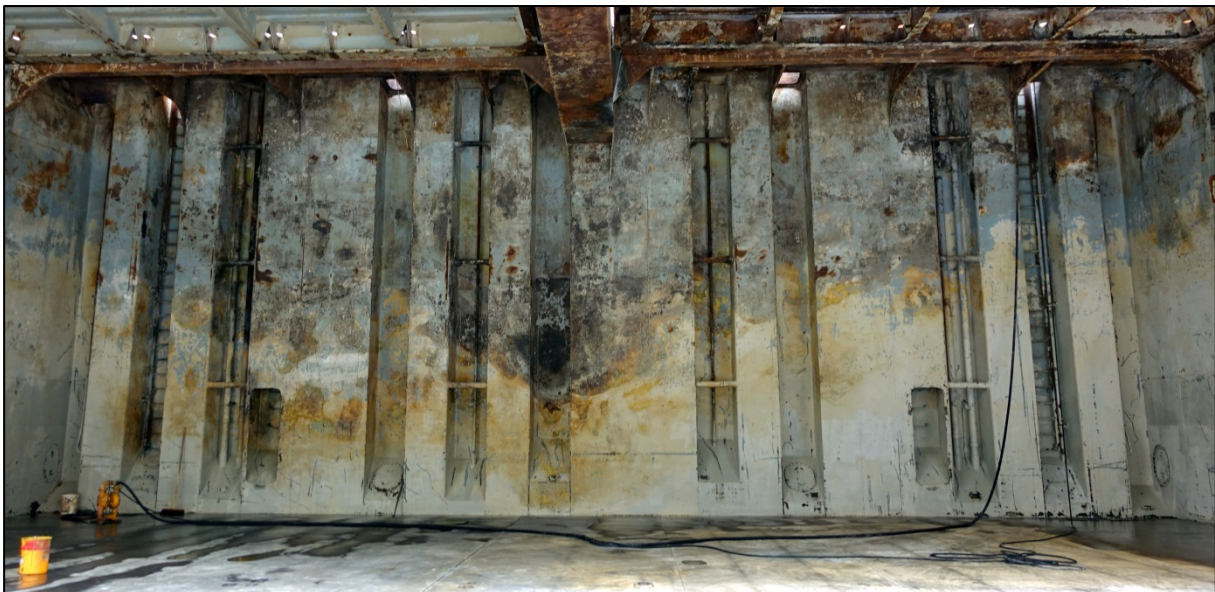
Figure 42: Cargo hold 3's lower hold, aft bulkhead edge
Traces of intense heat on the aft transverse bulkhead from a height of 2.2 m

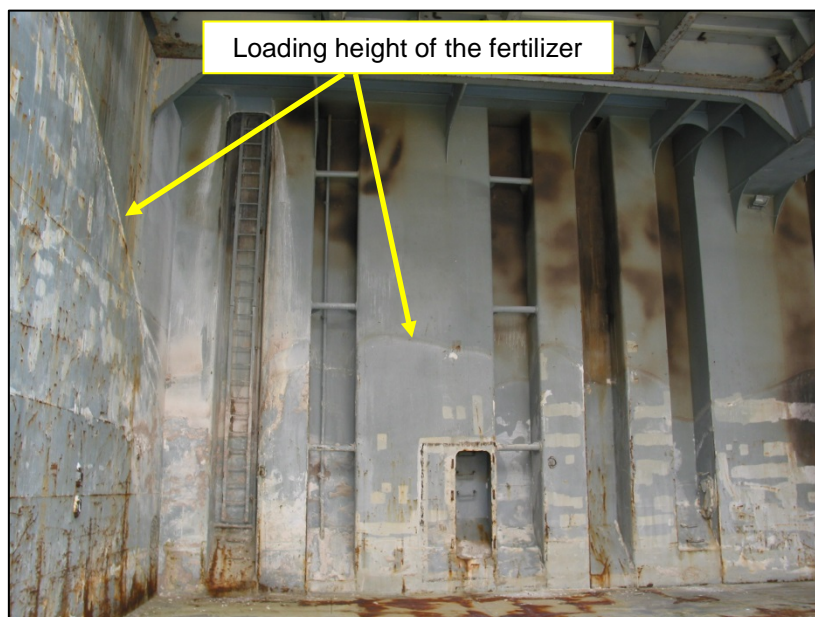
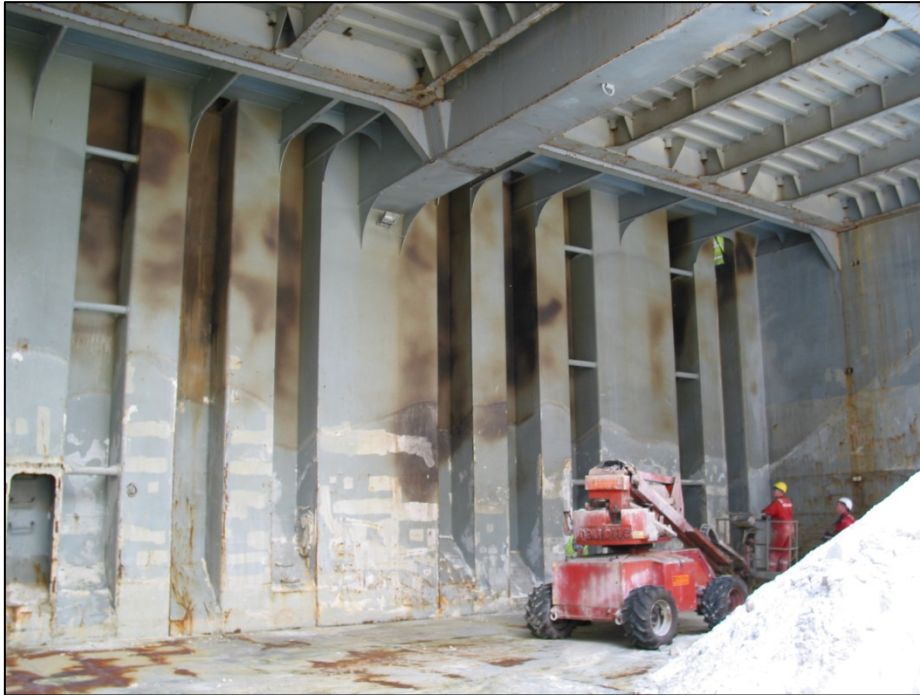
Cargo hold 4 was then surveyed, where changes to the colour of the coating were found on the transverse bulkhead as a result of the high temperatures in cargo hold 3. Cargo hold 4 still contained remaining items of cargo at this point. Consequently, the walls were not yet cleaned, meaning the previous filling level was still easy to discern there due to the deposits. It was apparent here that the cargo had been loaded well trimmed. The majority was in the aft section and it seemed as if the aft cargo hold light was at least in the immediate vicinity of the cargo.

Figure 44: Cargo hold 4, forward bulkhead, port side

Figure 45: Cargo hold 4, forward bulkhead, view toward the starboard side

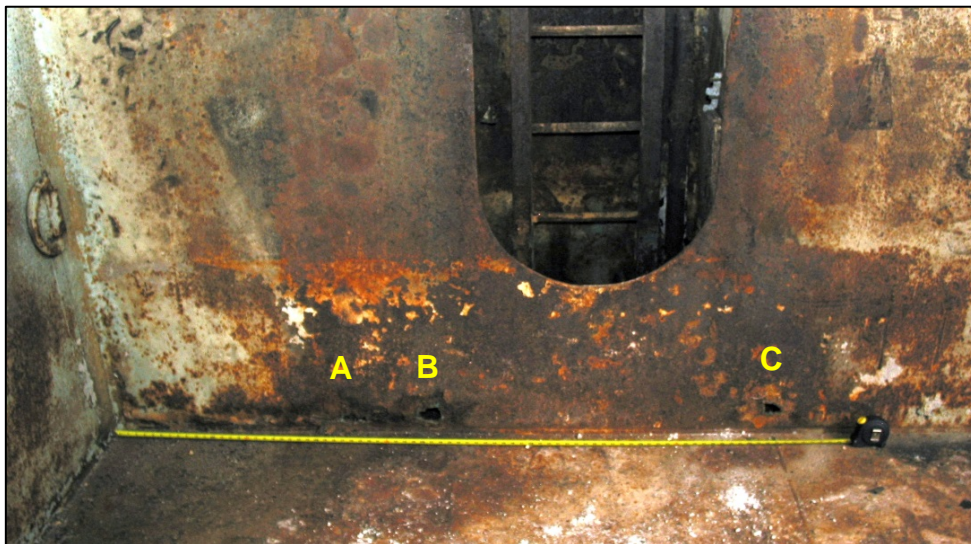
The BSU also documented the extent of rust penetration in the area of the tween deck between cargo holds 2 and 3. The investigators only ascertained minor alterations to the size of rust penetrations in comparison to the measurements on 26 August 2015, although the cargo holds were cleaned using high pressure with 400 bar to 700 bar according to the ship's management.

Figure 49: Cargo hold 3, tween deck, transverse bulkhead to cargo hold 2, port side

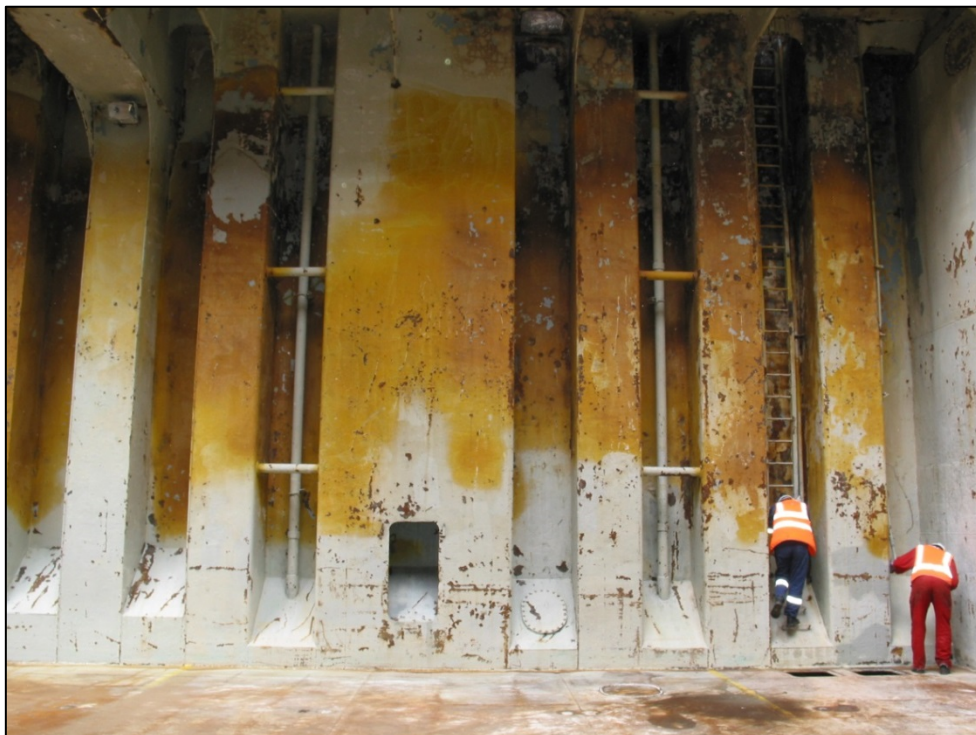
Figure 61: Cargo hold 2's lower hold, port side of aft edge with discolouration
