Bundesstelle für Seeunfalluntersuchung
Federal Bureau of Maritime Casualty Investigation
Federal Higher Authority subordinated to the Ministry of Transport
and Digital Infrastructure

Investigation Report 289/17

Less Serious Marine Casualty

**Collision between the
MV FINNSKY and the
steam icebreaker STETTIN
on the River Warnow
on 12 August 2017**

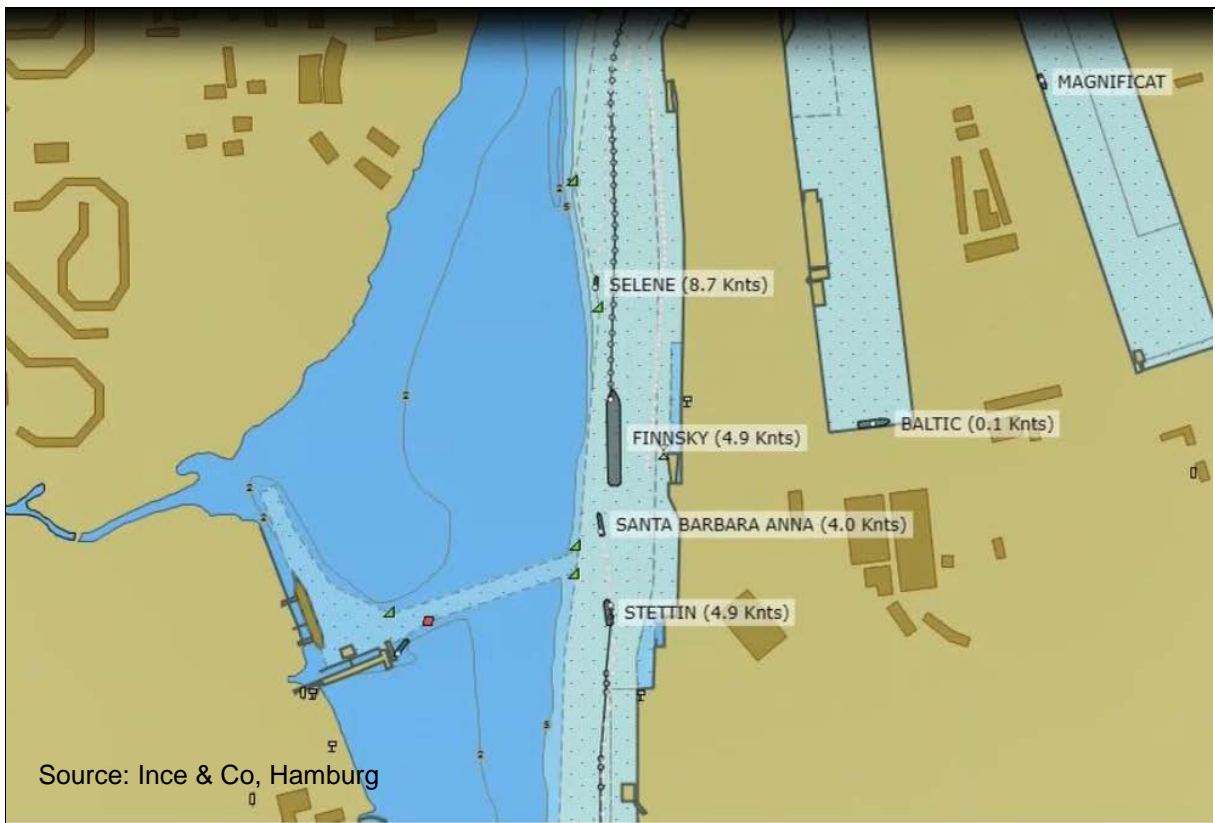
Figure 43: Image 1: AIS/ECDIS shortly before the collision

STARBOARD MANOEUVRE OF THE STETTIN IMPOSSIBLE

12. Based on the initial situation described above and the customary manoeuvring practise, it was out of the question for the STETTIN to give way to starboard. Moreover, it was virtually impossible for the STETTIN to give way to starboard. Image 1 shows the positions of the FINNSKY, the SANTA BARBARA ANNA and the STETTIN shortly before the collision.

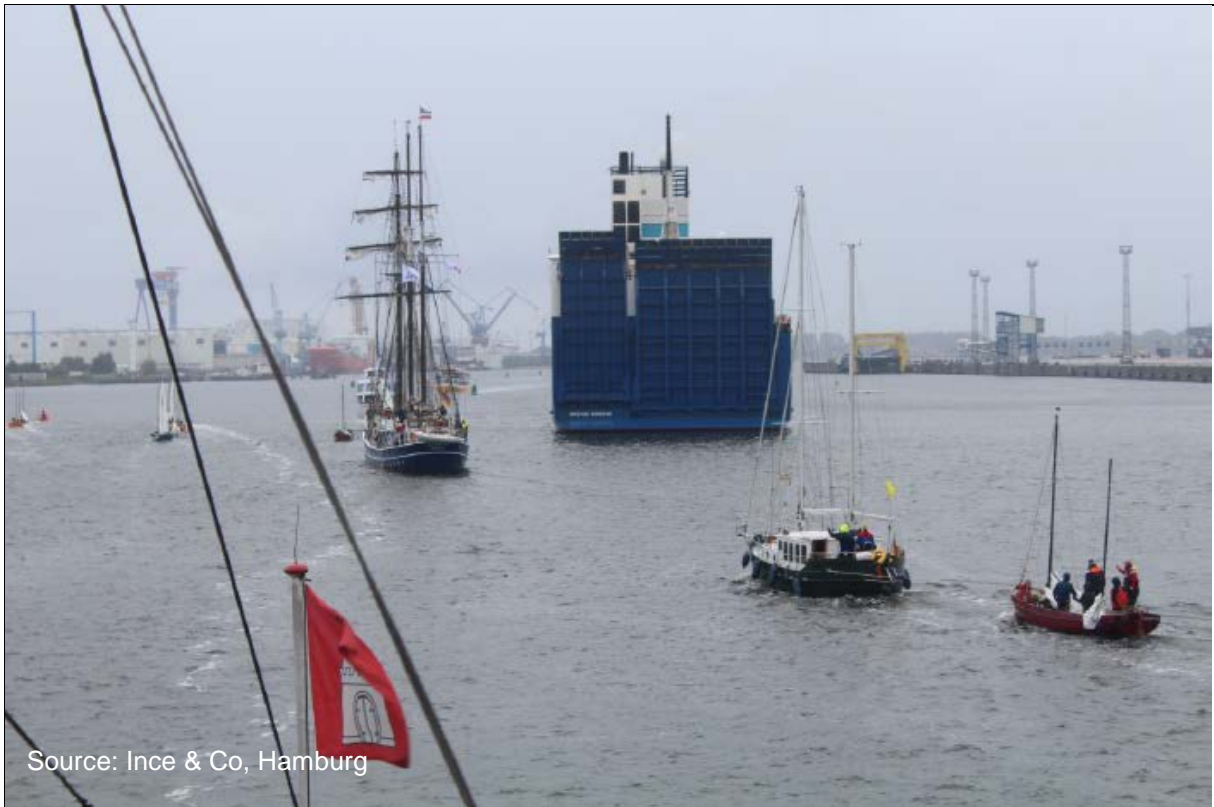
Figure 44: Image 2: Photograph from the bridge of the STETTIN

14. The photograph was taken from the bridge of the STETTIN. In particular, it shows a towed convoy to starboard (in addition to other vessels), which is crossing the STETTIN from starboard to port. It is obvious that the STETTIN could not possibly turn to starboard at this point in time.

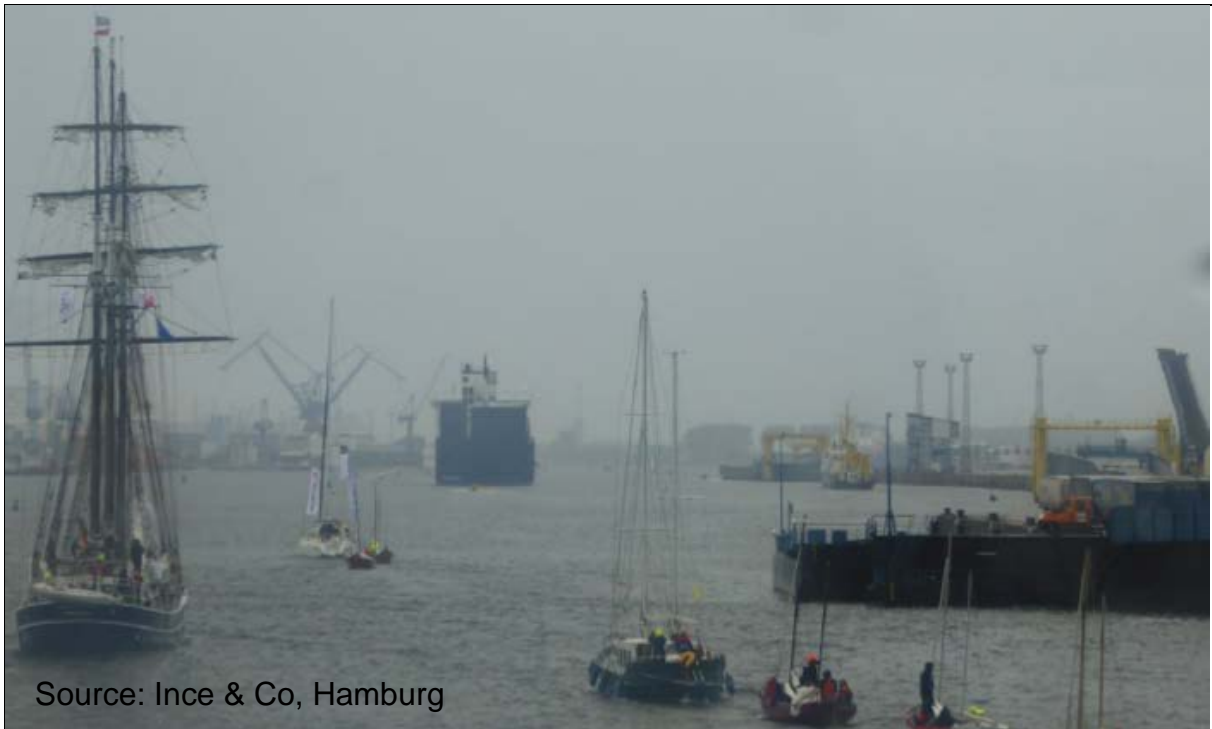
Figure 45: Image 3: Photograph from the bridge of the STETTIN

15. Image 3 shows another photograph. This was taken a few minutes earlier, also from the bridge of the STETTIN.
16. It shows two relevant items of information on the starboard side of the STETTIN. Firstly, one of the ro-ro terminals is shown there. This projects westwards into the Unterwarnow. It is obvious that the STETTIN could not possibly go to starboard before passing this terminal. Furthermore, Image 3 shows the towed convoy already seen in Image 2. This is already on the starboard side of the STETTIN's bow. Viewed together, Images 2 and 3 thus clearly indicate that this towed convoy sailed on starboard side just ahead of the STETTIN during the entire approach. Because of this towed convoy and the ro-ro terminal projecting into the Unterwarnow, at no time was it possible for the STETTIN to give way to the FINNSKY to starboard.

17. It is also worth taking a closer look at the FINNSKY in this photograph. Her course (in relation to the green buoy line, in particular) clearly shows that the FINNSKY is already traversing to the east at this point.

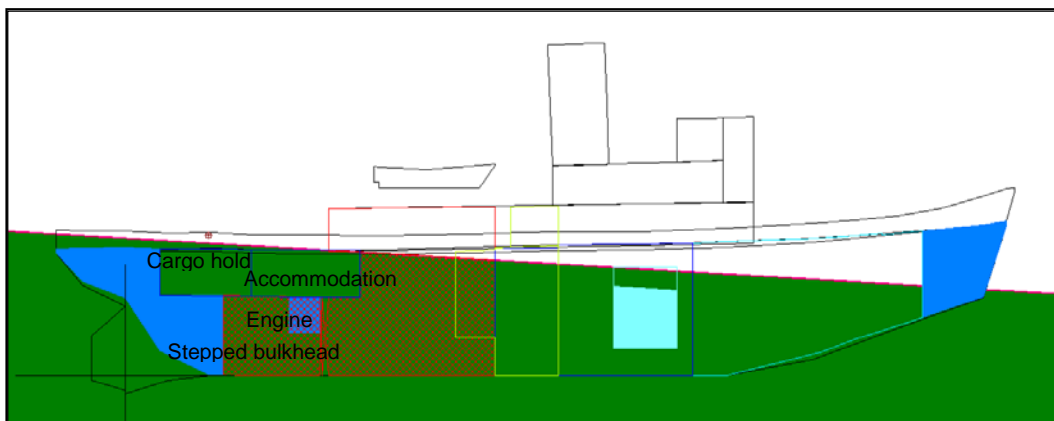
Figure 47: Load case 1: Damage stability calculation

The STETTIN does not survive the required scenario of collective flooding with integrated stepped bulkhead of the accommodation or the cargo hold with the engine room below the main deck (bulkhead deck). Contrary to the requirements of the Directive, in considering a consistent 1-compartment status when only one compartment in each of the four load cases is flooded, the ship would always remain buoyant and comply with the stability criteria specified here, too.

Load case 1: Flooding of the engine room and the accommodation or cargo hold under the main deck (bulkhead deck).

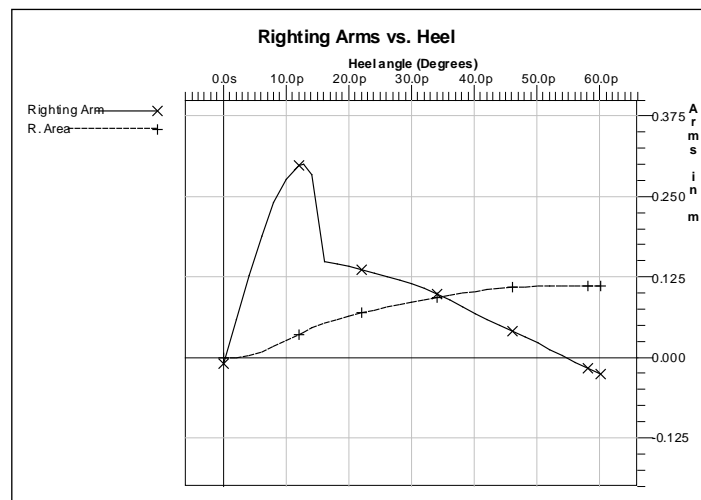
Figure 48: Righting lever curve damaged stability calculation

The ship does **not** comply with the following conditions of Chapter II-1, Part B of the Directive:

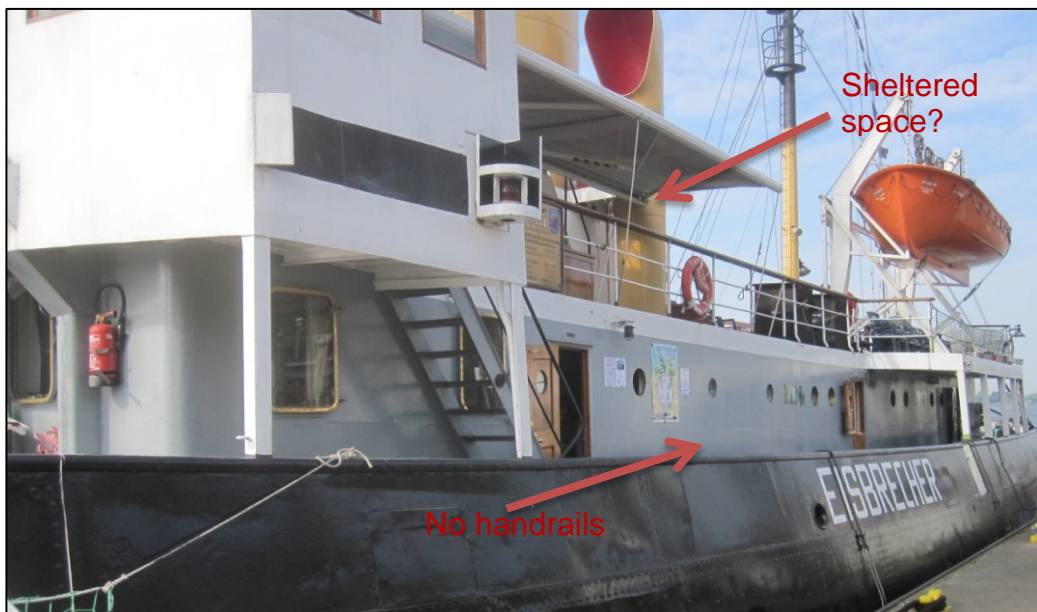
Figure 49: Sheltered space and handrails?

The additional permission for the safety certificates for traditional vessels includes the following condition: "*Sheltered space under deck is available for each person on board.*" The statement of the Ship Safety Division (BG Verkehr) advises that in accordance with the professional opinion of the BG surveyor, this sheltered space and its areas are defined on board but not documented. In his calculations (Annex 9.3), the expert acting on behalf of the STETTIN arrives at a total of 1224 people (BG Verkehr 225 people) for whom a sheltered space exists. In making these calculations, the expert identifies the area on the boat deck beneath the awning as a sheltered space, despite the fact that this area is not below deck.

It would seem urgently necessary for the Ship Safety Division (BG Verkehr) to define and specify precisely what constitutes a sheltered space and, as suggested by the expert Jan Hatecke, that such spaces be included in the emergency plan.
