**Bundesstelle für Seeunfalluntersuchung**  
**Federal Bureau of Maritime Casualty Investigation**  
Federal Higher Authority subordinated to the Ministry of Transport  
and Digital Infrastructure

## Investigation Report 423/16

**Serious Marine Casualty**

**Collision between the MV MERIDIAN,  
MV NEWYORKER and MSC DIANA  
at the Stromkaje, Bremerhaven,  
on 20 November 2016 at 0153**

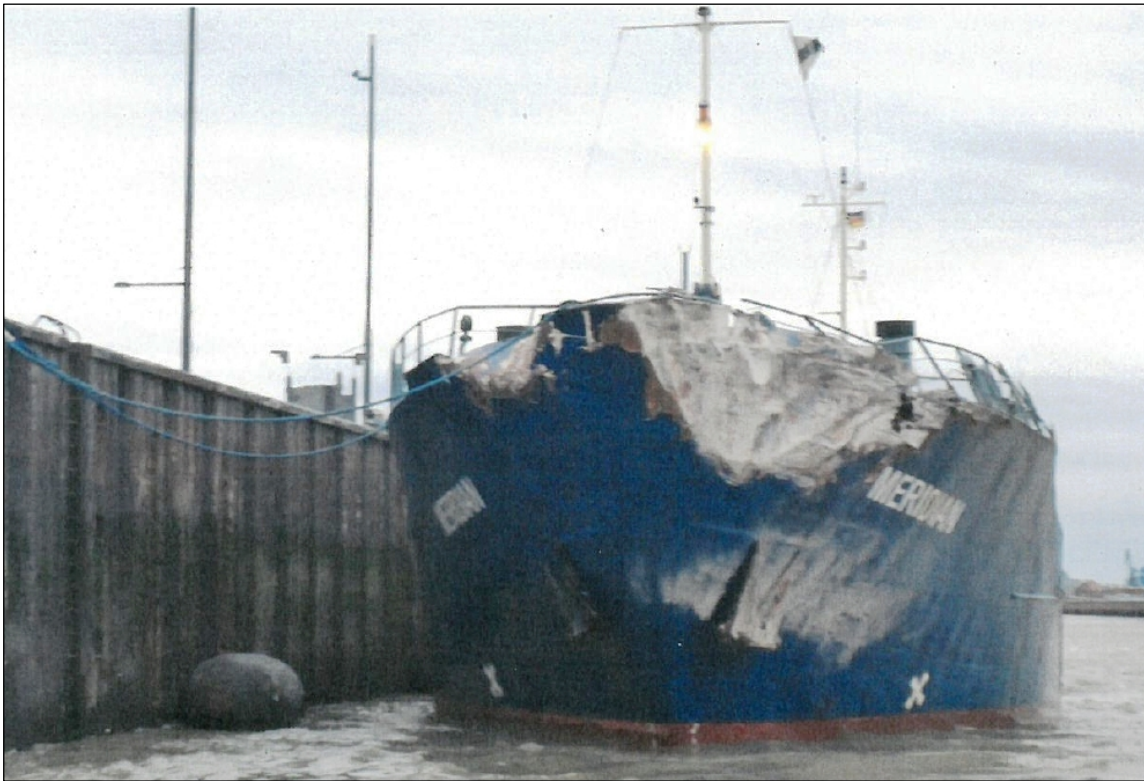
The collision with the pier caused heavy damage to the MERIDIAN's fore section. The damage sustained by the pier's structure was so heavy that operation of the container gantry crane on top of it had to be suspended temporarily.

Figure 18: Damage to the MERIDIAN's bow

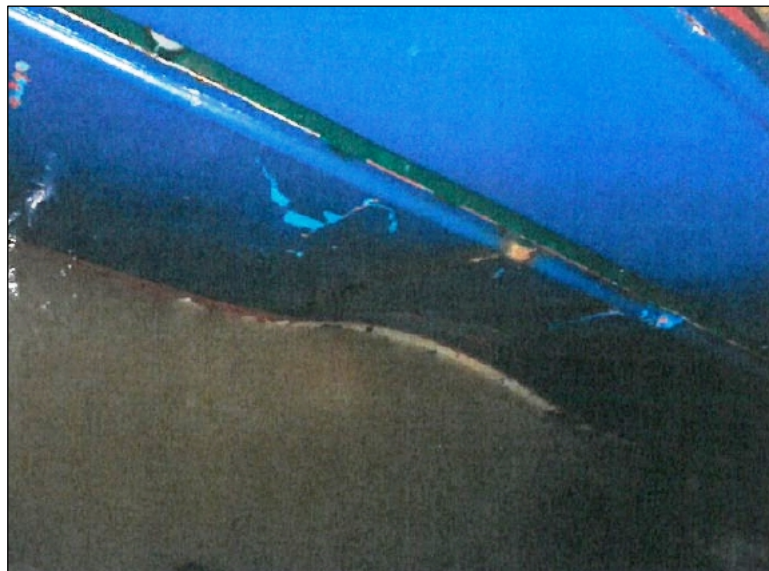
This contact with the bulbous bow left no visible damage on the MSC DIANA. However, it did result in indentation with cracking on the starboard side of the MERIDIAN. The MERIDIAN's crew was able to stop the slight water ingress that followed.

Figure 19: Crack on the MERIDIAN's waterline

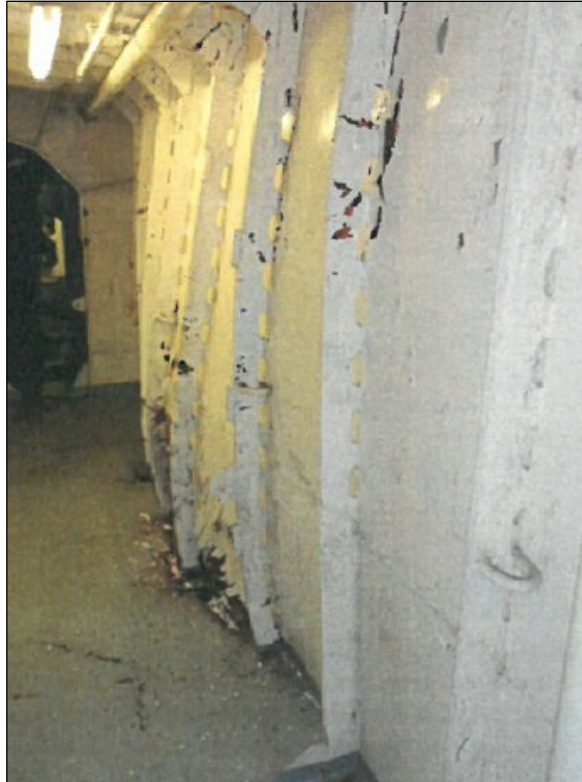
Figure 20: Damage to the MERIDIAN's starboard side...

The MERIDIAN's shell plating was dented level with the all-weather passageway to such an extent due to the collision with the MSC DIANA's bulbous bow that there was slight water ingress, which the crew managed to contain.

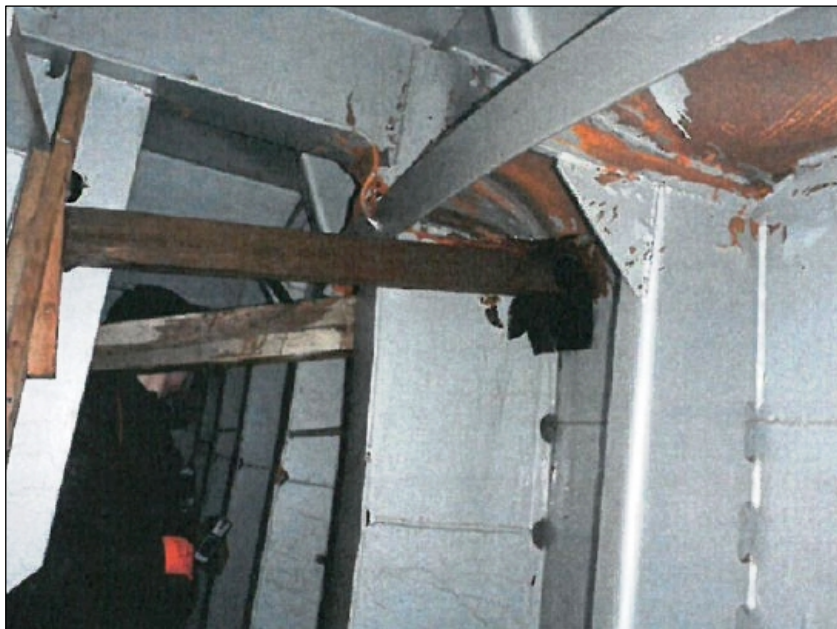
Figure 21: ...with water ingress

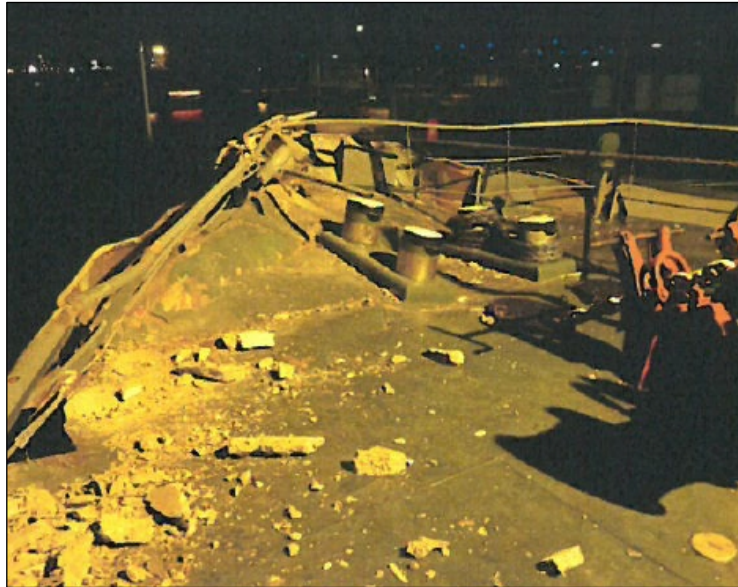
Figure 22: Damage to the MERIDIAN's fore section

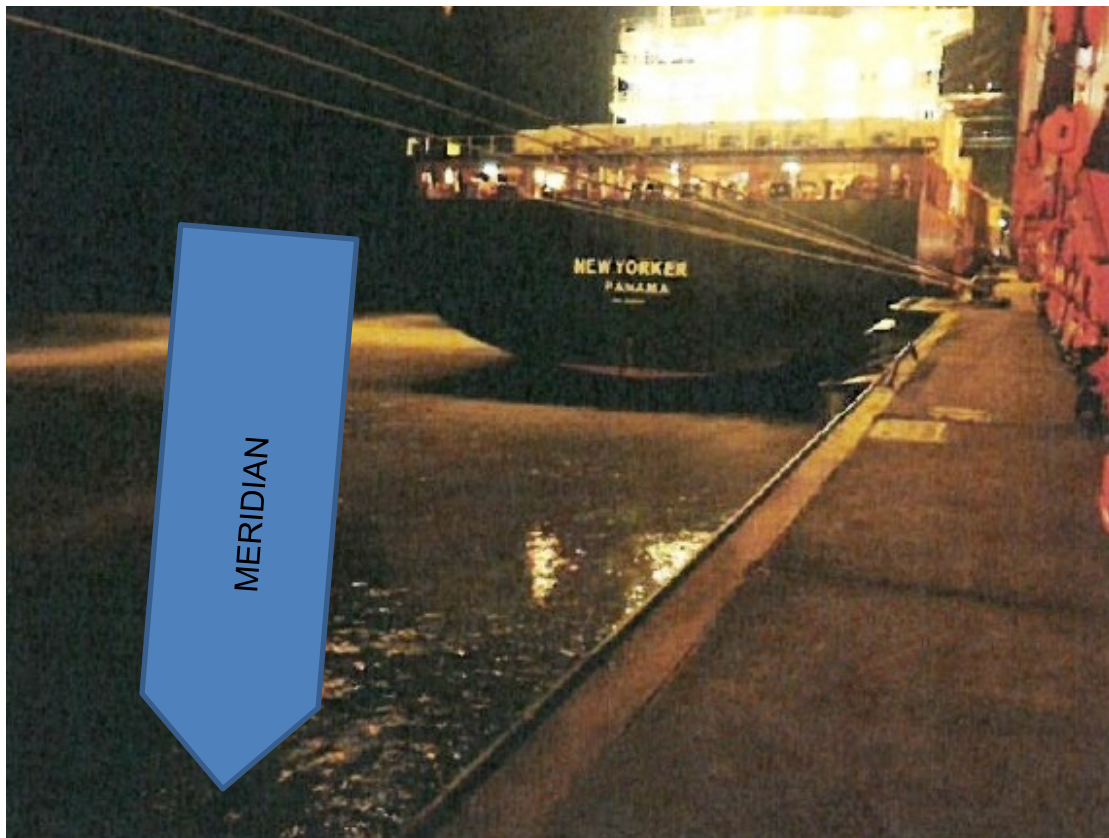
Figure 23: View from the scene of the collision with the pier to the NEWYORKER

For illustration purposes, Figure 23 shows the vacant gap at Pier 2020 between the NEWYORKER and MSC DIANA (not in the image but on the left margin). The blue arrow represents the MERIDIAN. The damage to the pier structure was clearly visible on the following day (see Figure 24). The following heavy damage was found on the pier and documented:

- dolphin torn from the anchorage at the pier;
- access ladder with mounting torn from the pier;
- significant traces on the pier's concrete foundation.

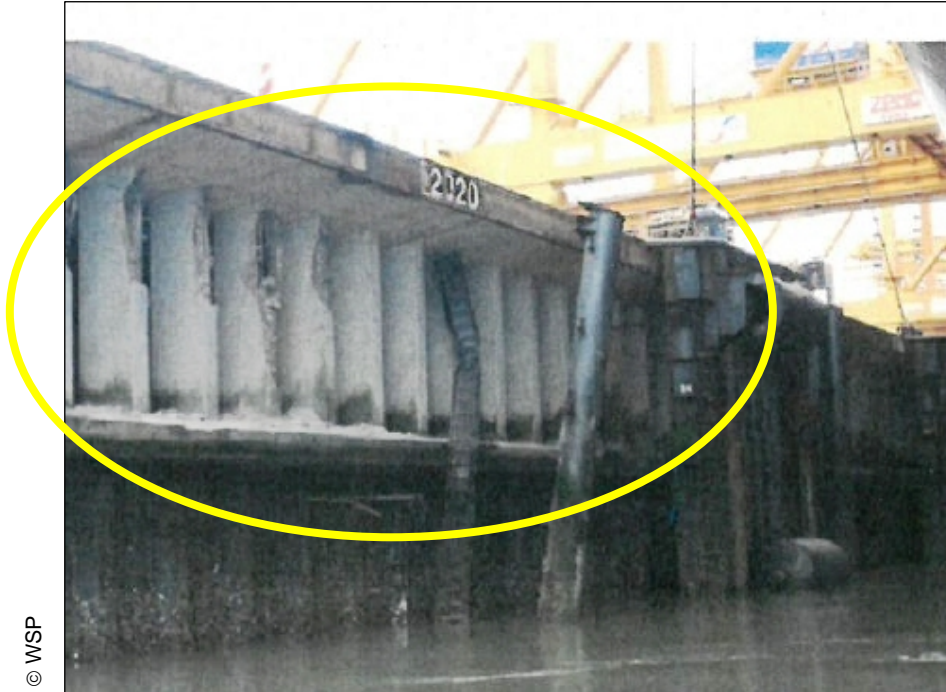
Figure 24: Damage to the pier

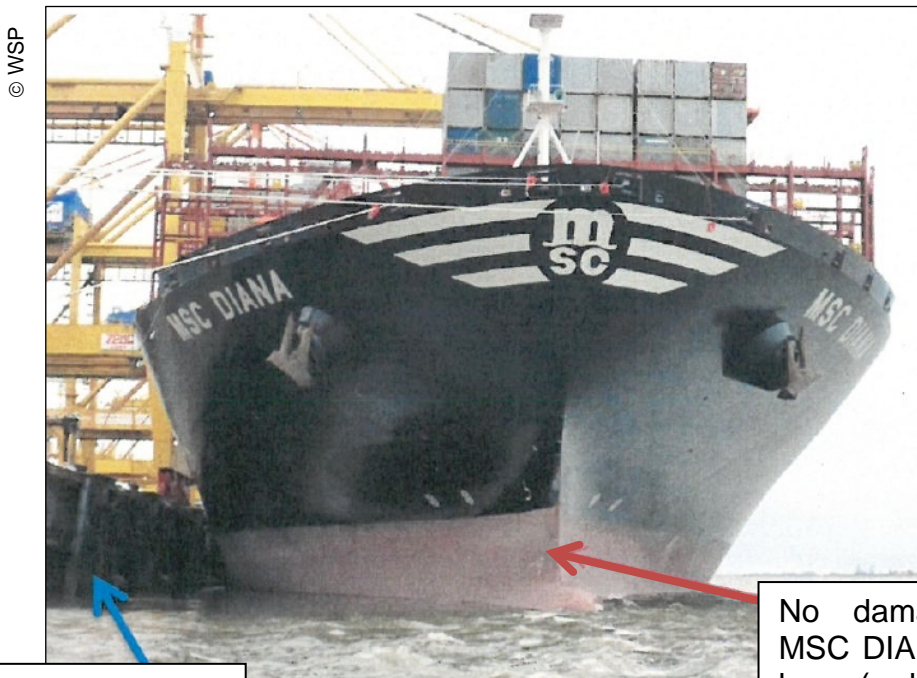
Figure 25: MSC DIANA

The blue arrow shows the scene of the collision between the MERIDIAN and pier.

No damage to the MSC DIANA's bulbous bow (red arrow) was visible during daylight, either.

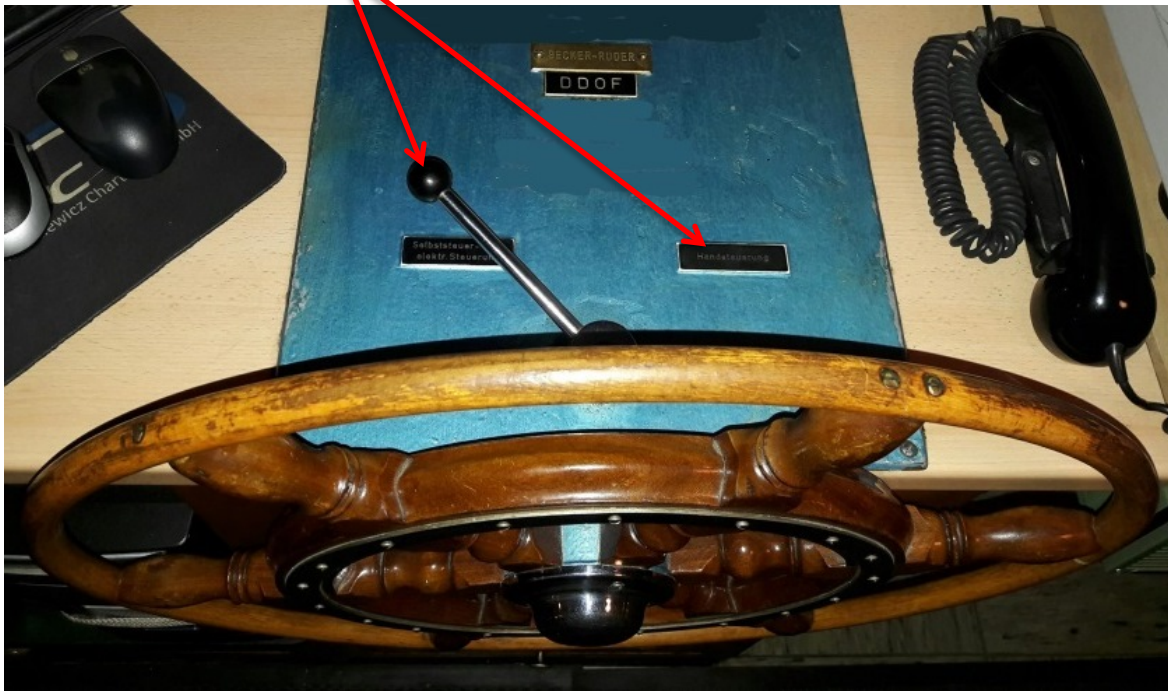
Figure 26: Manual steering and lever switches

A third, non-mandatory means of steering also exists so as to operate the rudder in the event of the electronics failing. However, this requires both setting the lever switch to hand steering (see Figure 26) and switching two valves in the steering gear compartment manually, so as to bypass the defective electronics. This would have made it possible to alter the course and avoid the subsequent collisions with the NEWYORKER and the pier. That this did not happen can probably be explained by the lack of time and the anxiety that started to take hold of the helmsman.

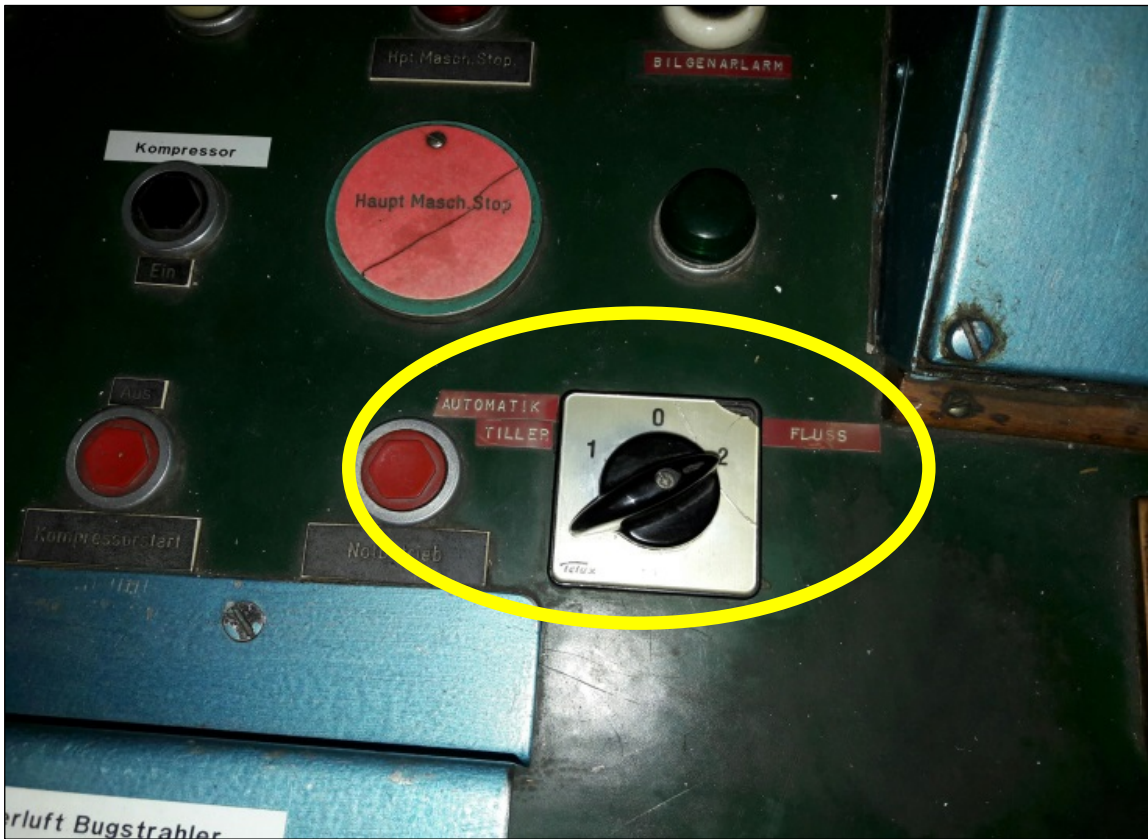
Figure 27: The three-stage rotary switch

To switch from autopilot to rudder control using the riverpilot tiller, the switch must pass the '0' position. This switching must have rendered the entire electric steering gear inoperative.

On 21 November 2016, a service company removed the rotary switch. It was found in the process that the cable contact points were corroded and the screws on the terminal strip loose. A new switch was installed and successfully tested in the presence of the WSP. The crew later opened the entire bridge console and found more corrosion, which it removed.

A service company later found out that the contacts of a switch were loose and corroded. Accordingly, in addition to the primary means of steering, the backup – i.e. the mandatory and basically present second means of steering – also failed.

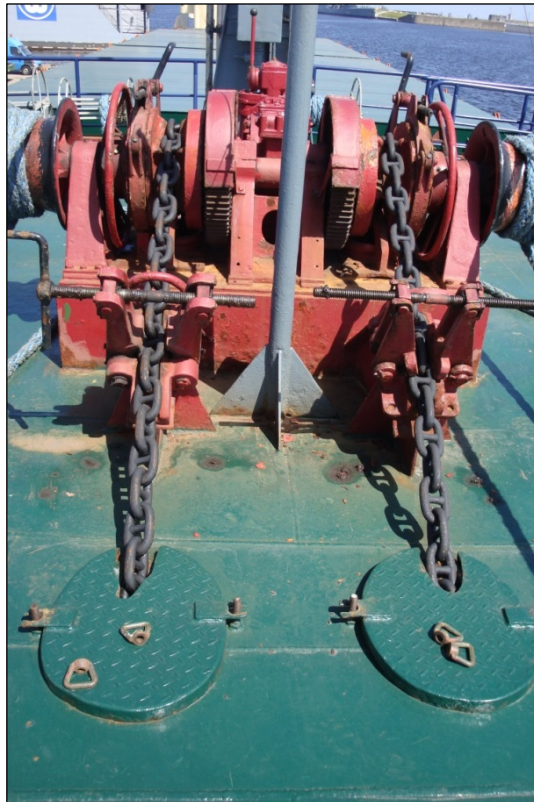
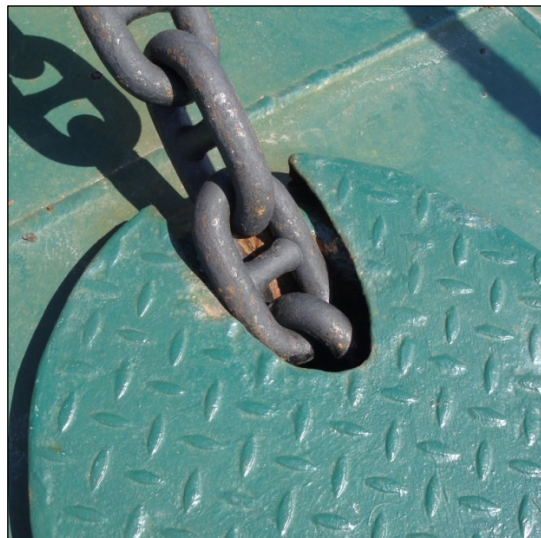
Among other things, the WSP found immediately after the accident that the anchor chains were covered by the fairlead plates, indicating that the anchors were apparently not ready to drop. The master was able to refute this charge with his explanation by showing the BSU that the plates had been specially cut so that they permanently covered the fairlead while at the same time allowing the anchor chains to run out. Figures 31 and 32 illustrate this.
