Investigation Report 431/15

Serious Marine Casualty

**Serious engine damage
followed by fire
on board the cargo vessel THETIS D
on 26 October 2015
in the Kiel Bight**

14 June 2018

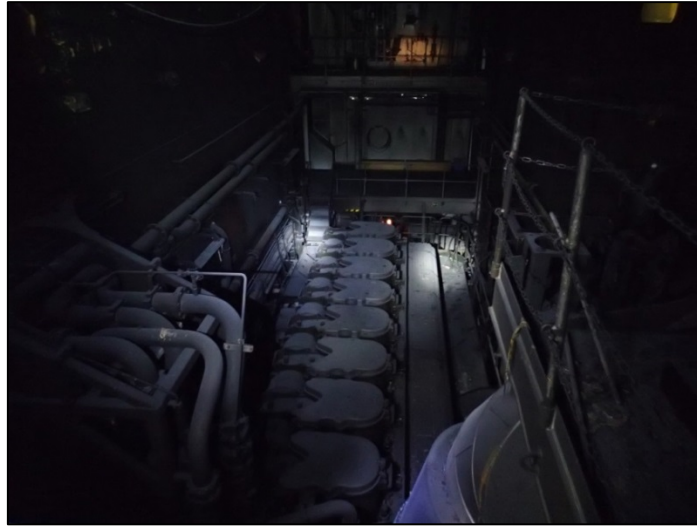
Figure 3: View of the main engine (taken on 27 October 2015)

The BSU's investigation team carried out an initial survey on board in the port of Kiel Ostuferhafen on 27 October 2015. At this point, the engine room only had makeshift lighting because the fire had destroyed most of the lights (see Fig. 3).

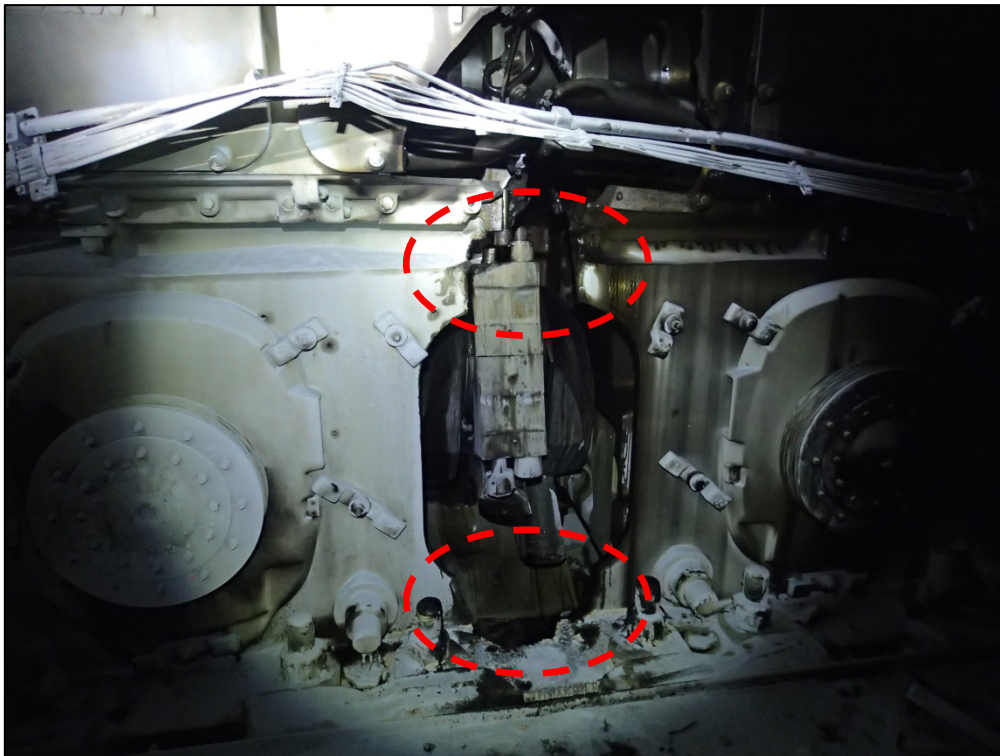
Figure 4: Cylinder 7's drive unit opening (taken on 27 October 2015)

It was found during a visual inspection of the main engine that the drive unit openings on both sides of cylinder 7 exhibited considerable damage. The maintenance cover had been blasted off on both sides and large fragments of the engine frame had broken away (see Fig. 4).

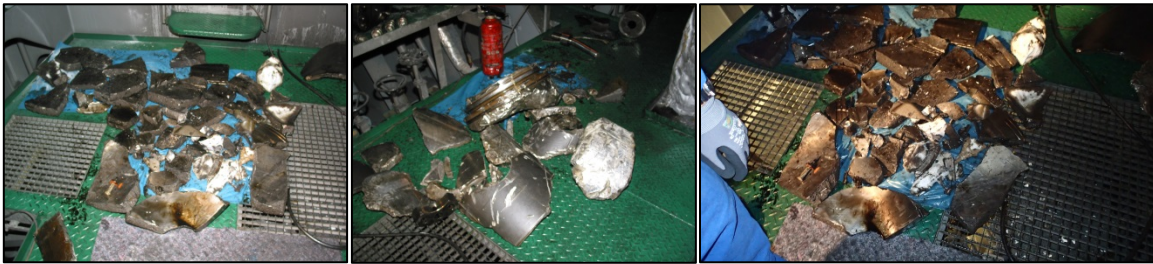
Figure 5: Sorted debris (taken on 3 November 2015)

The BSU commissioned an expert with a detailed investigation of the engine damage and carried out another survey of the THETIS D with him on 3 November 2015. The THETIS D's engine room personnel were interviewed during this survey. In the meantime, a certain amount of cleaning and clearing work had already taken place in the engine room. The debris had been divided into groups of individual components (see. Fig. 5).

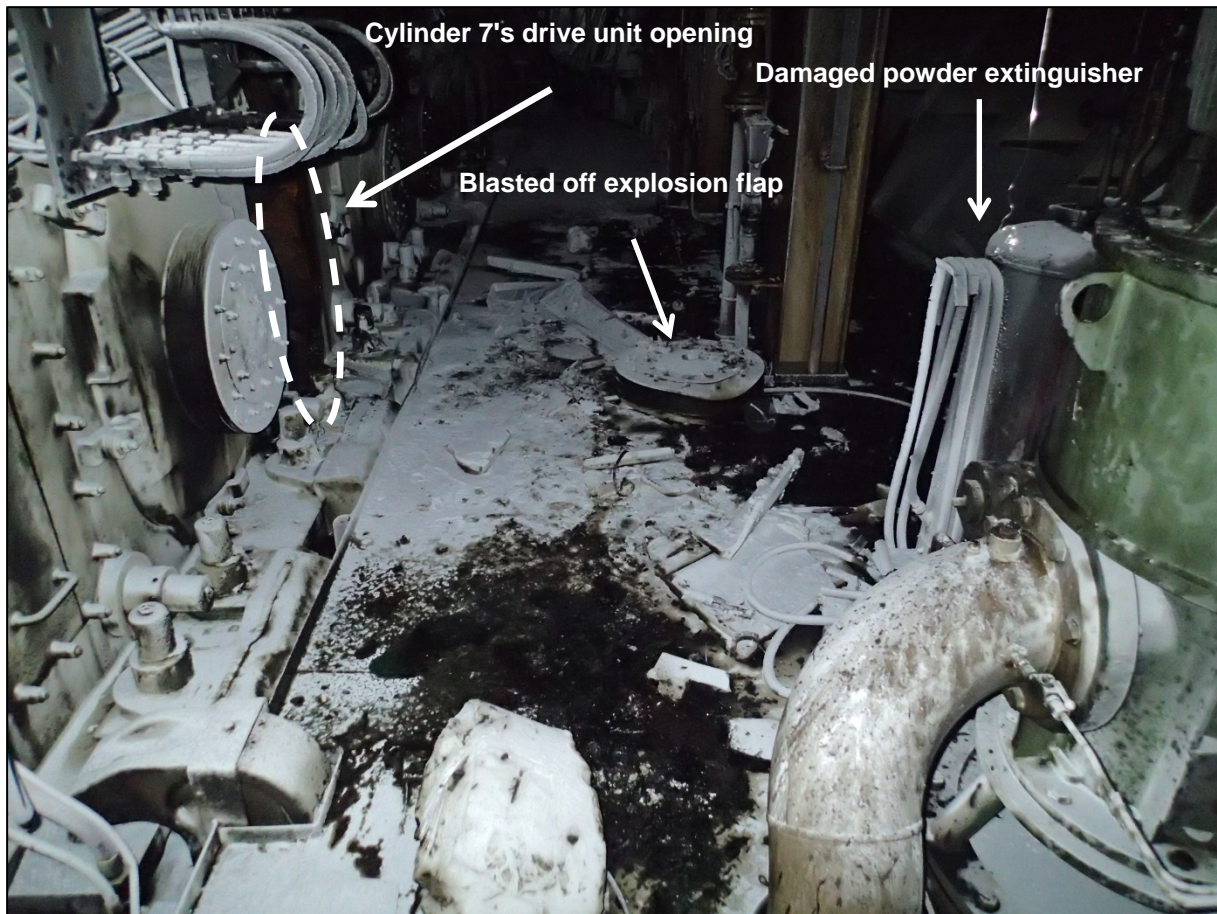
Figure 6: Debris in front of a drive unit opening belonging to cylinder 7
(taken on 27 October 2015)

Parts of the connecting rod were 7 m away. A large amount of lubricating oil had escaped.

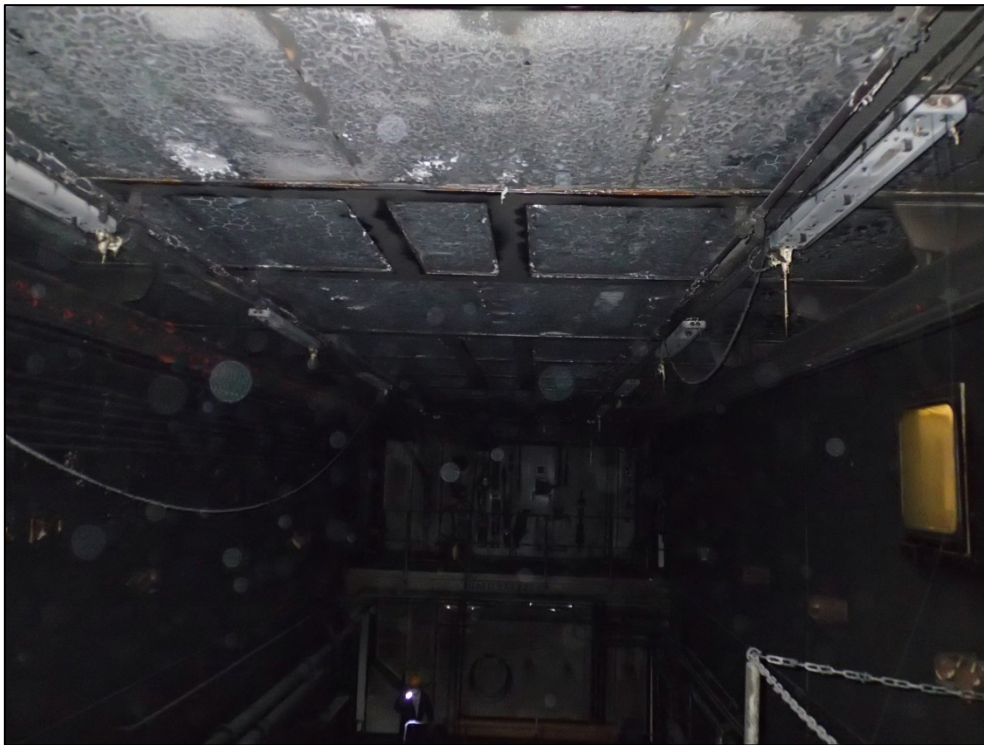
Figure 7: Traces of fire in the engine room

The entire engine room exhibited heavy fire damage (soot build-up, melted overhead lighting – see Fig. 7).

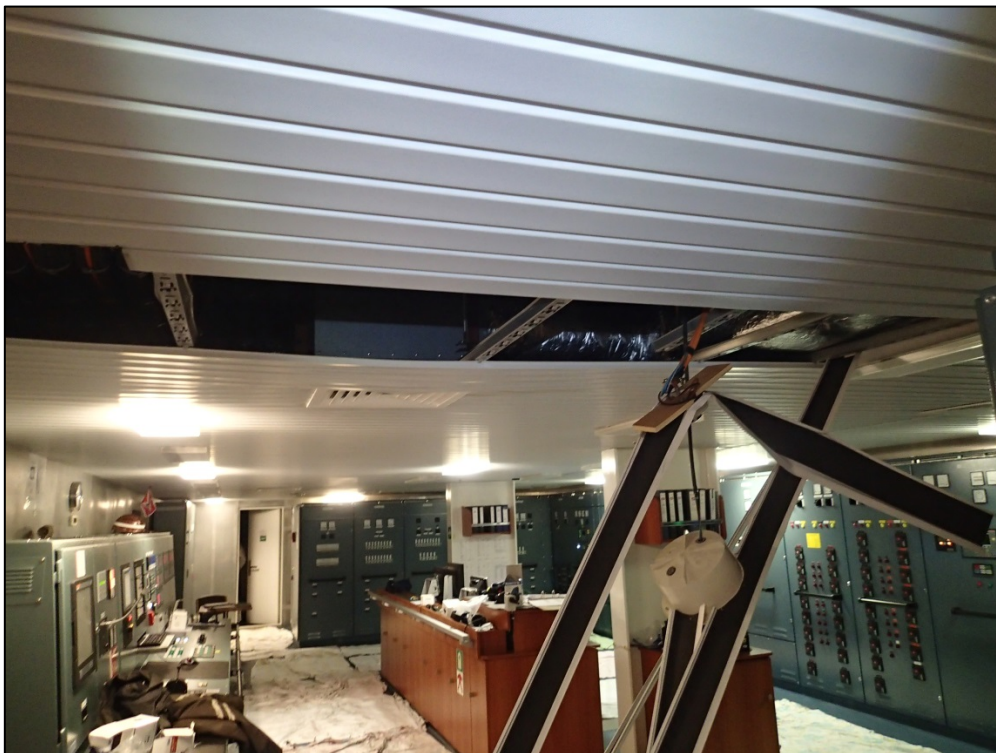
Figure 8: ECR with detached ceiling lining

No traces of fire were visible in the ECR, where only a part of the ceiling lining had loosened (see Fig. 8).

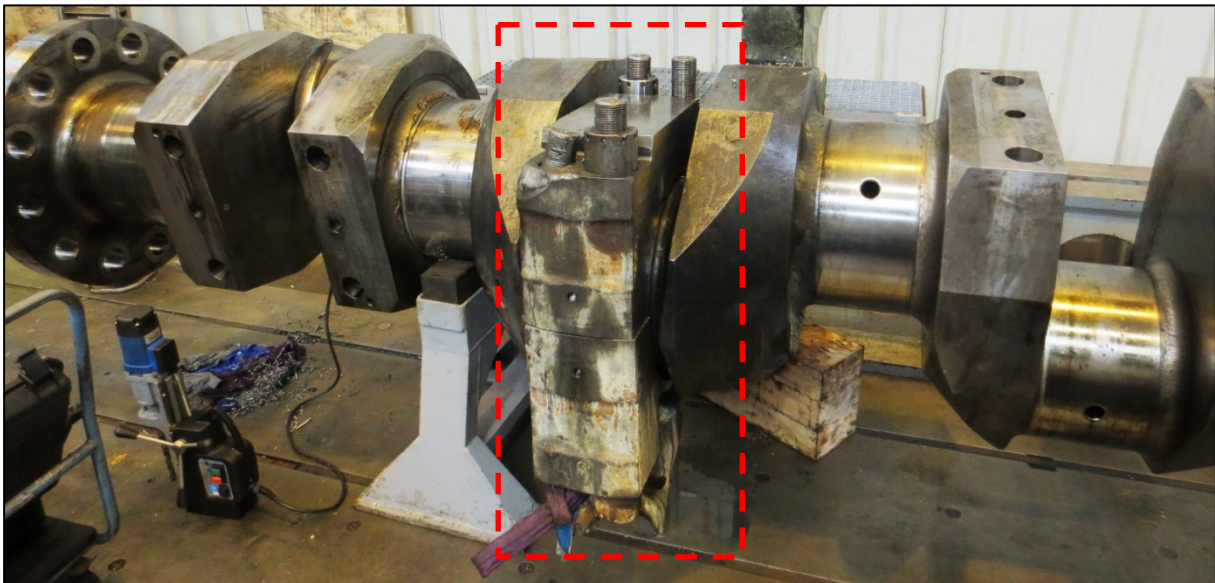
Figure 10: Damaged connecting rod bearing after the removal of the crankshaft

Prof. Dipl.-Ing. Hark Ocke Diederichs assisted the BSU's investigation team in this safety investigation. The assessment centred on the examination of cylinder station 7's damaged connecting rod (see Figure 10).

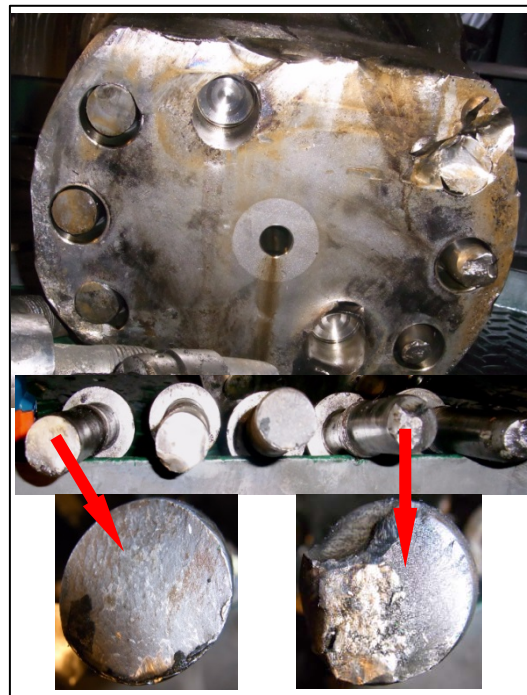
Figure 12: Broken bolts for the split shank

Three of the six connecting bolts for the split shank exhibit typical characteristics of a ductile shear stress break, the other three bolts a ductile bending forced fracture with lateral contraction. This suggests that the connecting rod was first kinked (bending forced fracture), and afterwards the separation surfaces shifted (sliding) and "cut" the other bolts as a result.

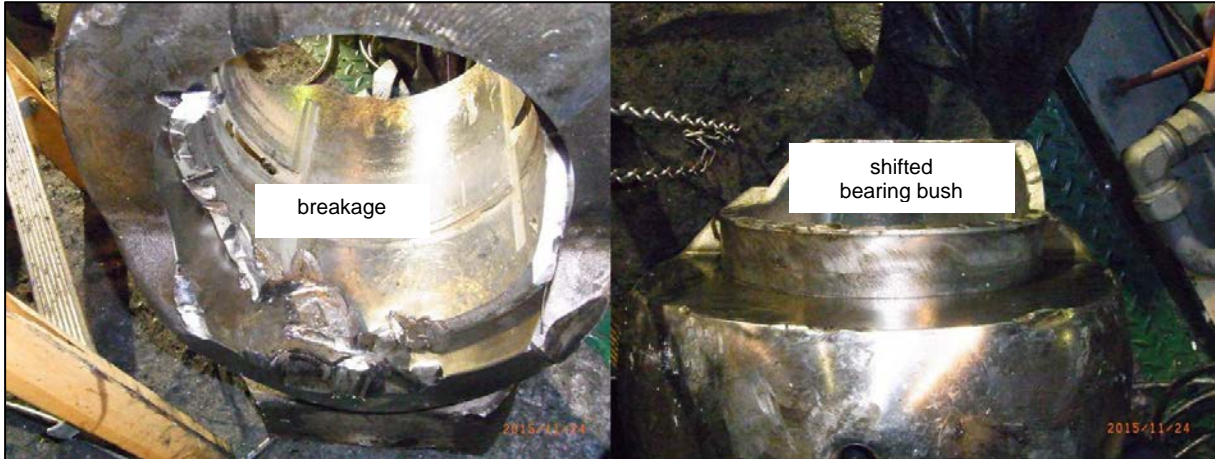
Figure 13: Connecting rod eye with breakage and laterally shifted bearing bush

Large pieces were broken out from the bearing bush in the connecting rod eye and the bush was pushed approx. 50 mm out of the bore. The connecting rod eye and bearing bush exhibit heat tones. [...]

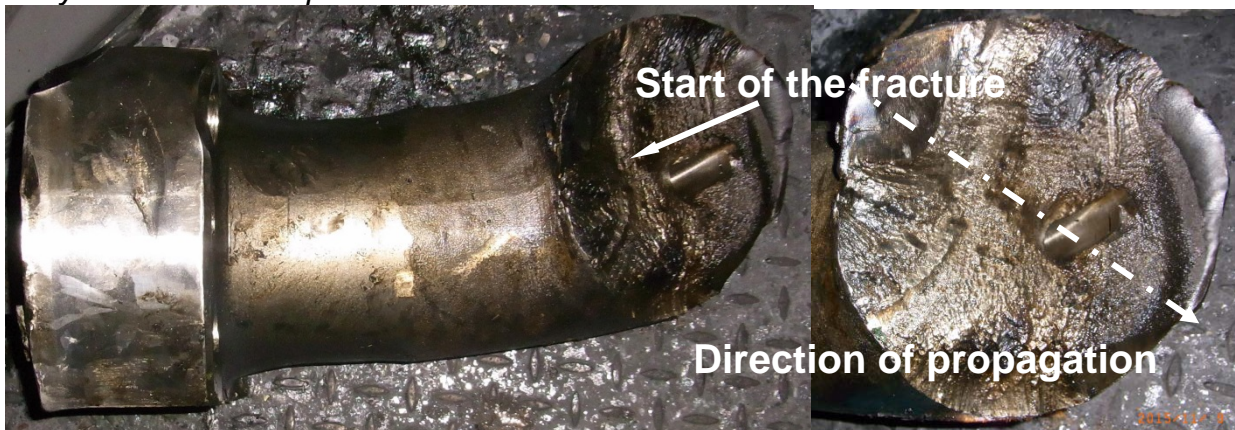
Figure 14: Broken connecting rod with detailed enlargement of the broken surface

The broken surface exhibits the typical characteristics of a ductile forced fracture. It is noticeable that the fracture begins in the middle and then continues in a curve. This suggests that a compressive force and torsional force must have been applied at the same time."

After assessing the fracture patterns on the bolts, the expert arrives at the conclusion that the connecting rod fractured under great force due to buckling. This is reportedly only possible if the piston is blocked while moving upward.

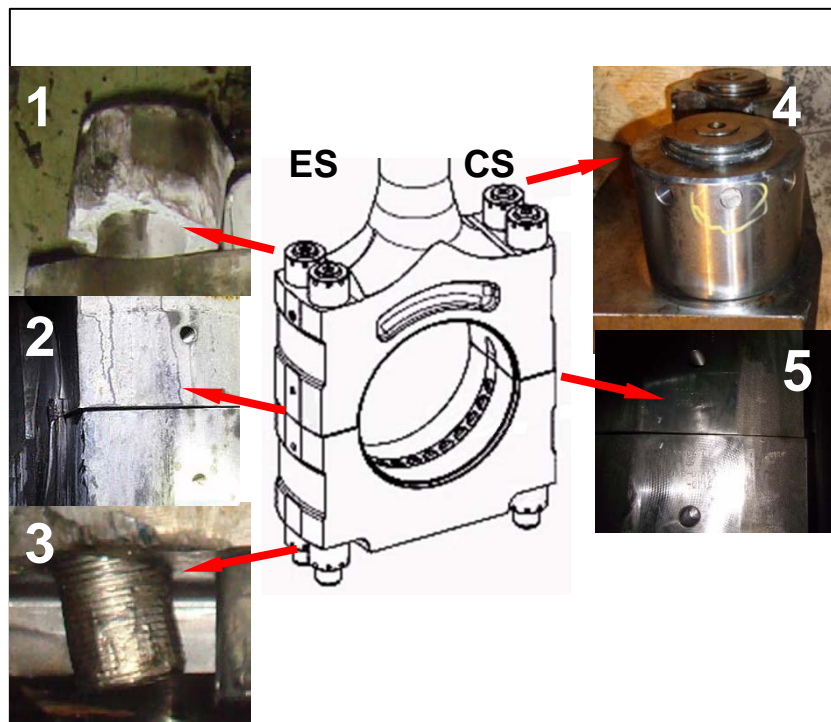
"The connecting rod bearing was fixed and would not rotate around the crank pin. It was not possible to measure the bearing play, but it could be felt to be large. The visible external damage is shown in [Figure 15; label ES = exhaust side, CS = control side]."

Figure 15: Visible external damage on the connecting rod bearing

- 1 *Ring nut fragmented and free end of thread bent.*
- 2 *Bearing shell squeezed out sideways, gap between bearing housing halves and shift of the housing halves*
- 3 *Bolt exited out of bearing housing*
- 4 *Broken rotating pin in the upper ring nut*
- 5 *Wedge-shaped gap between bearing housing halves*

- the serious engine damage was caused by low pre-stressing on the connecting rod bearing bolts;
- excessive wear on the connecting rod bearing occurred, subsequently resulting in deformation. This caused a reduction in bolt force, among other things;
- the engine's loss of power worsened due to increased friction in cylinder 7 (piston seizure), whereupon the automatic load governor had to increase the fuel supply to compensate for the reduced revolution rate, and
- the expert thinks it unlikely that previous damage to the bearing shells would have caused the present damage to the bearing.

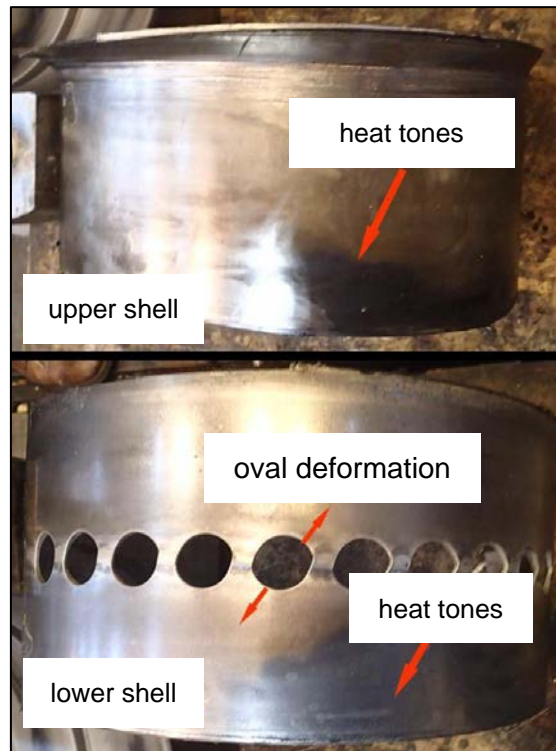
Figure 16: Rear side of the bearing shells

The expert was unable to find any scoring or other signs that were indicative of rotating bearings on the bearing seats or on the back of the bearing shells. According to his diagnosis, both bearing shells had been driven out of the bearing bore laterally and exhibited localised, blue discolouration. The bores in the lower shell exhibited oval deformation (see Figure 16), which permits the conclusion that misalignment had occurred.

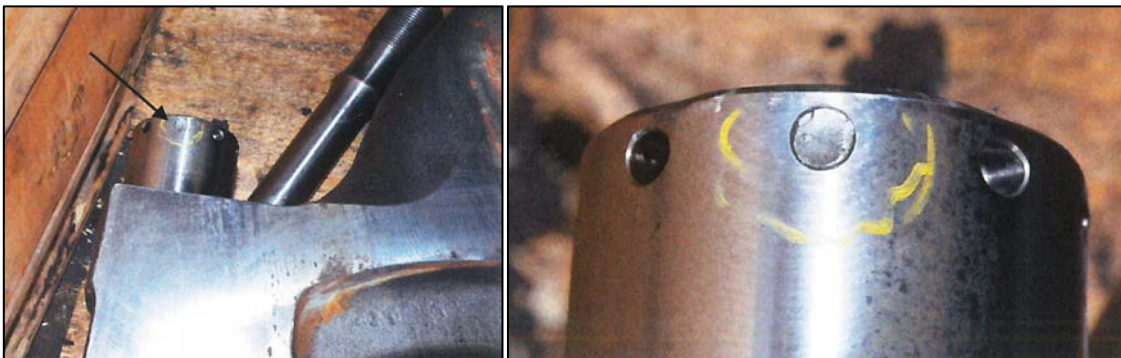
Although the BSU's investigators did not receive any information regarding the exact procedure for inspecting the connecting rod bearing on the THETIS D, the bolted connections examined do permit conclusions as to the type and quality of the inspection by the then chief engineer officer. When examining the upper connecting rod nuts, it was noticed that one of the nuts still had a broken tommy bar in the bore (see Figure 23).

Figure 23: Broken tommy bar in one of the upper connecting rod nuts

Tommy bars are used to tighten the tensioner nuts by hand. The tommy bar's diameter was 12 mm, meaning it could not have snapped due to manual tightening alone. The fragment found is thus an indication of the application of greater force, e.g. by lateral blows with a hammer.

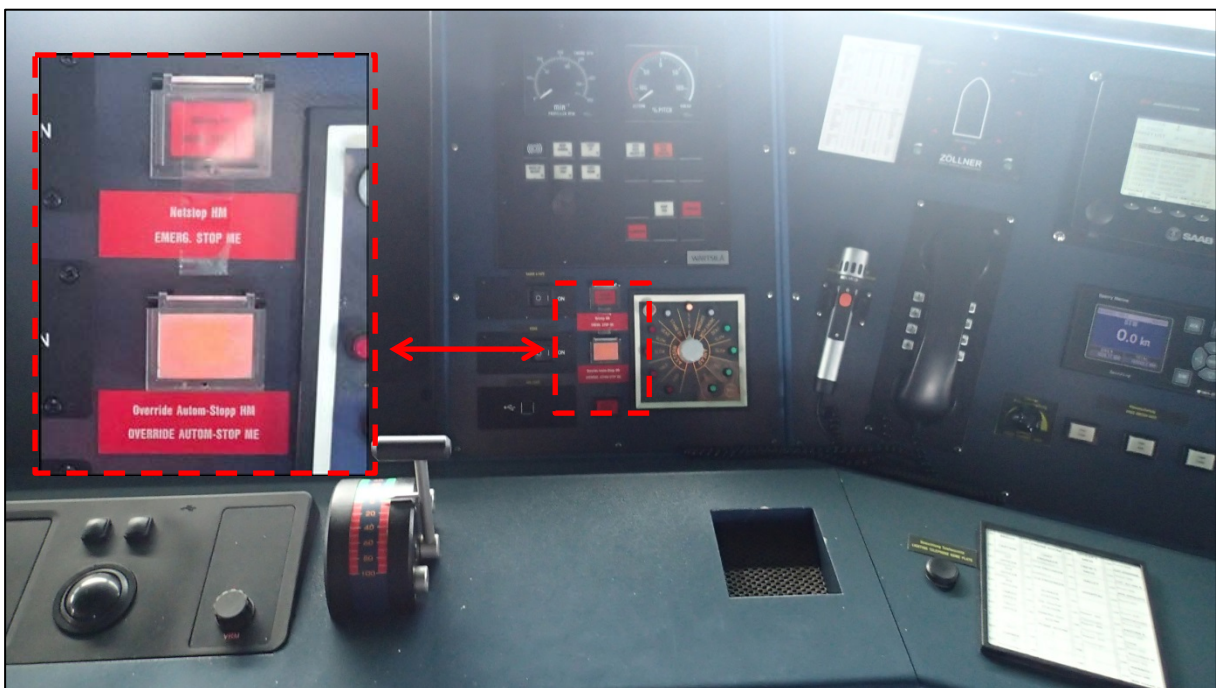
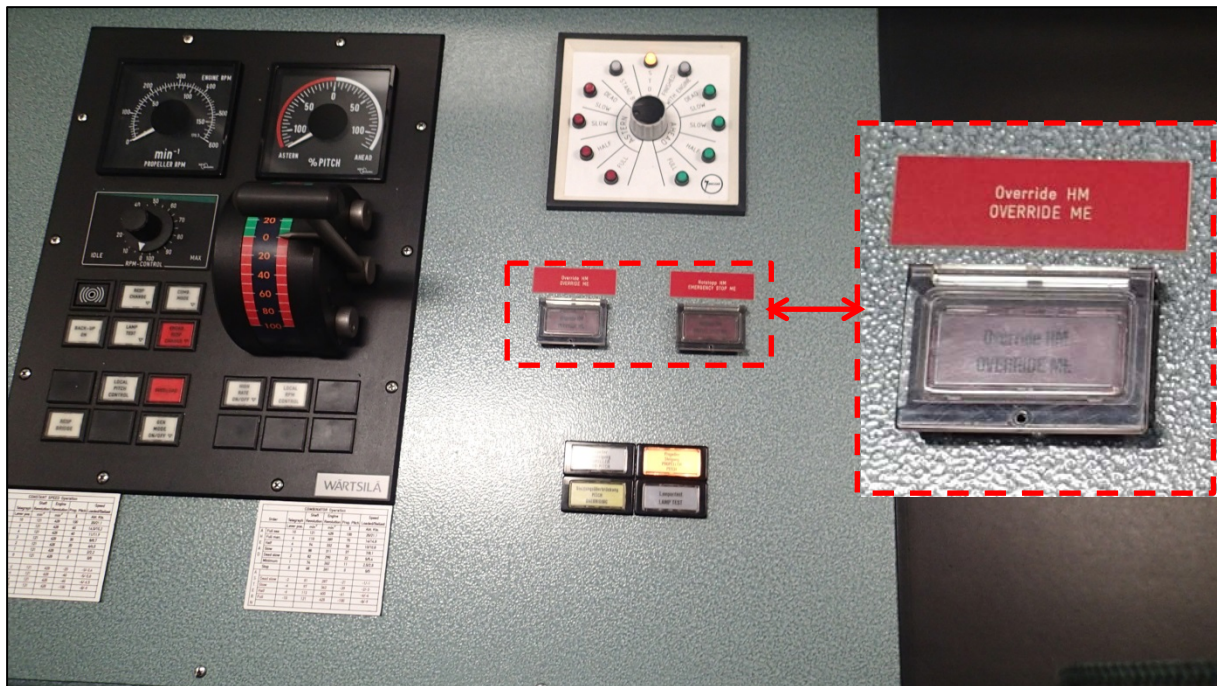
For example, it was evident that the ship's command of the THETIS D regularly enables override mode in estuary trading. Override is an emergency mode that can be enabled by pushbutton on the bridge and in the ECR. When override is enabled, the main engine is not stopped automatically if limits previously defined in the system are exceeded or not reached. The main engine's numerous safety systems are virtually cancelled out, i.e. the main engine continues to run unimpeded. The purpose of override is to keep the ship manoeuvrable in exceptional situations when greater risks would otherwise prevail.

The pushbutton on the bridge and in the ECR for enabling override mode is positioned next to the main engine's emergency shutdown and has a safety cover to prevent unintentional operation (see Figures 24 and 25).
