# Interim Investigation Report pertaining to the serious marine casualty 241/18

Grounding of the Tank Motor Vessel PAZIFIK off Indonesia on 9 July 2018

5 July 2019

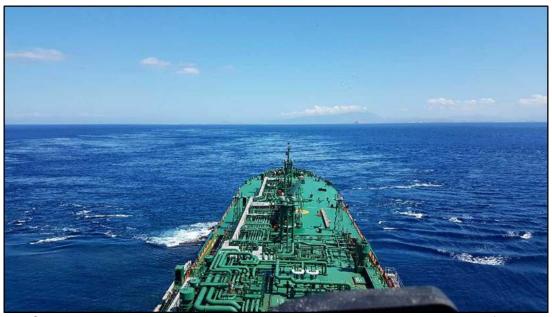
Shoal on port side and starboard side with rocks on the water surface

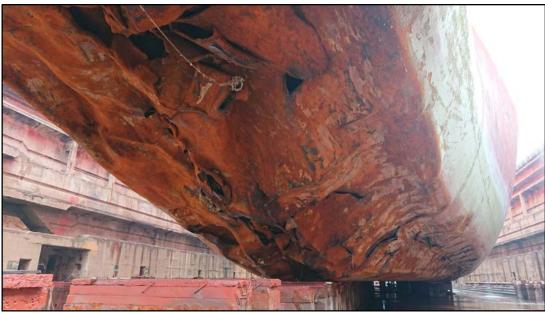
At about 1110 local time on 9 July 2018, the German tank motor vessel PAZIFIK grounded on a shoal between the islands of *Komodo* and *Banta* on  $\phi$  08°29,21'S  $\lambda$  119°20,31' E. The ship carried a cargo of 18,000 t ammonia. No cargo spilled since only the forepeak and ballast water tanks were damaged. At about 0850 local time on 11 July 2018 the PAZIFIK manoeuvred clear of the shoal by transferring cargo and ballast water and sailed to a repair yard in Singapore by her own power.

Damaged forepeak and ballast water tanks

Approx. 50 m of the double bottom were renewed during the repair work and the rudder, which was damaged during the towing attempt, was repaired.

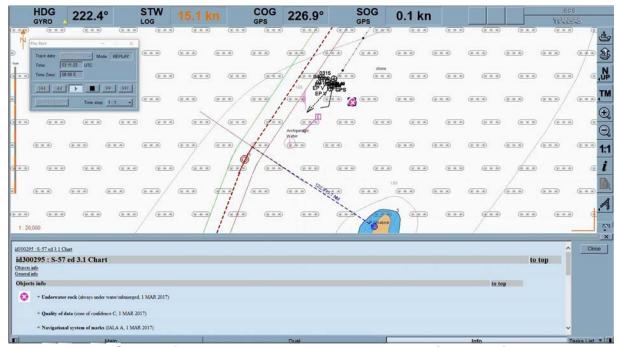
On the day of the accident, the ship was navigated by a Transas Navilailor 4000 ECDIS and the ENC-nautical chart id 300295 ed.3.1 S-67. The shallow was not plotted in this nautical chart.

Scene of the accident on the electronic chart (on board)
